Inspection Photos

API: 071-09420

Operator: EVERGREEN NATURAL RESOURCES

Inspection Date: 3/23/2020

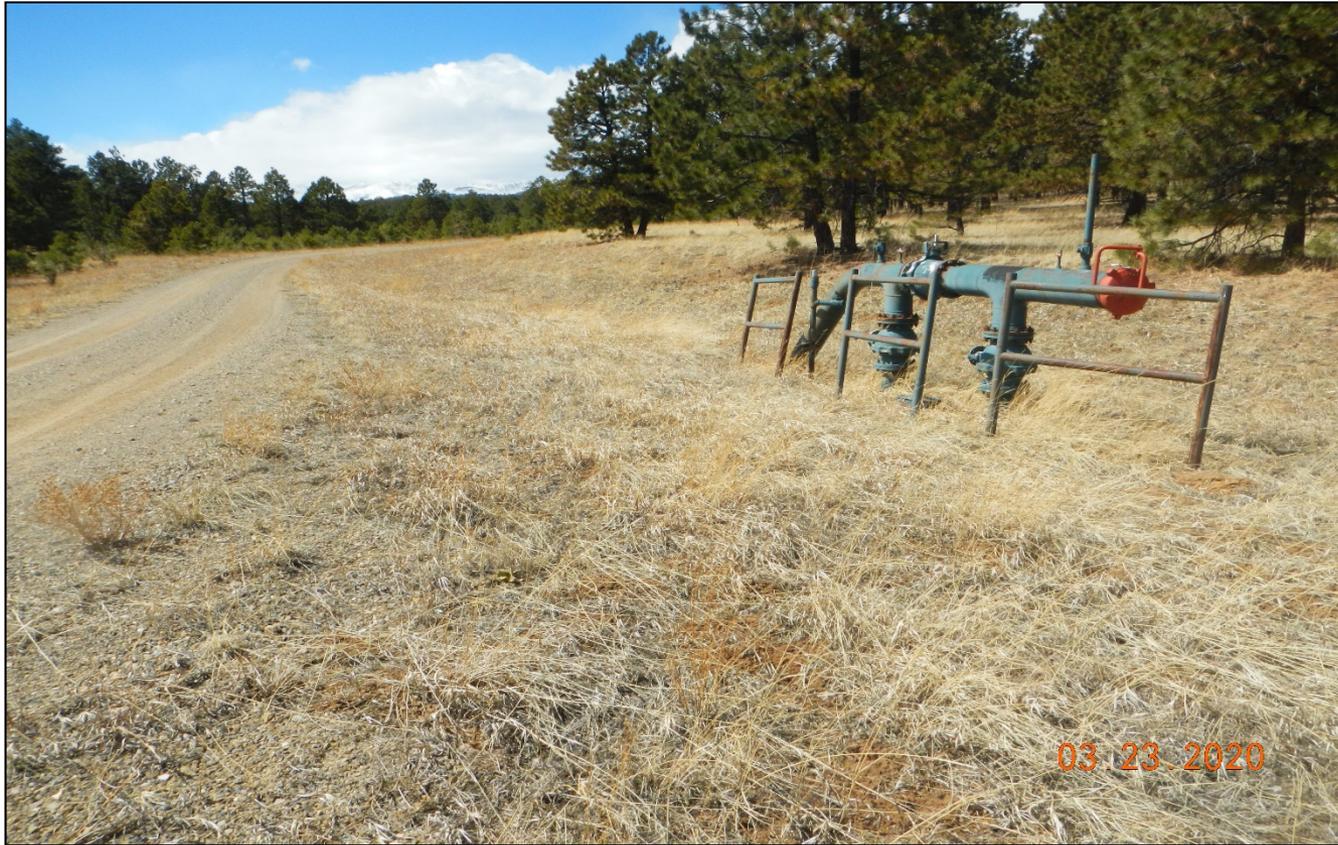
Photo 1. The pig launcher receiver remains along the main access road. No other PR wells remain west along the road. Lat/Long: 37.25975,-104.97719.

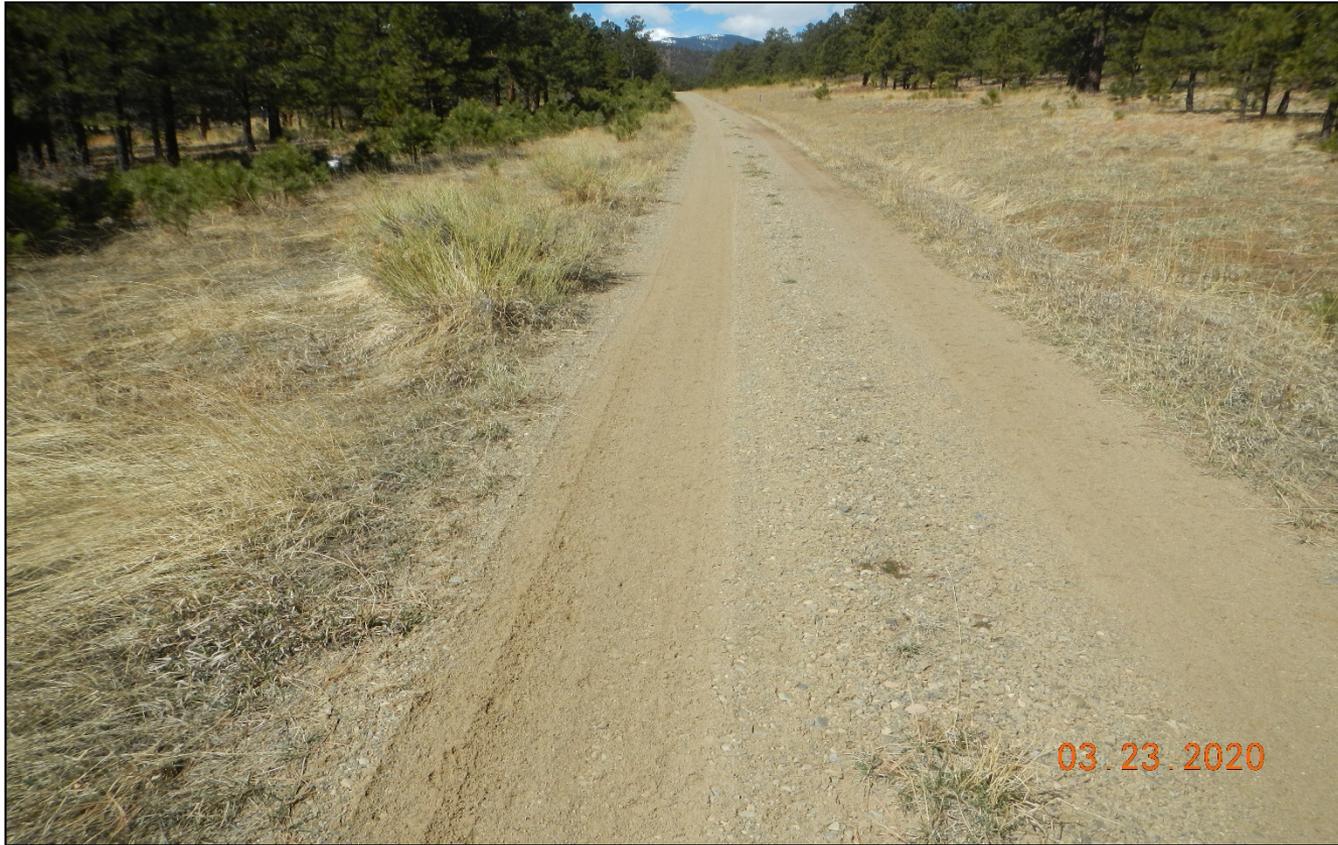
Photo 2. Facing west along the main access road. This road appears to be pre-existing.

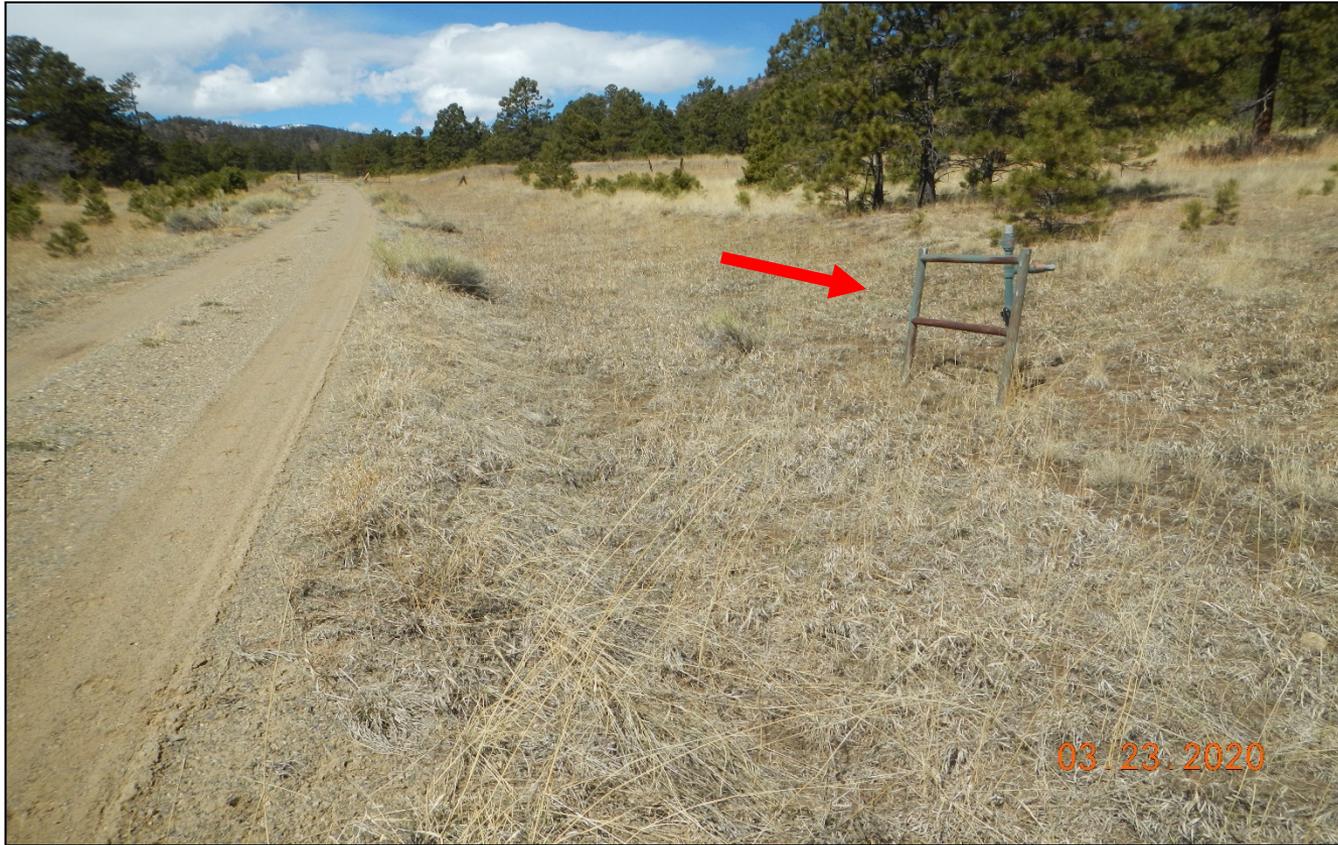
Photo 3. There is a pipe riser that remains along the main access road at Lat/Long:37.26190,-104.98726.

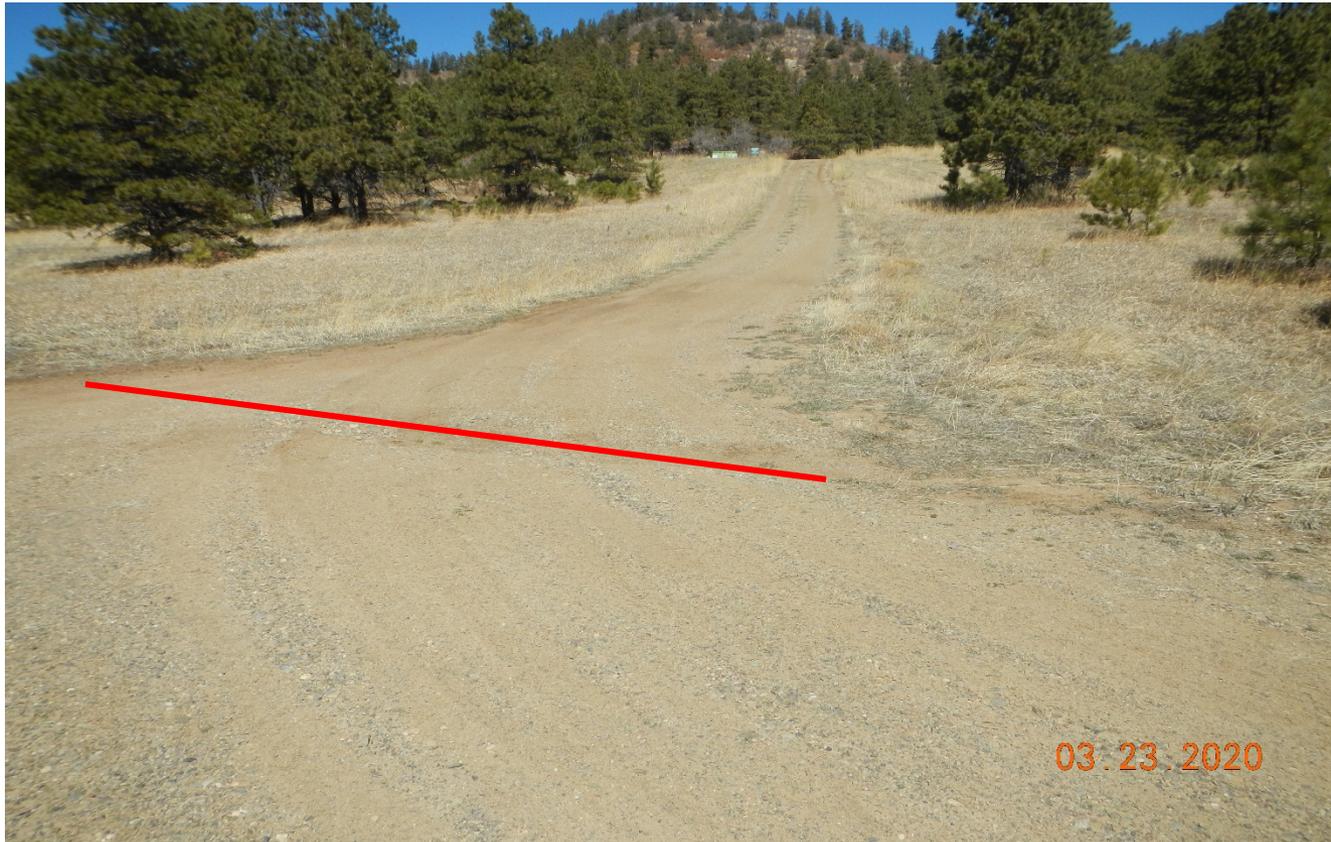
Photo 4. Facing northwest at the beginning of the access road (above red line). This road was not pre-existing and has not been reclaimed.

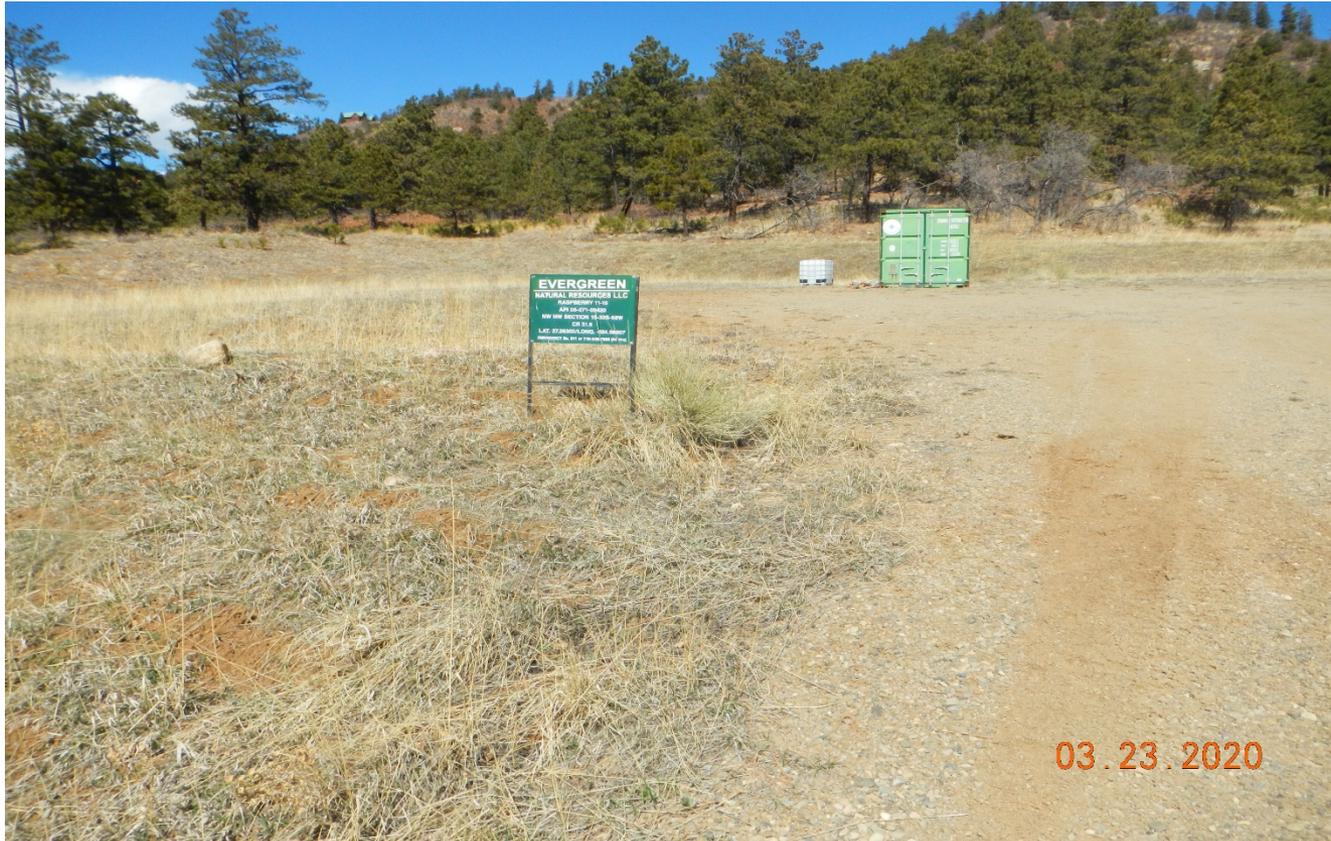
Photo 5. Facing northwest toward the location. The location has not been recontoured and reclaimed.

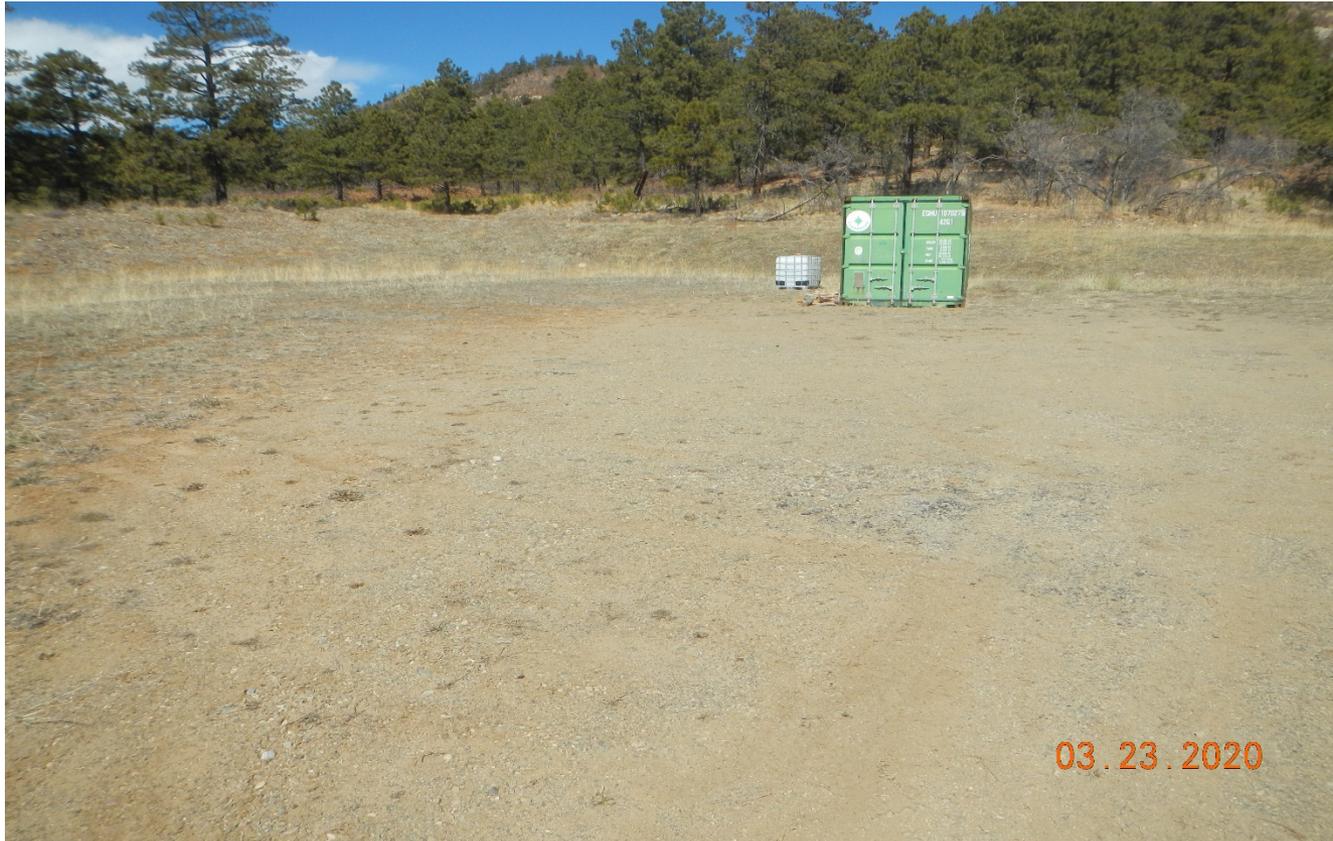
Photo 6. Facing northwest toward the location. A connex storage container is placed on location. The center of the location is bare of vegetation and gravel remains.

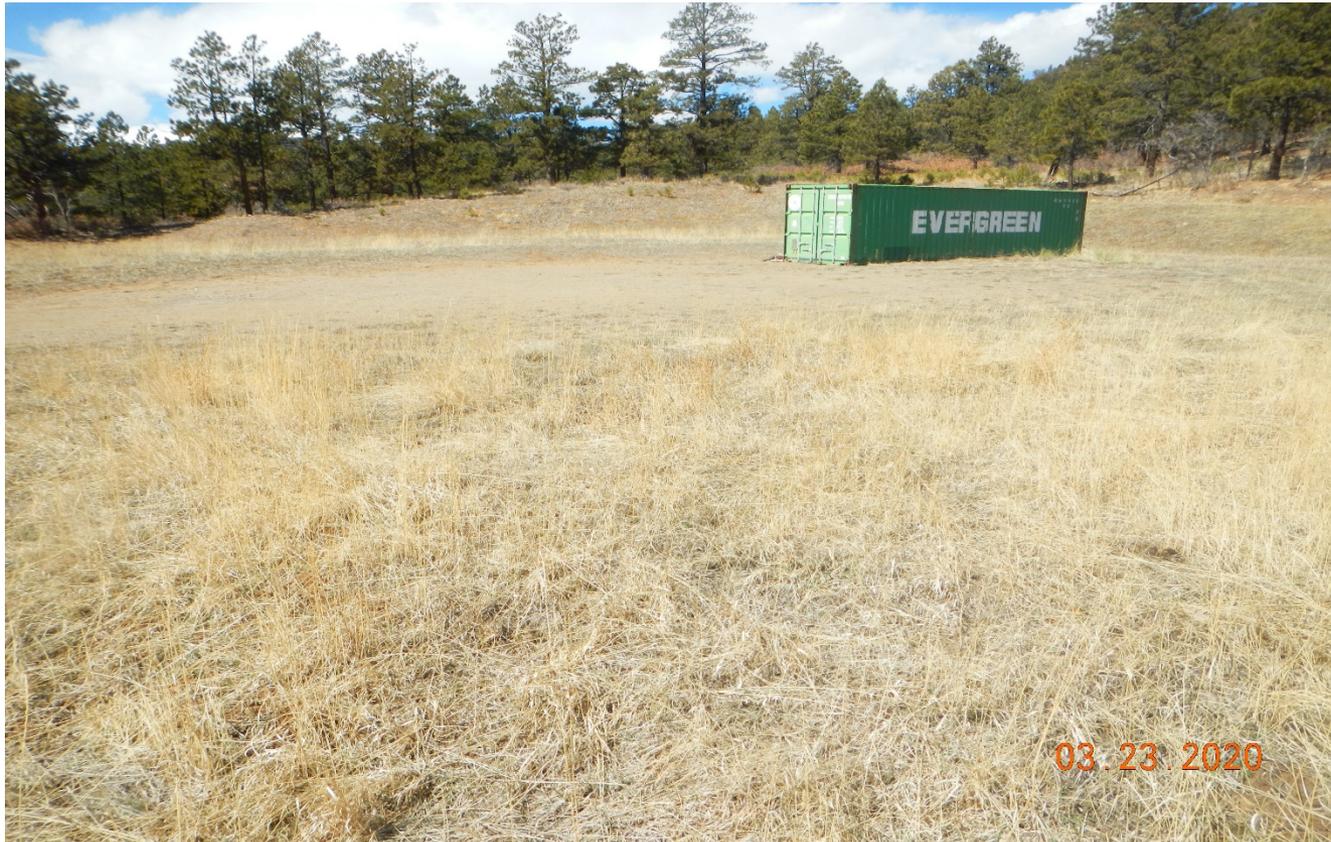
Photo 7. Facing northwest toward the location. A connex storage container is placed on location.
