Inspection Photos

Location Name: MARALEX RESOURCES INC FEDERAL-68S98W /25SESW

Location ID: 312507

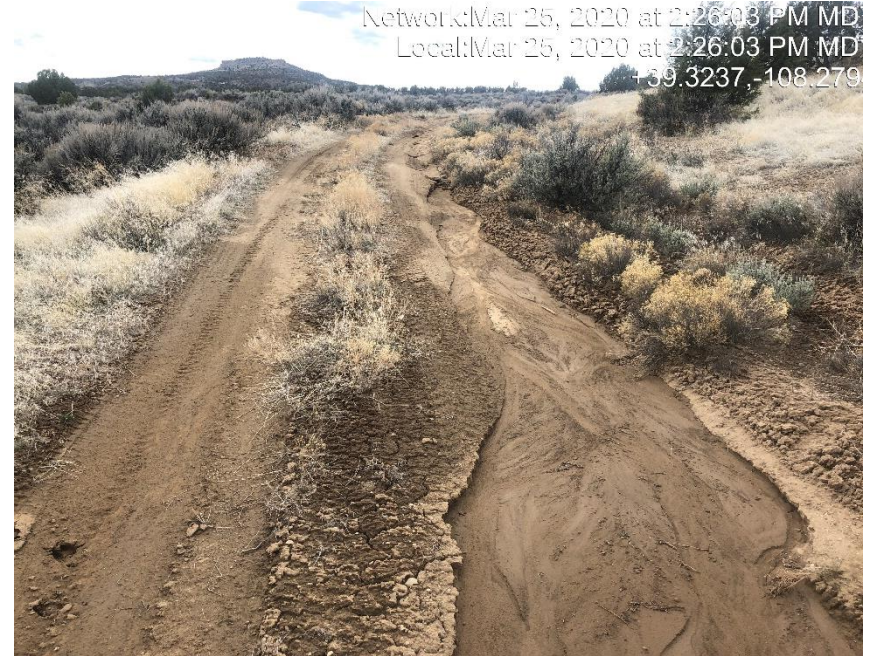
Photo #0835 Access road has not been maintained.

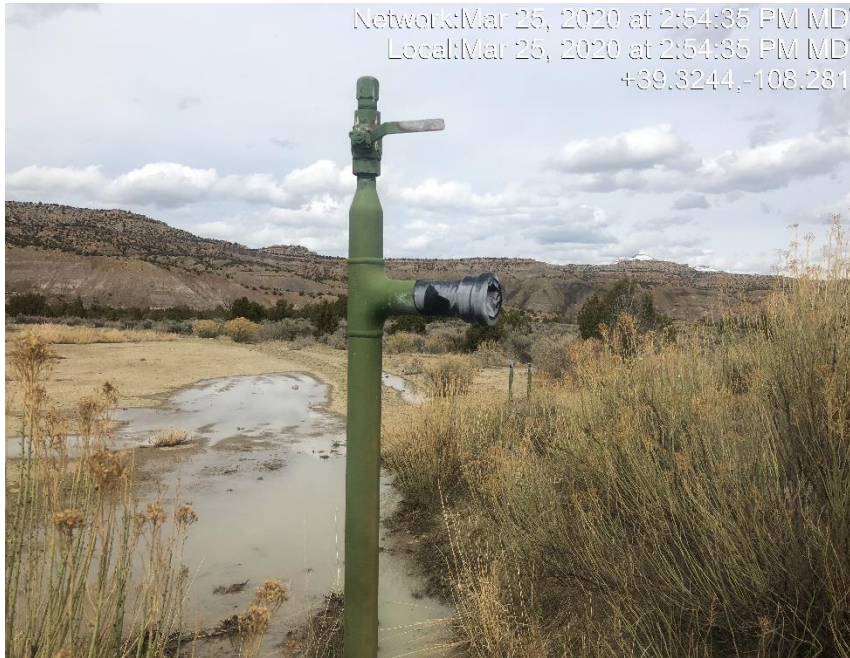
Photo #0837 Multiple flow line risers not LO/TO.

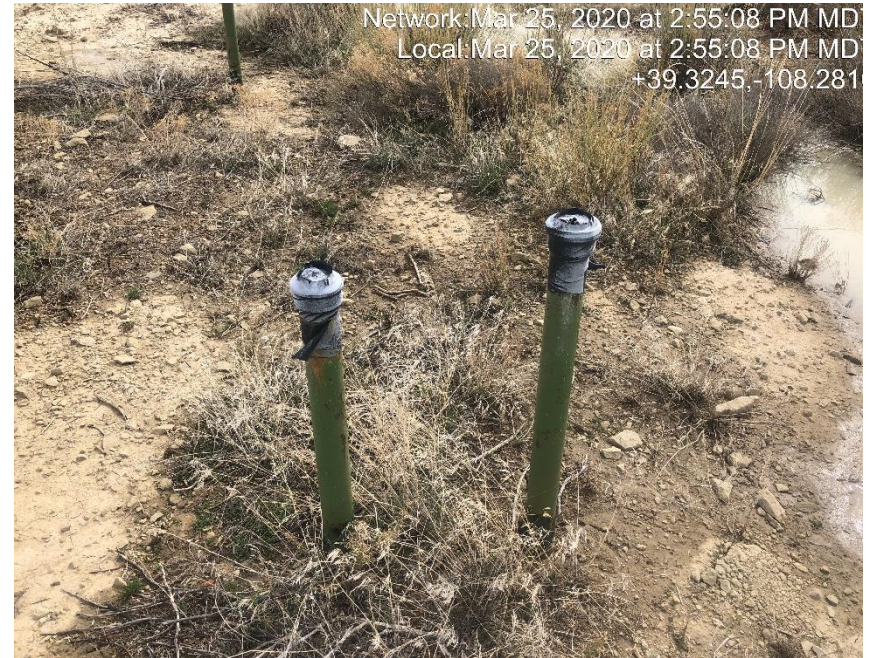
Photo #0838 Multiple flow line risers not LO/TO.

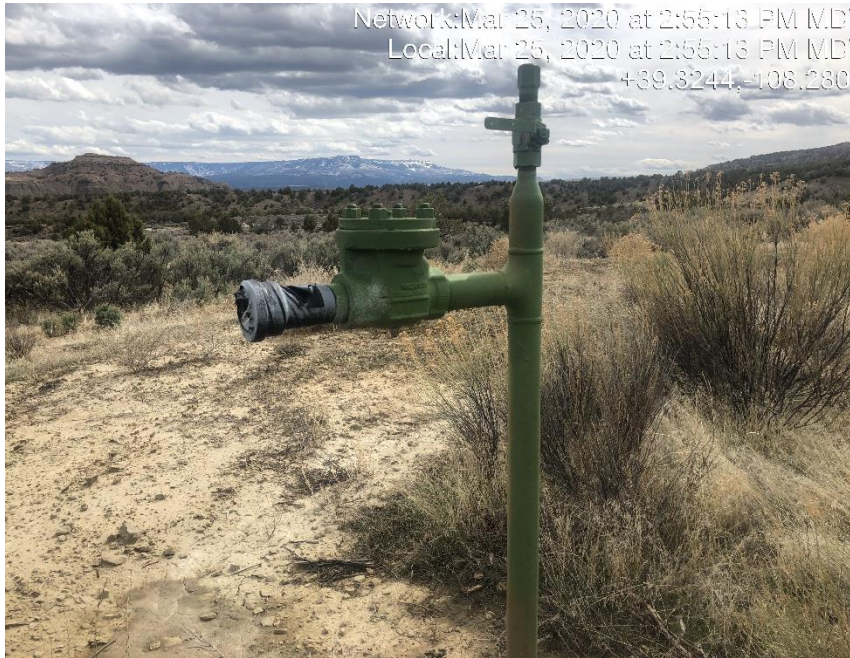
Photo #0839 Multiple flow line risers not LO/TO.

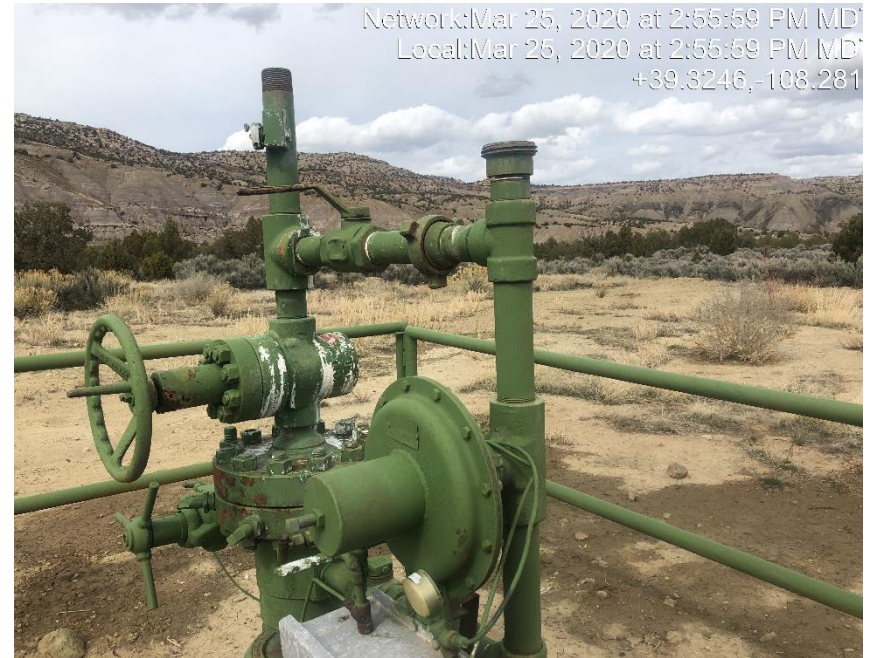
Photo #0840 Multiple flow line risers not LO/TO.

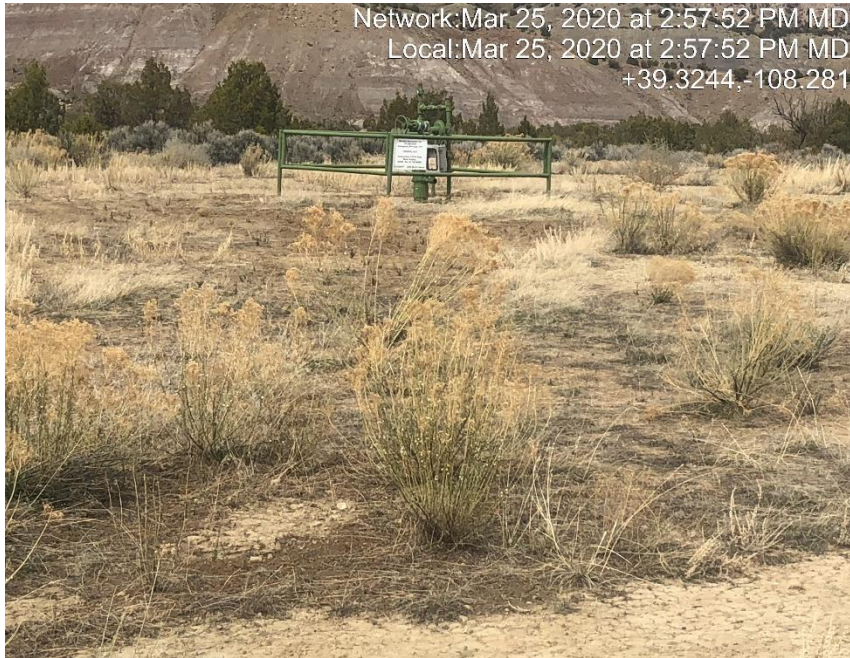
Photo #0841 Multiple places with debris on location.
