Banta Ridge 16-19-1-103

API: 05-103-10311

Inspection: 700400672

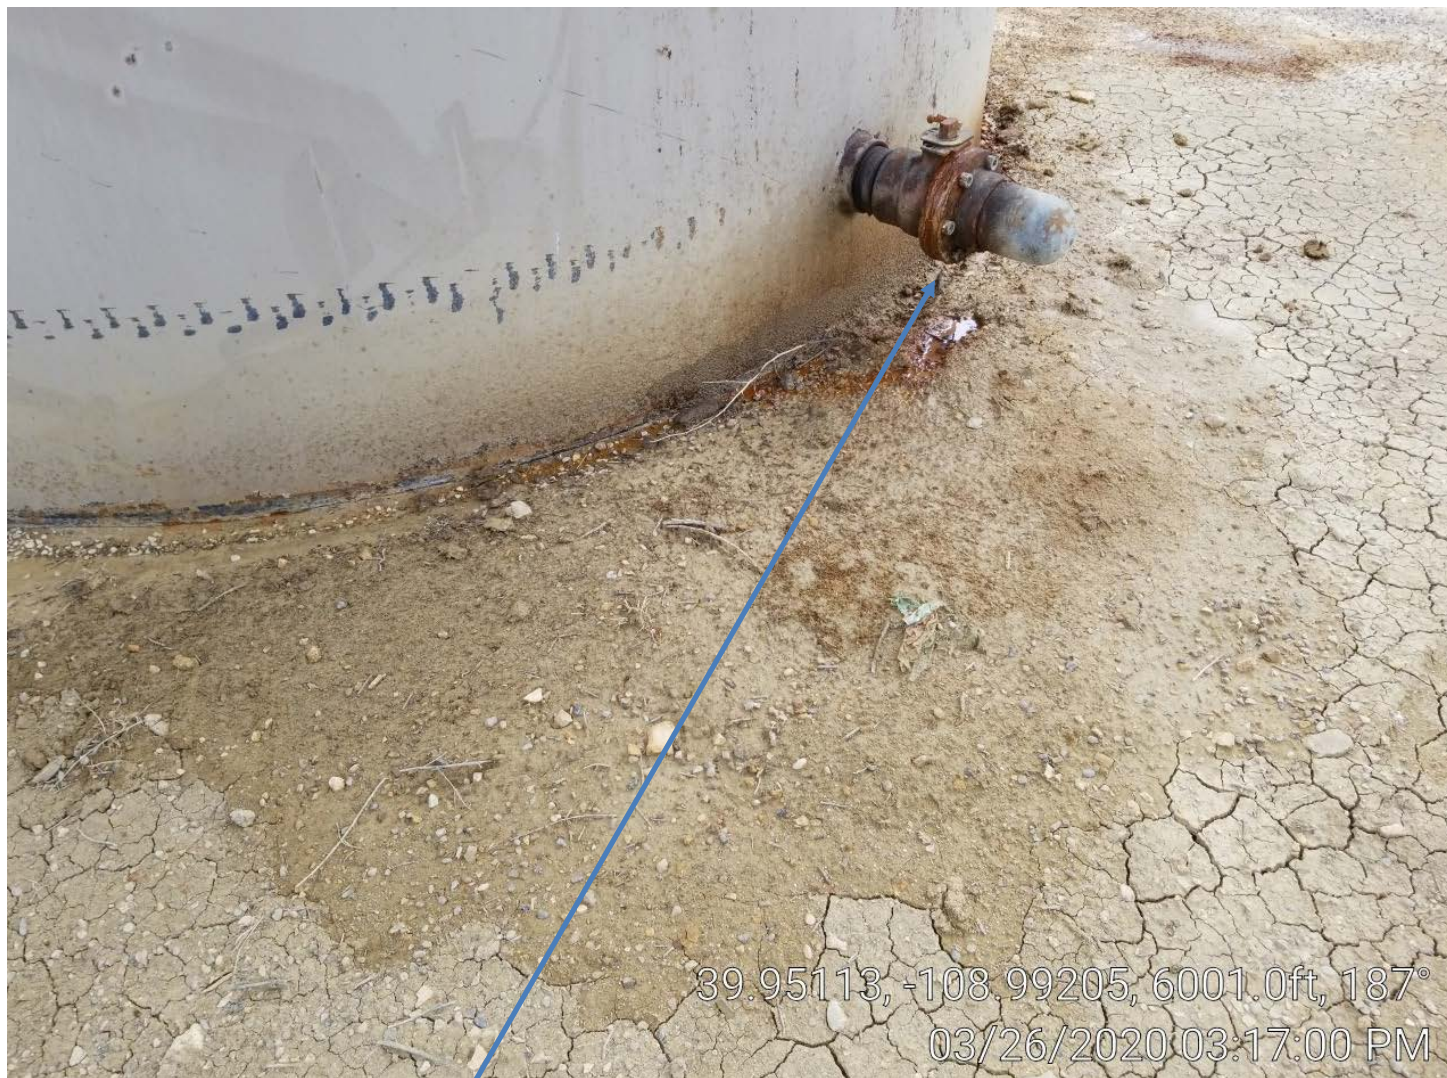
Photo 5. Leaking tank.

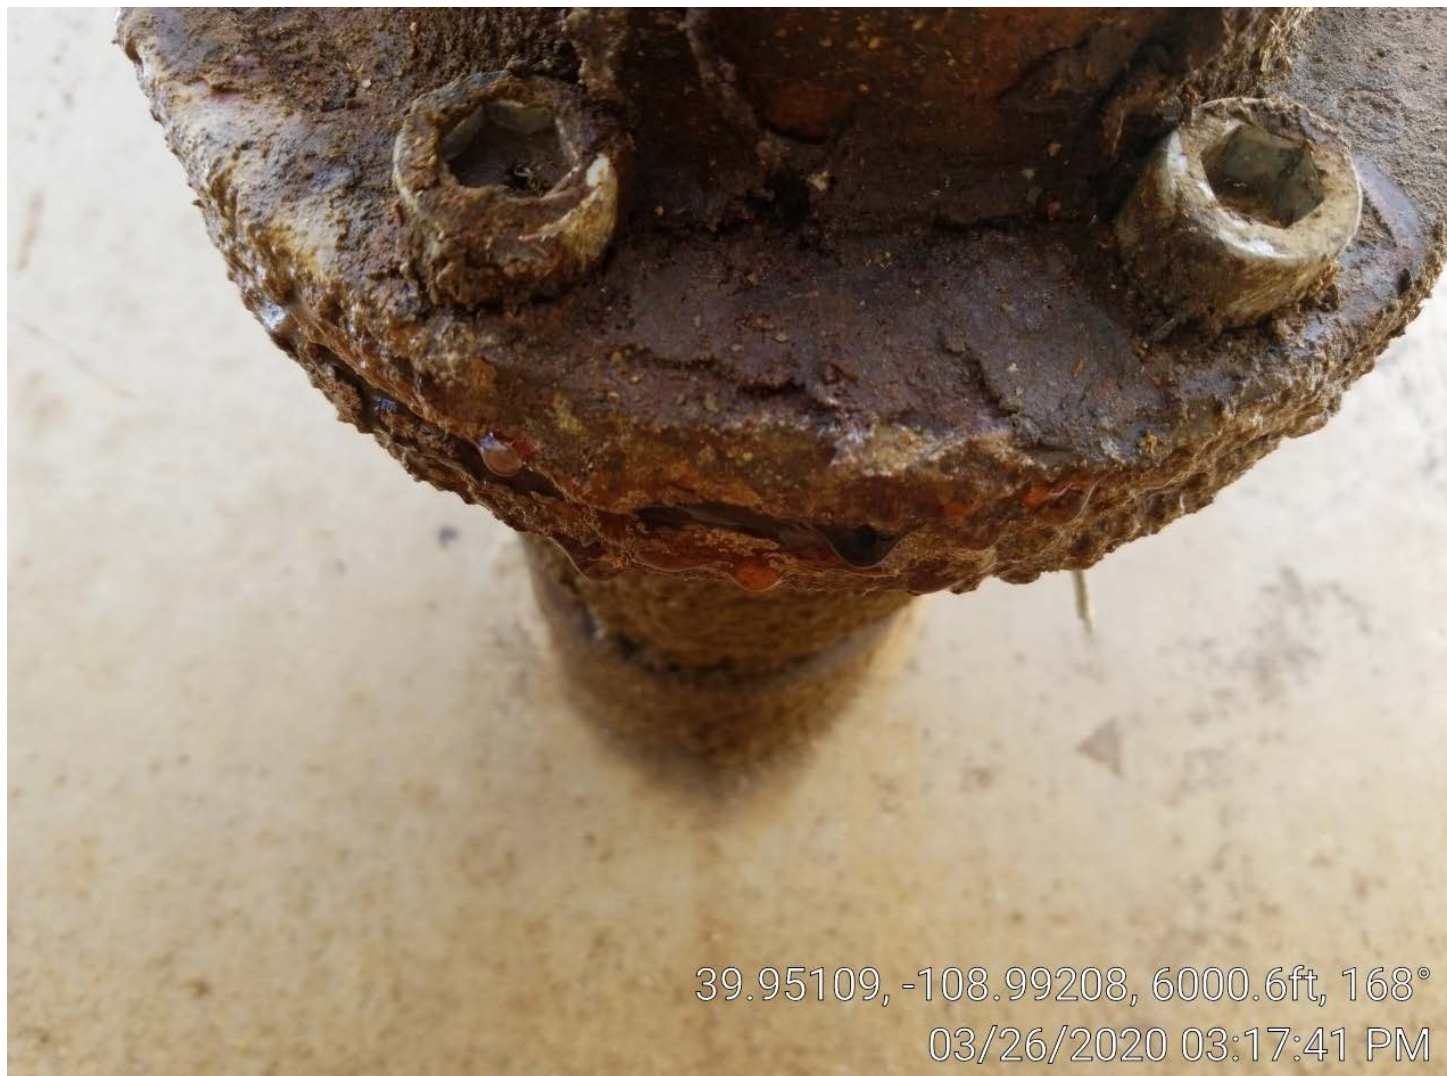
**Photo 6. Leaking tank flange.**
