Inspection Photos  
Operator: Hilcorp Energy  
API#: 067-05815  
Date: 3/24/2020

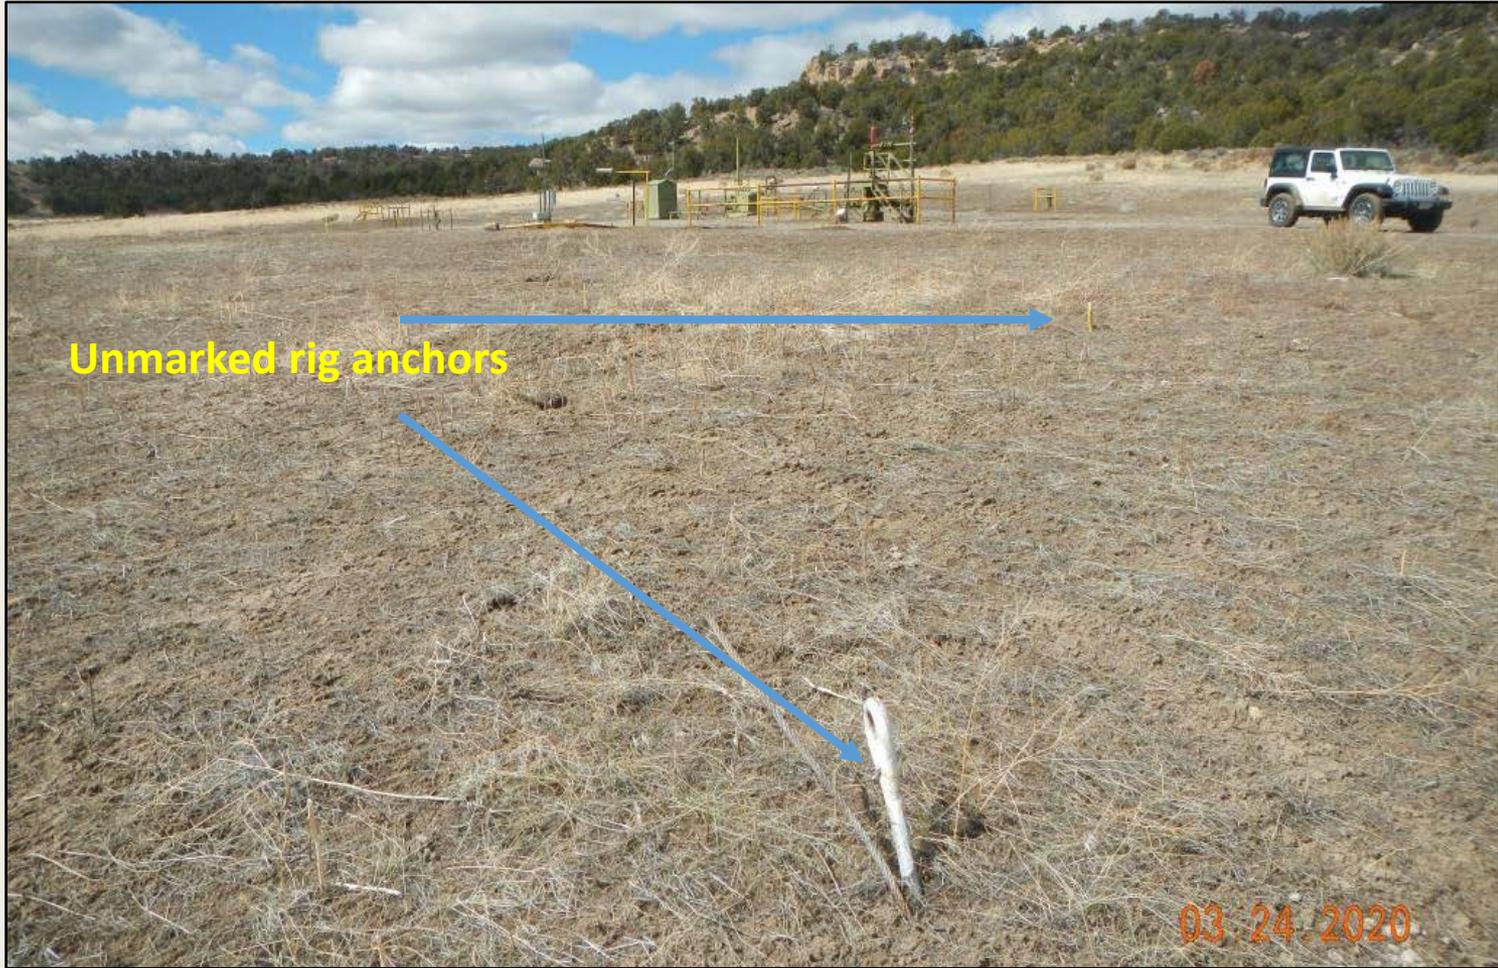
Photo 1. View of the project area from the northeastern corner facing center. Multiple unmarked rig anchors observed throughout the project area.

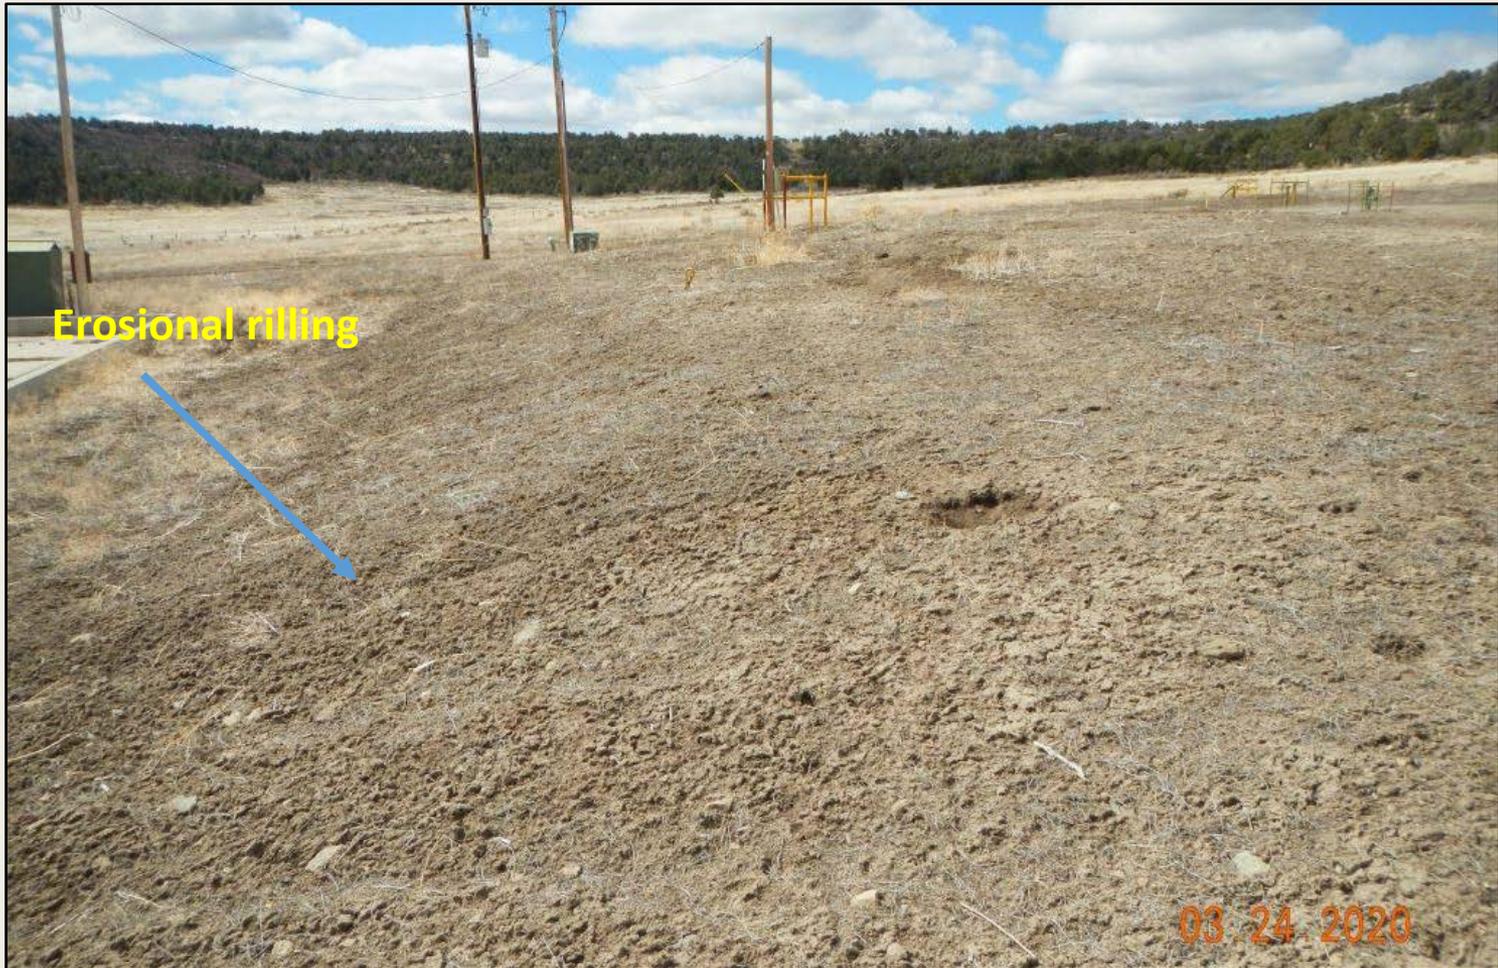
Photo 2. View of the eastern fill slope from the northeastern edge facing southward. Slope is largely comprised of bare soils. Erosional rilling observed along slope.

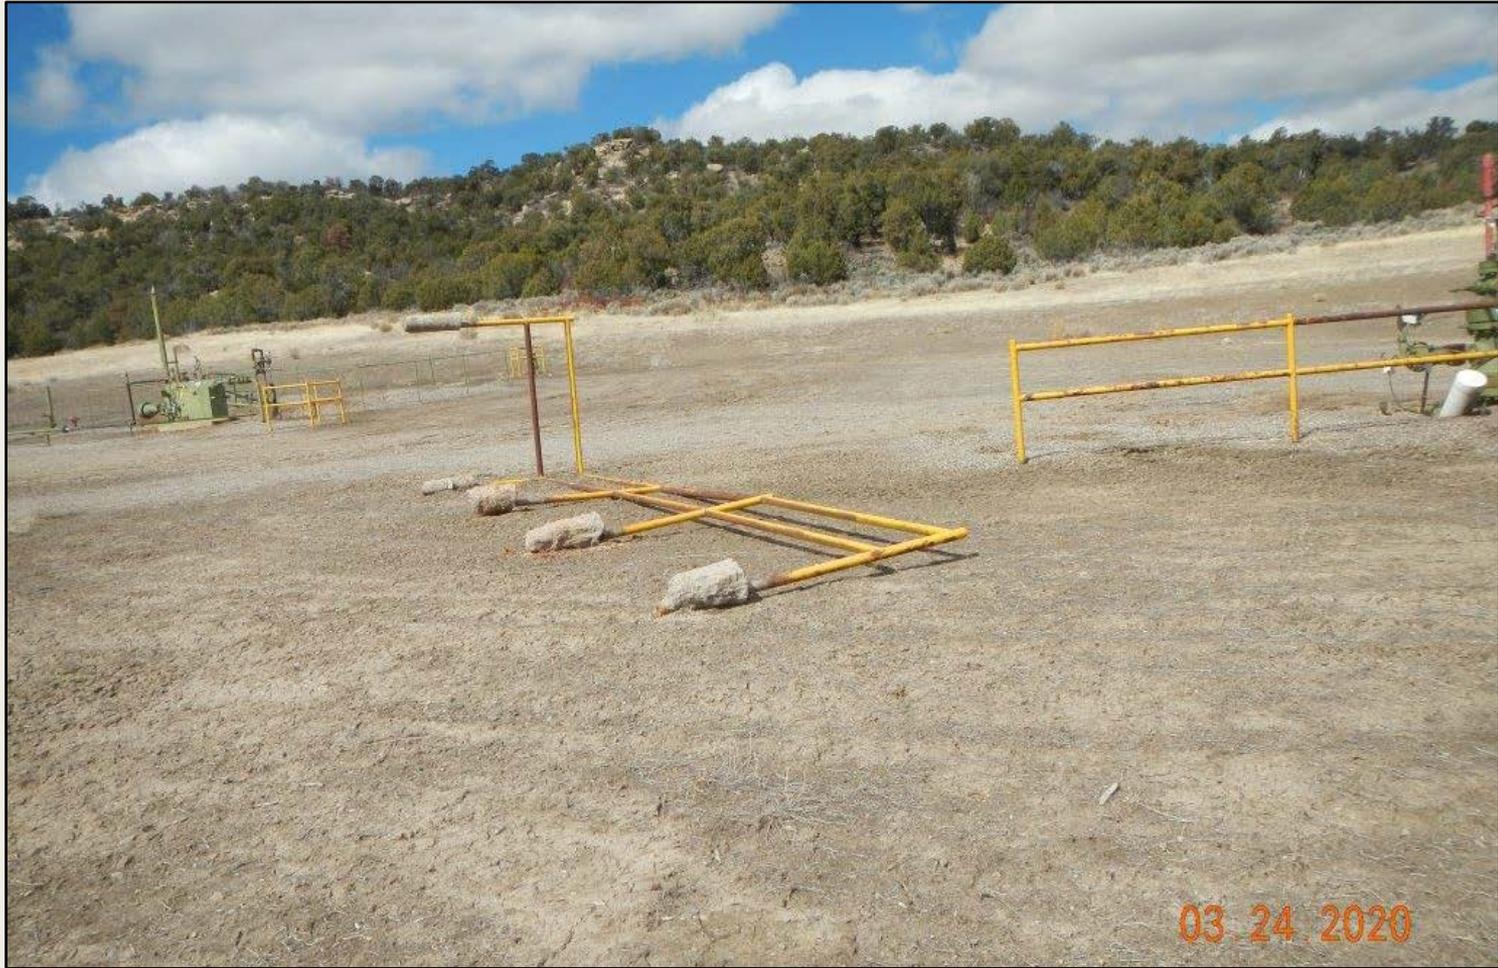
Photo 3. View of unused equipment on the well pad.

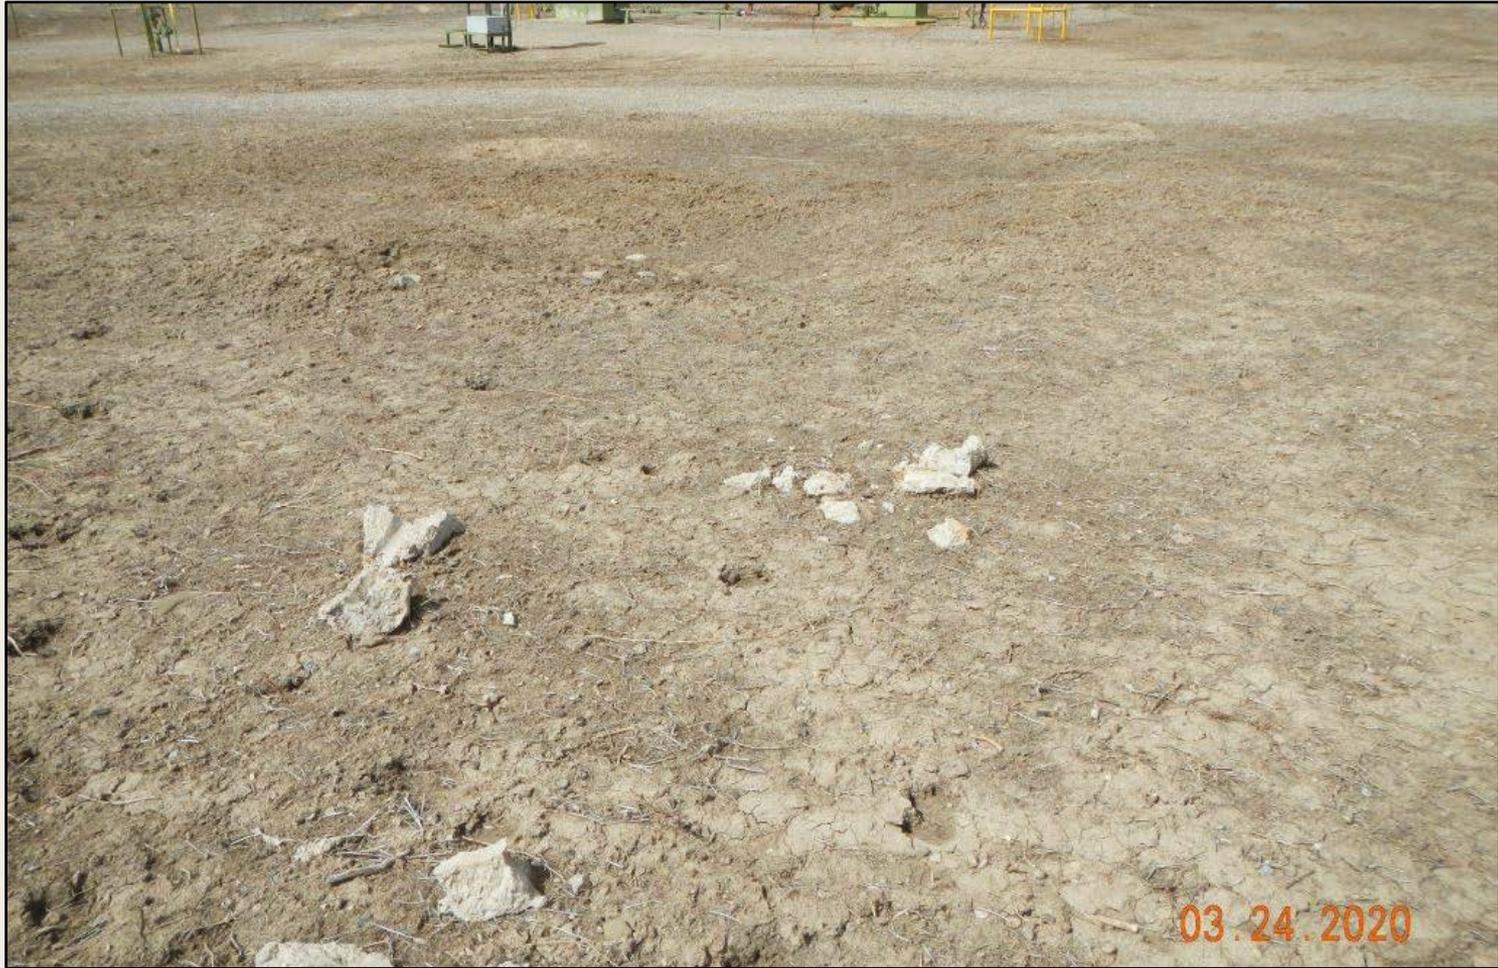
Photo 4. View of cement debris on the well pad.

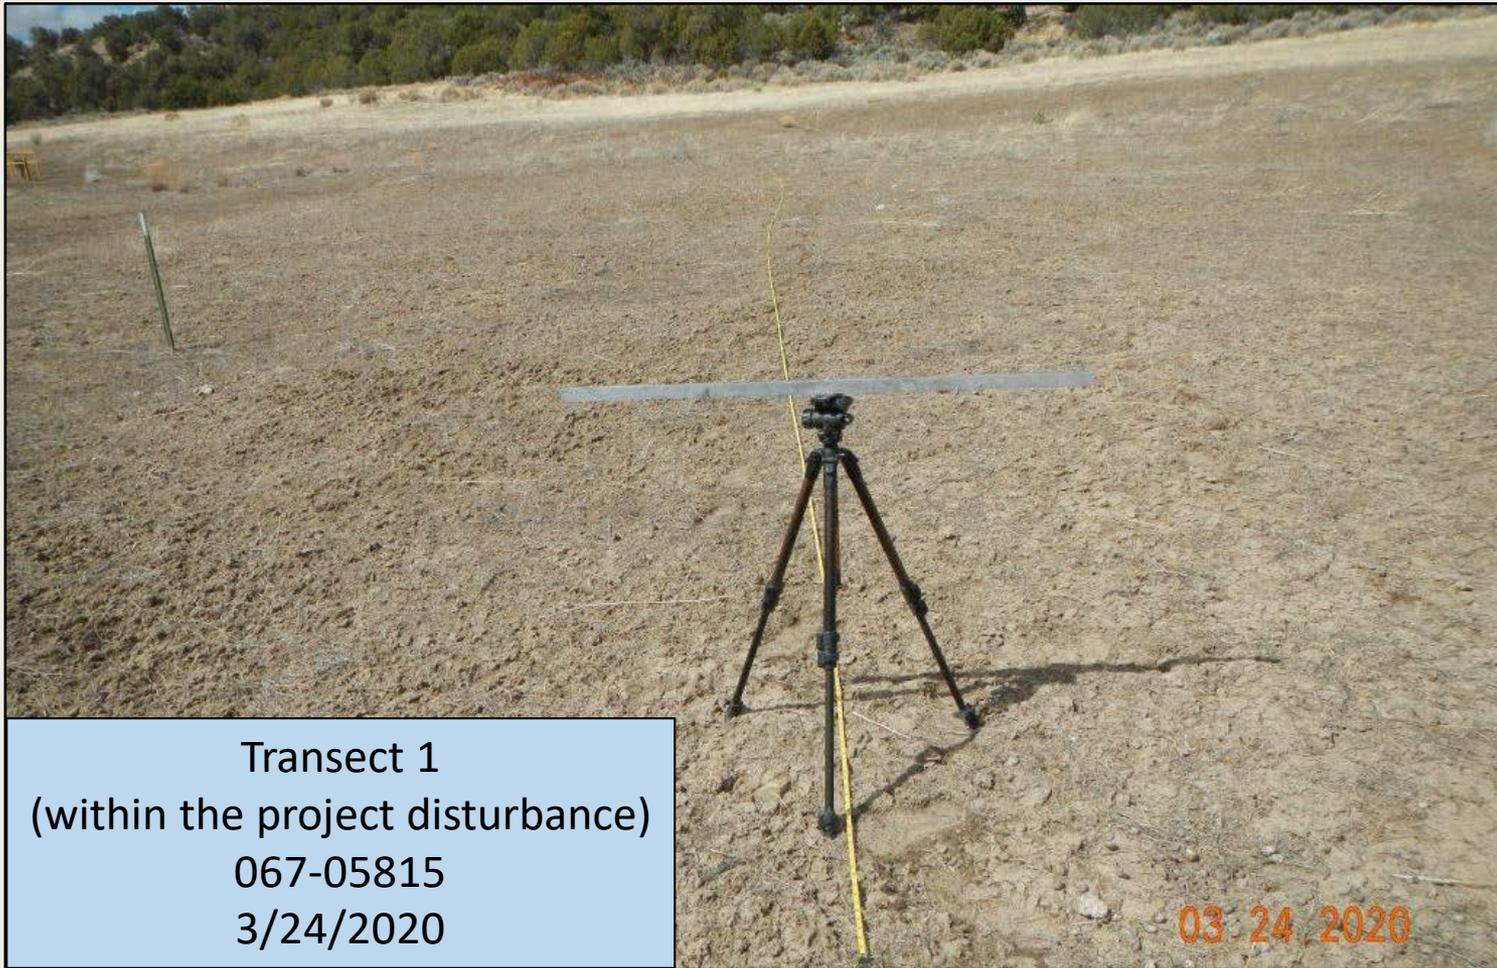
Photo 5. View of the beginning of Transect 1, within the project area, facing westward.

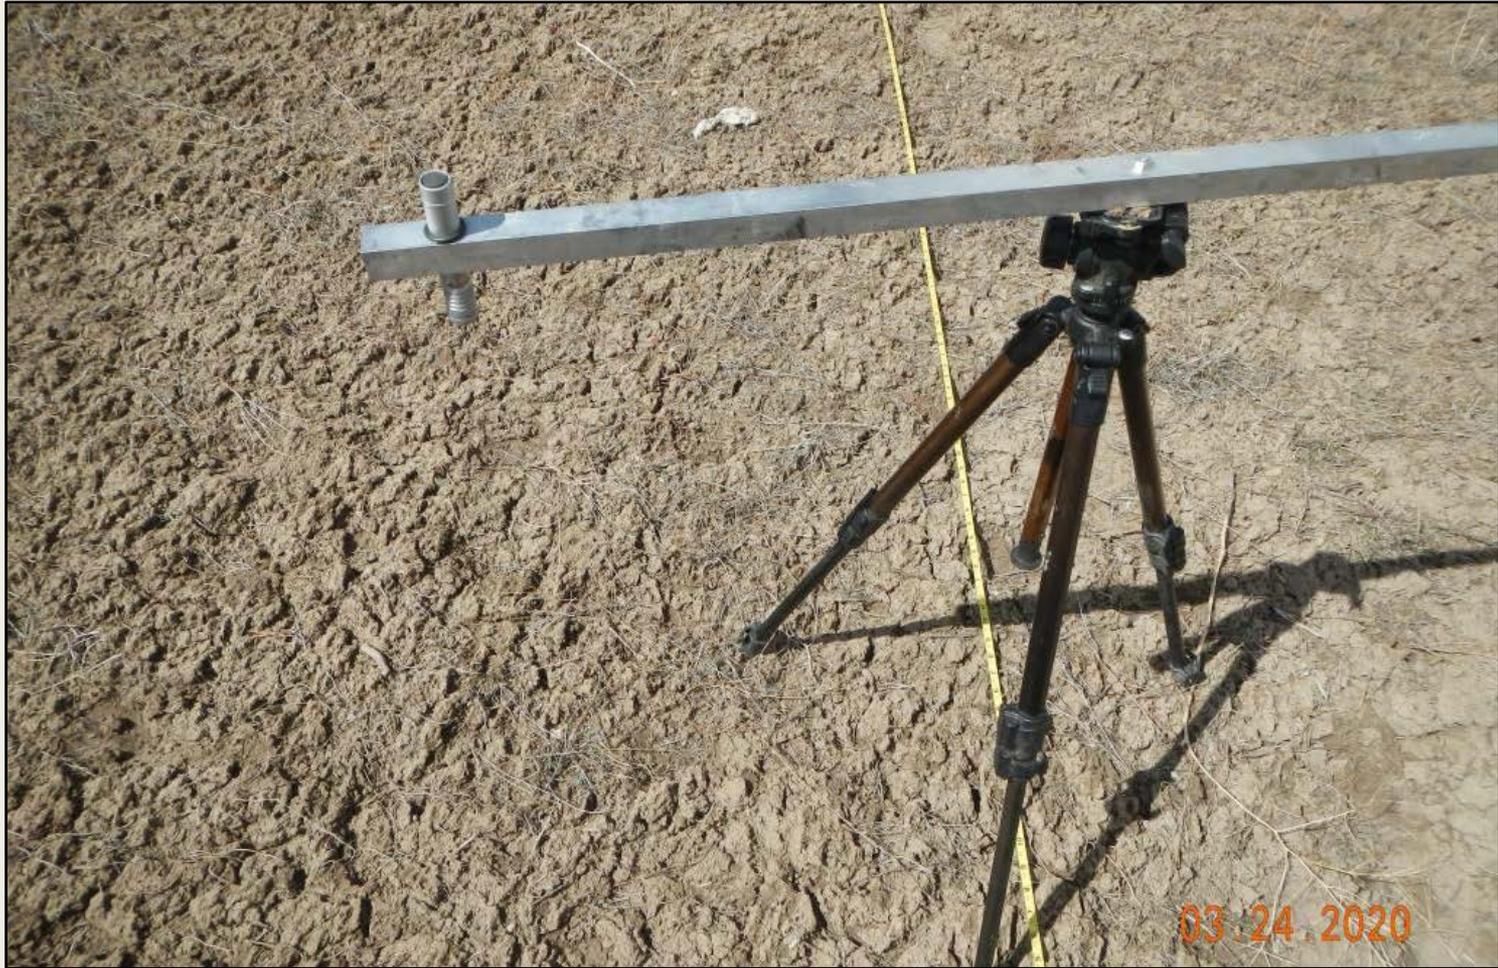
Photo 6. Birdseye view from the midpoint of Transect 1, within the project disturbance. No desirable vegetation observable.

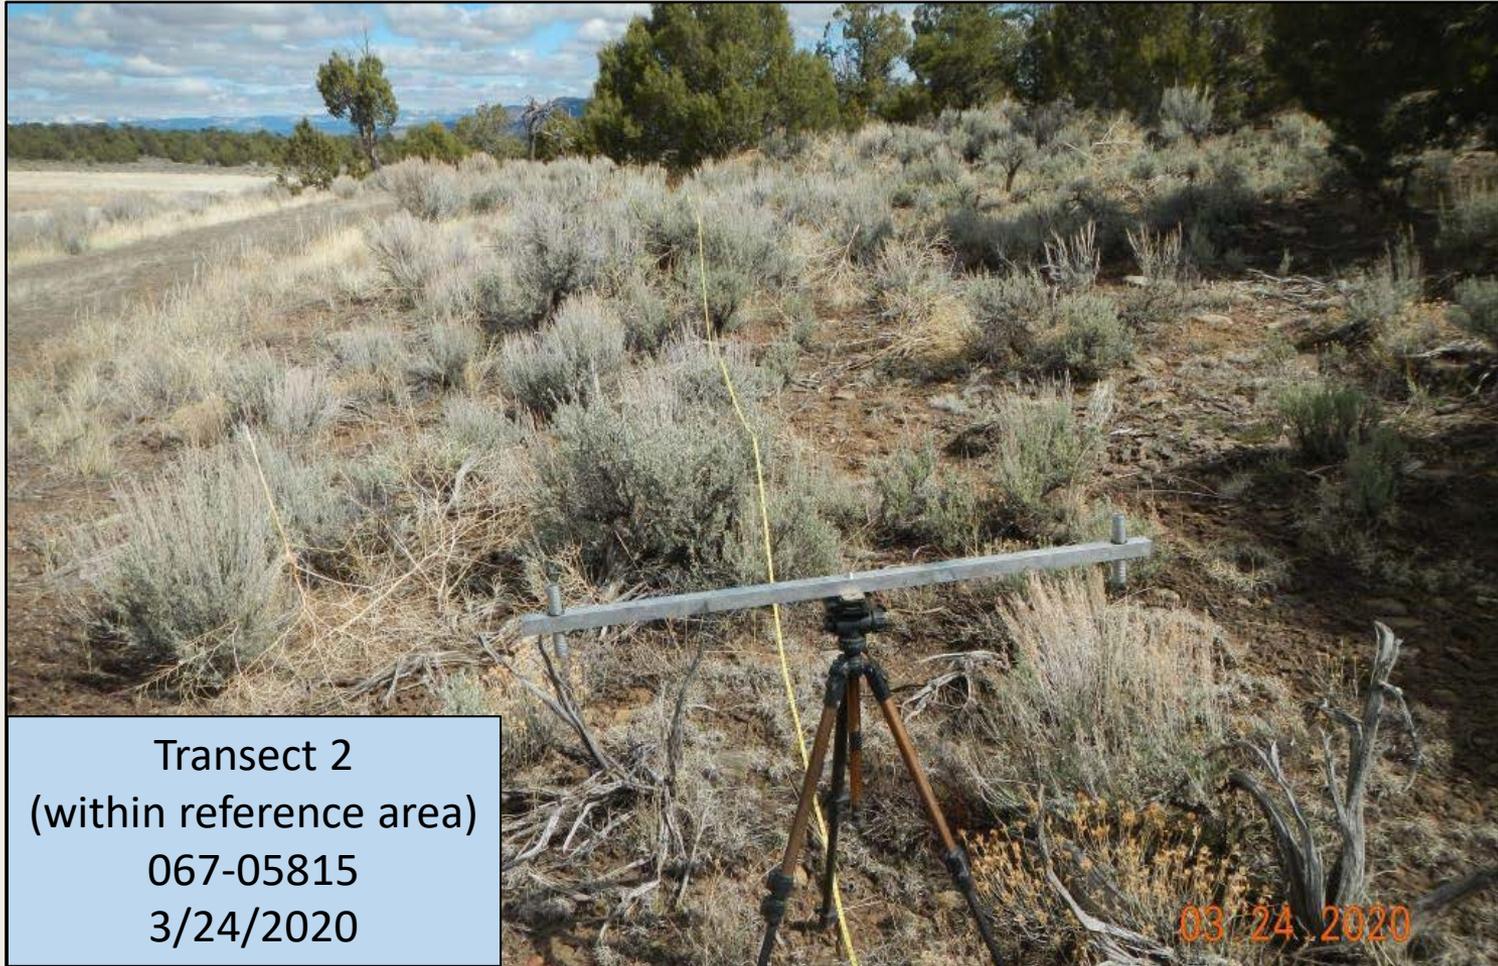
Photo 7. View of reference area, comprised of sagebrush shrubland, dominated by big sagebrush with grasses and forbs such as blue grama, James galleta, and yellow rabbitbrush.

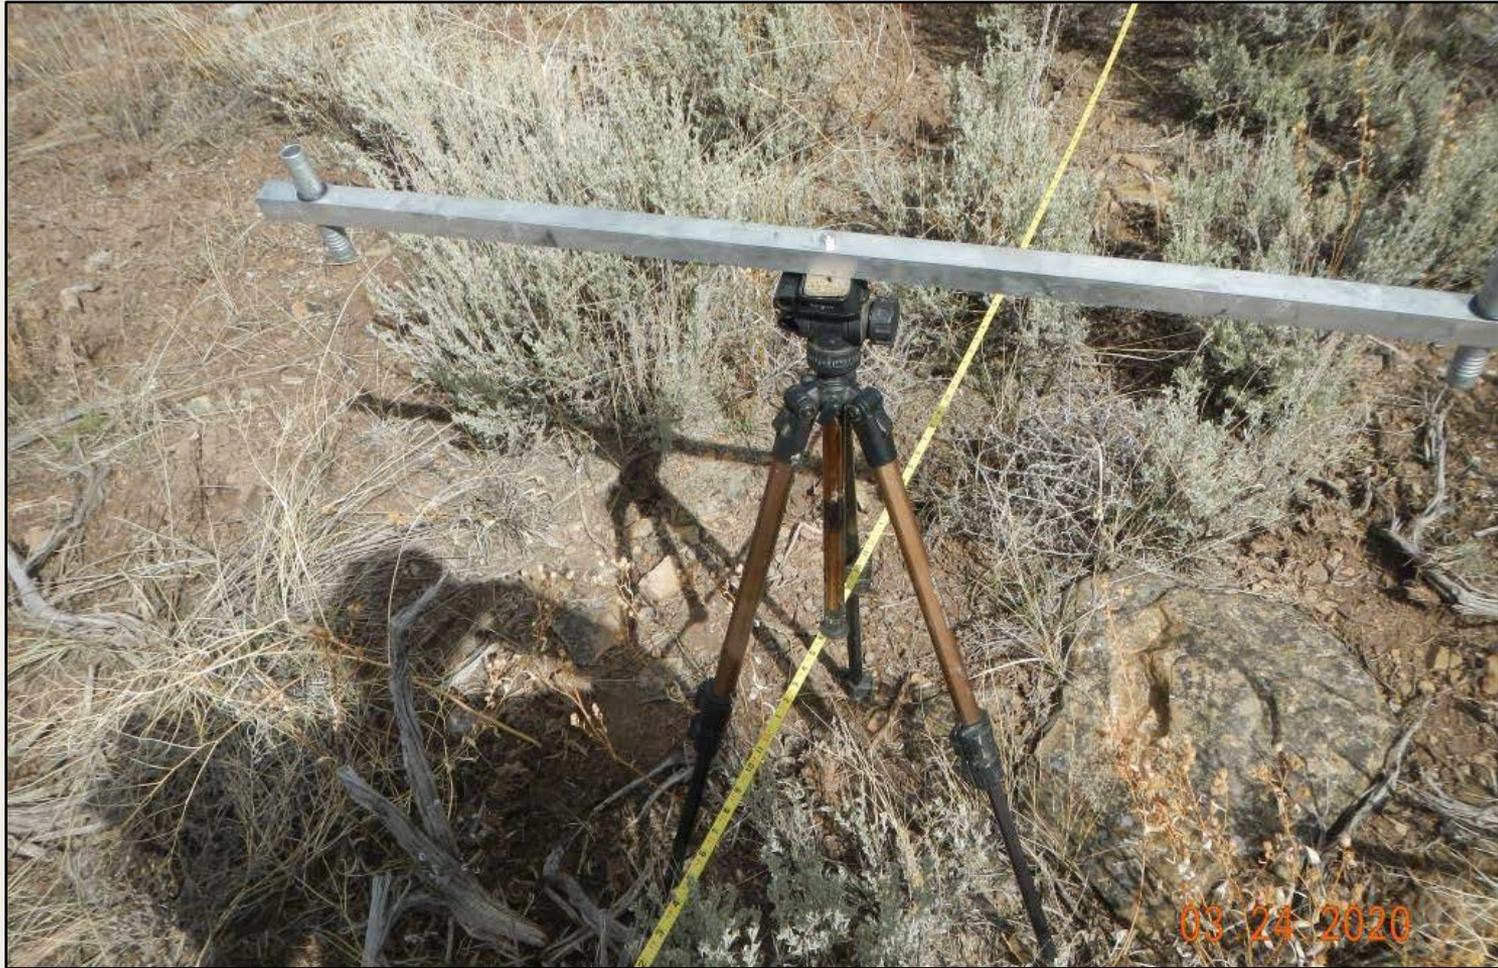
Photo 8. Birdseye view of vegetation at transect midpoint.
