Inspection Photos

Operator: Hilcorp Energy
API#: 067-08186
Date: 3/24/2020

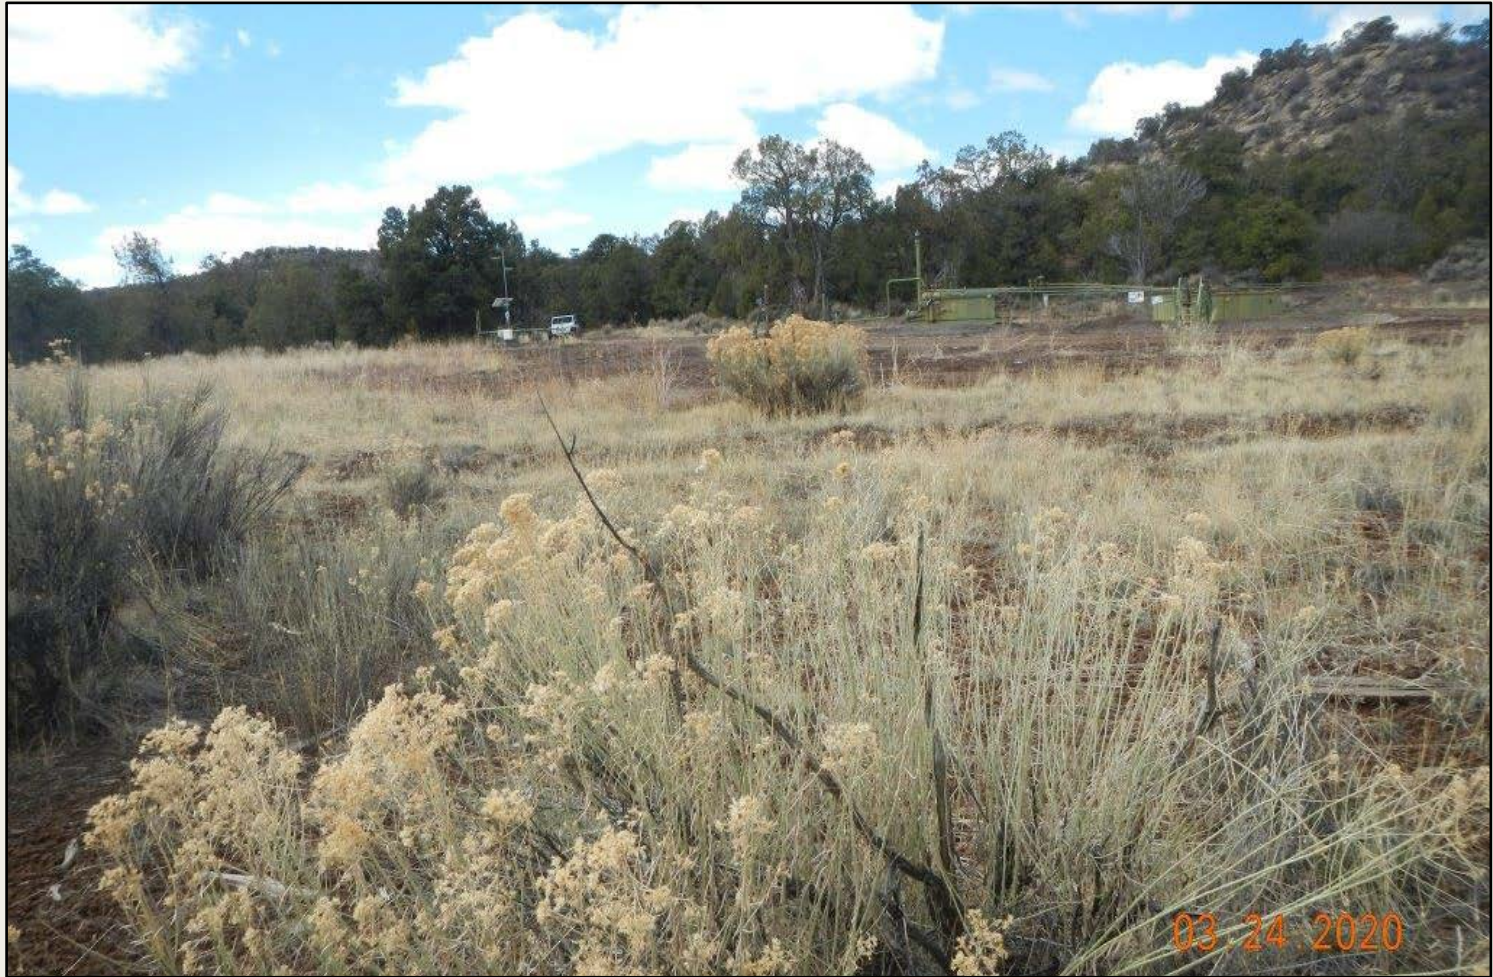
Photo 1. View of the project area from the northeastern corner facing center.

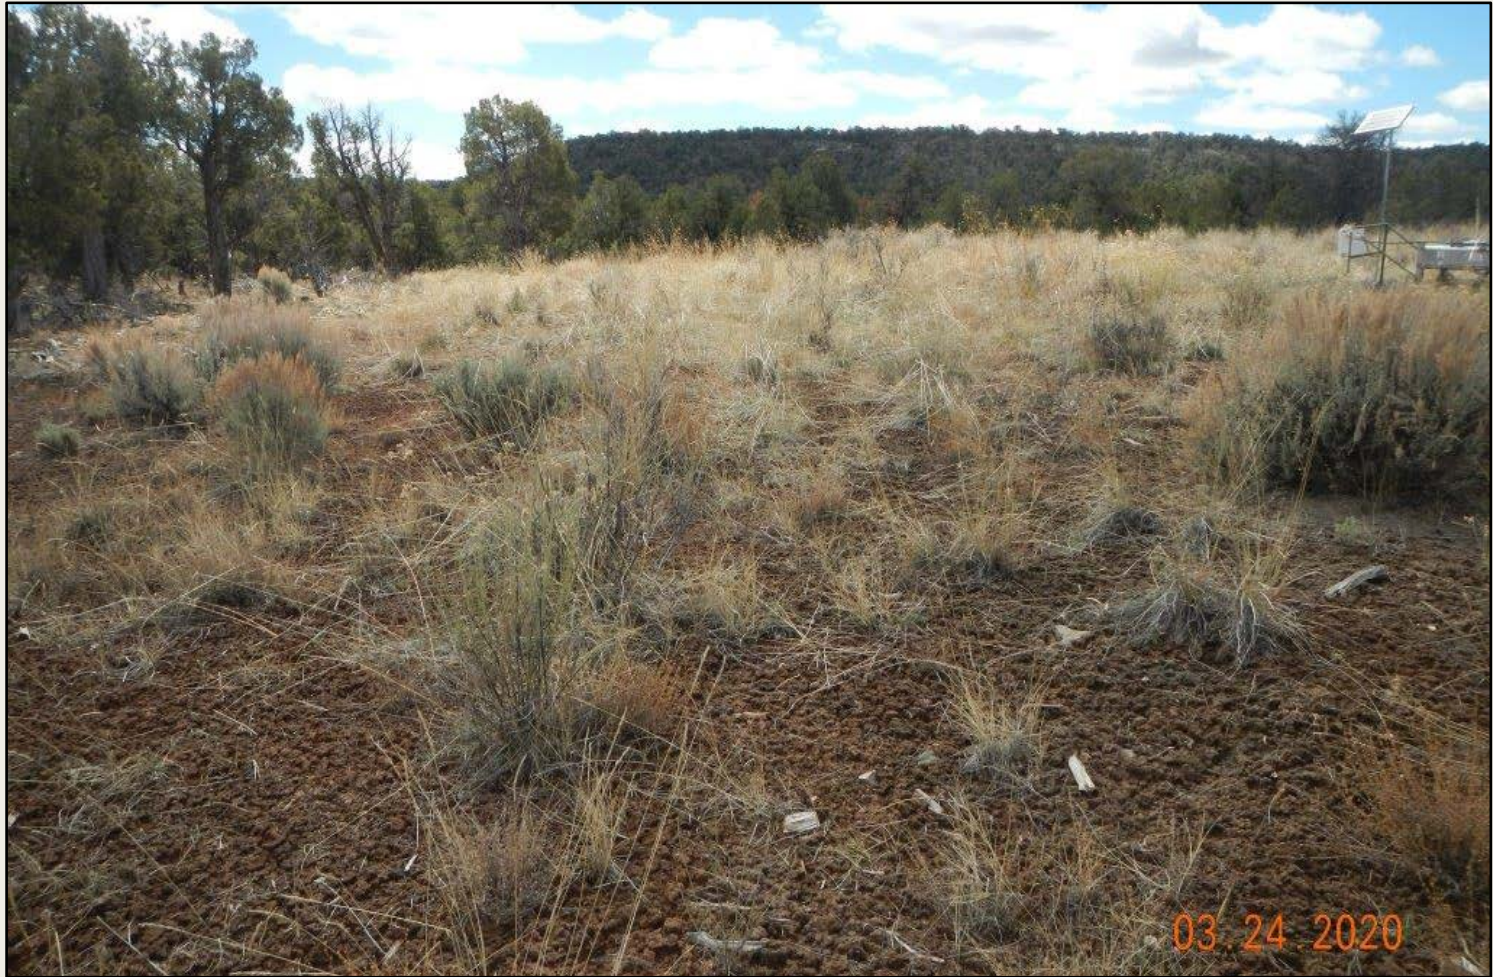
Photo 2. View of the eastern fill slope from the northeastern edge facing southward. Revegetation I progressing with mixed wheatgrasses, rubber rabbitbrush, sagebrush, and fourwing saltbush.

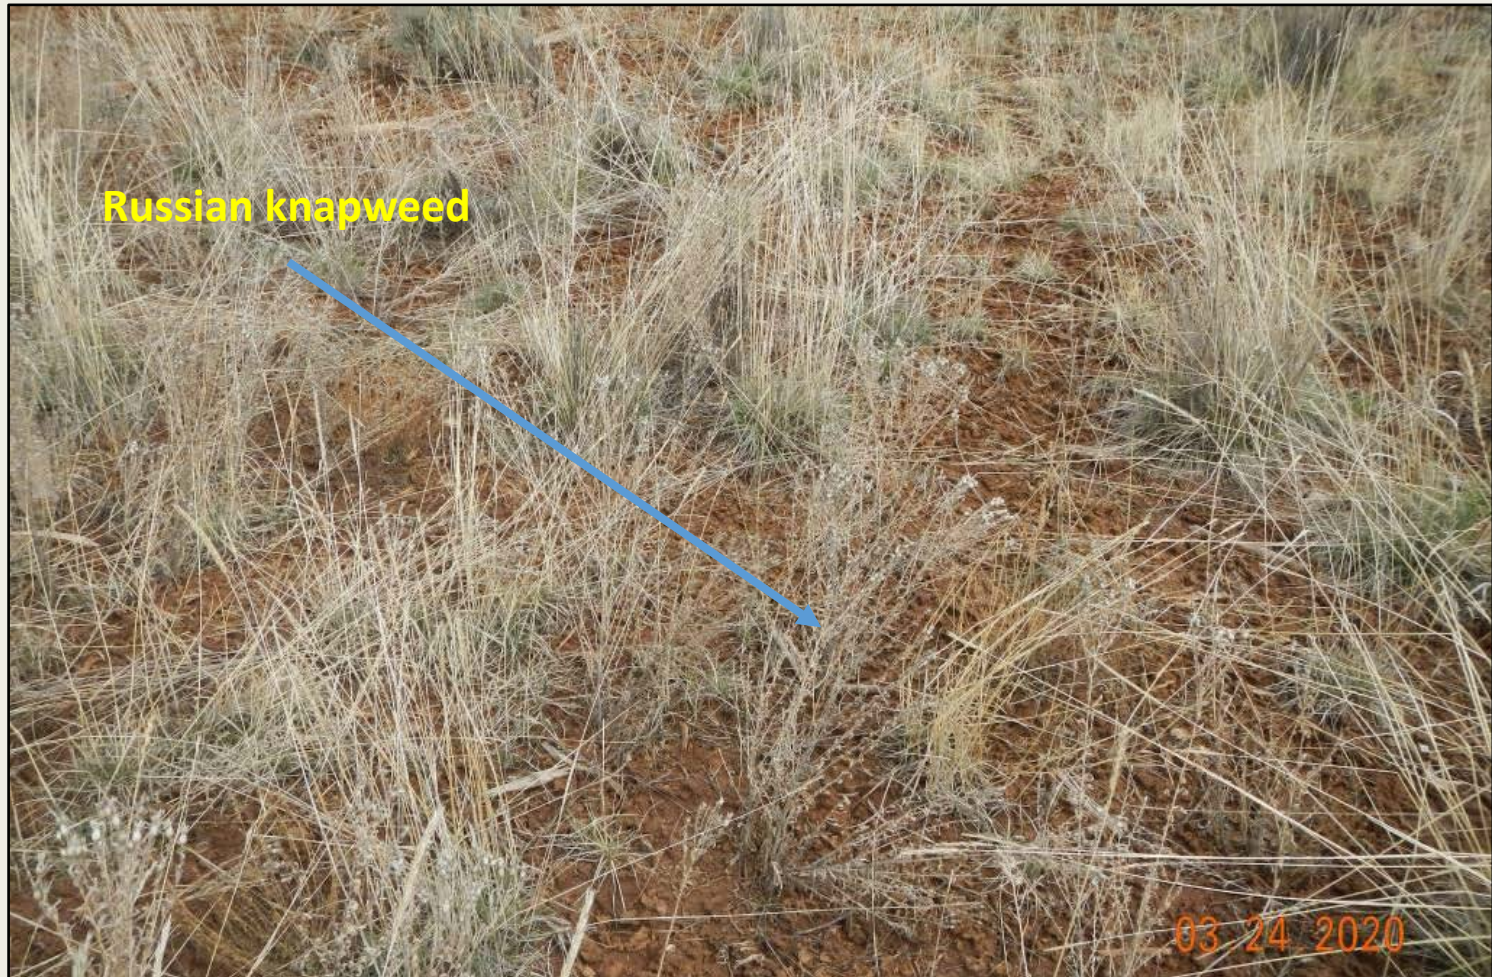
Photo 3. View of Russian knapweeds within the northeastern project area. Approximately 150 individuals observed.

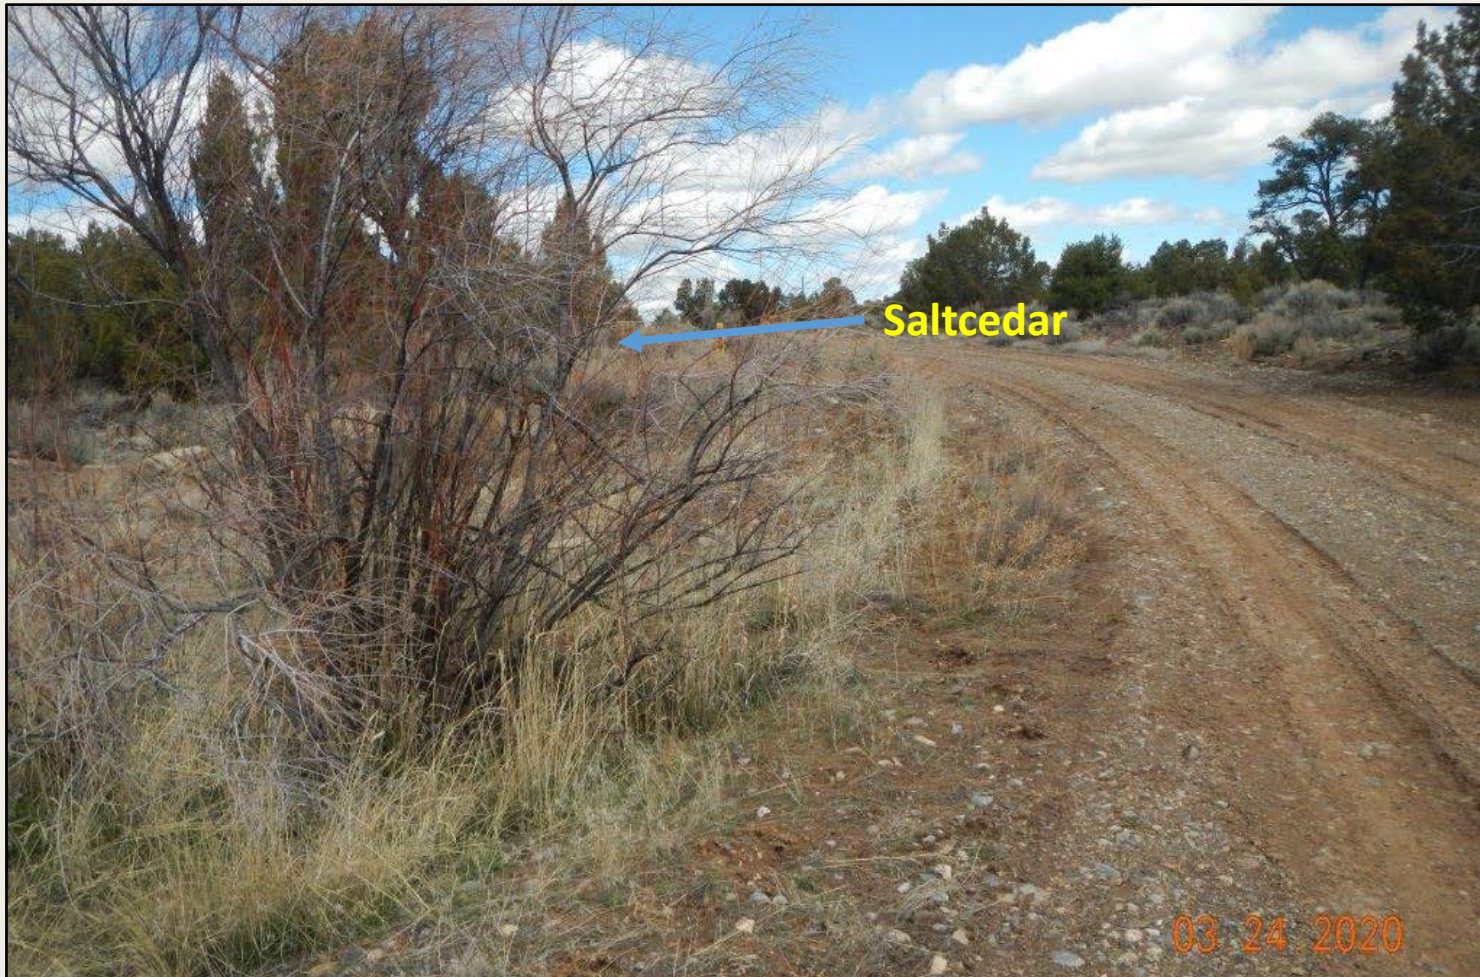
Photo 4. View of saltcedar tree (noxious weed) at entrance to access road. Needs to be removed.

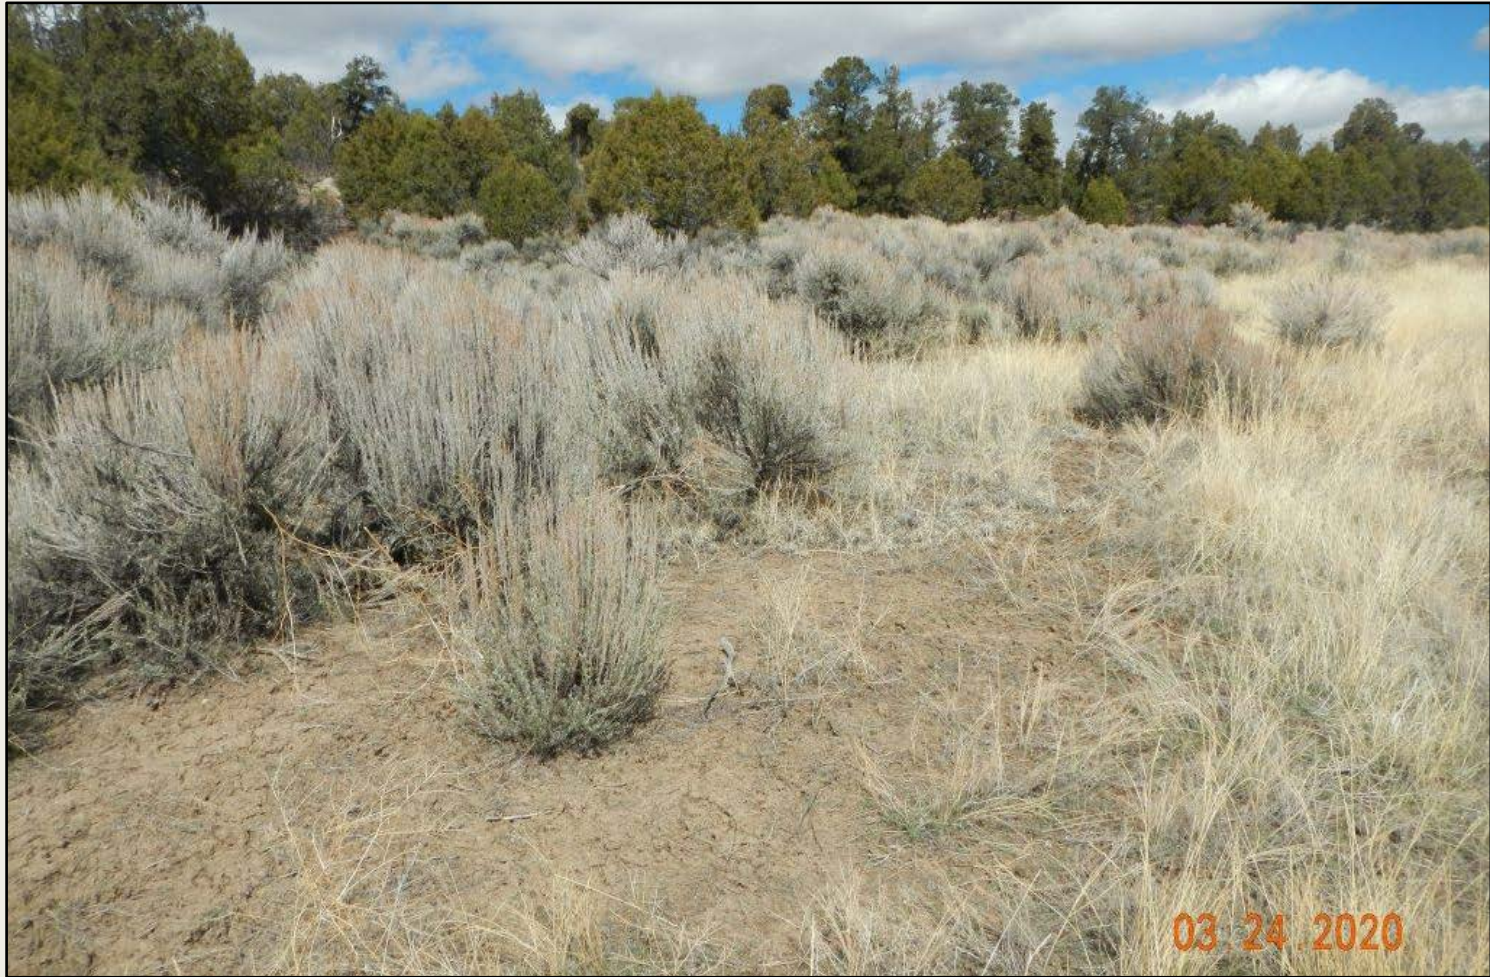
Photo 5. View of reference area vegetation comprised of sagebrush dominated shrubland with native grasses, forbs, and sub-shrubs in the understory. Pinyon and junipers are largely on slopes.
