Inspection Photos
Location Name: Sanchez #3
API: 05-067-05341

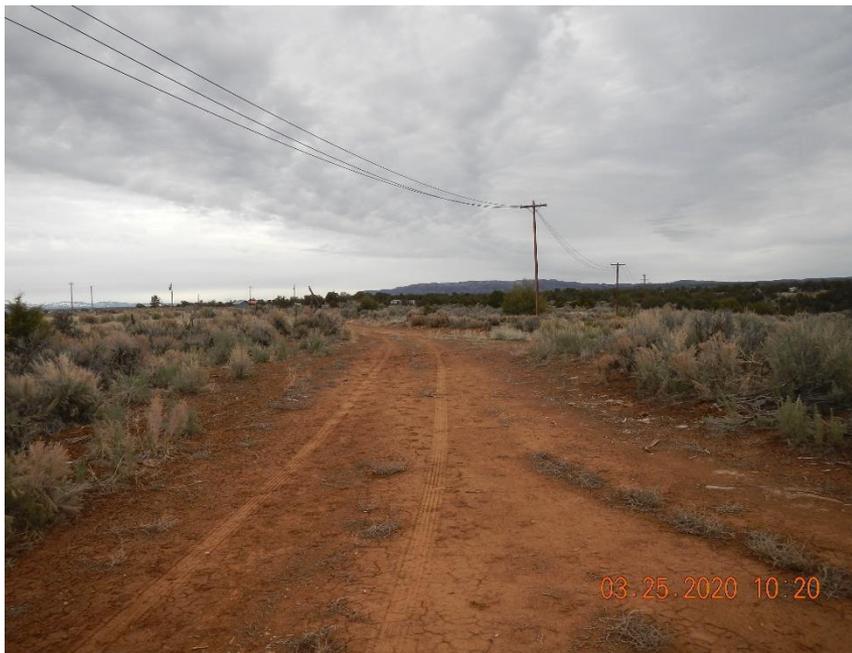
Sanchez #3 access road.

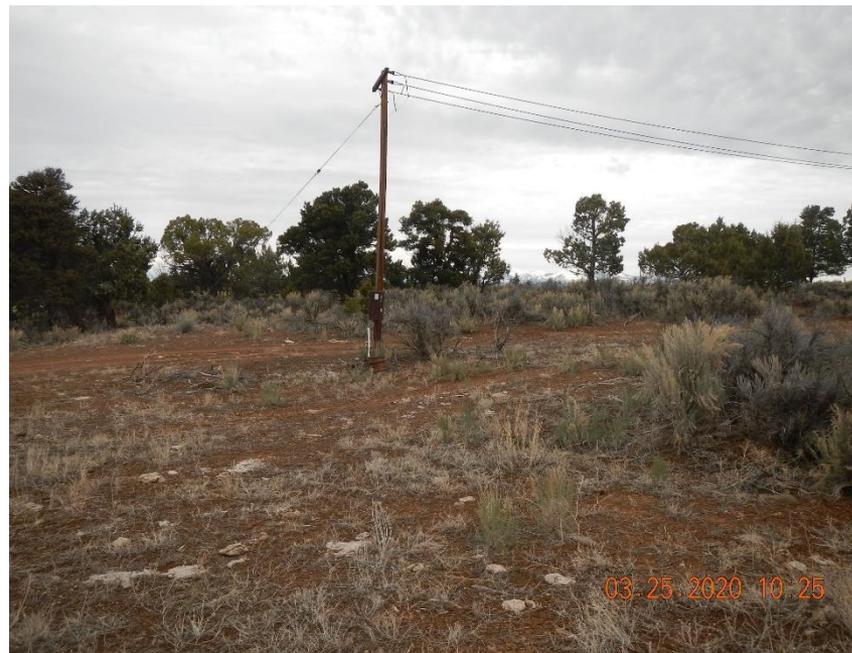
Electrical supply to location.

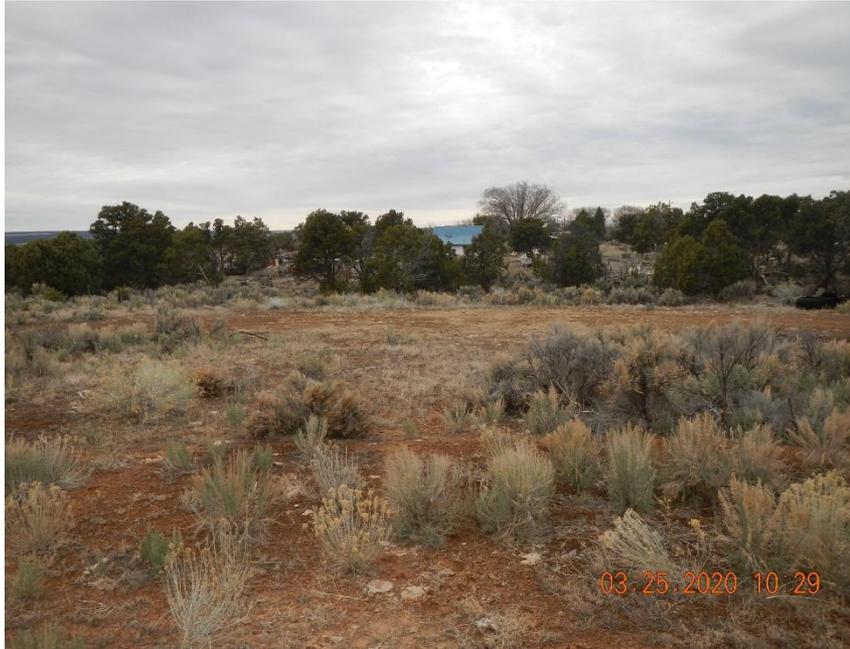
Location photo looking west from secondary containment berm for AST.

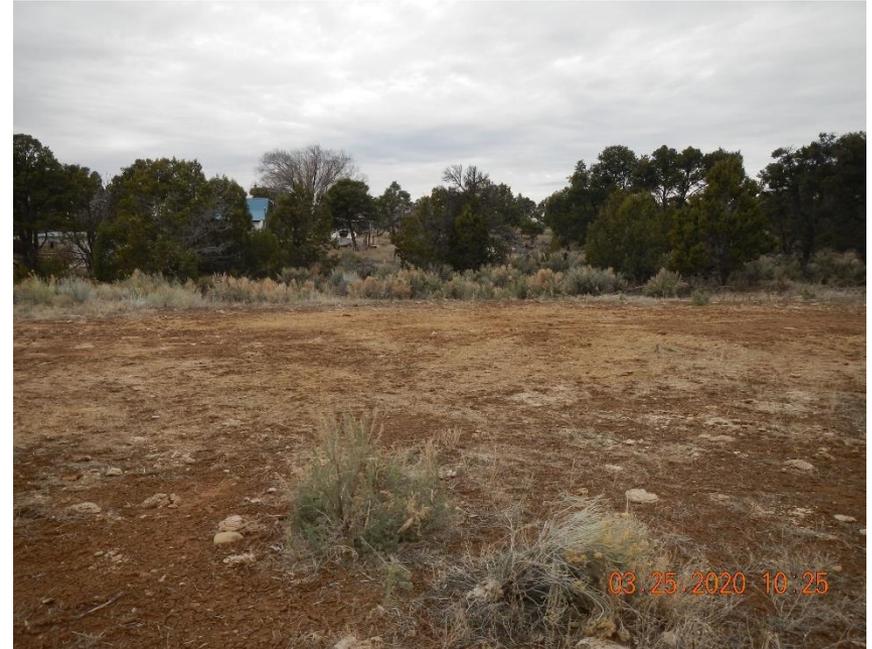
Location photo of PA well pad.

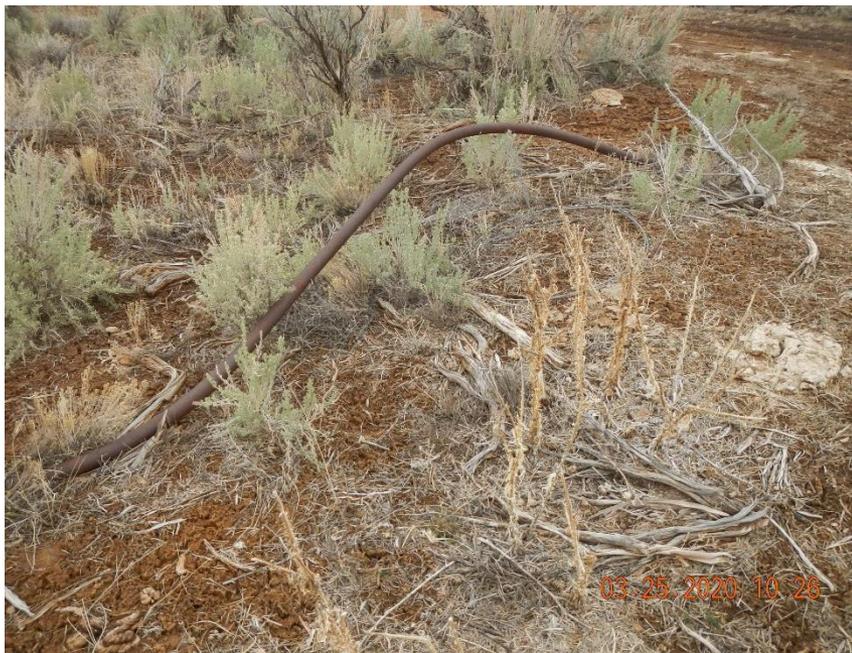
Steel pipe and other debris on location.

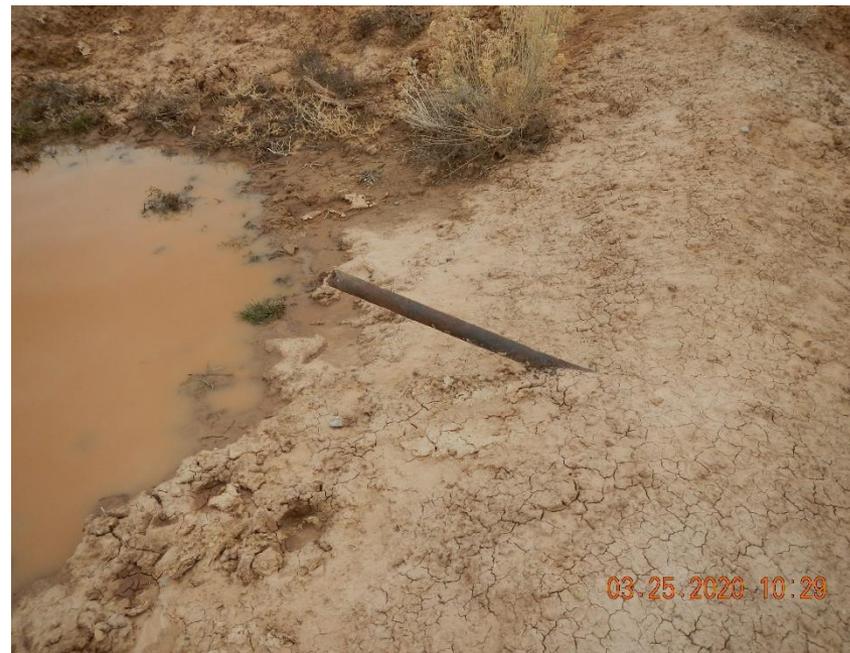
Steel pipe protruding from secondary containment berm.

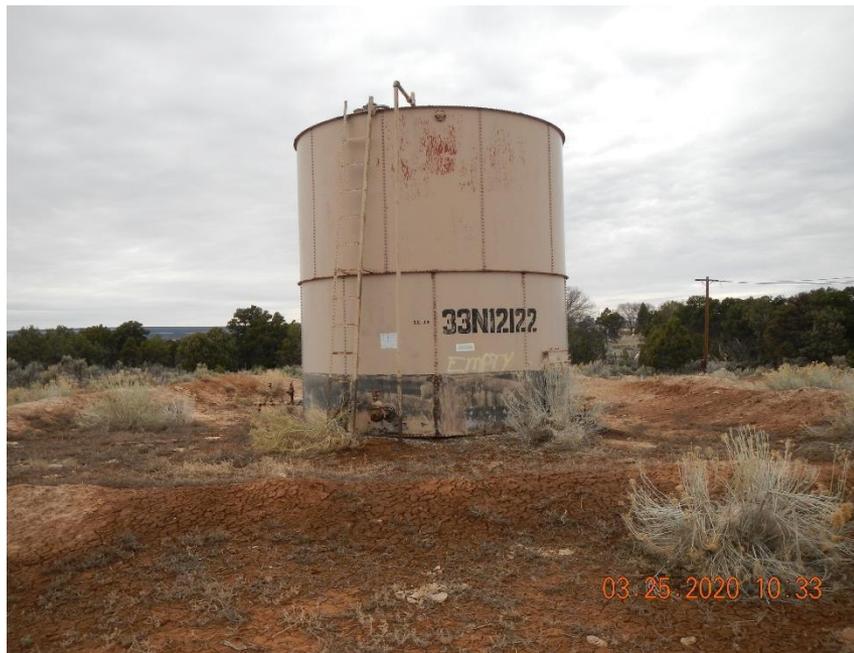
Crude oil AST, marked empty by COGCC field inspector.

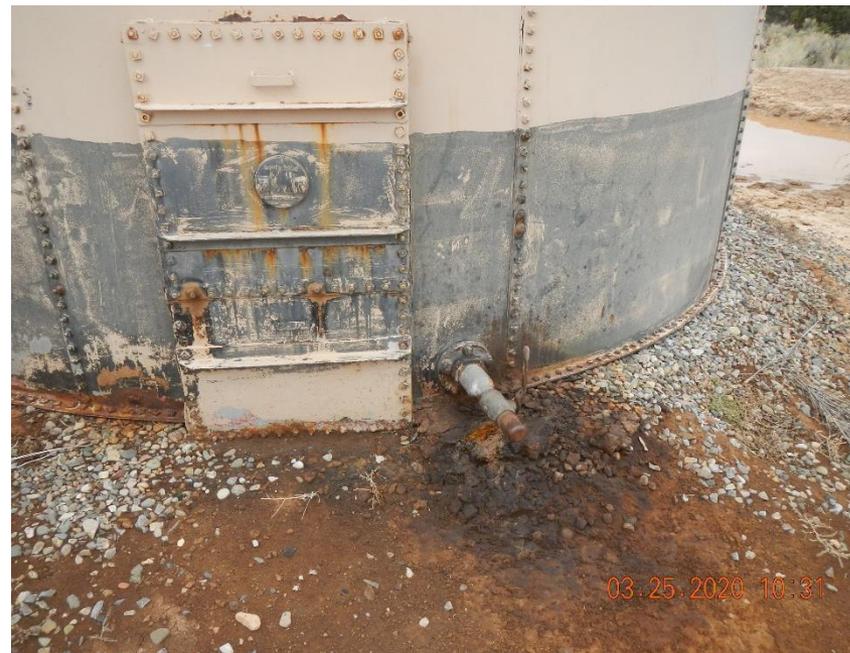
Oil stained soil beneath load out valve.

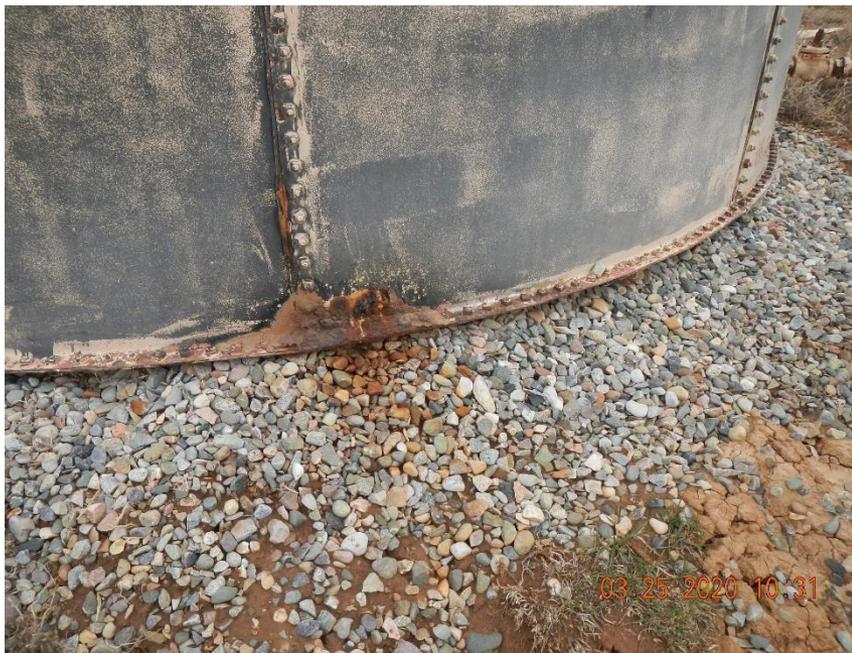
Stained area beneath compromised seam along bottom of AST.

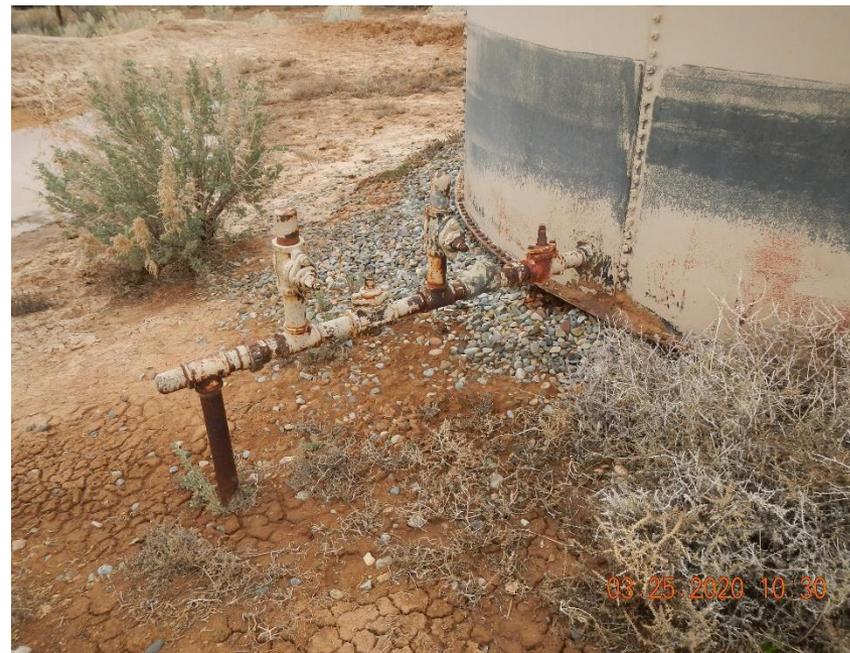
Flow line to AST.
