Inspection Photos

Operator: Hilcorp Energy
API#: 067-06145
Date: 3/24/2020

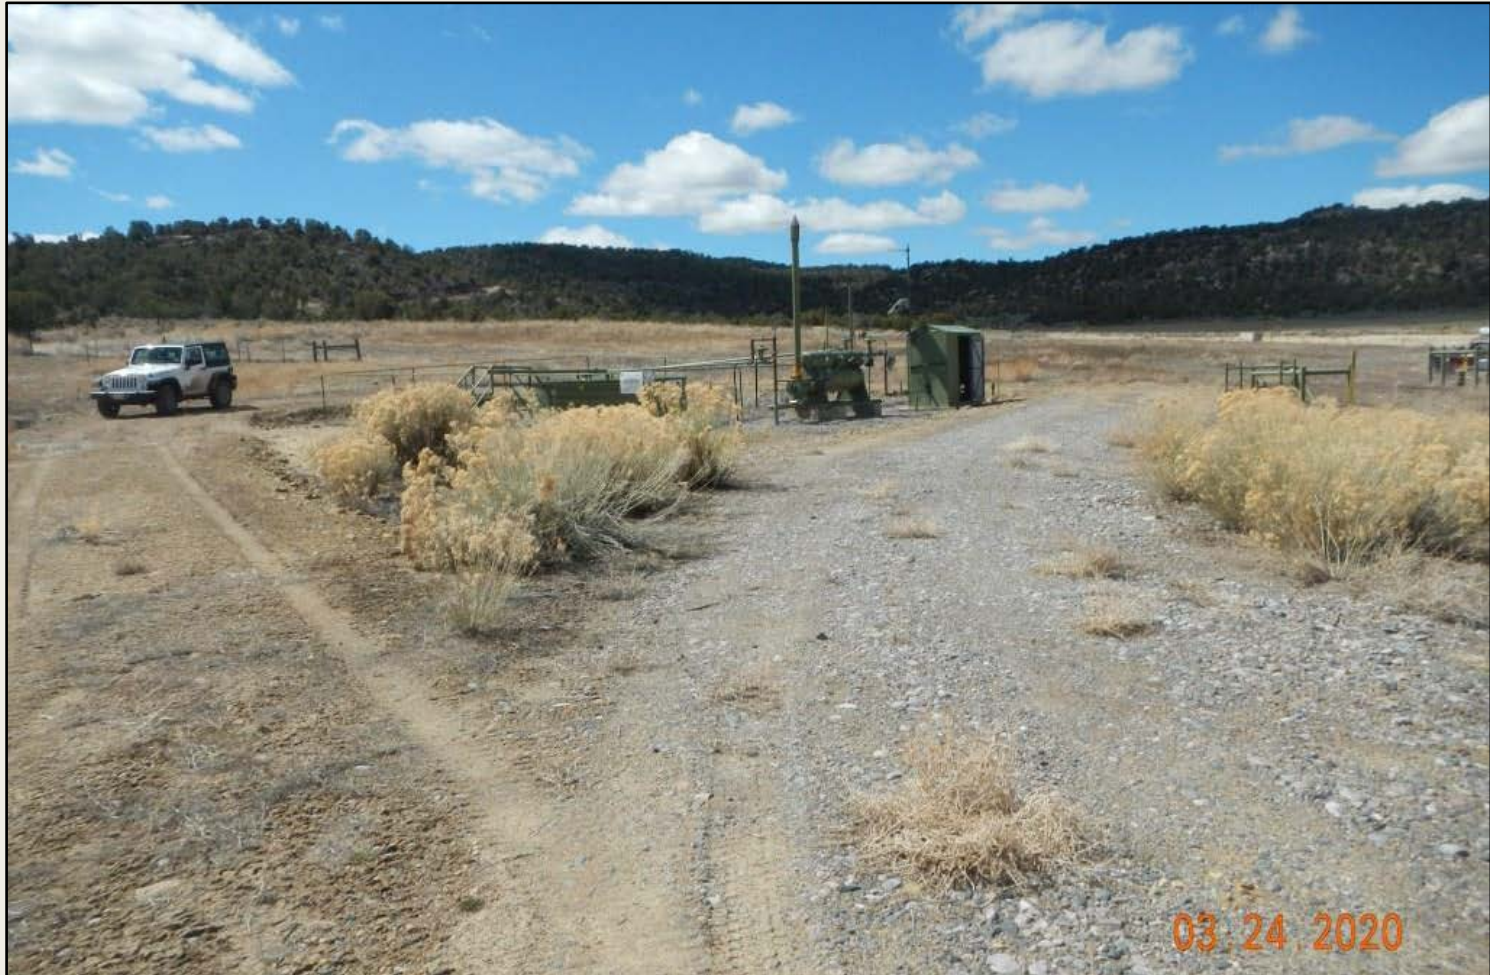
Photo 1. View of the project area from the well pad entrance facing center.

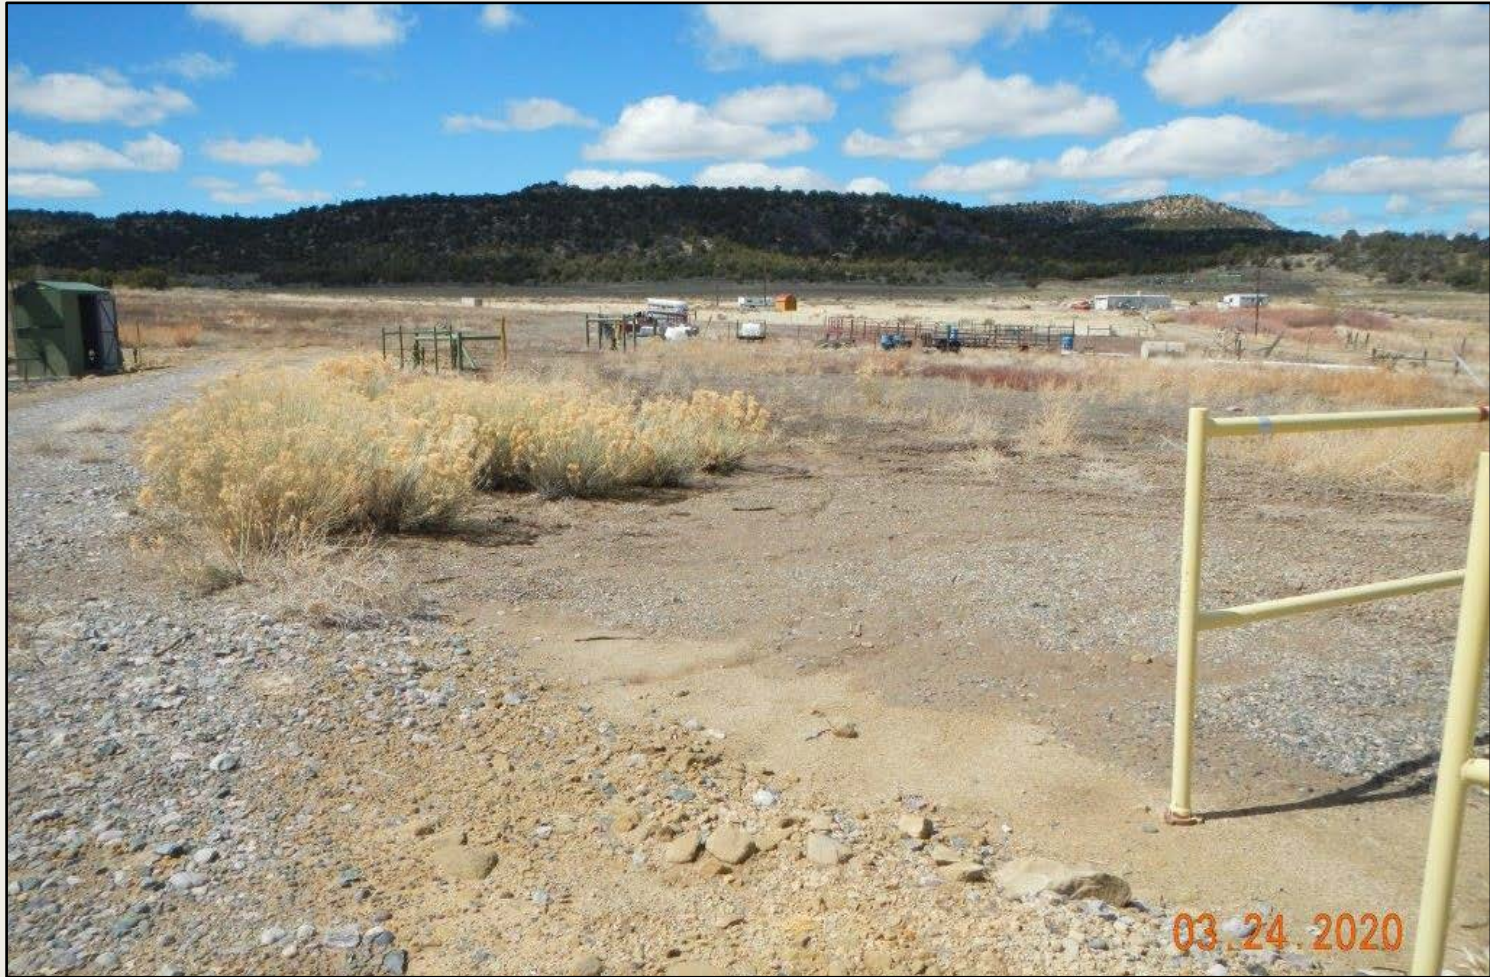
Photo 2. View of the northern project area from the well pad entrance facing westward. Revegetation is sparse within the majority of the project area. Some areas are revegetating with rubber rabbitbrush and sand dropseed.

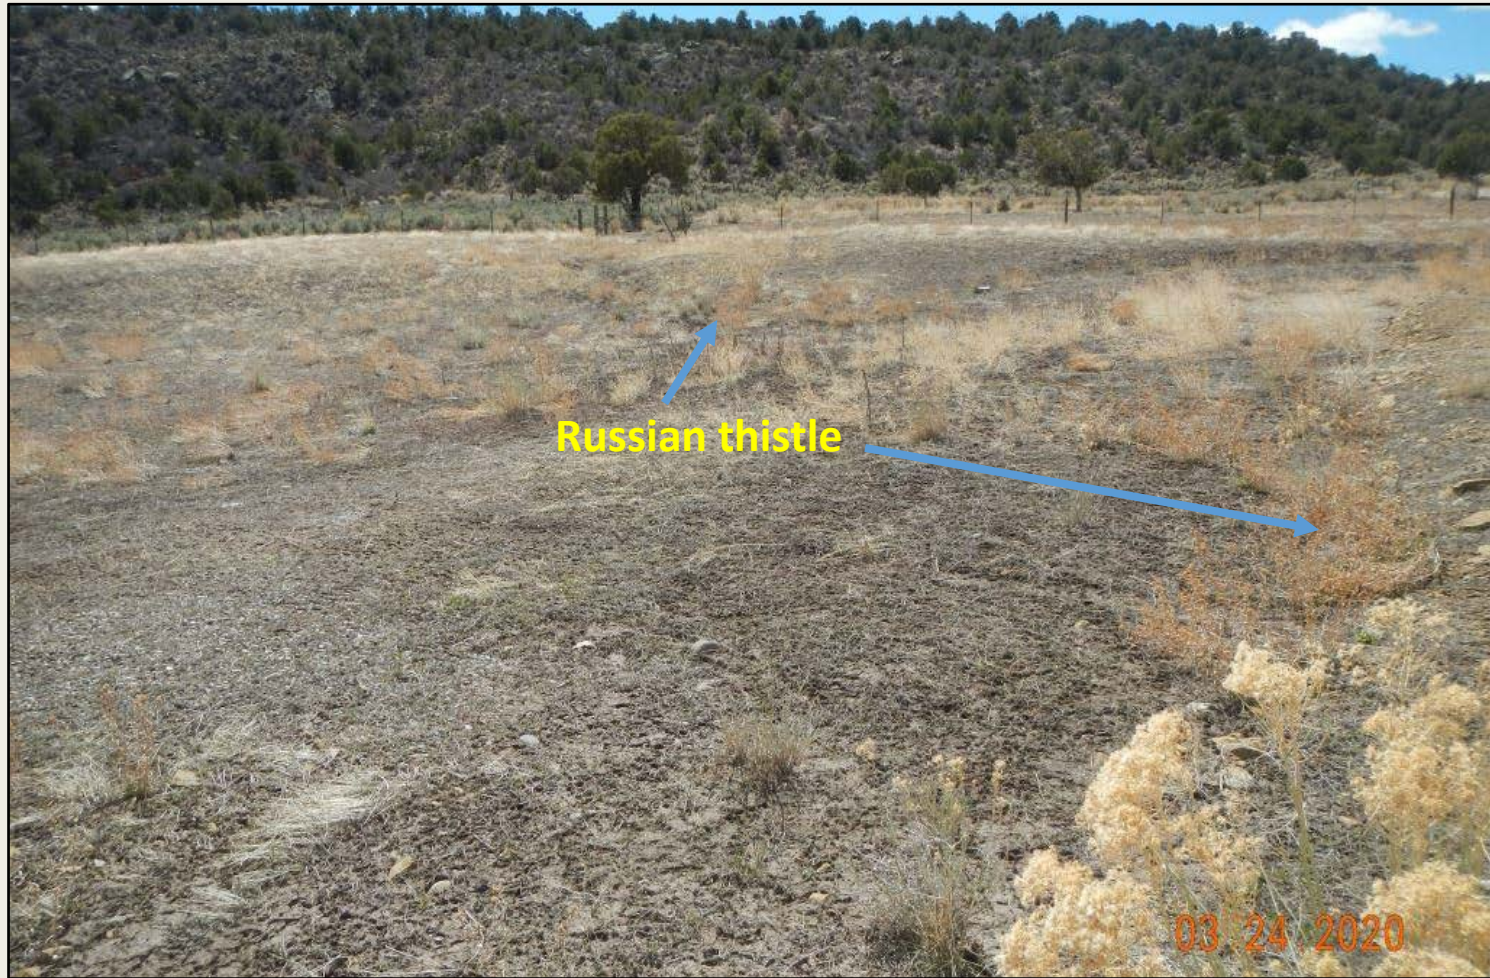
Photo 3. View of the southeastern project area facing southward. Significant portions of the interim reclamation area lack desirable vegetation and are only supporting weeds such as Russian thistle and cheatgrass.

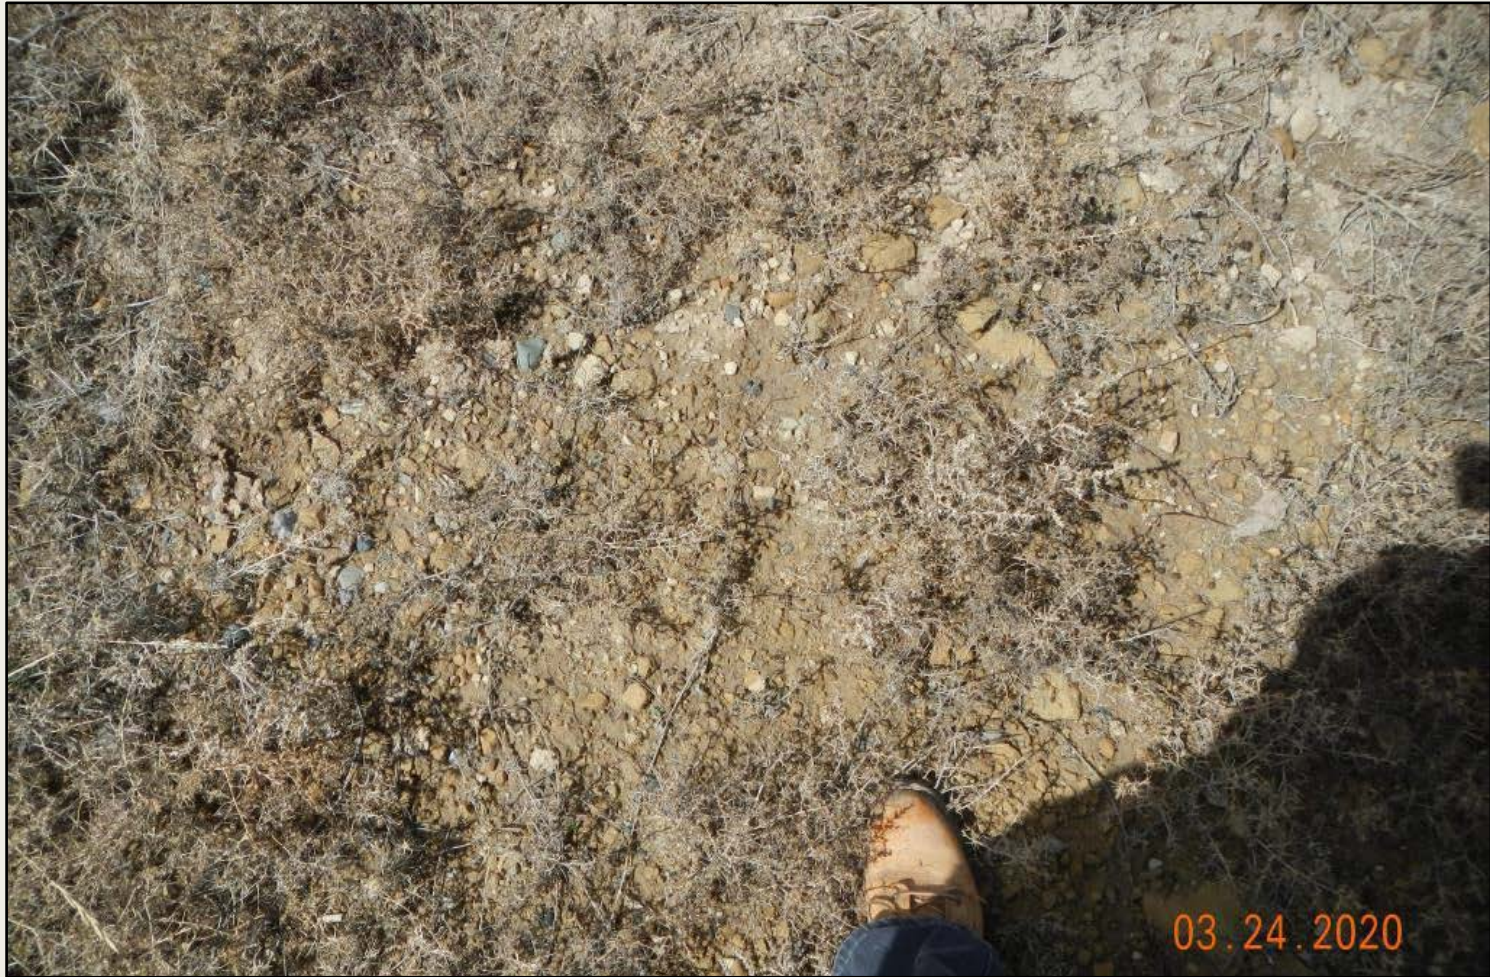
Photo 4. Birdseye view of lack of desirable vegetation in the interim reclamation area. Observable vegetation is Russian thistle debris.

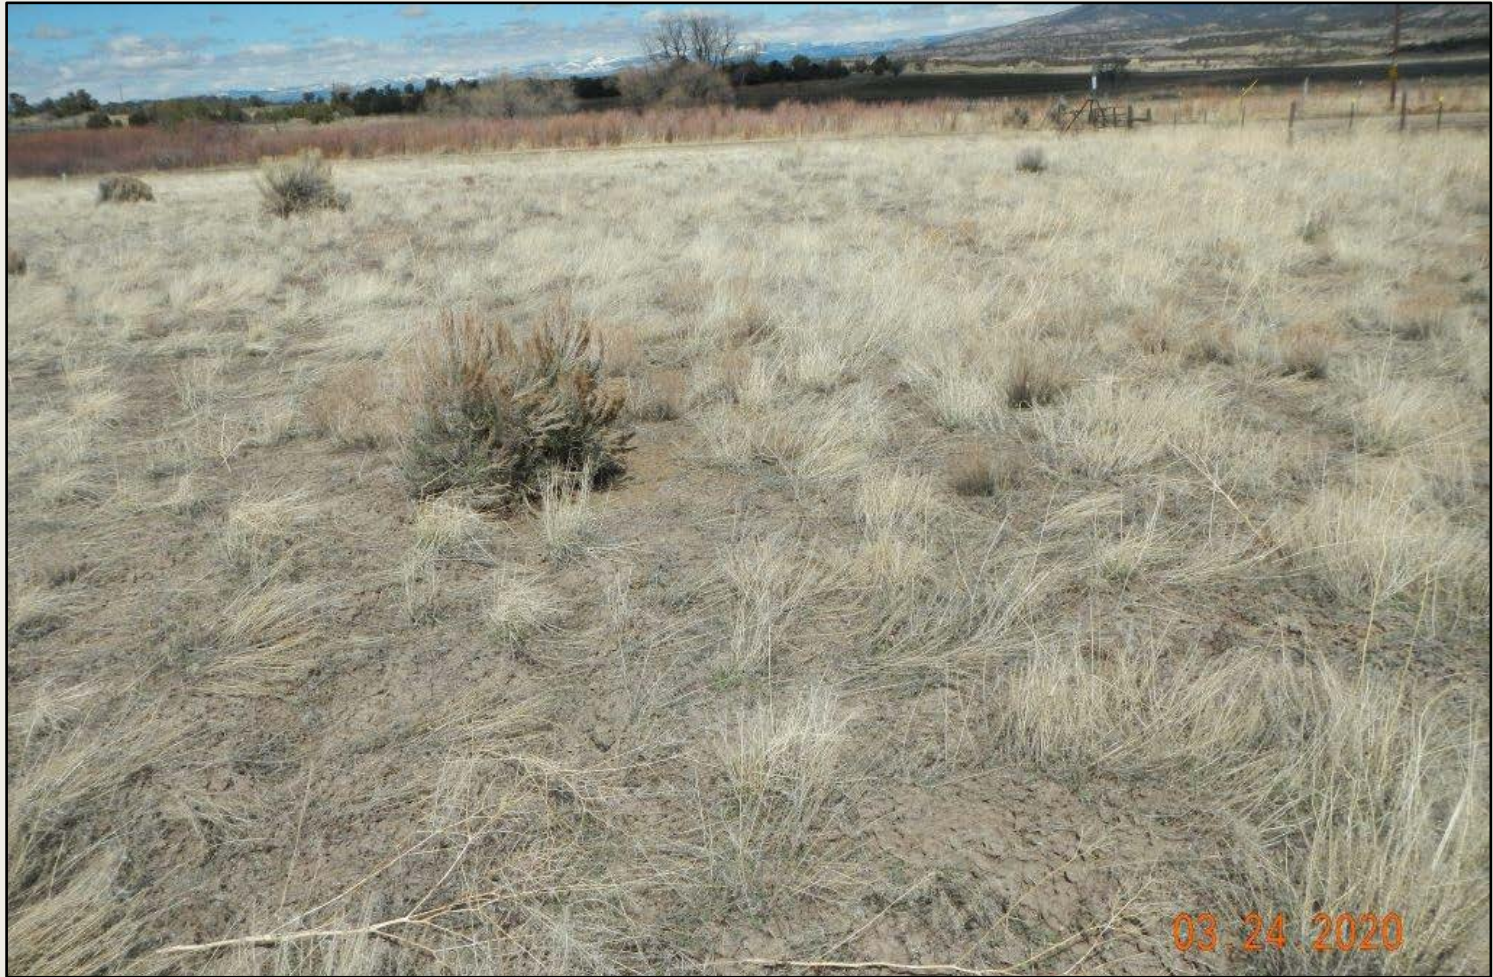
Photo 5. View of reference area vegetation, largely comprised of open sagebrush shrubland with native perennial grasses and forbs.
