Inspection Photos
Operator: Hilcorp Energy
API#: 067-07232
Date: 3/24/2020

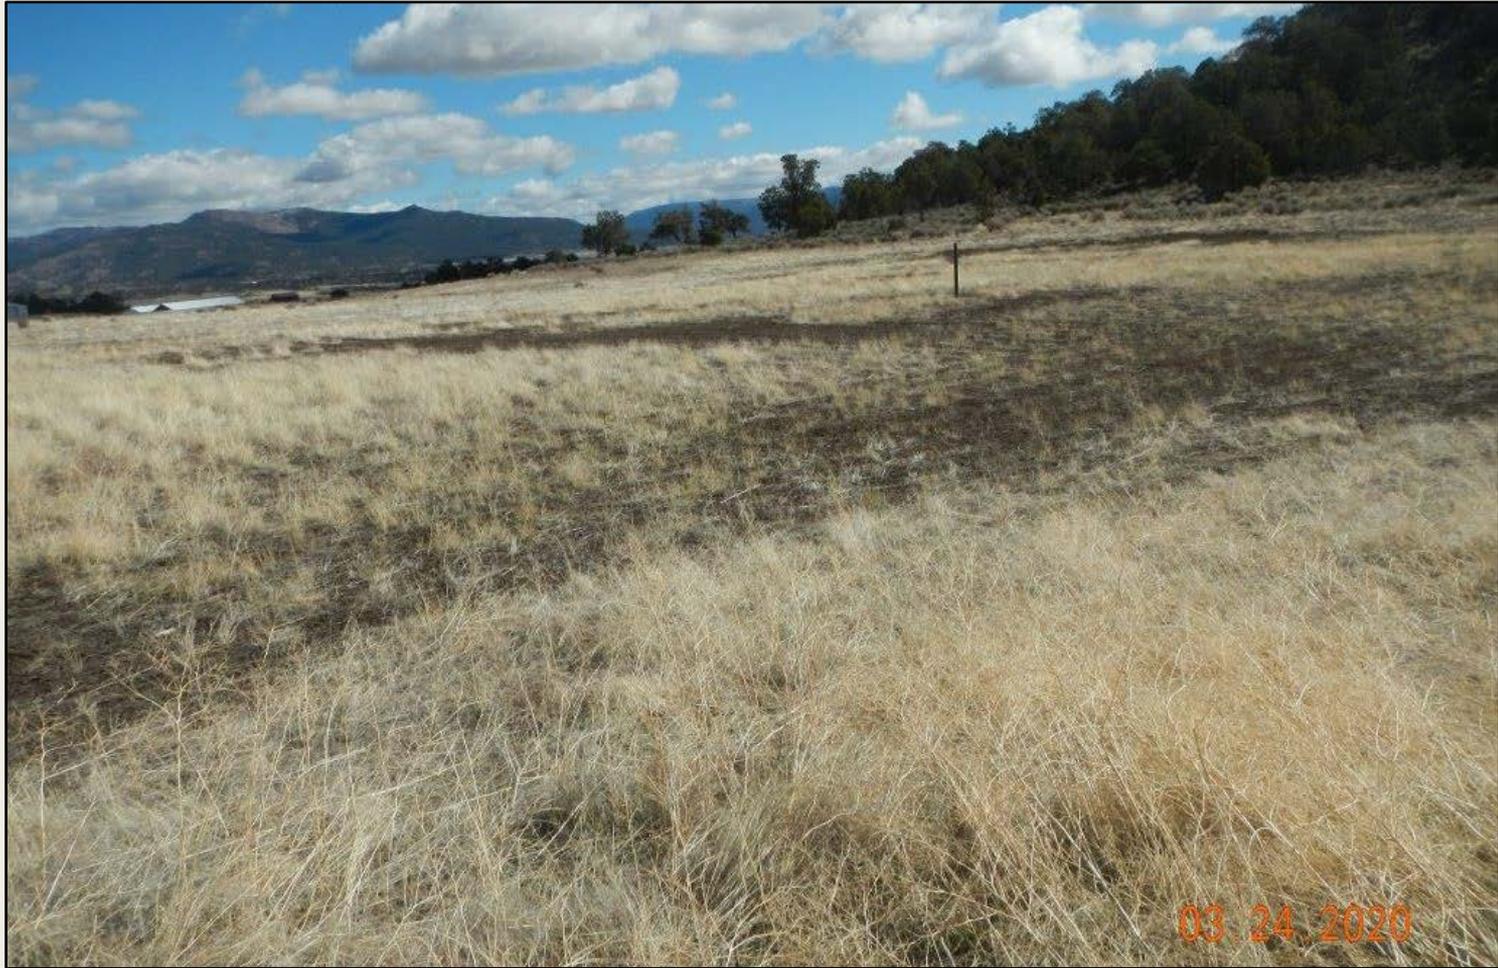
Photo 1. View of the project area from the southwestern corner facing center. Significant portions of the project area are lacking desirable vegetative cover.

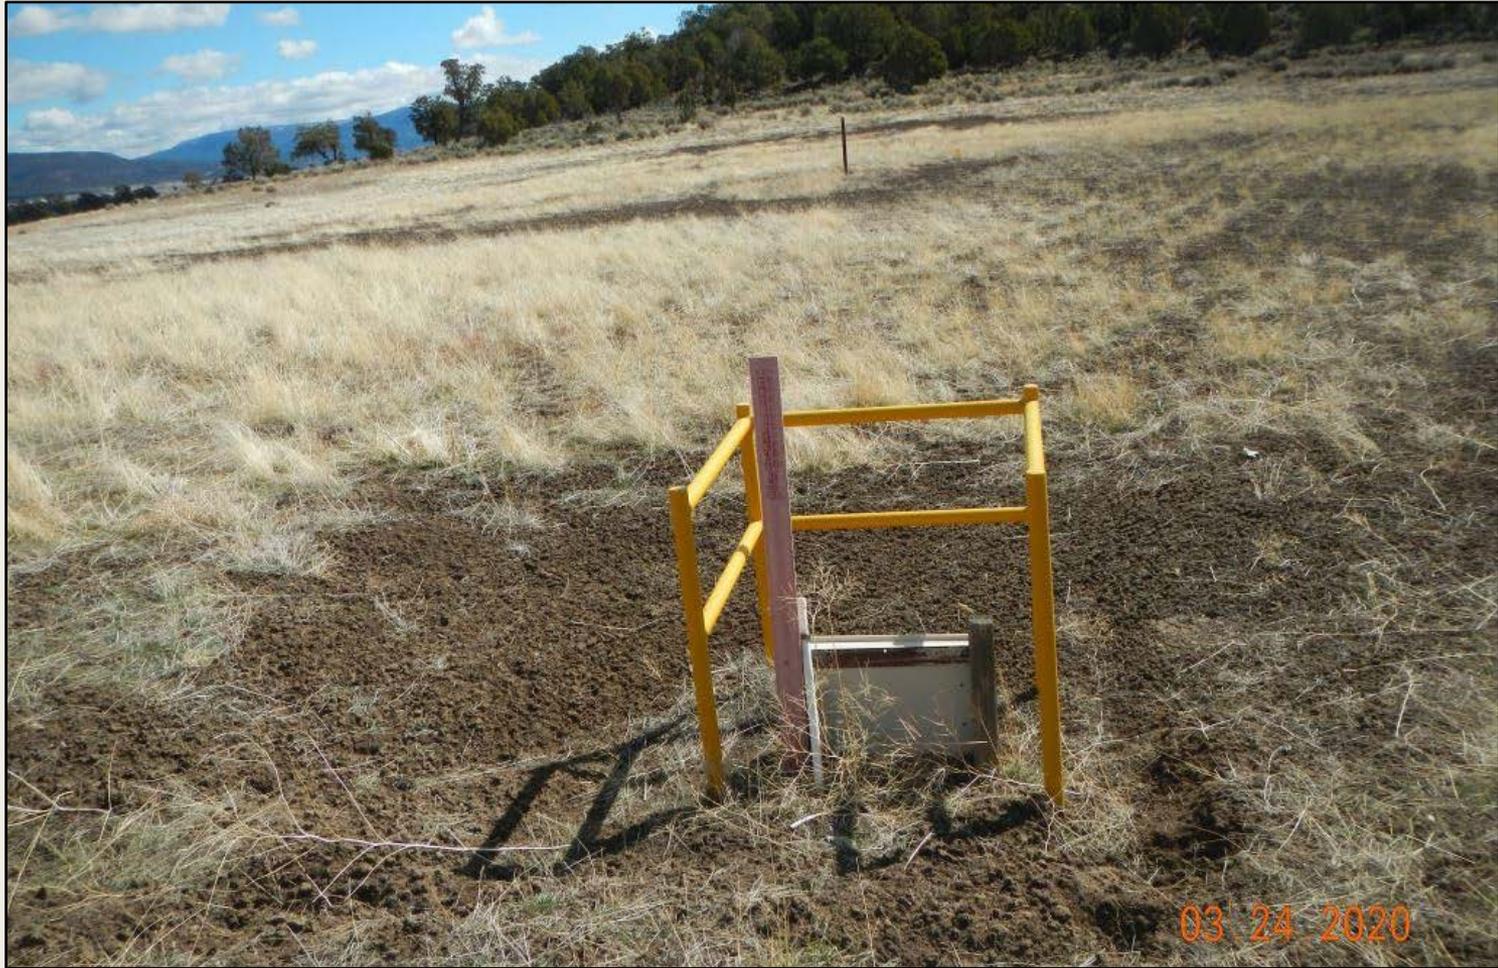
Photo 2. View of equipment within the southwestern project area that needs to be removed.

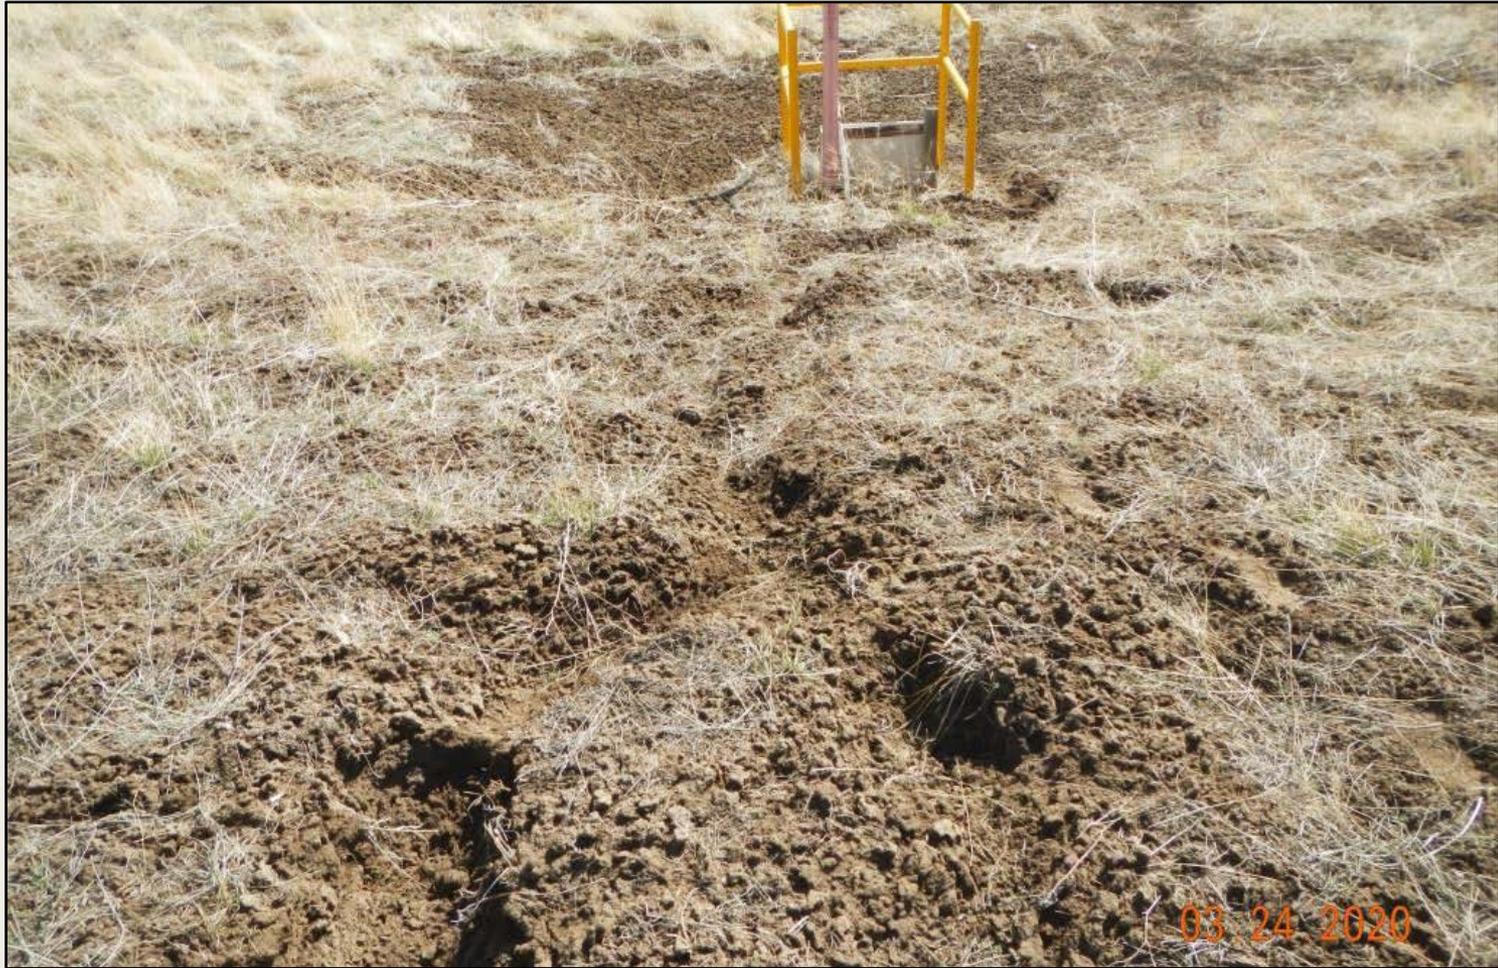
Photo 3. View of erosional channel channeling approximately 1 foot wide and 10 inches deep, within the southwestern project area.

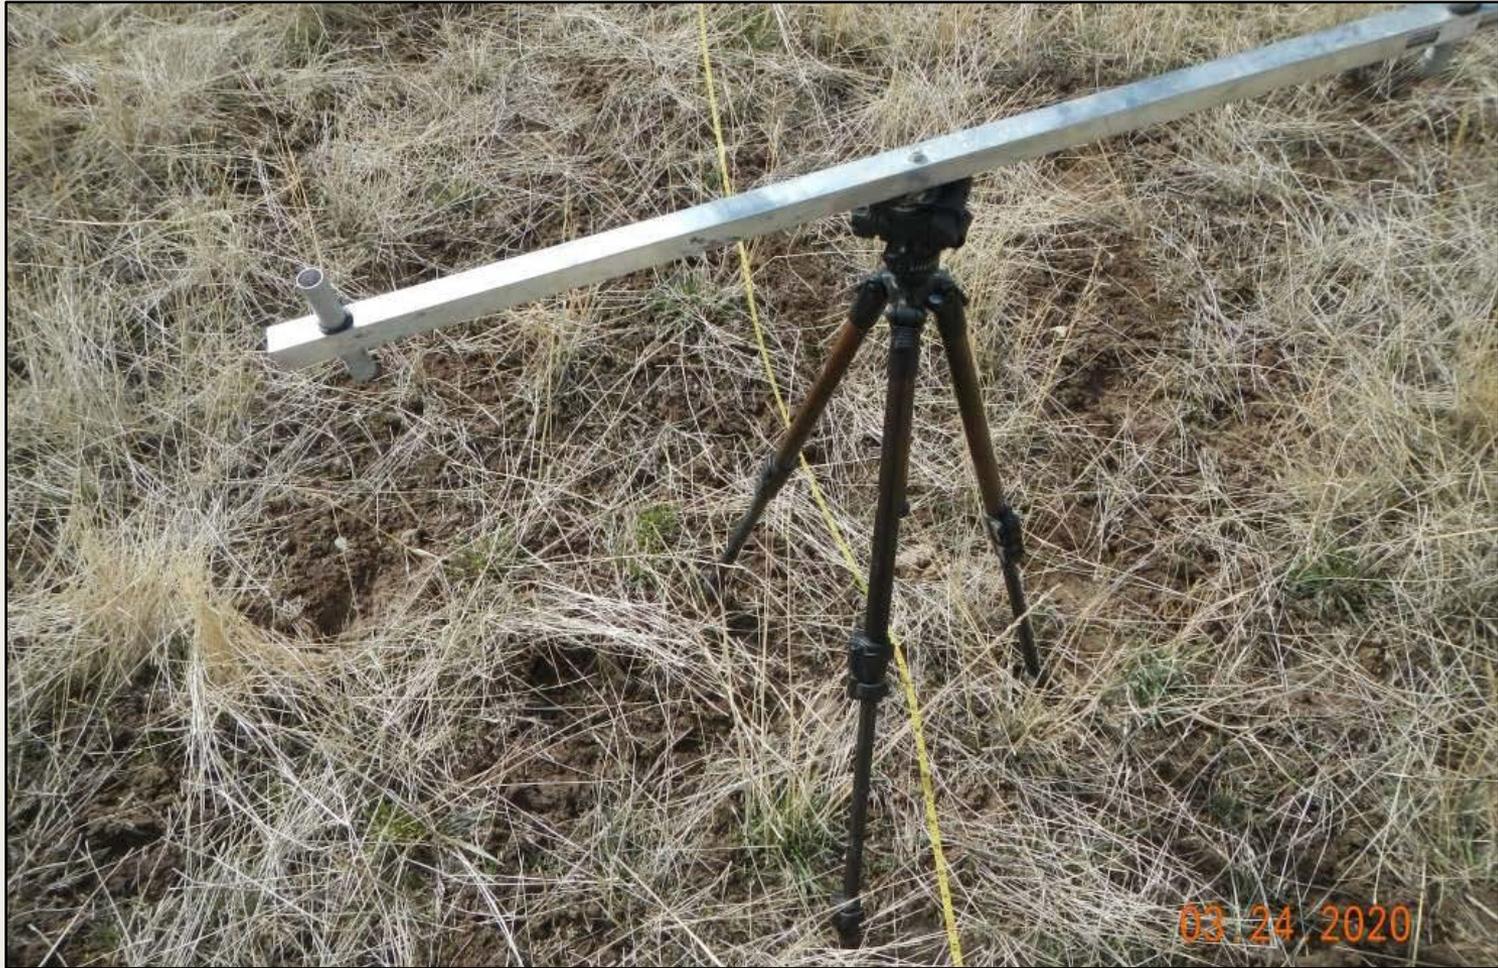
Photo 7. View of vegetation at midpoint along Transect 2, within the project area. Revegetation is comprised of a mix of wheatgrasses becoming established within portions of the project area.

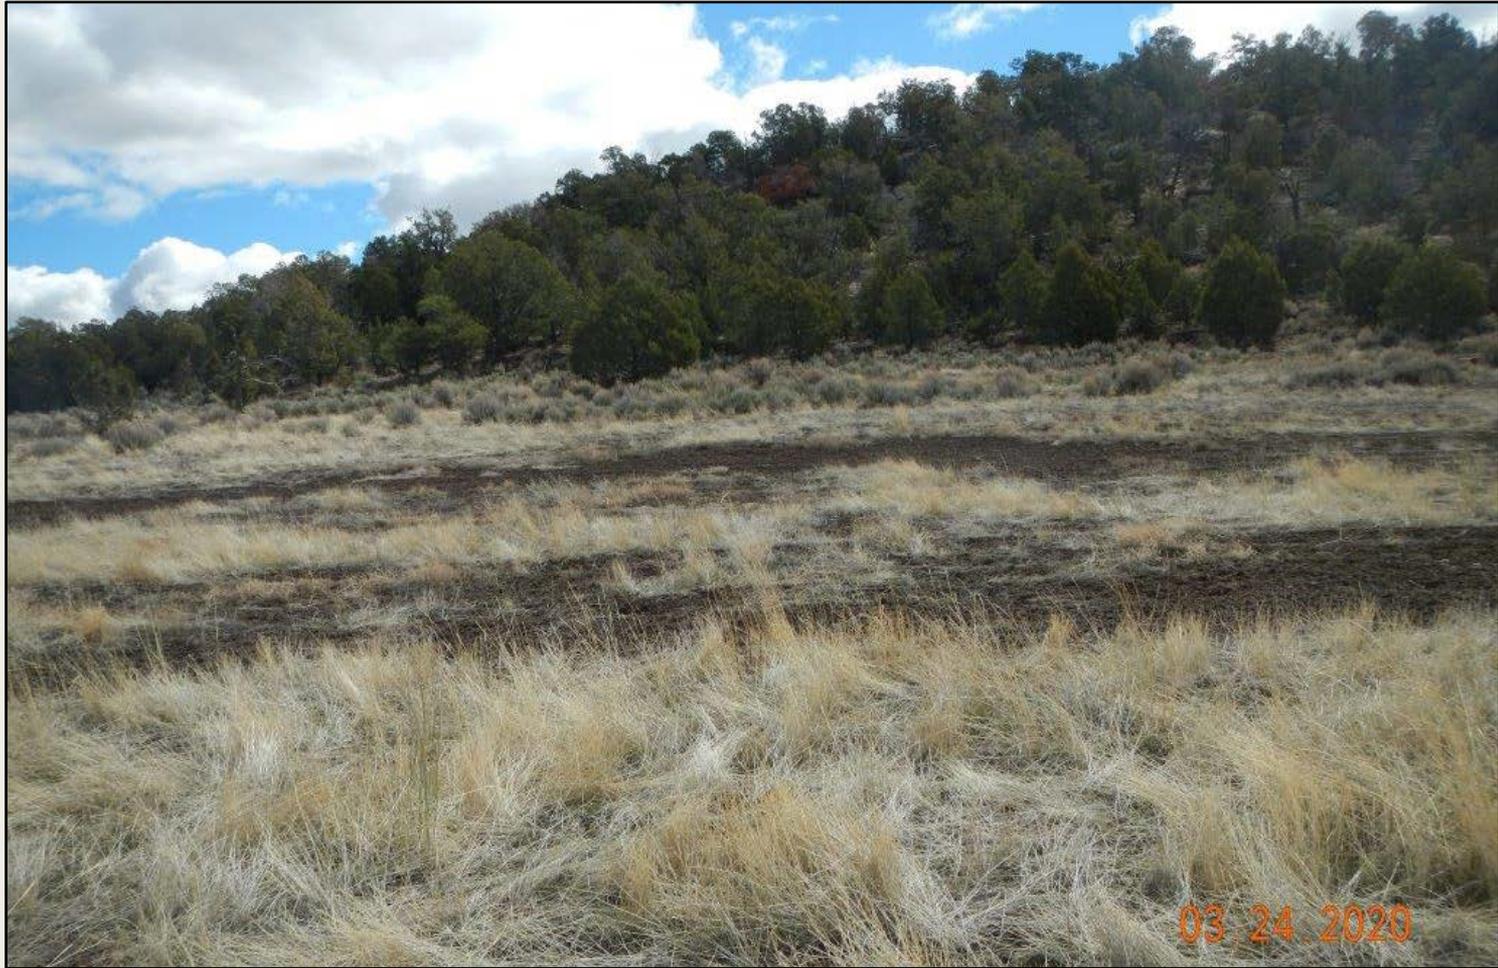
Photo 8. View of the eastern project area, facing eastward from the well pad center. Patches of bare soils remain on location and revegetation lacks uniformity.

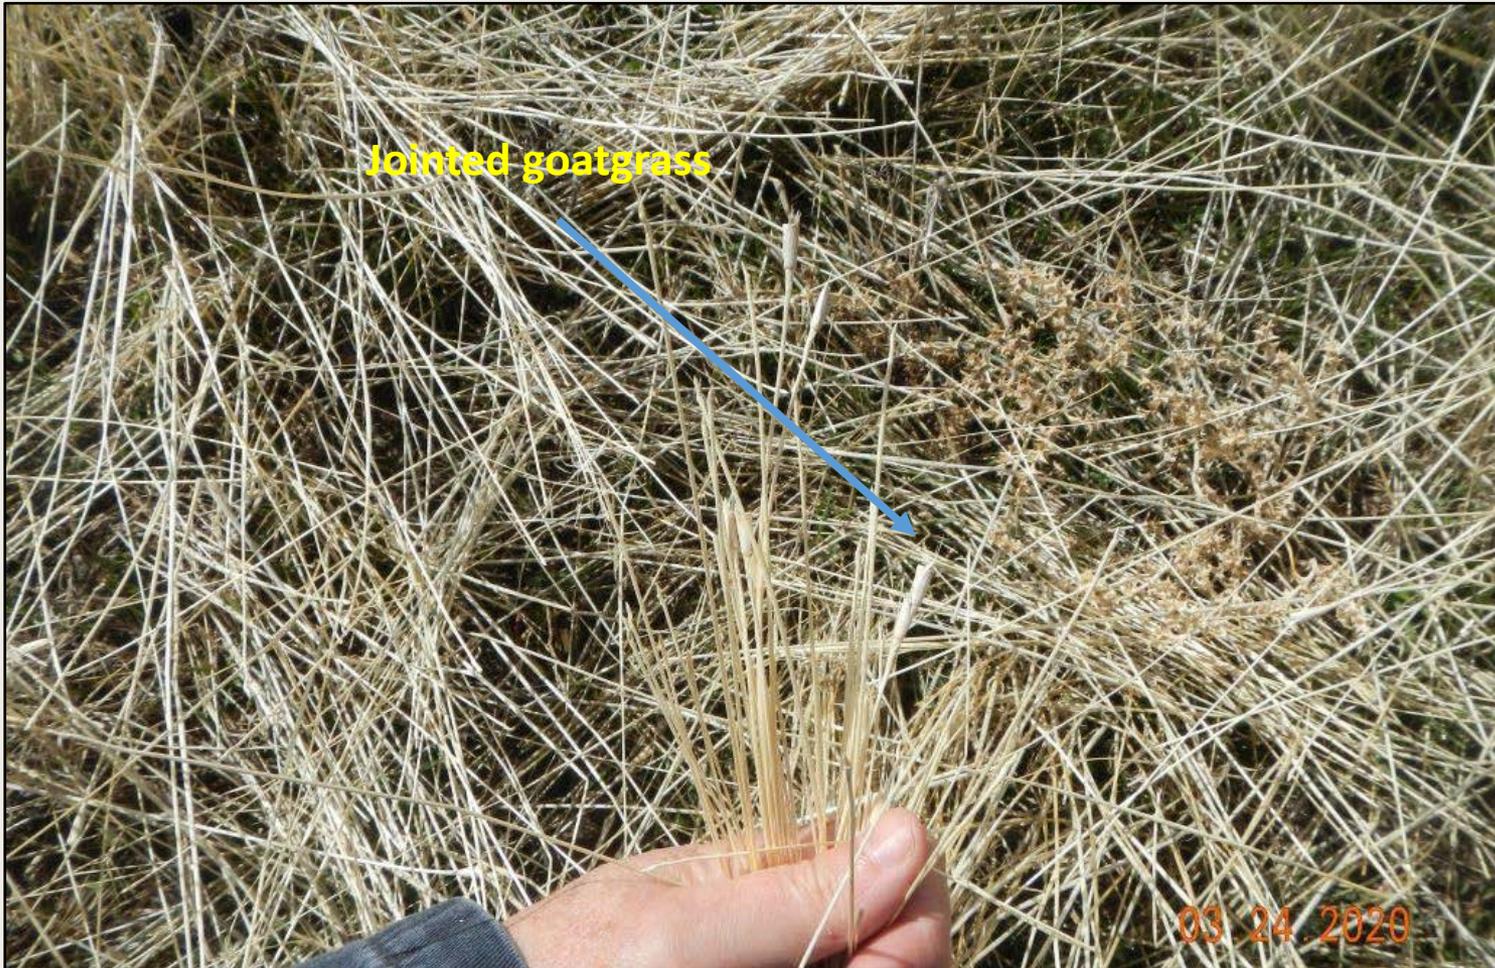
Photo 9. View of jointed goatgrass flowerheads observed within the project area.
