Inspection Photos

Operator: Hilcorp Energy
API#: 067-07243
Date: 3/24/2020

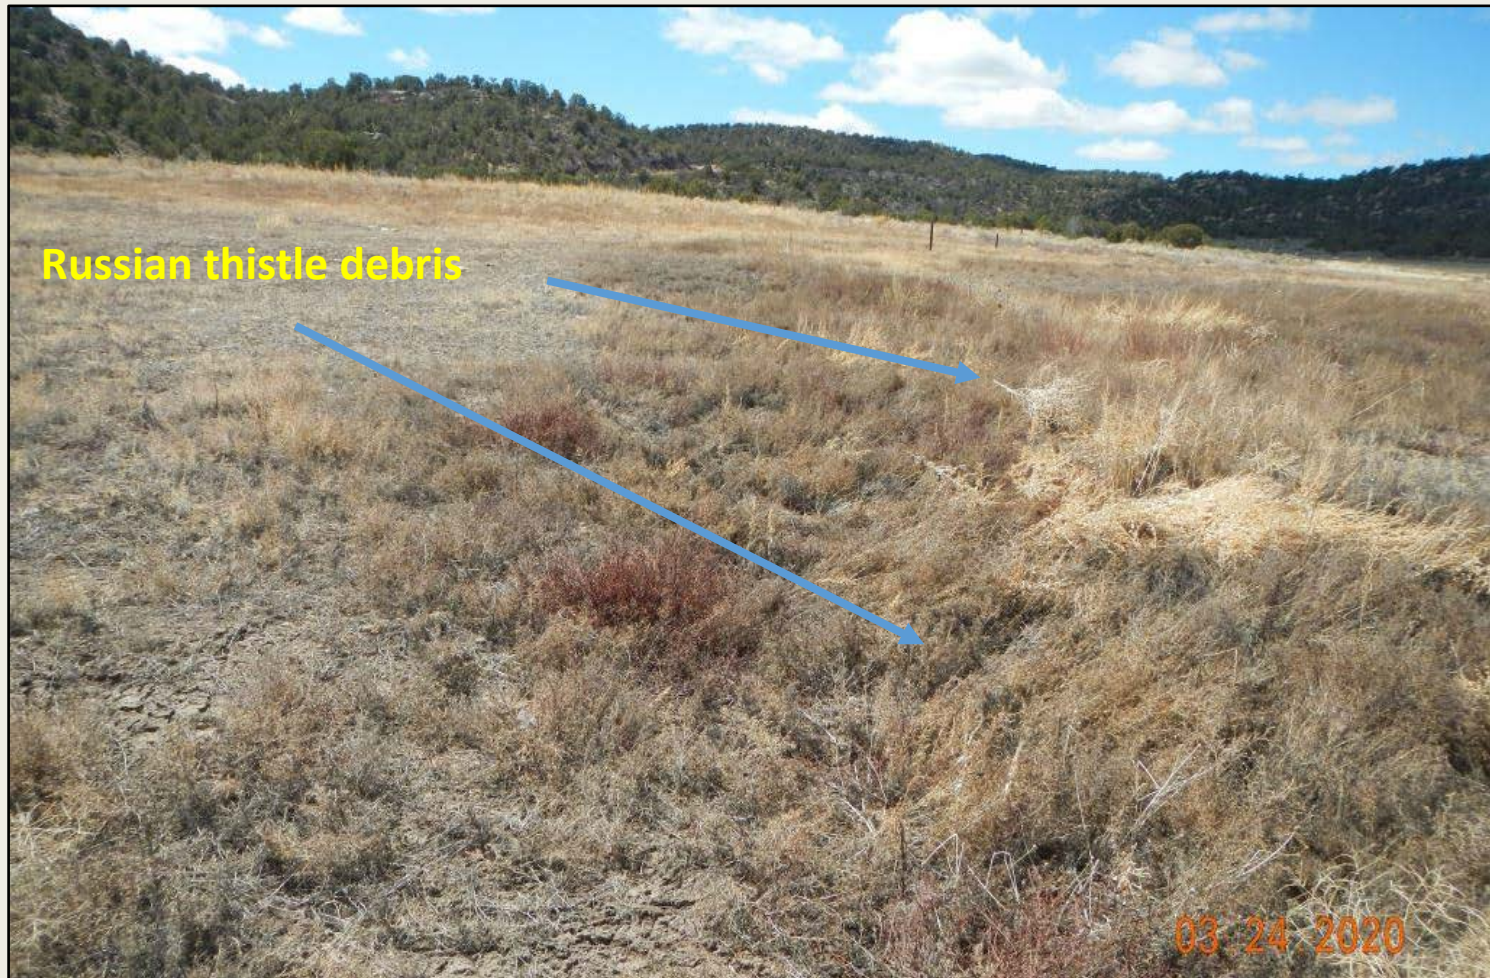
Photo 1. View of the project area from the former well pad entrance facing center. Dense, dried vegetation on the well pad is largely Russian thistle debris.

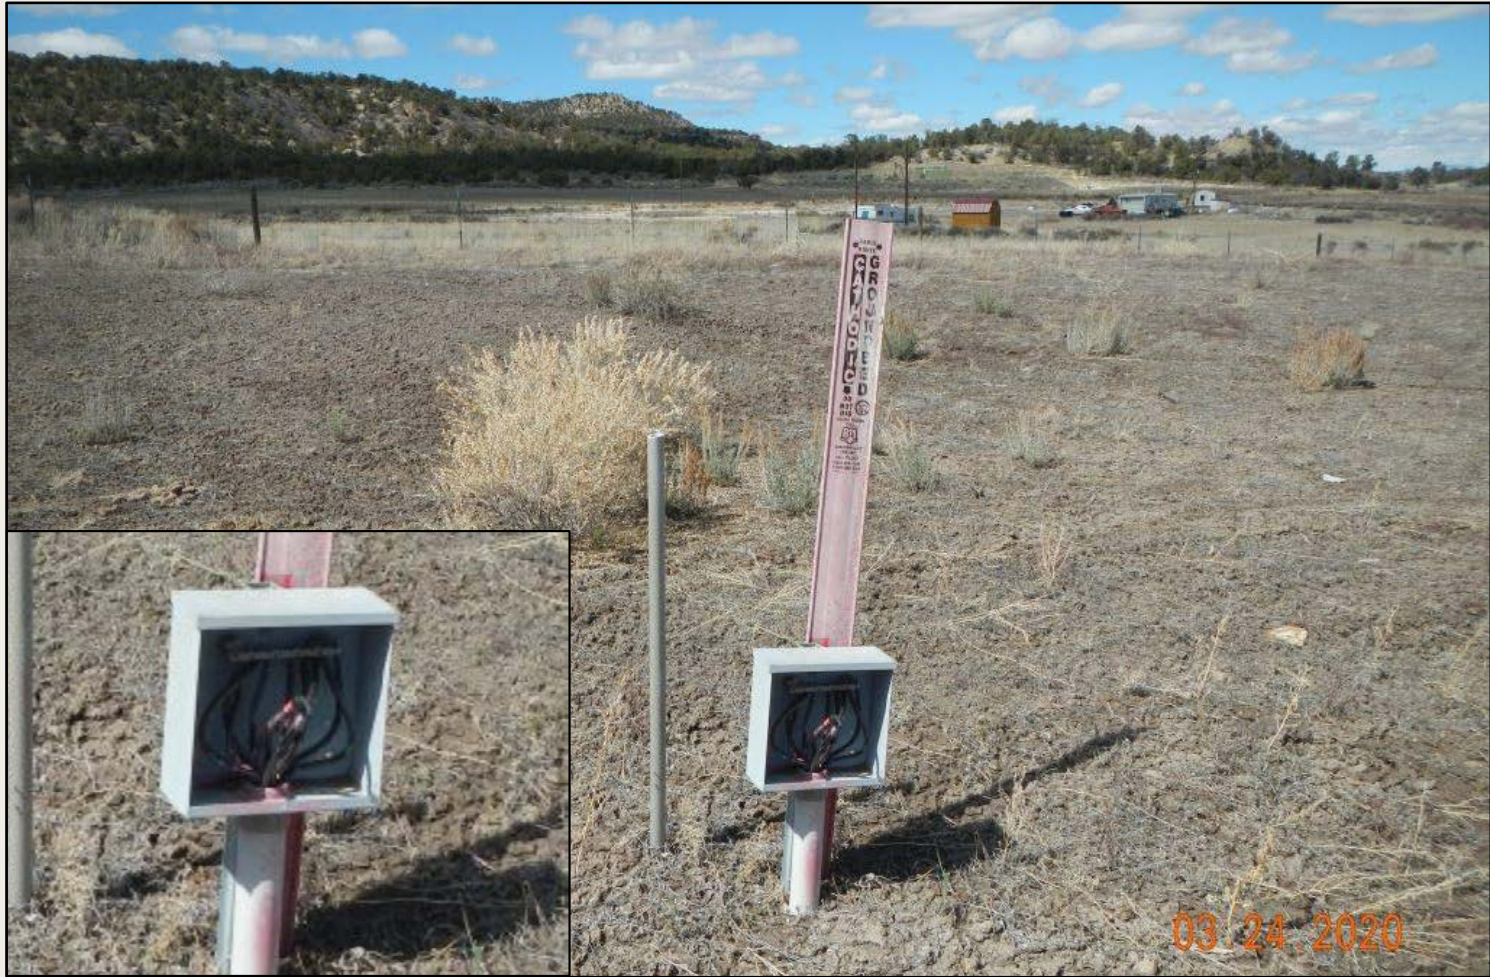
Photo 2. View of electrical equipment that remains within the western project area. Closeup in lower left inset shows exposed electrical wiring.

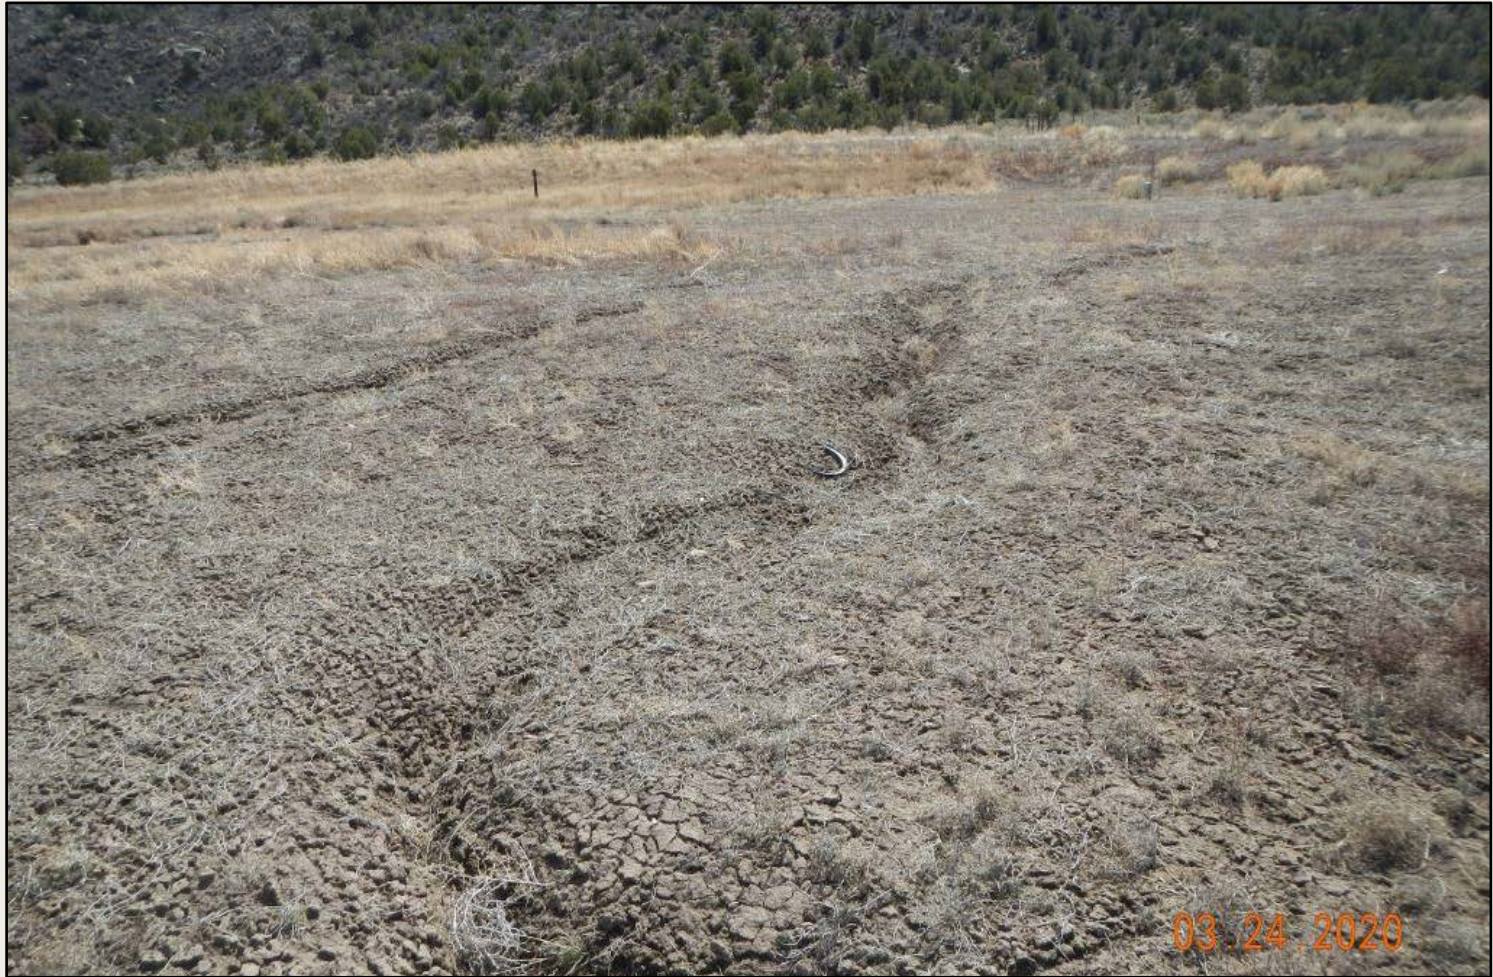
Photo 3. View of erosional rilling (approximately 1 foot wide and deep) within the northwestern project area facing up-slope (southward).

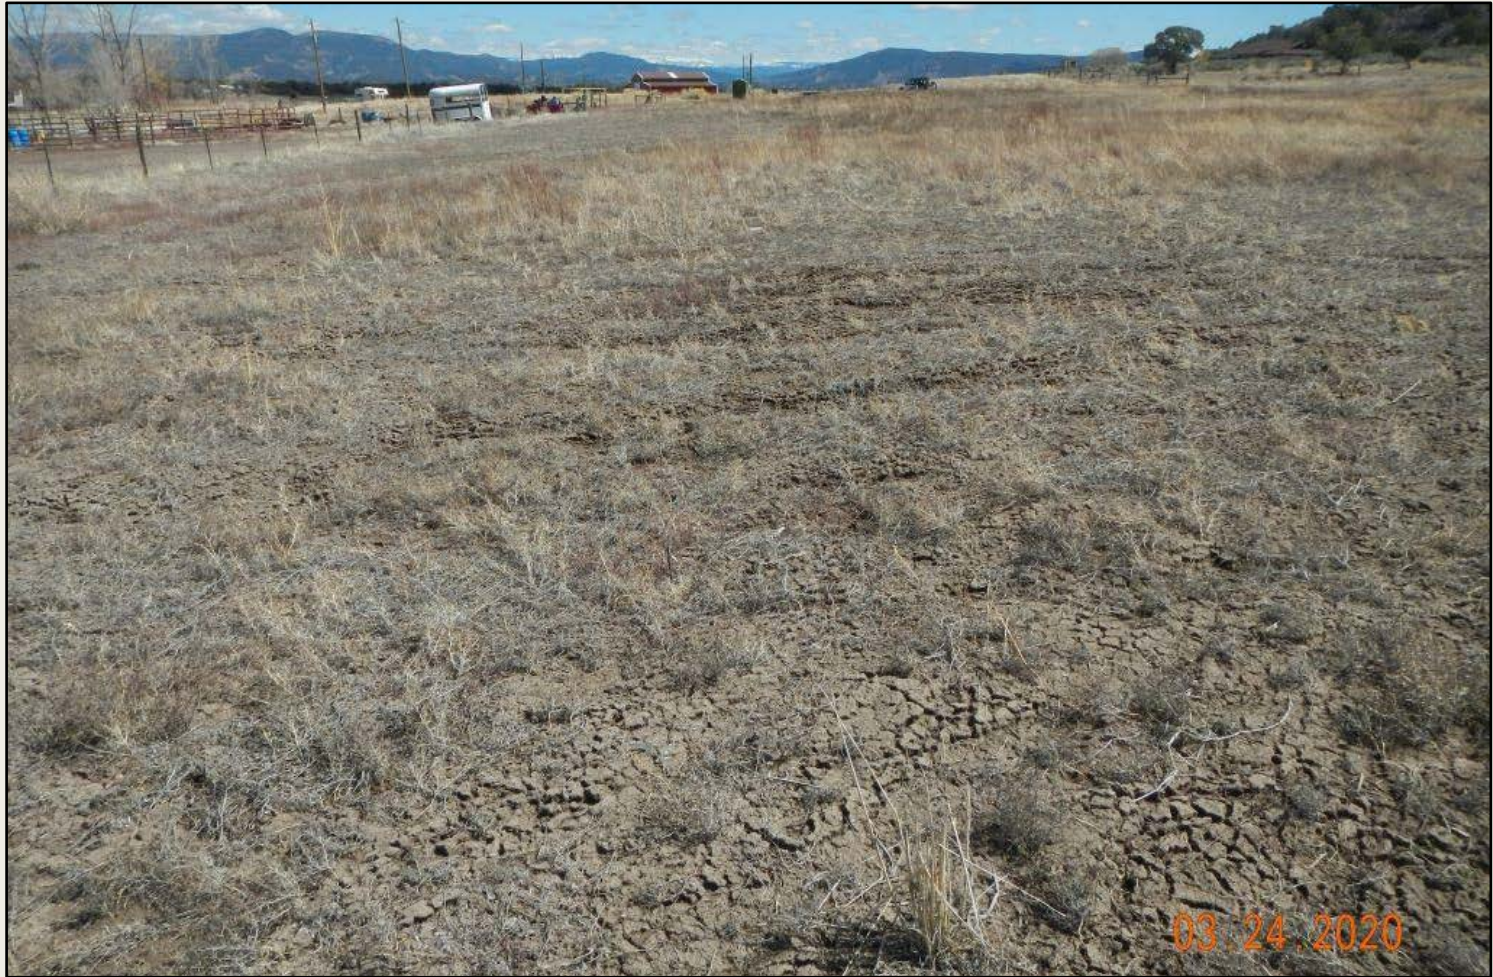
Photo 4. View of the northern fill slope facing eastward from the northwestern corner of the well pad.

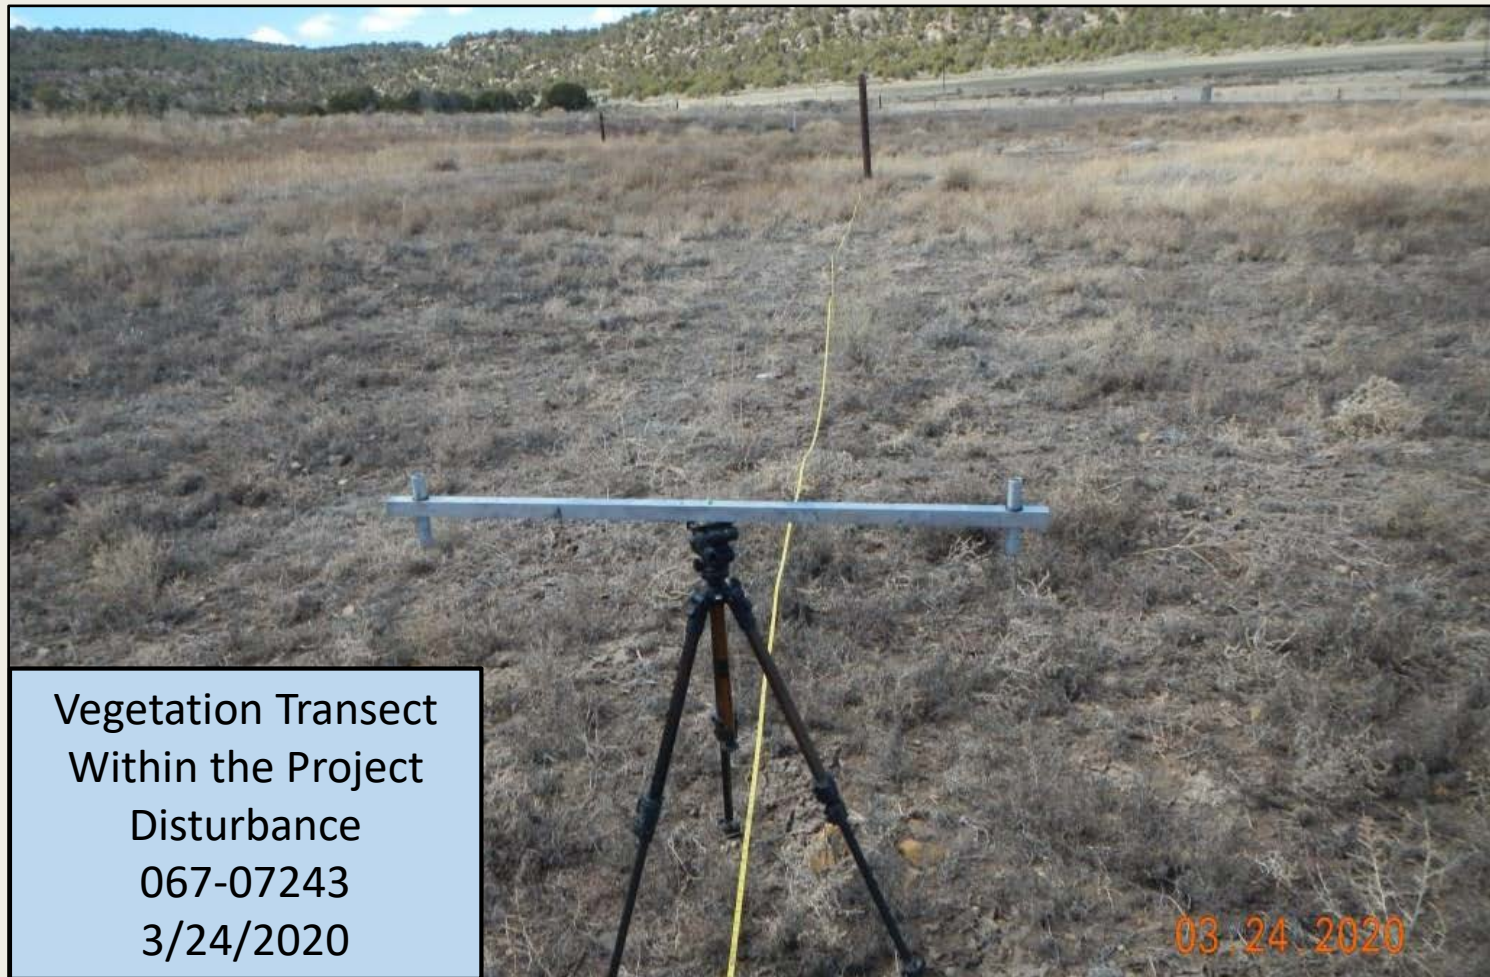
Photo 5. View from the beginning of Transect 1, within the project disturbance area facing westward. No desirable vegetation was detected along vegetation transect.

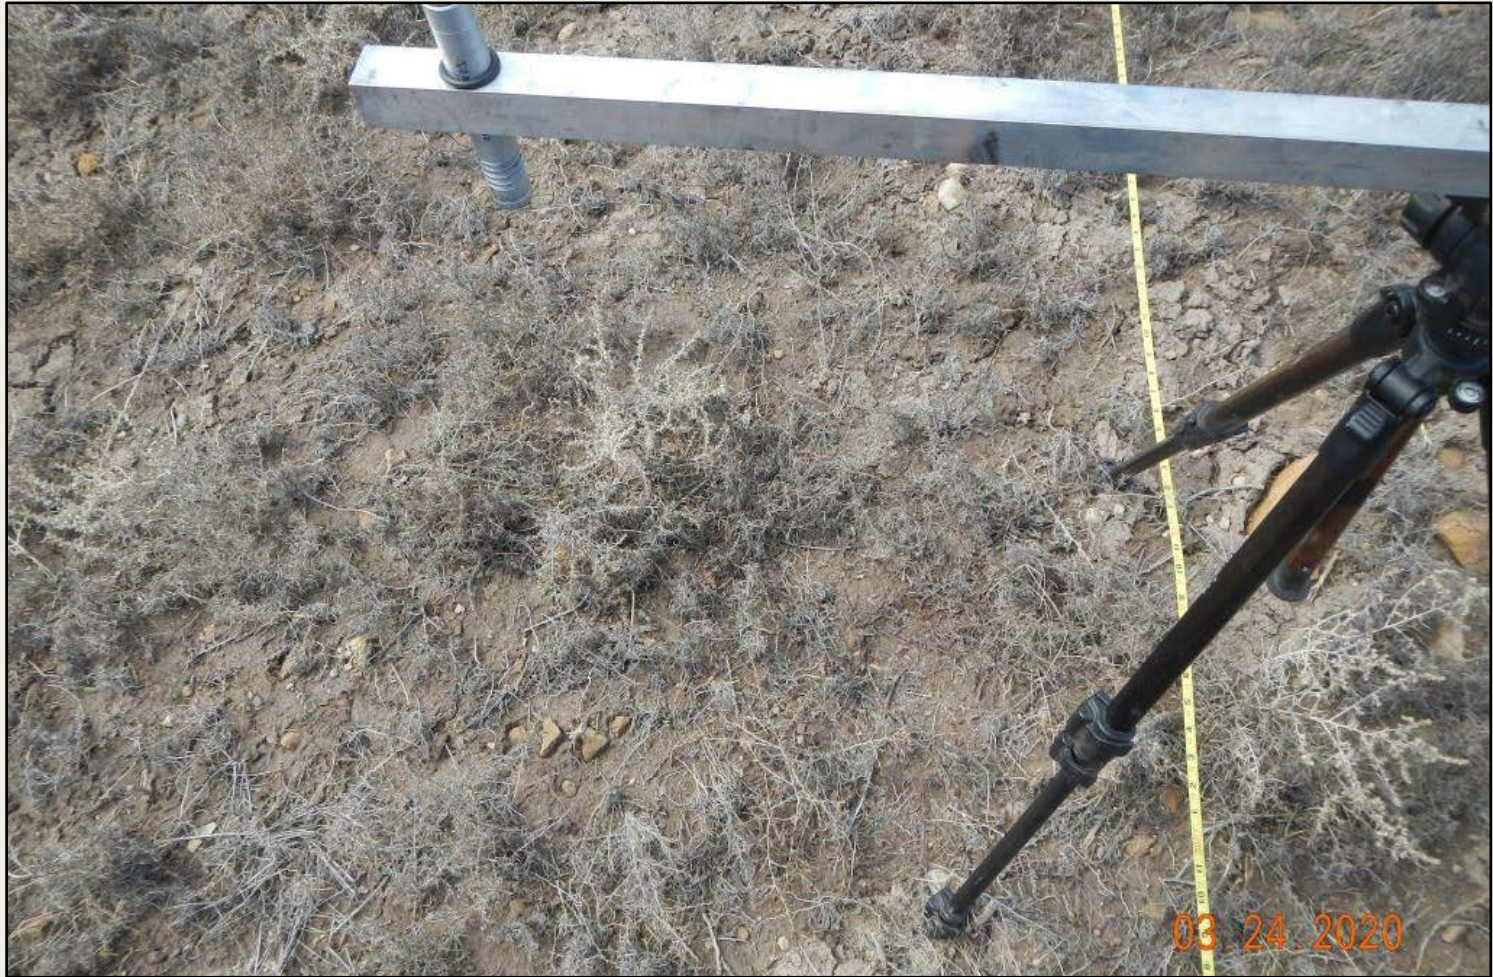
Photo 6. Birdseye view of midpoint along the vegetation Transect. Observable vegetation is all weed debris from previous growing seasons-largely Russian thistle and bindweed.
