## Inspection Photos

Location Name: VPR C NO. 75 CA DATE 4-30-20

API#: 05-071-07397

INSP. #: 695102463

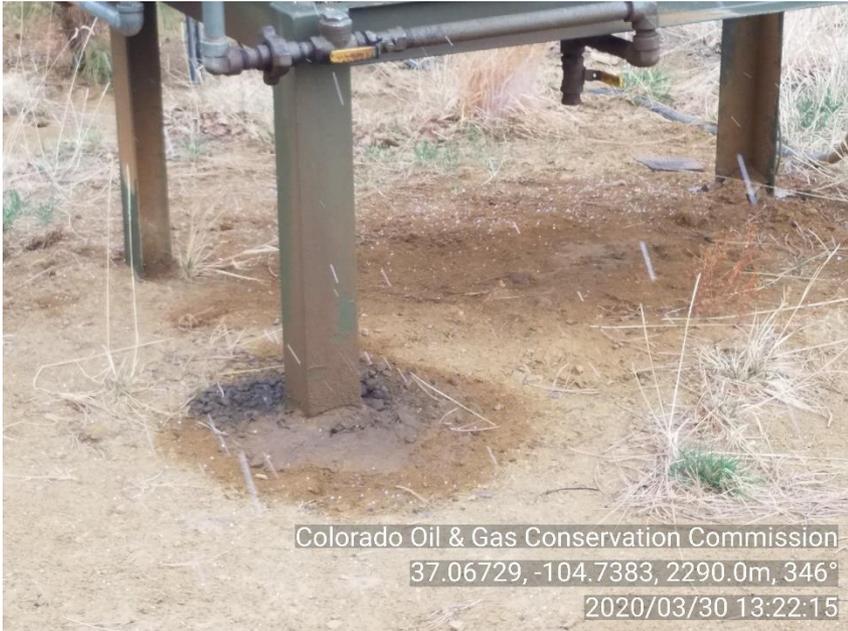
**PHOTO 3: AREA OF IMPACTED SOIL APPEARS TO BE OIL FROM COMPRESSOR. Conduct maintenance on equipment, cleanup stained material and review self inspection processes. CA DATE 4-30-20.**

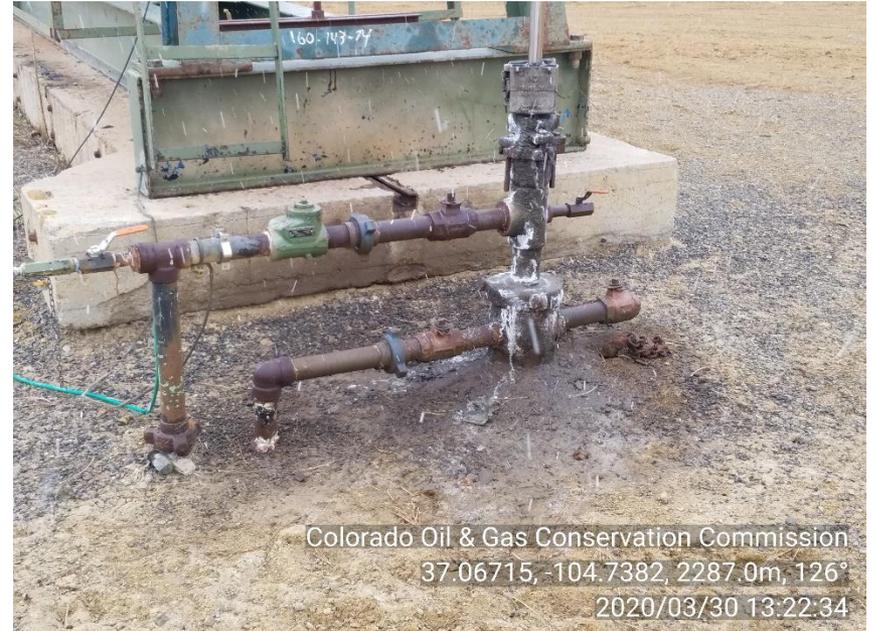
**PHOTO 4: AREA OF IMPACTED SOIL APPEARS TO BE OIL FROM POLISH ROD LUBRICATOR. Conduct maintenance on equipment, cleanup stained material and review self inspection processes. CA DATE 4-30-20.**
