Inspection Photos

Location Name: AP 12-05 FOLLOWUP CA DATE 4-30-20

API#: 05-071-06170

INSP. #: 695102494

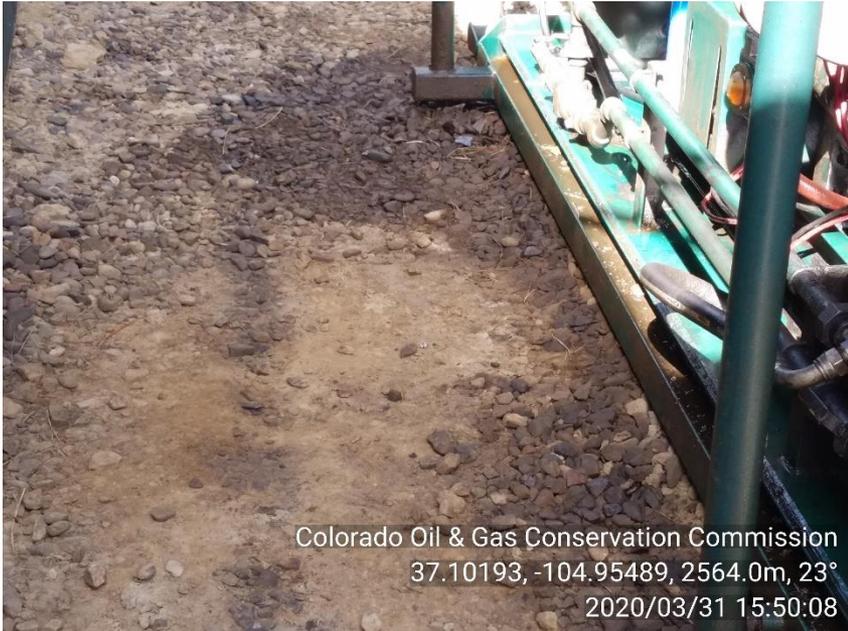
PHOTO 3: AREA OF IMPACTED SOIL AROUND COMPRESSOR SKID. Conduct maintenance on equipment, cleanup stained material and review self inspection processes. CA DATE 4-30-20.

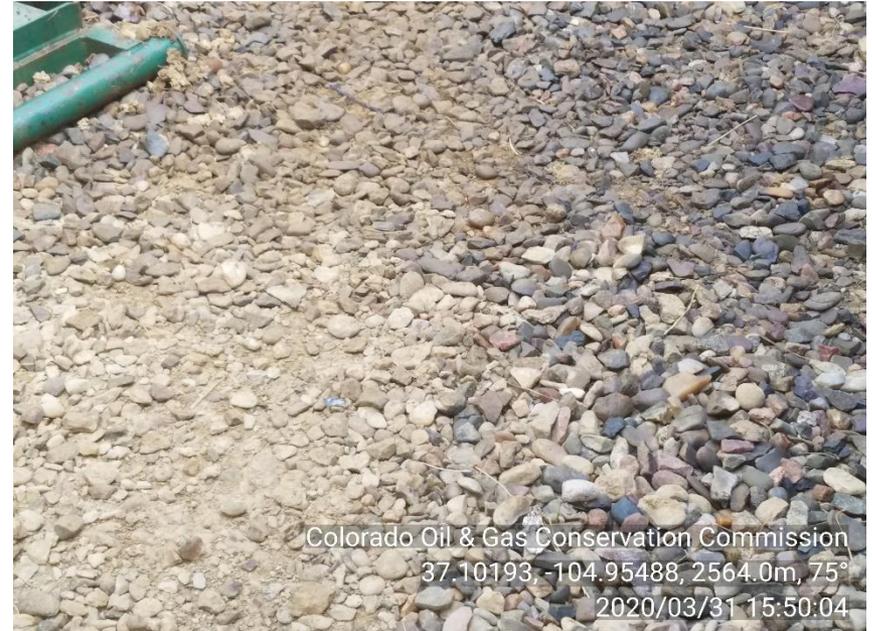
PHOTO 4: AREA OF IMPACTED SOIL AROUND COMPRESSOR SKID. Conduct maintenance on equipment, cleanup stained material and review self inspection processes. CA DATE 4-30-20.

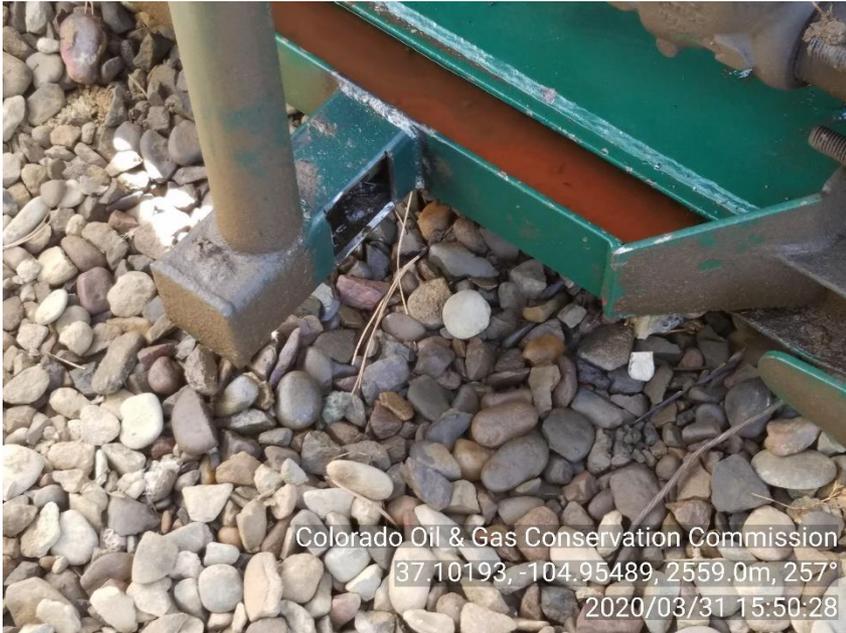
PHOTO 5: AREA OF IMPACTED UNDER COMPRESSOR SKID DRAIN APPEARS THAT SKID IS BEING DRAINED ON THE GROUND. Conduct maintenance on equipment, cleanup stained material and review self inspection processes. CA DATE 4-30-20.

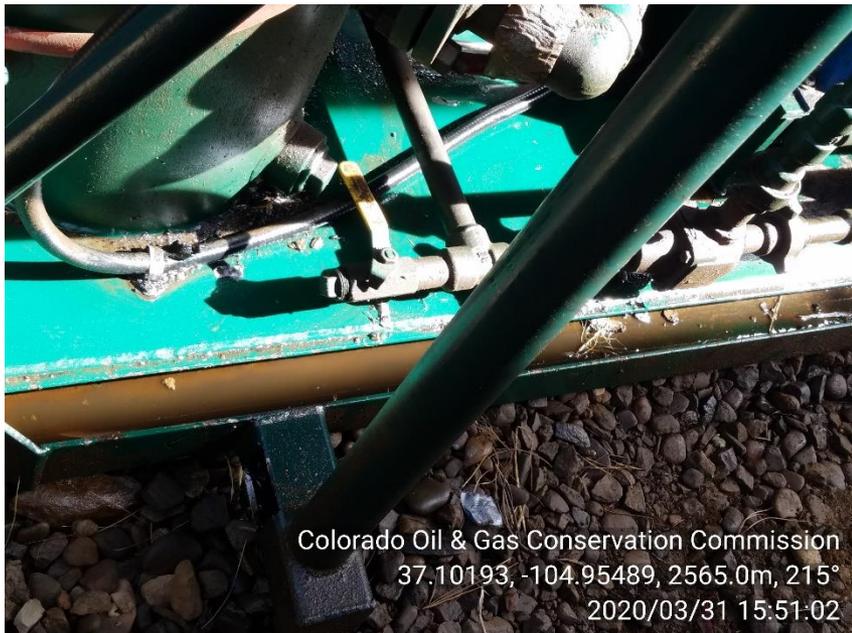
**PHOTO 6: STANDING OIL IN COMPRESSOR SKID.
COMPLY WITH GENERAL PERSIVIONS OF THE OIL
AND GAS ACT AND SB-181 REGARDING WILDLIFE
PROTECTION. CA DATE 4-30-20.**

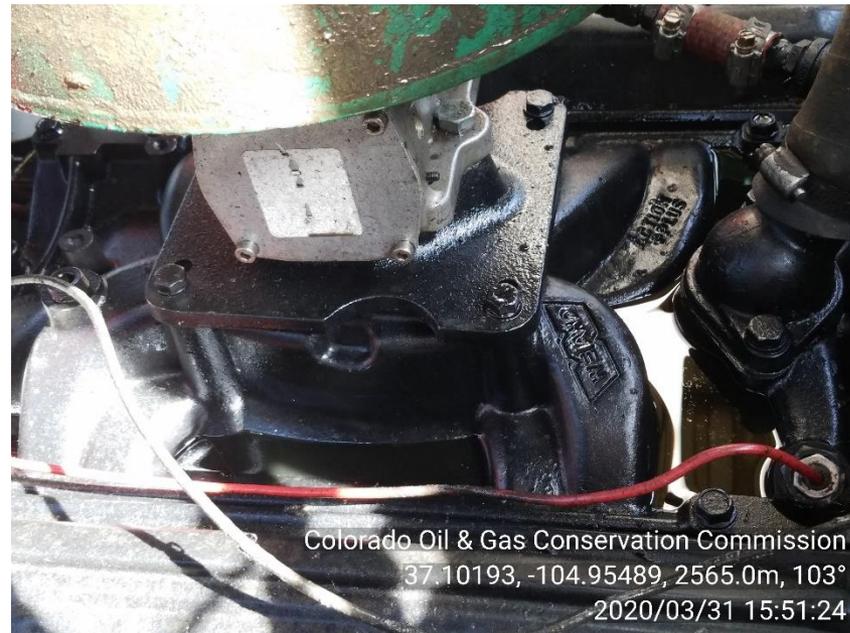
**PHOTO 7: STANDING OIL IN MANIFOLD ON COMPRESSOR
MOTOR. COMPLY WITH GENERAL PERSIVIONS OF THE OIL
AND GAS ACT AND SB-181 REGARDING WILDLIFE
PROTECTION. CA DATE 4-30-20.**
