Inspection Photos

Location Name: AP 12-06 CA DATE 4-30-20

API#: 05-071-08388

INSP. #: 695102496

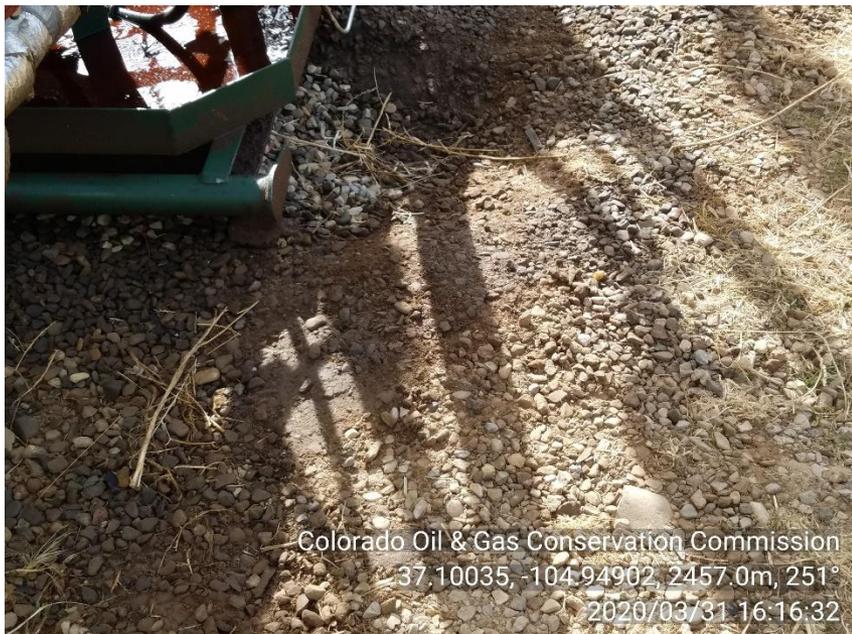
PHOTO 3: AREA OF IMPACTED SOIL APPEARS TO BE FROM DRAINING COMPRESSOR SKID ON THE GROUND. Conduct maintenance on equipment, cleanup stained material and review self inspection processes. CA DATE 4-30-20.

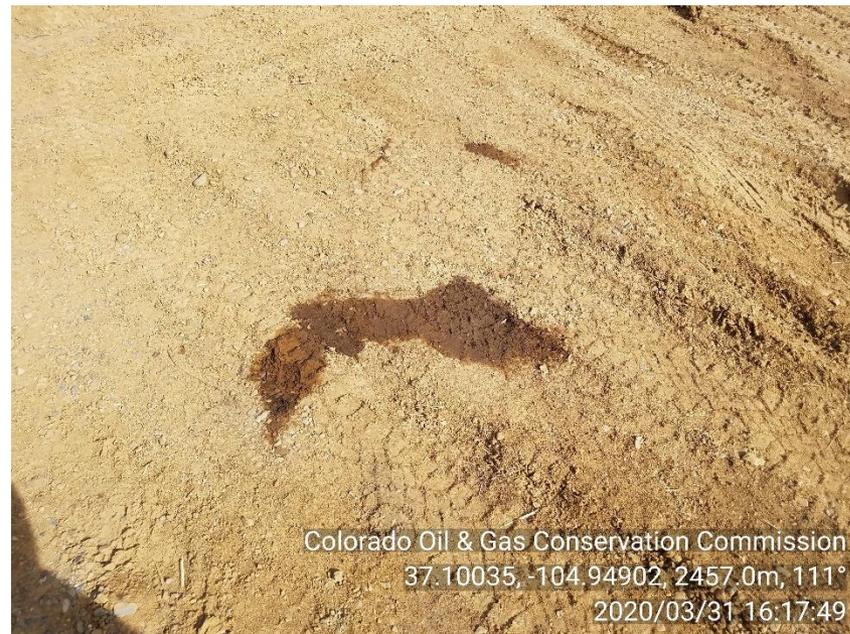
PHOTO 4: AREA OF IMPACTED SOIL BETWEEN WELLHEAD AND METER HOUSE. Conduct maintenance on equipment, cleanup stained material and review self inspection processes. CA DATE 4-30-20.

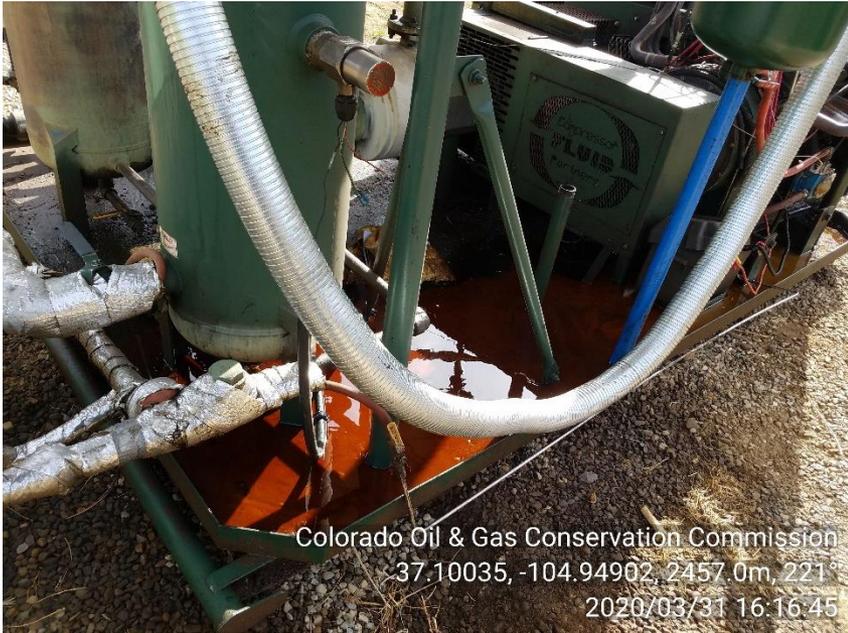
**PHOTO5: STANDING OIL IN COMPRESSOR SKID
CONTAINMENT APPEARS THE ENGINE OIL IS BEING
DRAINED INTO SKID. Comply with general
provisions of the oil and gas act for wildlife
protection. CA DATE 4-30-20.**
