Inspection Photos
Operator: BP America
API#: 067-09101
Date: 3/31/2020

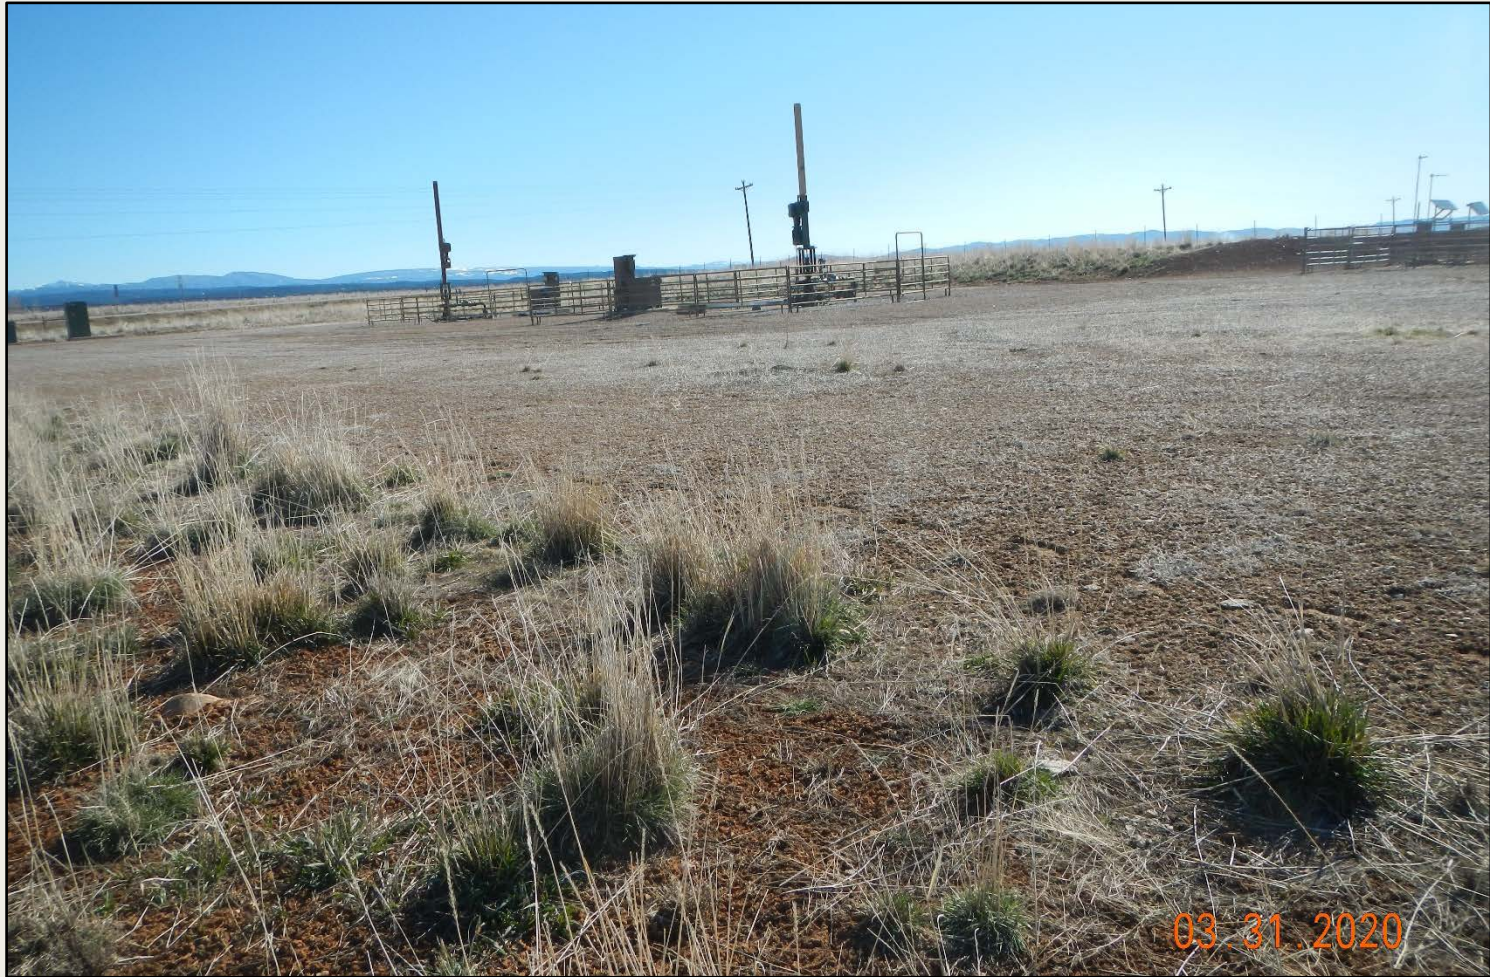
Photo 1. View of the project area from the southwestern corner facing center.

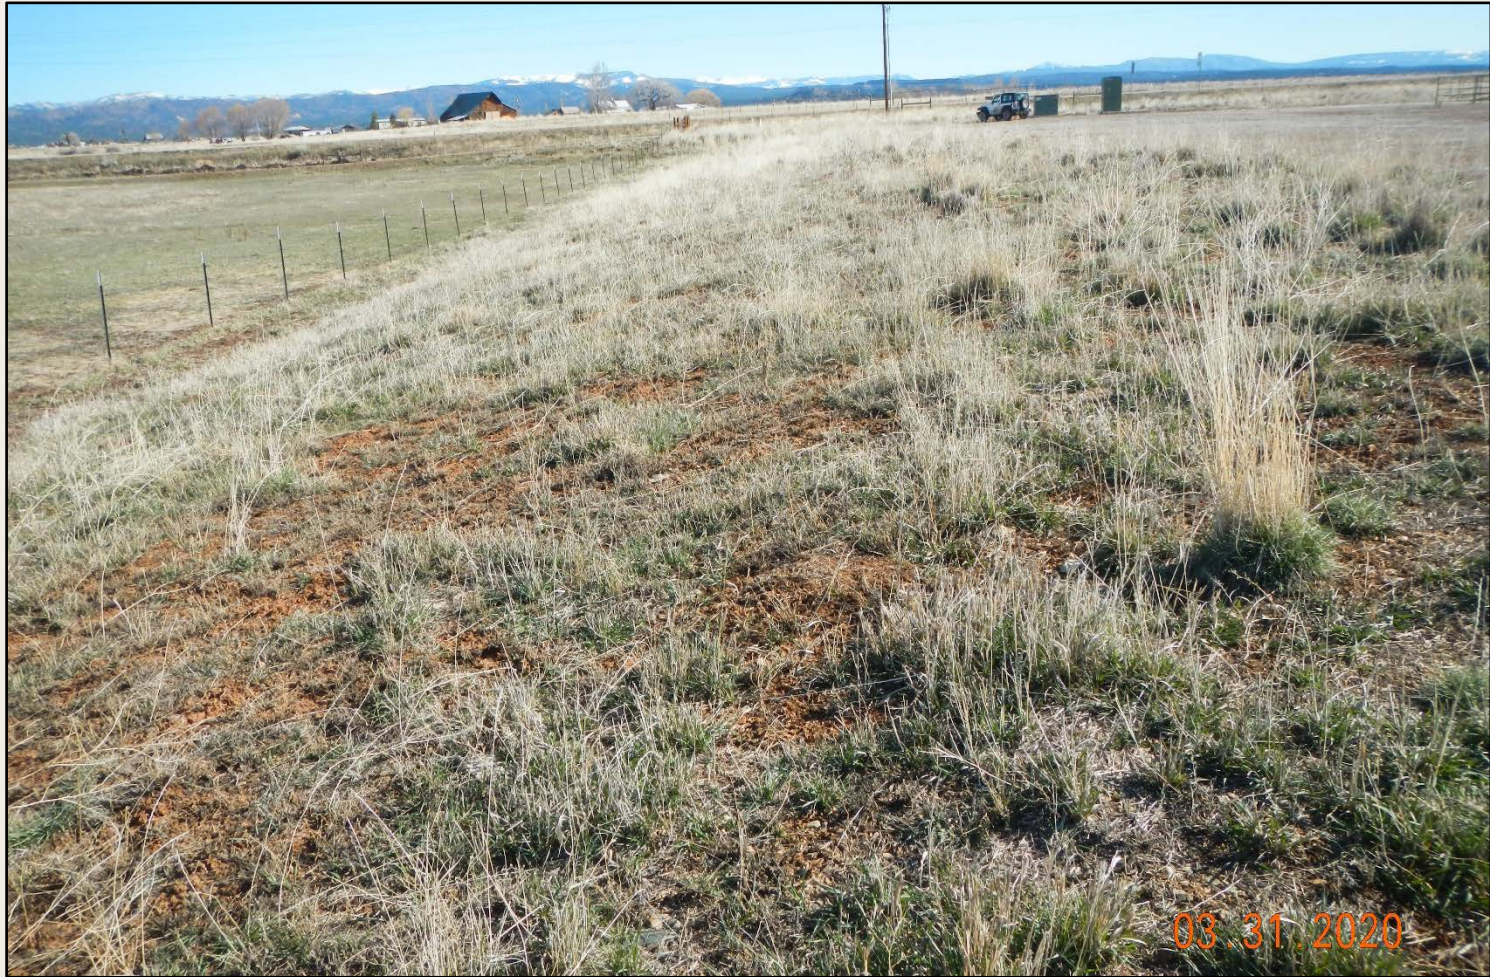
Photo 2. View of the western fill slope from the southwestern corner facing northward. Revegetation is progressing, largely with non-native grasses such as crested wheatgrass and intermediate wheatgrass. Final reclamation will need to be comprised of seed mix more similar to reference area.

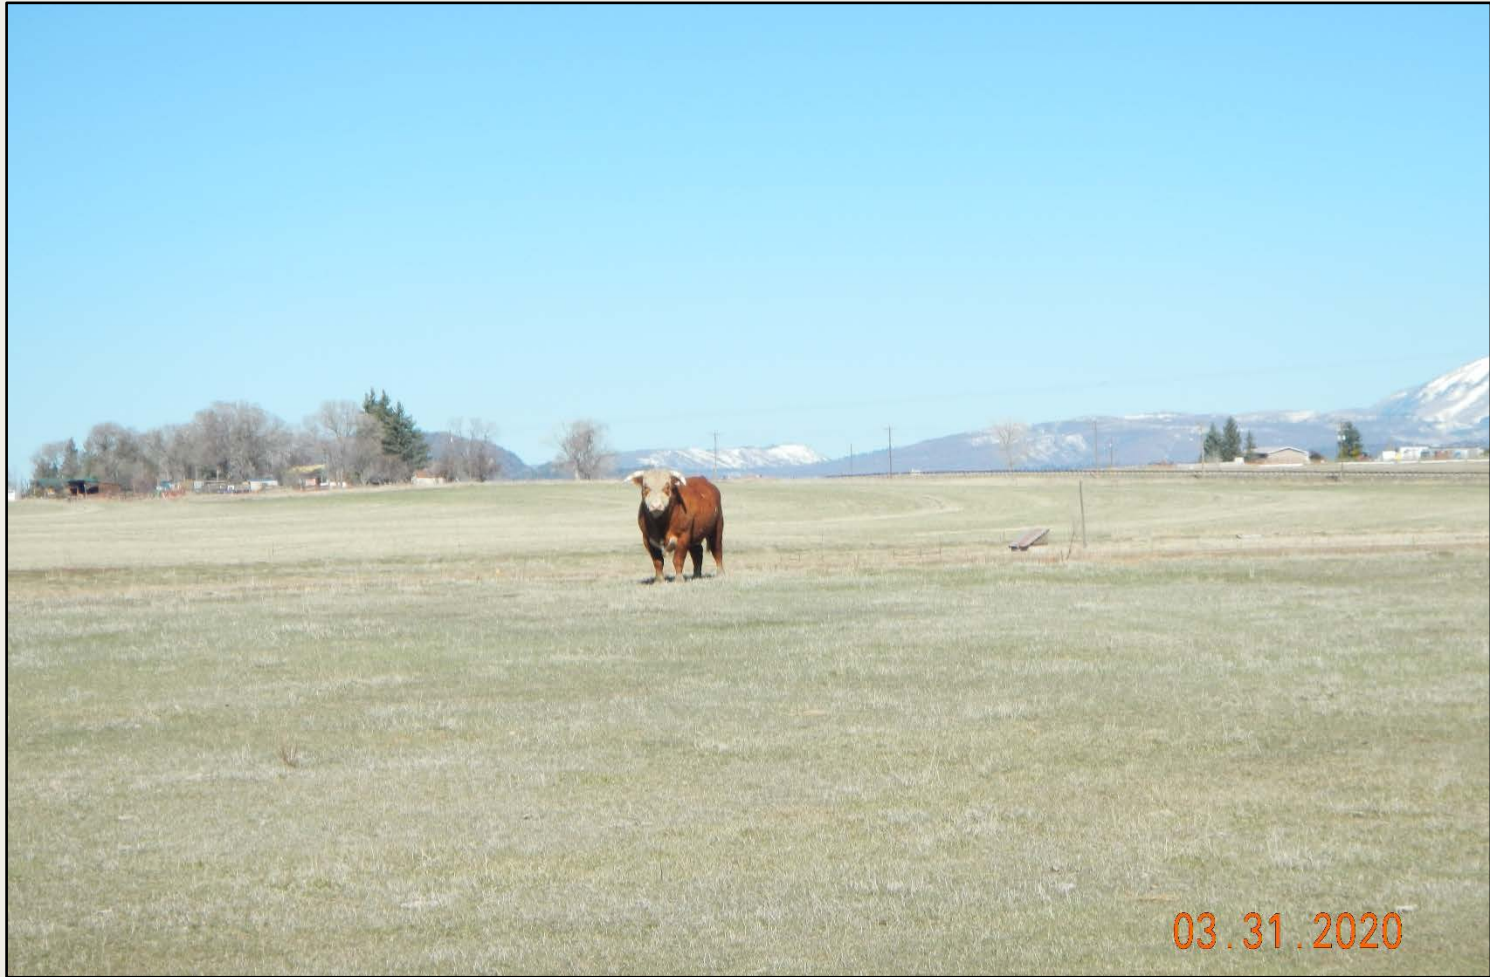
Photo 3. View of reference area vegetation, comprised of irrigated grass field. Grasses are not in identifiable condition at this time.
