# *Inspection Photos*

*Loc#3345744*

*Inspection #: 692402036*

Inspection Photos: Terra Federal DOE Loc#3345744

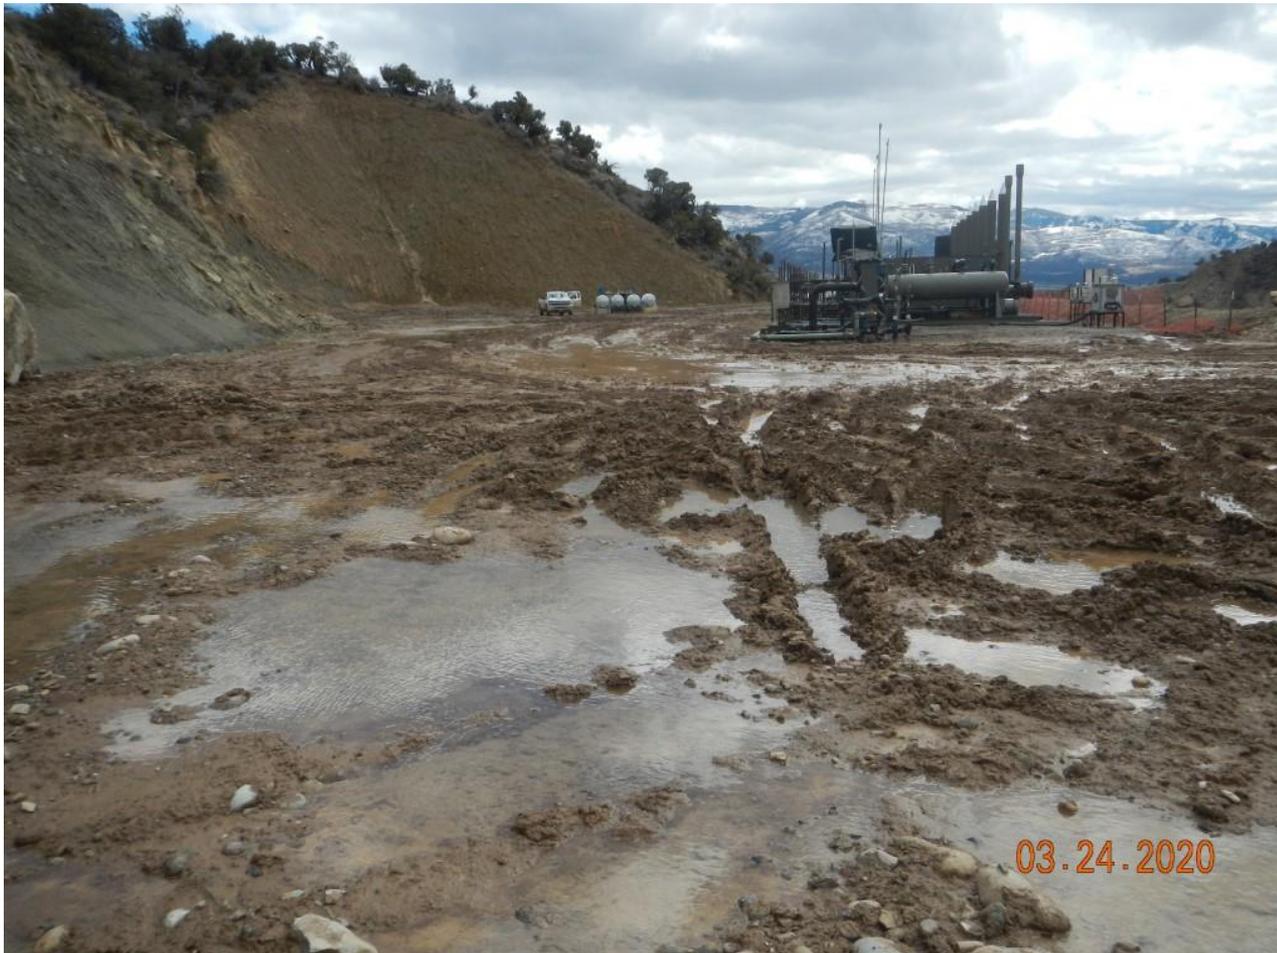
Photo#1:  
Overview of Location to South.

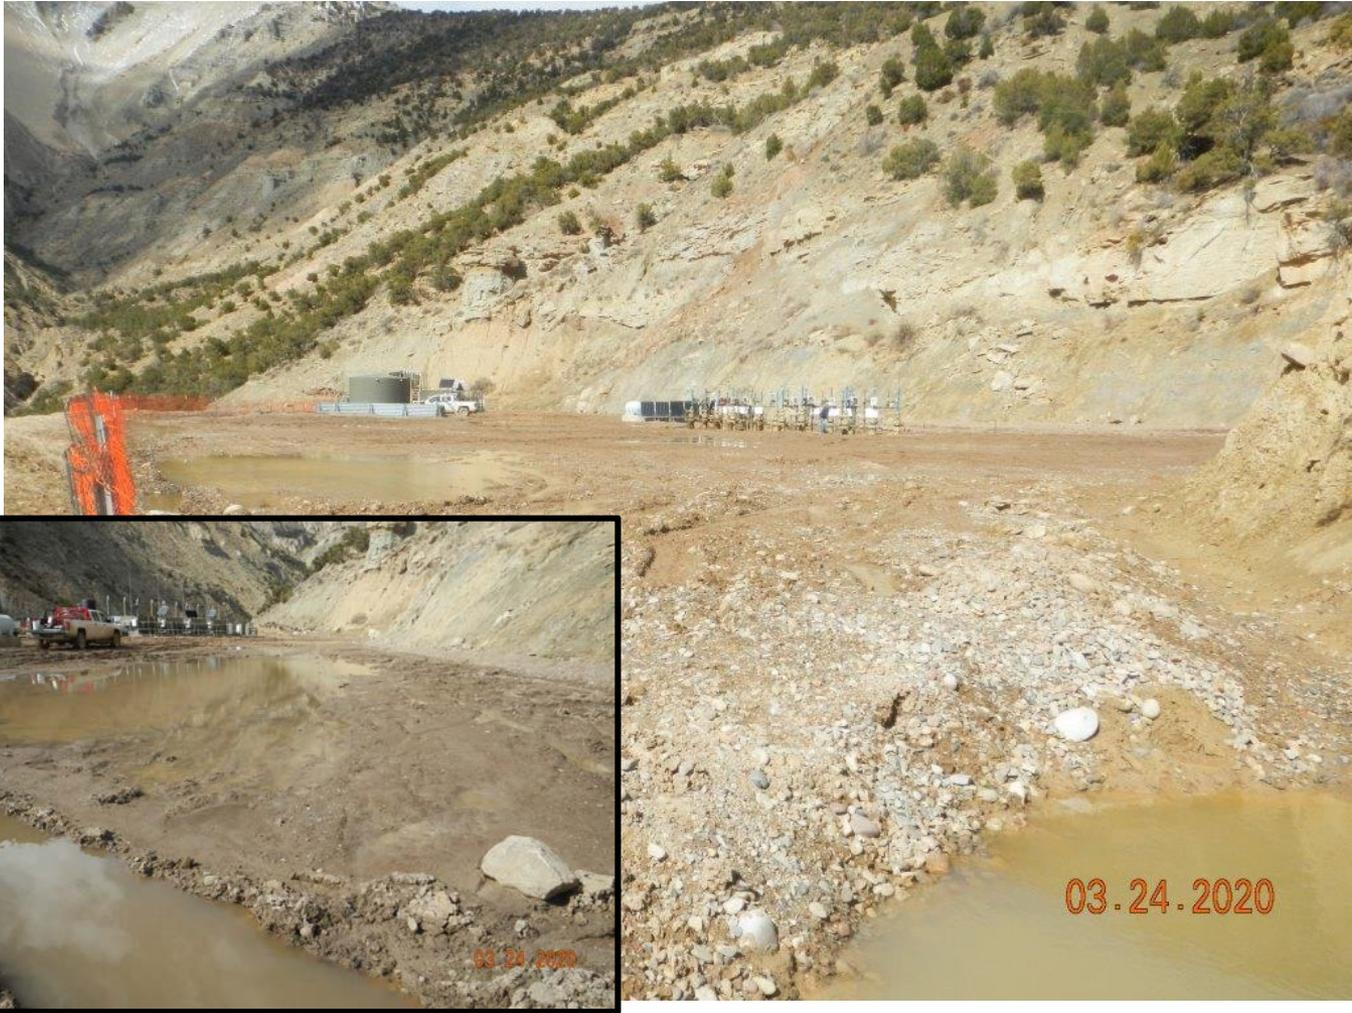
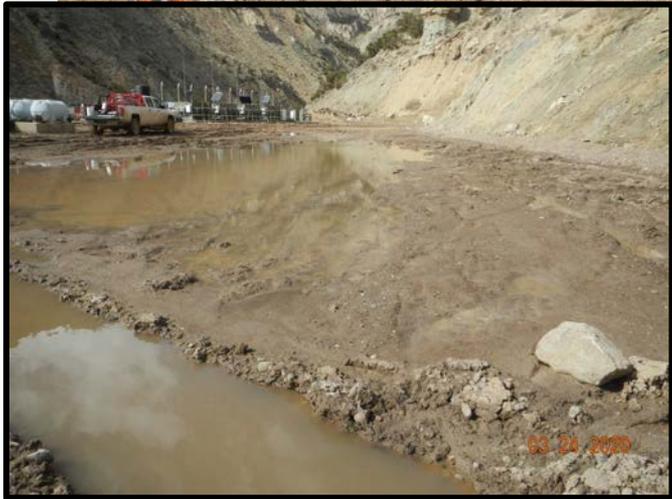
Photo#2:  
Views over Location to North

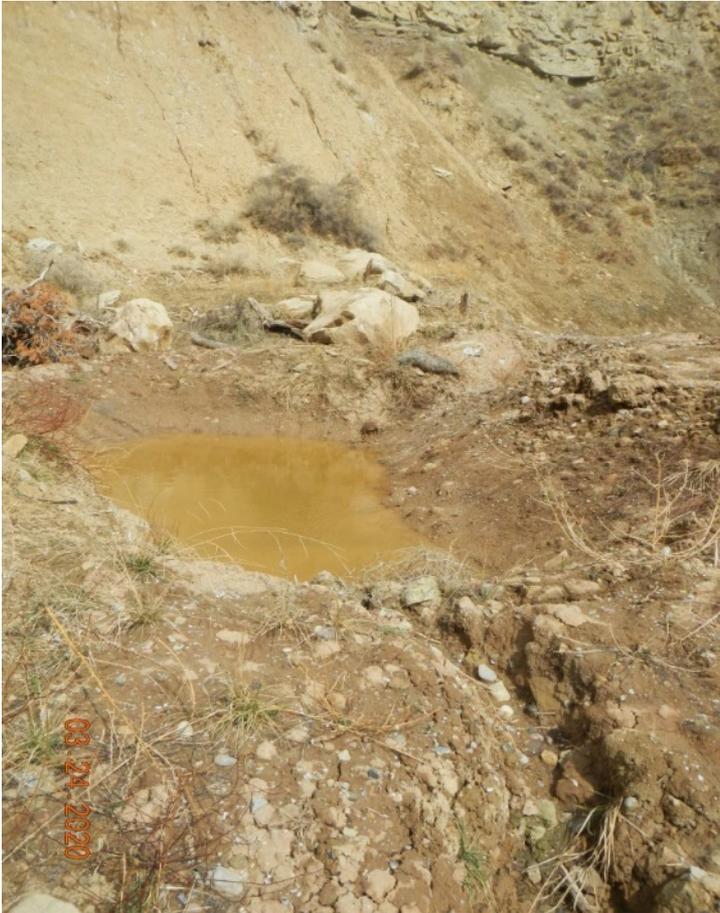
**Photo#3:**  
BMP at North end of site needing maintenance.

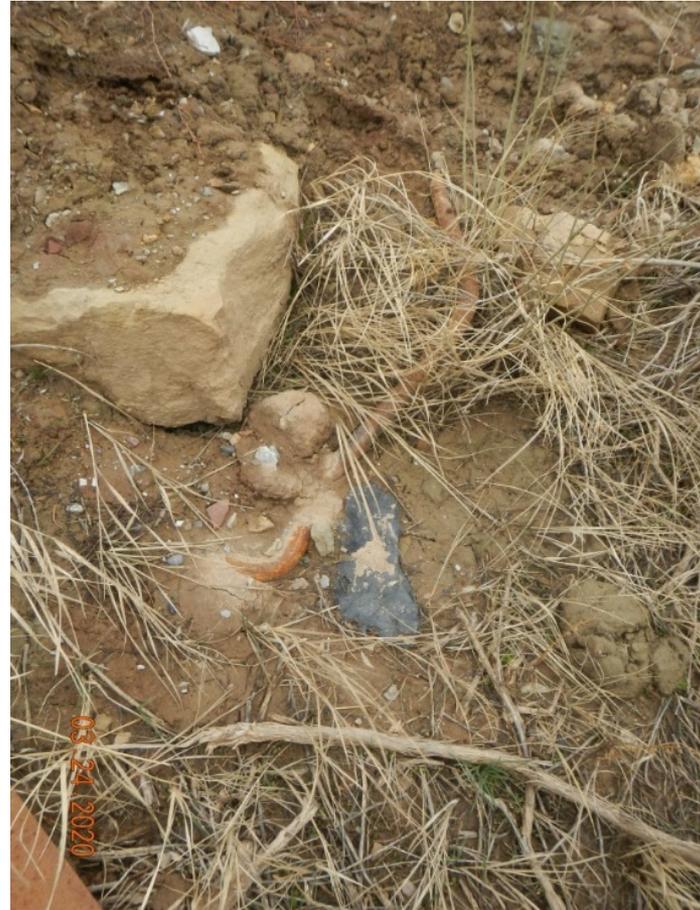
**Photo#4:**  
Anchor, no longer in use, noted Northwest  
of access road entry.

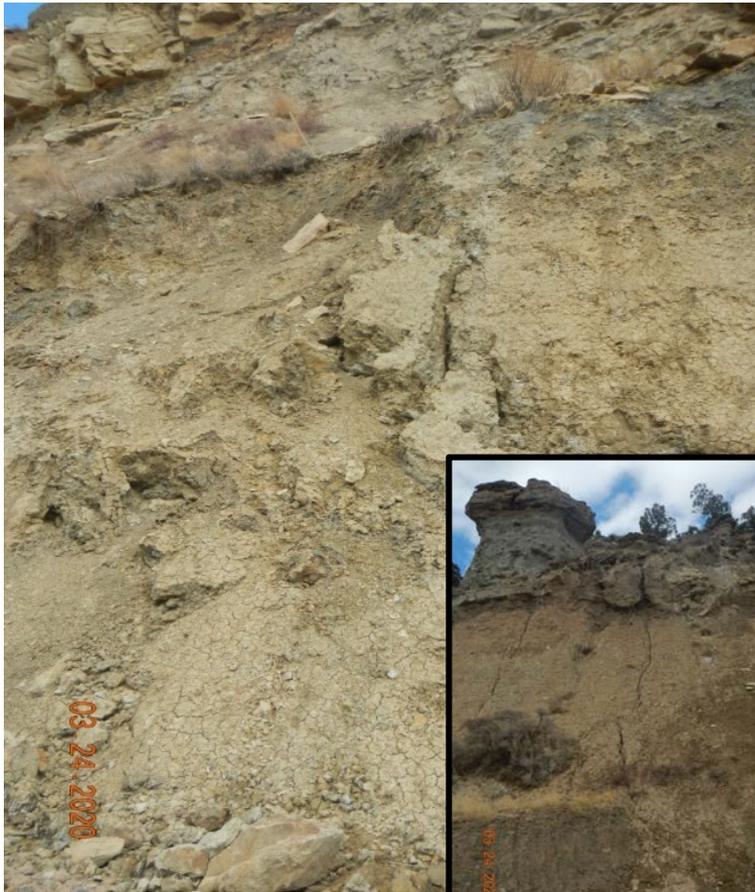
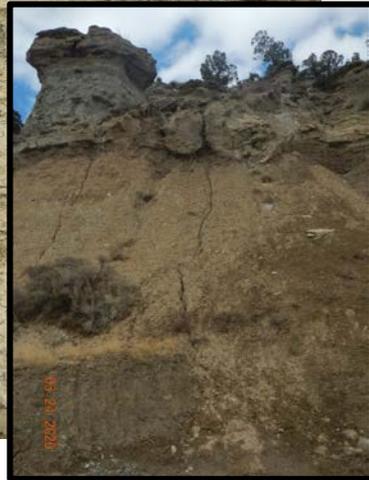
Photo#5:  
Cut slope along older, NE portion of site.

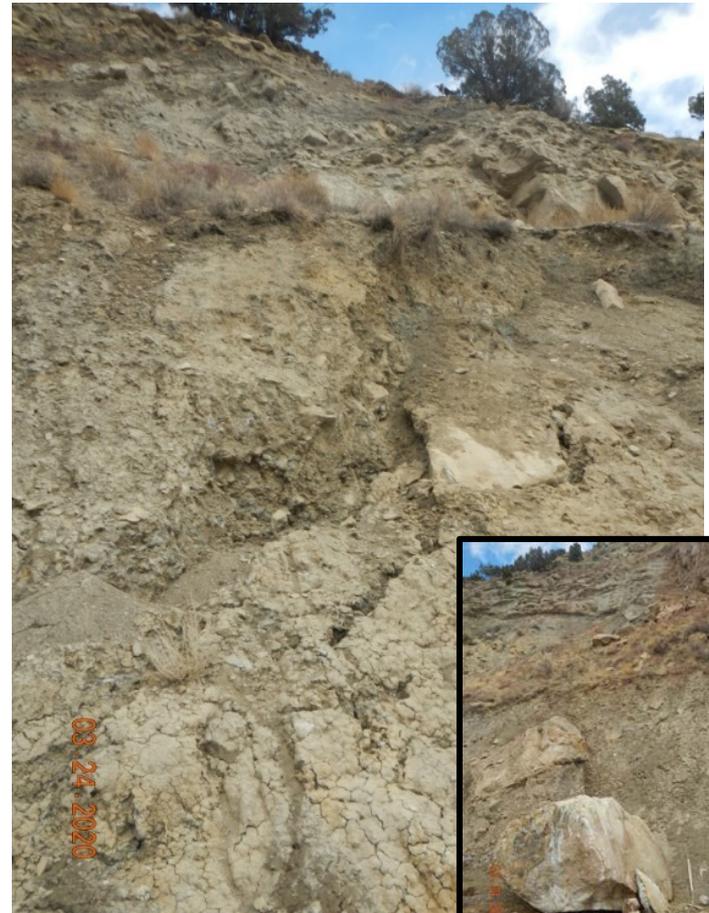
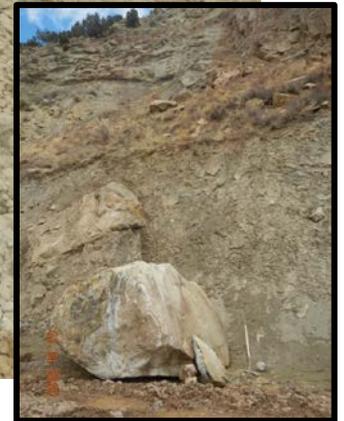
Photo#6:  
Cut slope along older, NE portion of site.

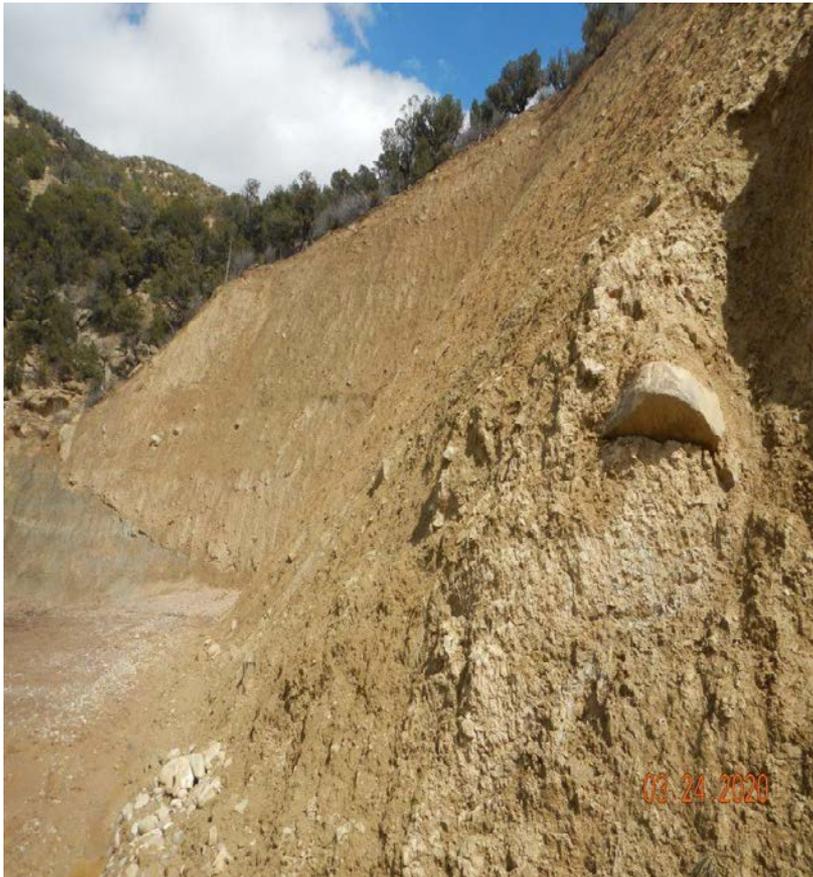
Photo#7:  
Cut slope along Southeast, expansion area of  
site.

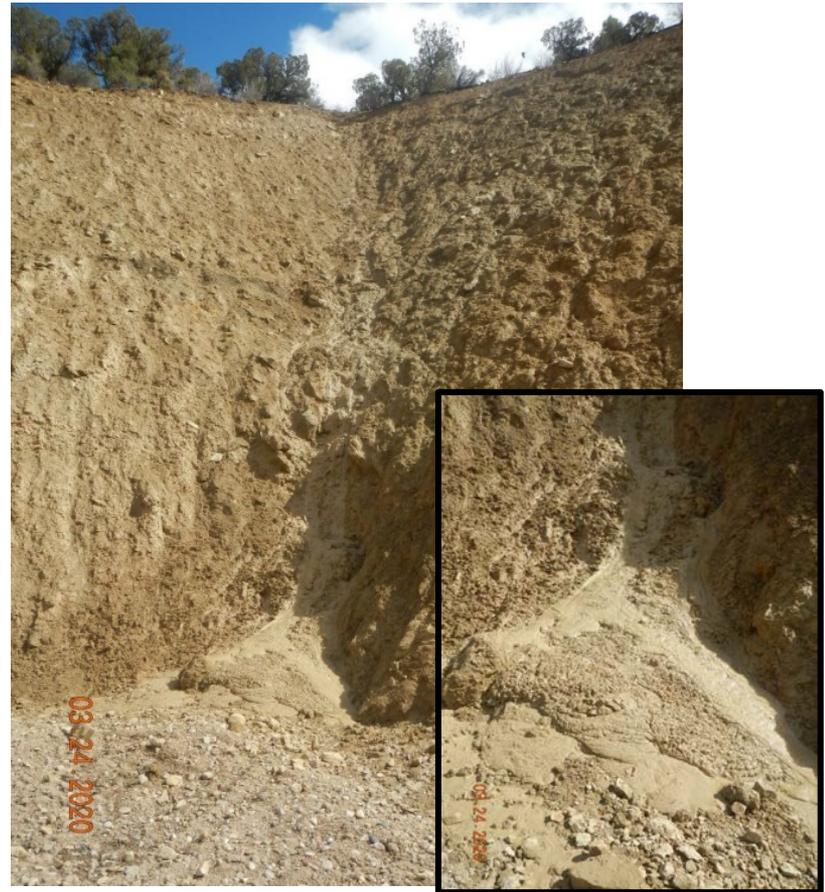
Photo#8:  
Cut slope along Southeast, expansion area of  
site.

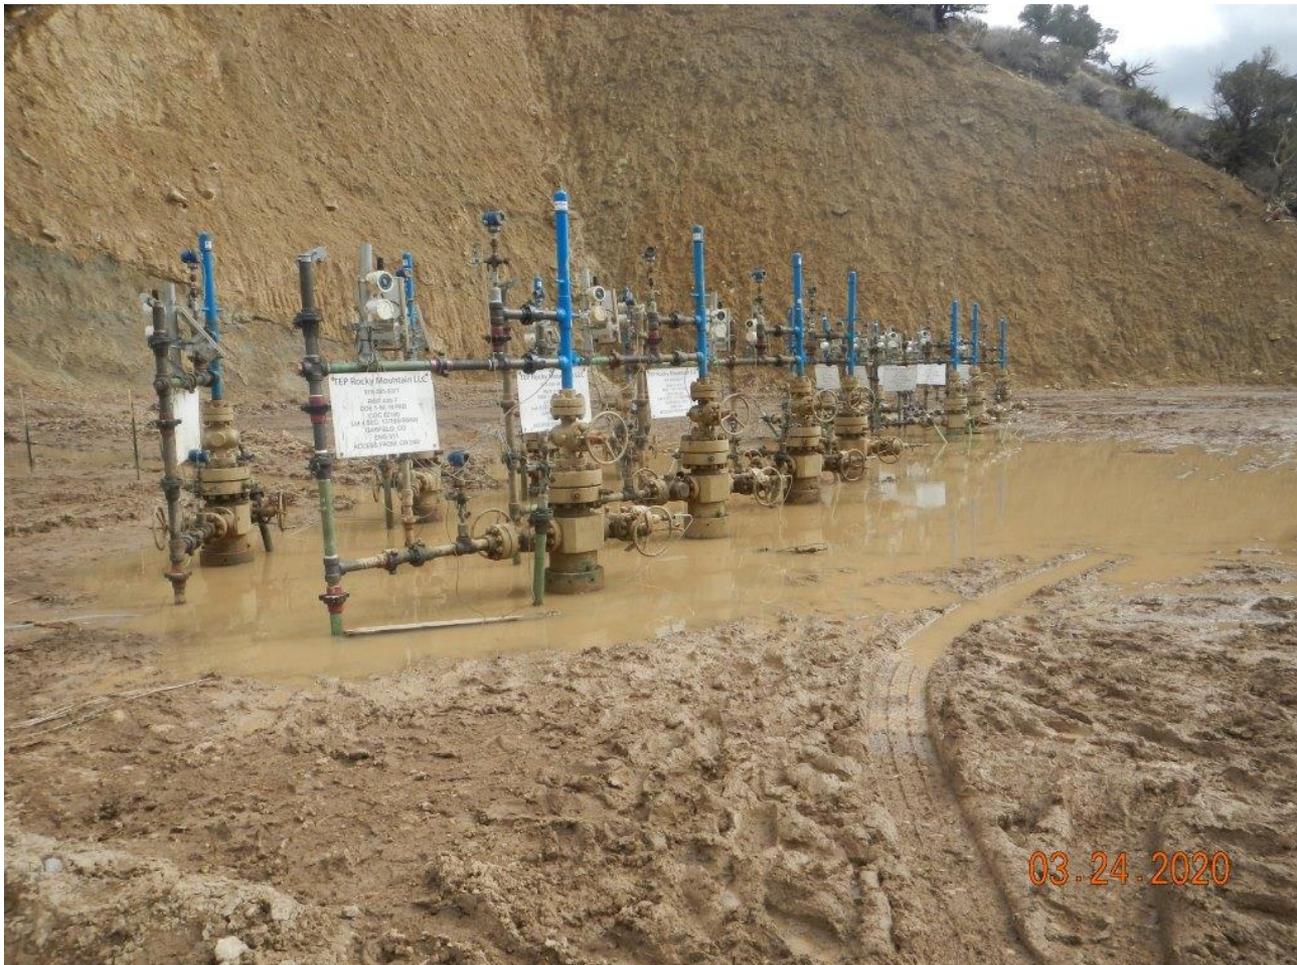
Photo#9:  
Well line up; view Southeast to Cut slope.

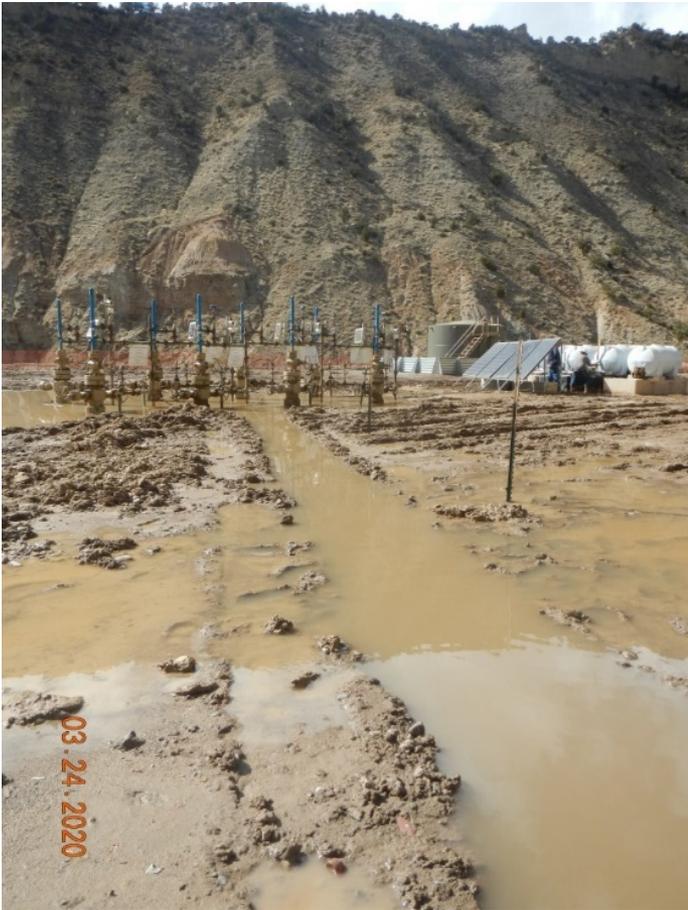
Photo#10:  
View West from Cut slope, over Wells; showing  
trench/ditch leading away from Wells > Photo#11.

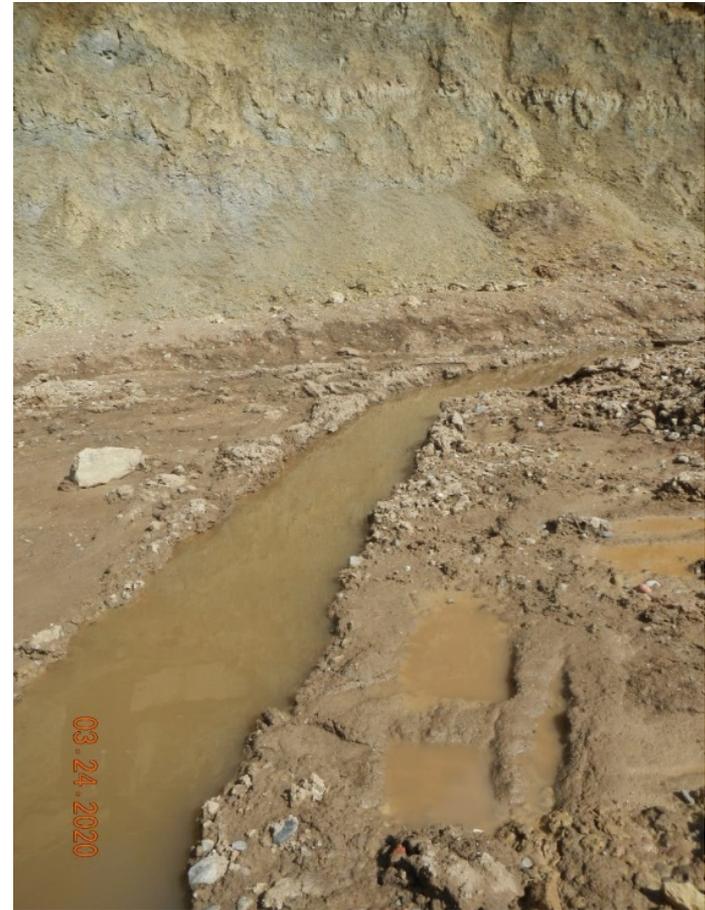
Photo#11:  
Trench/ditch continues Southeasterly along Cut  
slope > Photo#12.

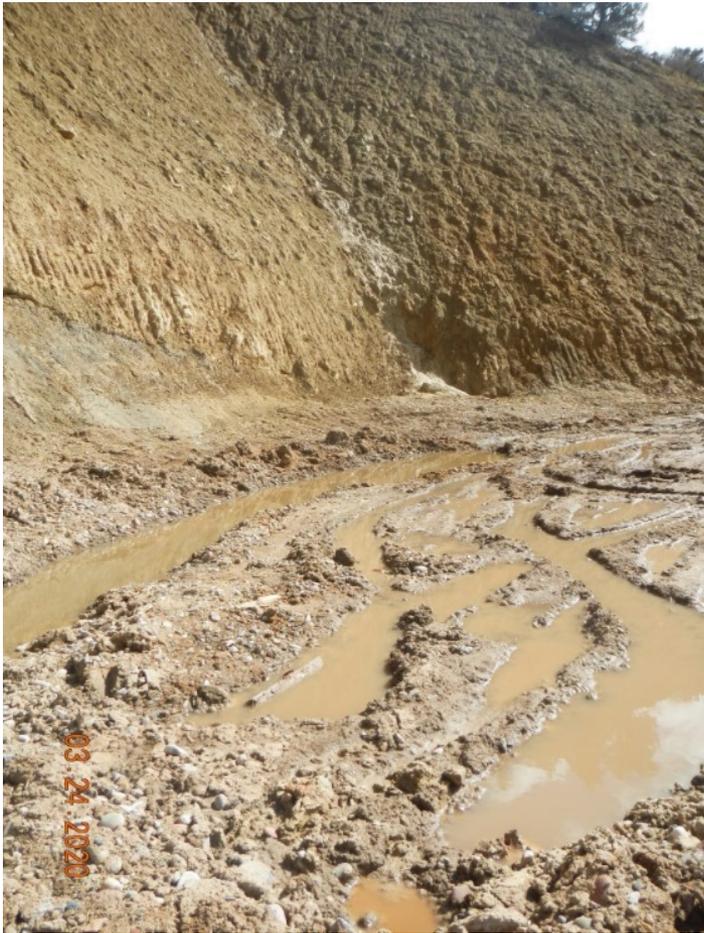
Photo#12:  
Trench/ditch continues Southeasterly along Cut  
slope > Photo#13.

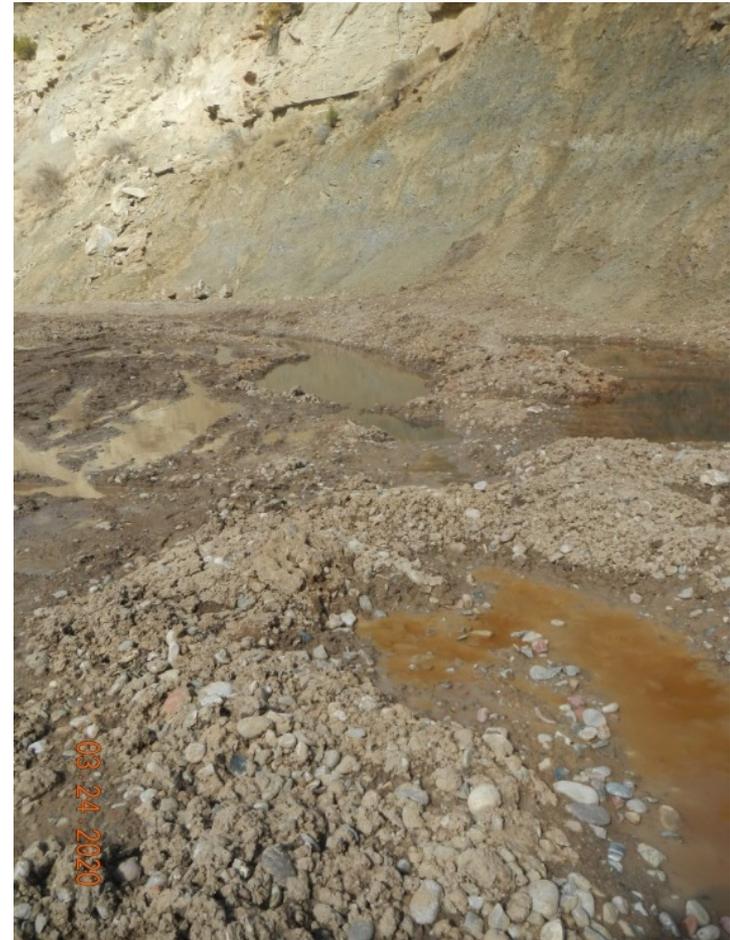
Photo#13:  
Looking back to Photo#12. Point where trench/ditch  
is blocked. Appears to have continued > Photo#14.

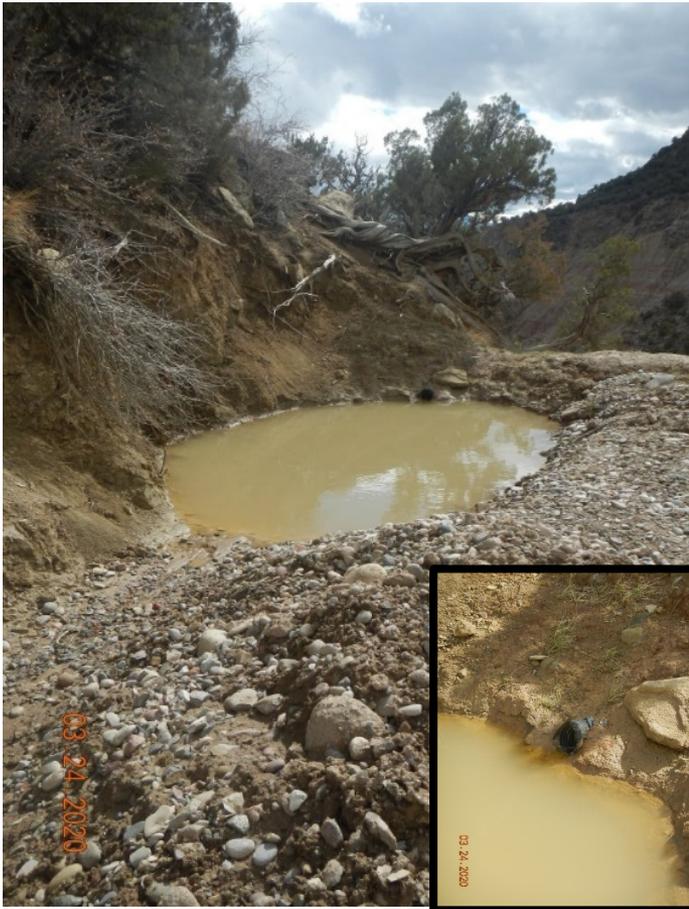
Photo#14:  
Apparent receiving BMP from previous Photos. Insert shows point of discharge/outflow, > Photo#15.

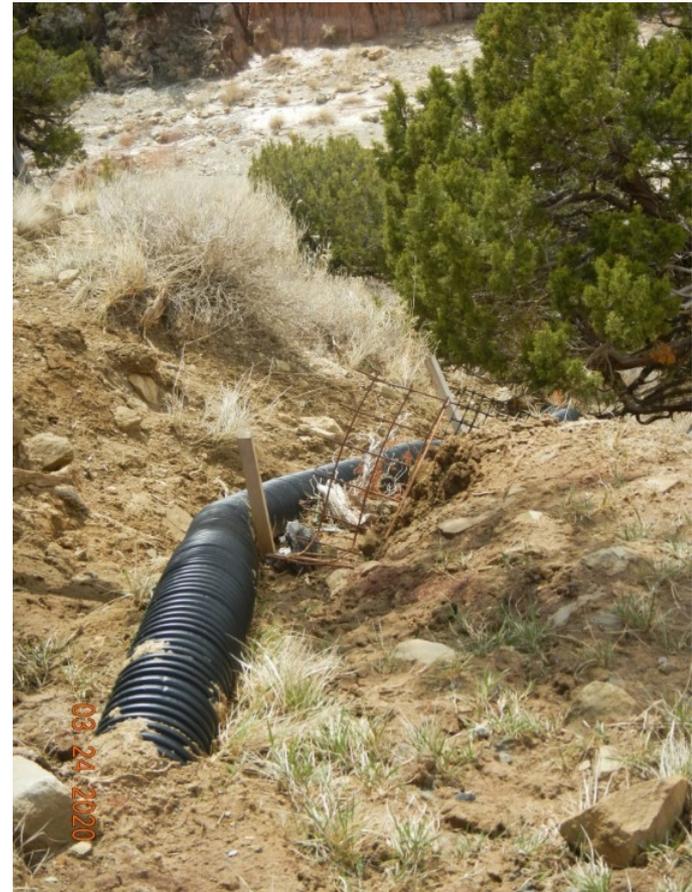
Photo#15:  
Flexible drain conveying stormwater to base of fill slope and access road below,> Photo#16.

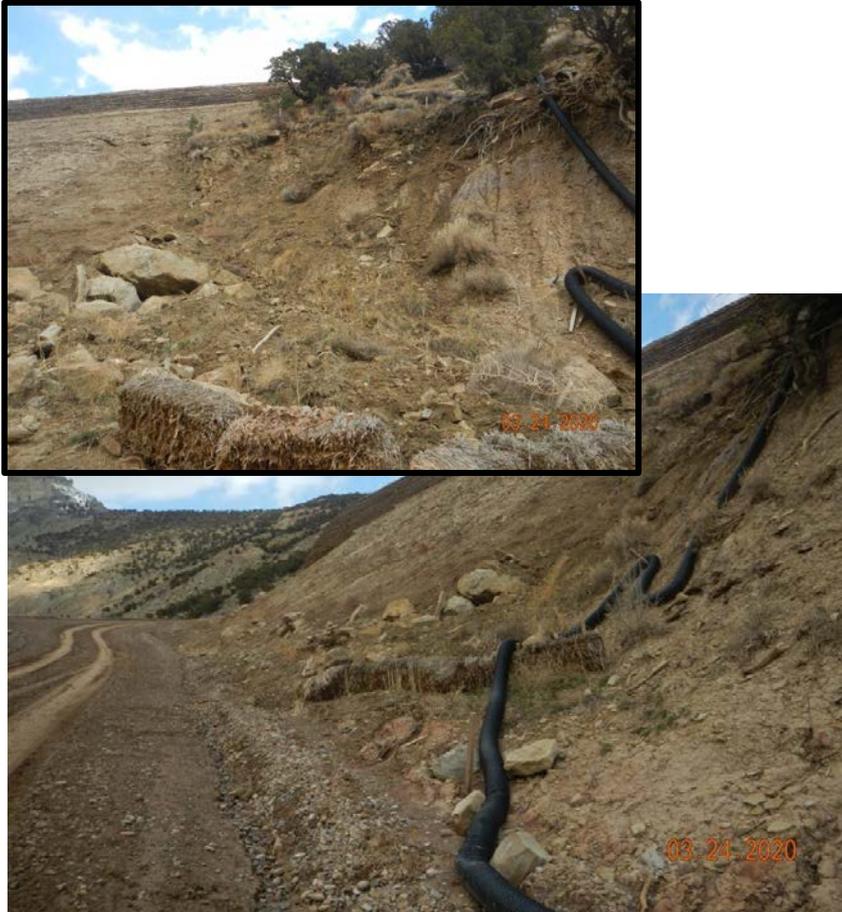
Photo#16:  
Flexible drain to convey stormwater from pad above  
and BMP in Photo#14.

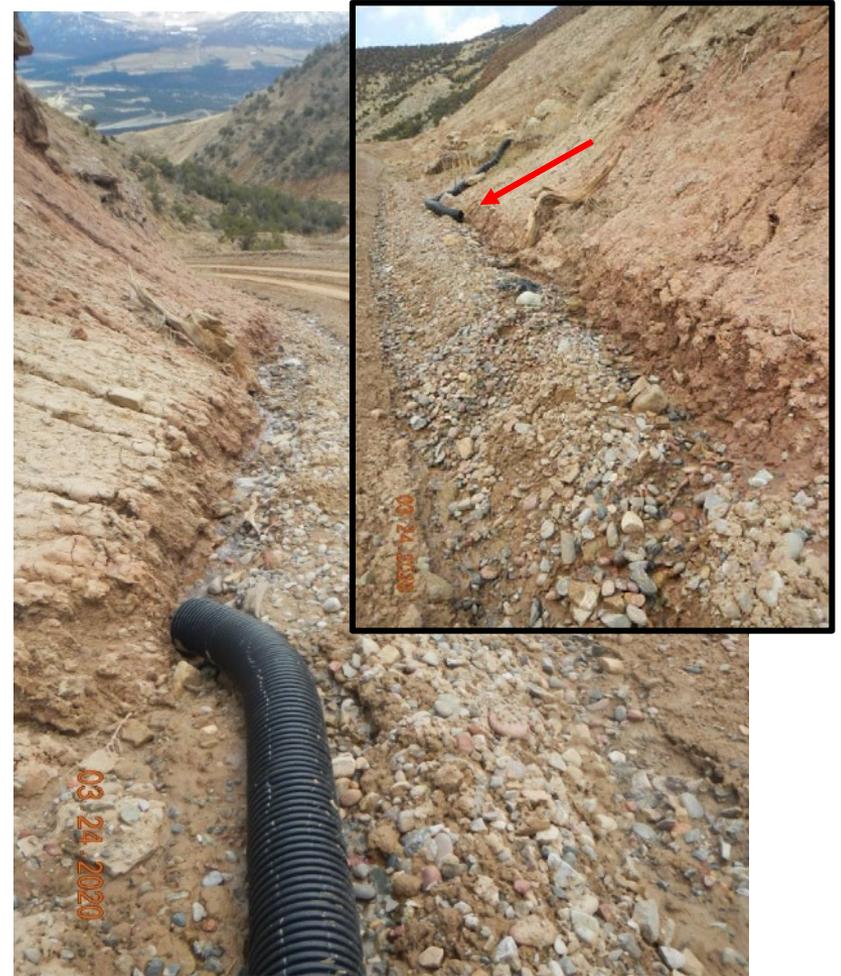
Photo#17:  
Flexible drain discharge point into access road  
ditch.

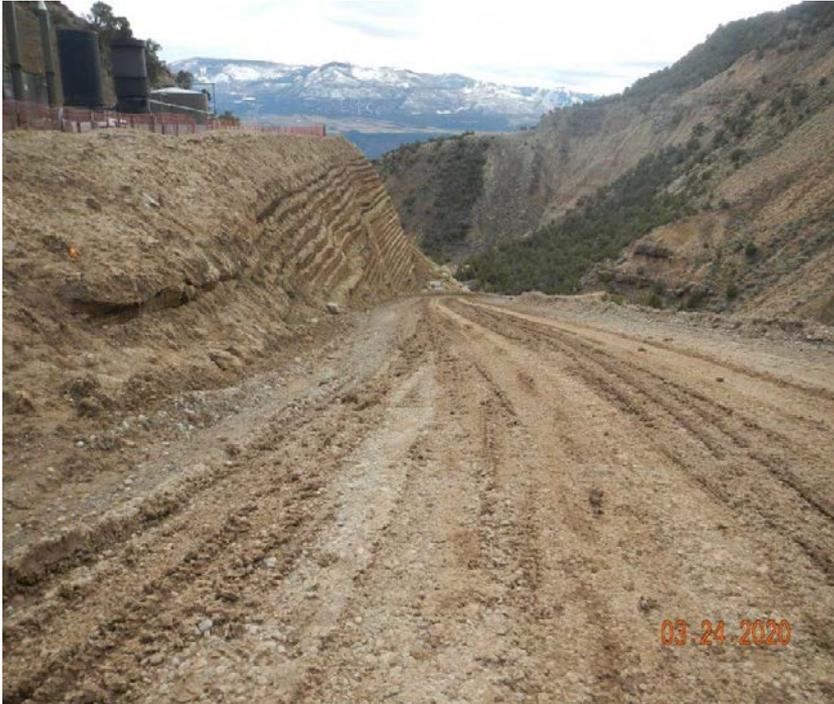
Photo#18:  
View down access road, leaving Location.

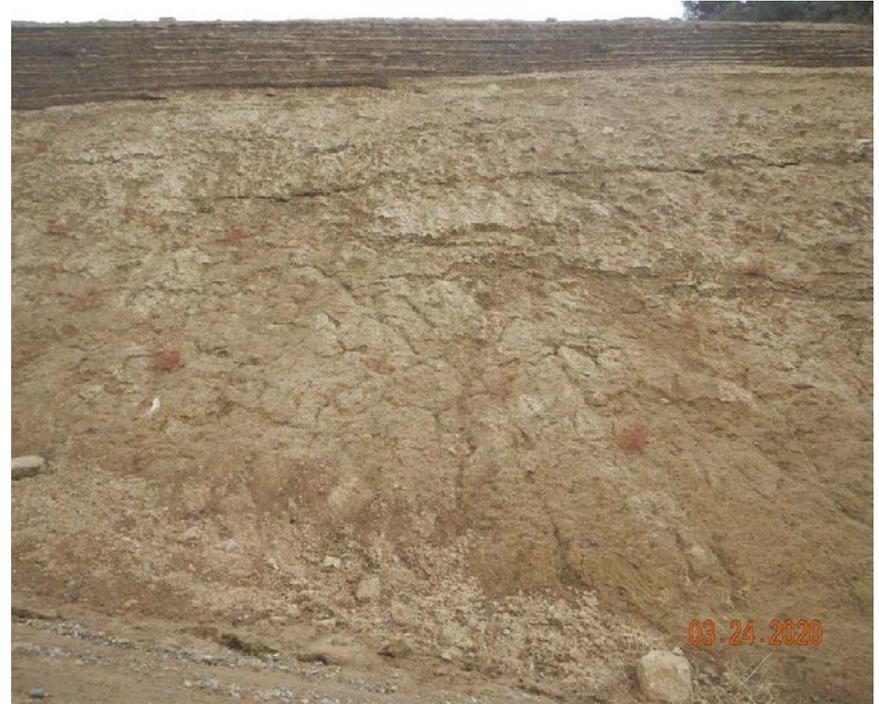
Photo#19:  
View up fill slope from access road to retaining structure.

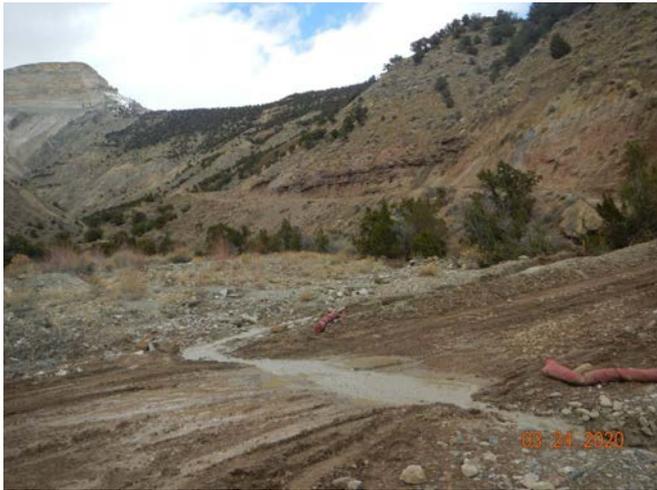
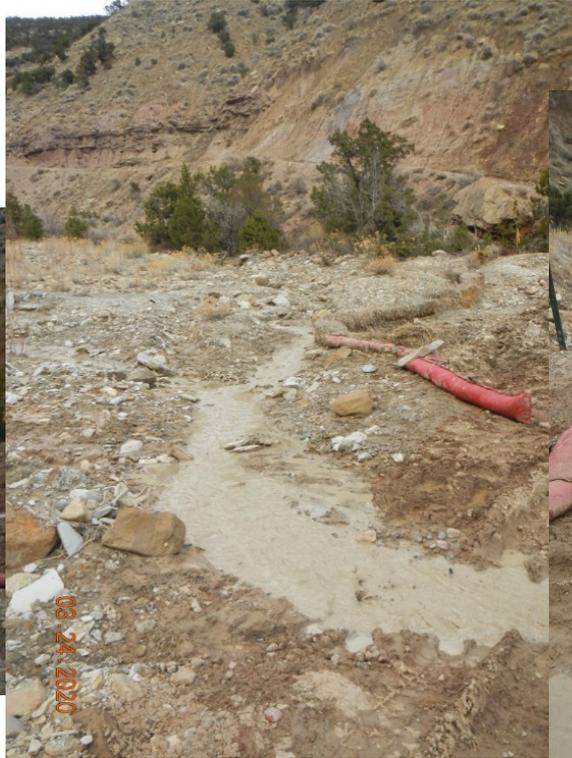
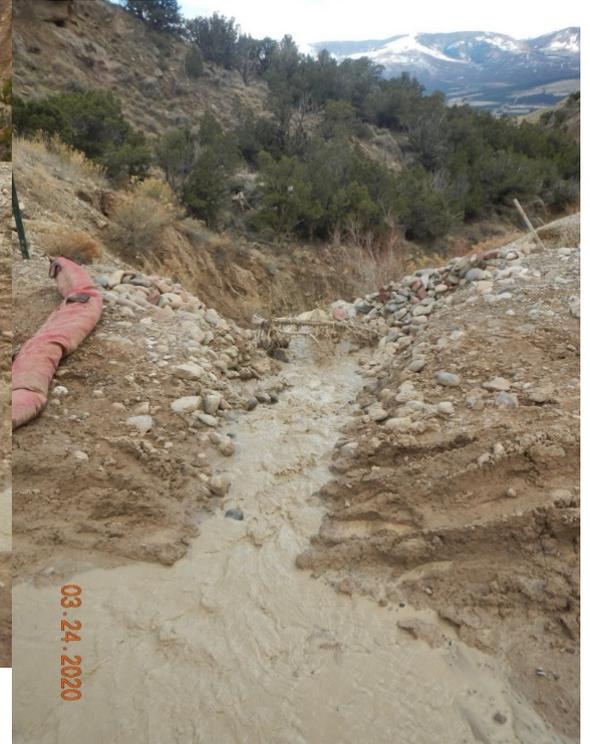
Photo#20:  
BMP failures along access road.
