Inspection Photos  
Operator: BP America  
API#: 067-08673  
Date: 3/31/2020

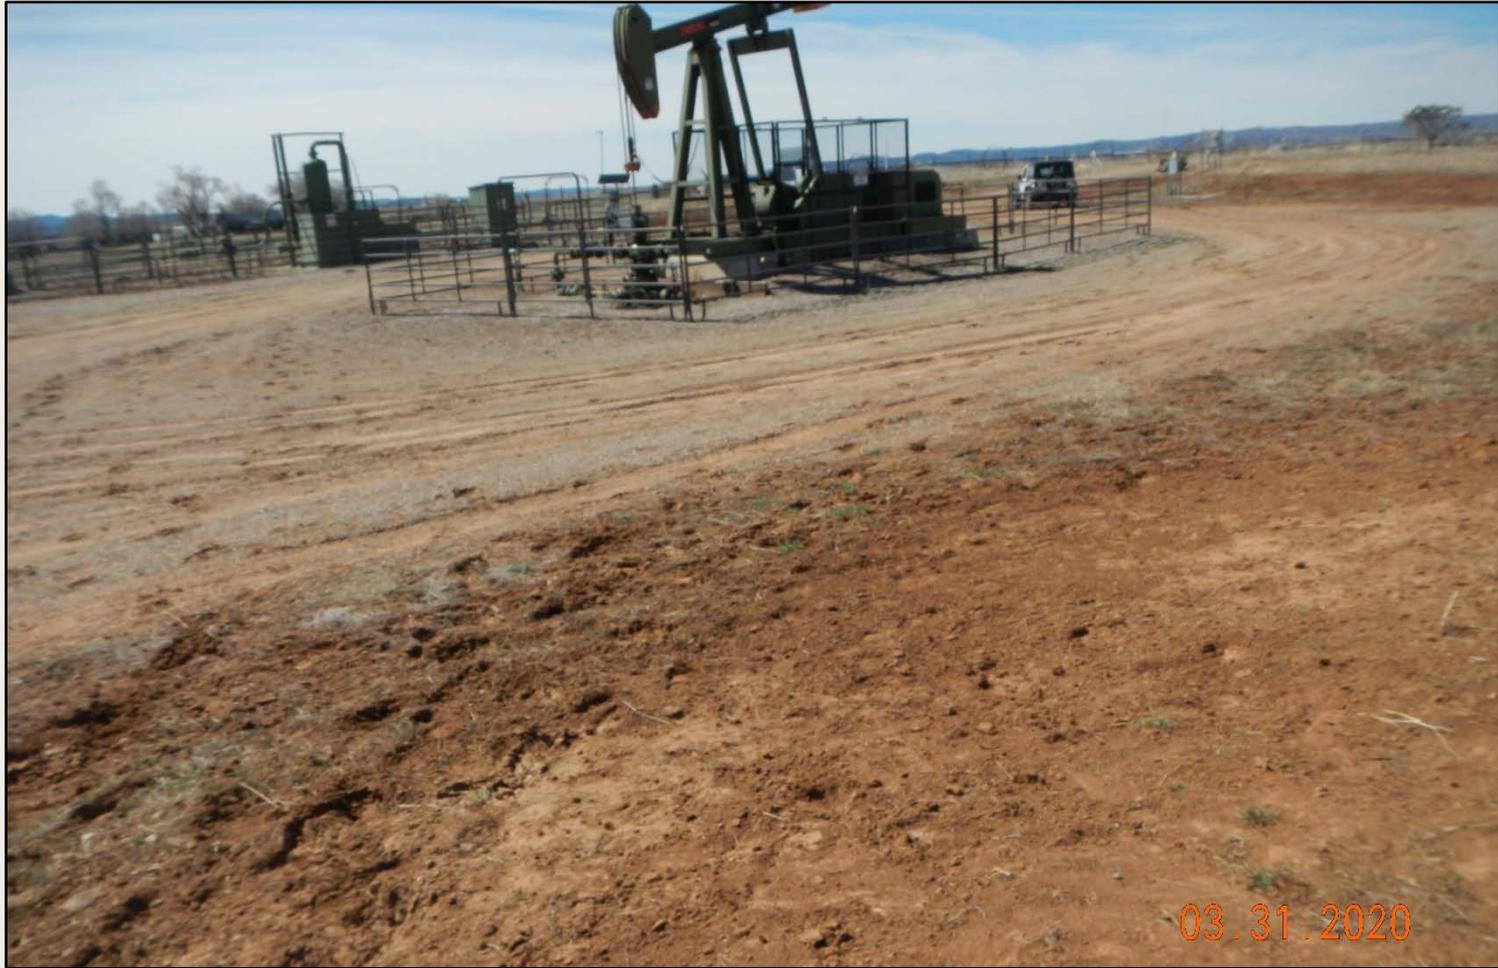
Photo 1. View of the project area from the northeastern corner facing center.

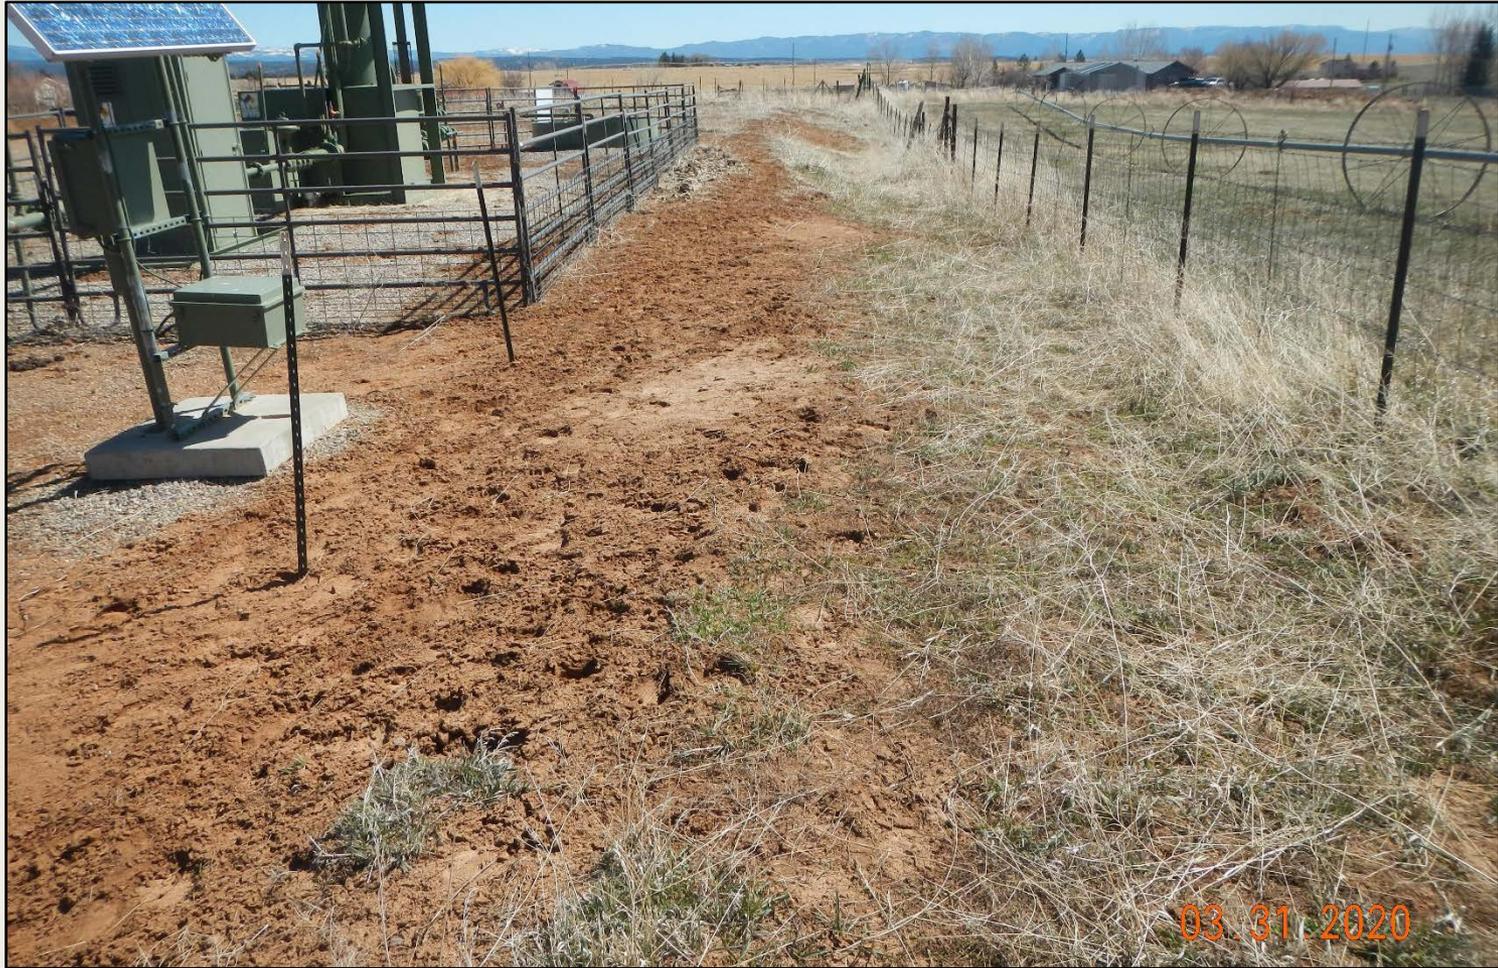
Photo 2. View of the southern fill slope from the southwestern corner facing eastward.

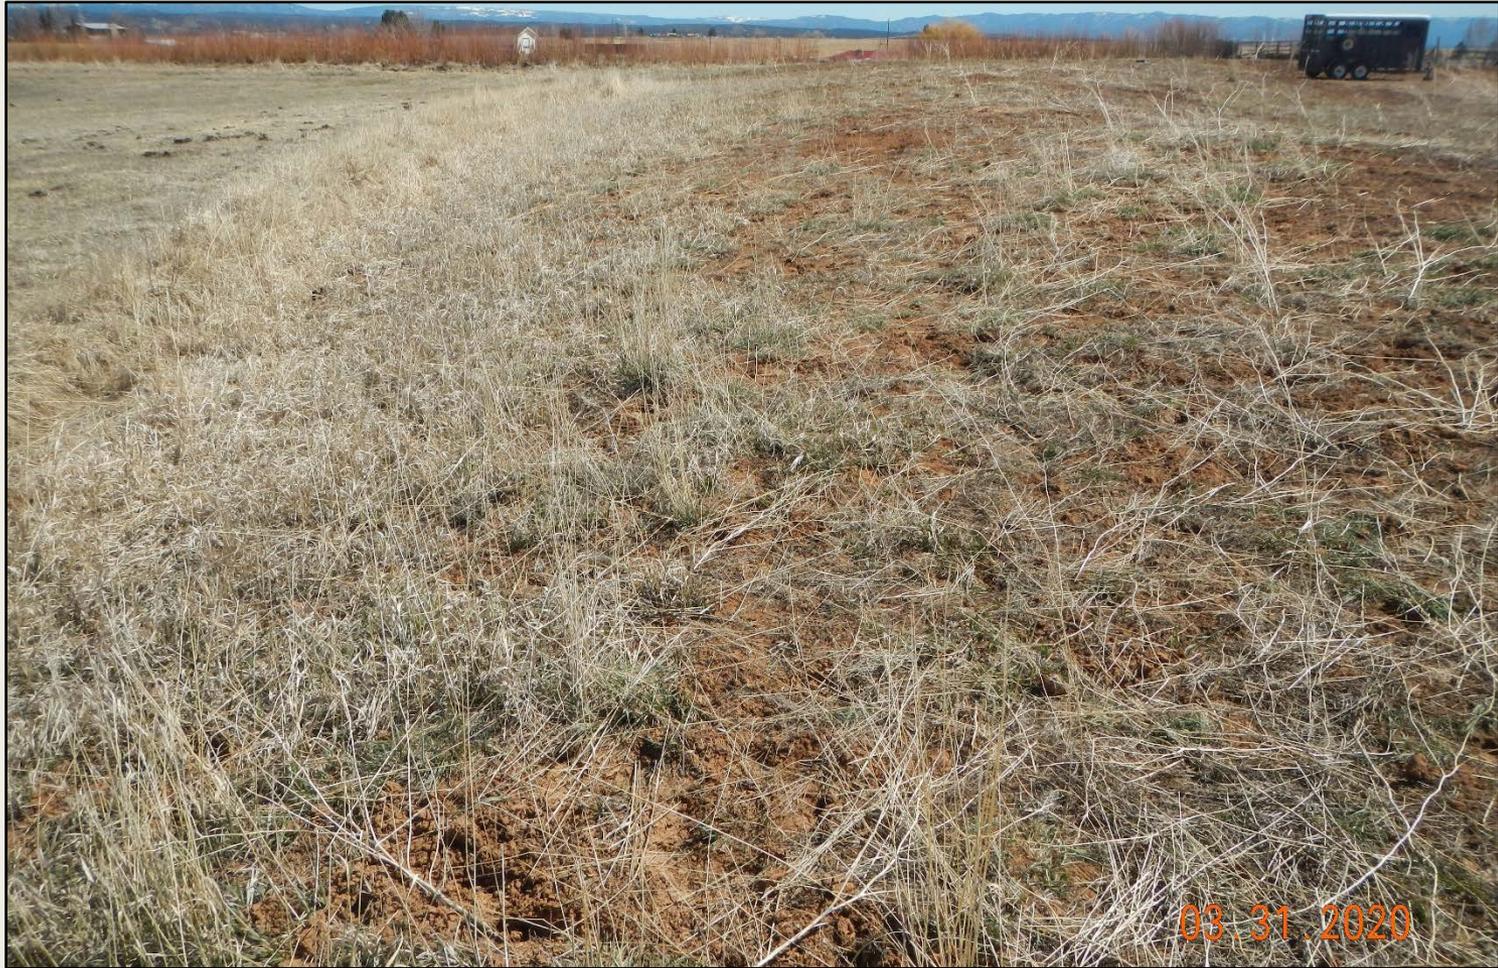
Photo 3. View of the northern project area from the northwestern corner facing eastward. Revegetation is progressing here with grasses such as smooth brome and crested wheatgrass.

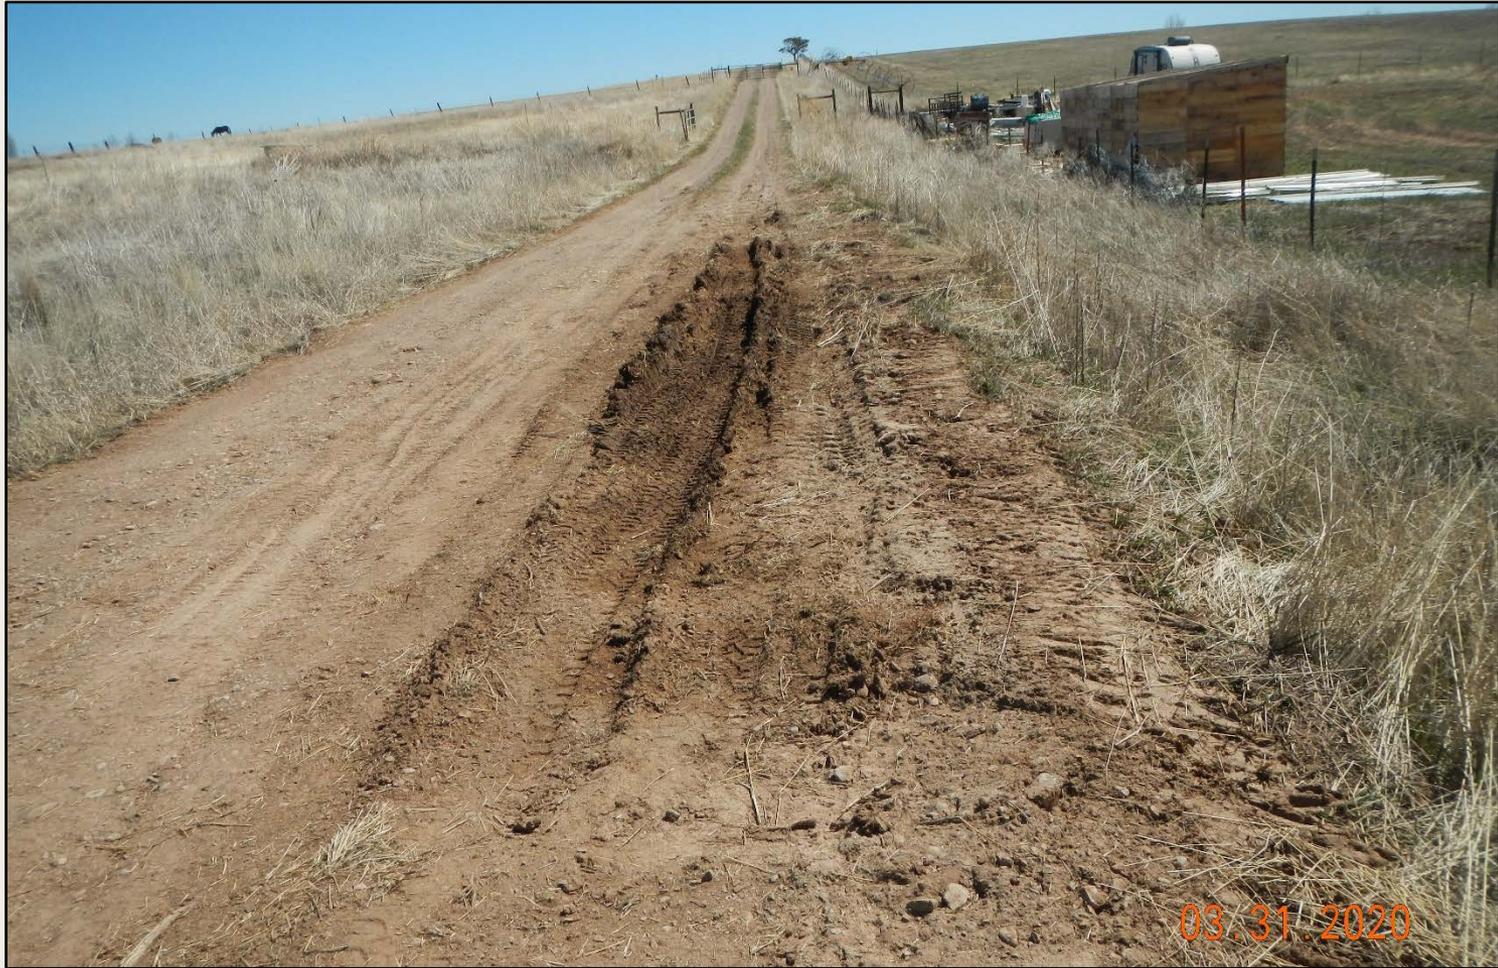
Photo 4. View of area along the access road where water is ponding and deep mud is resulting in expansion of road disturbance and rutting.

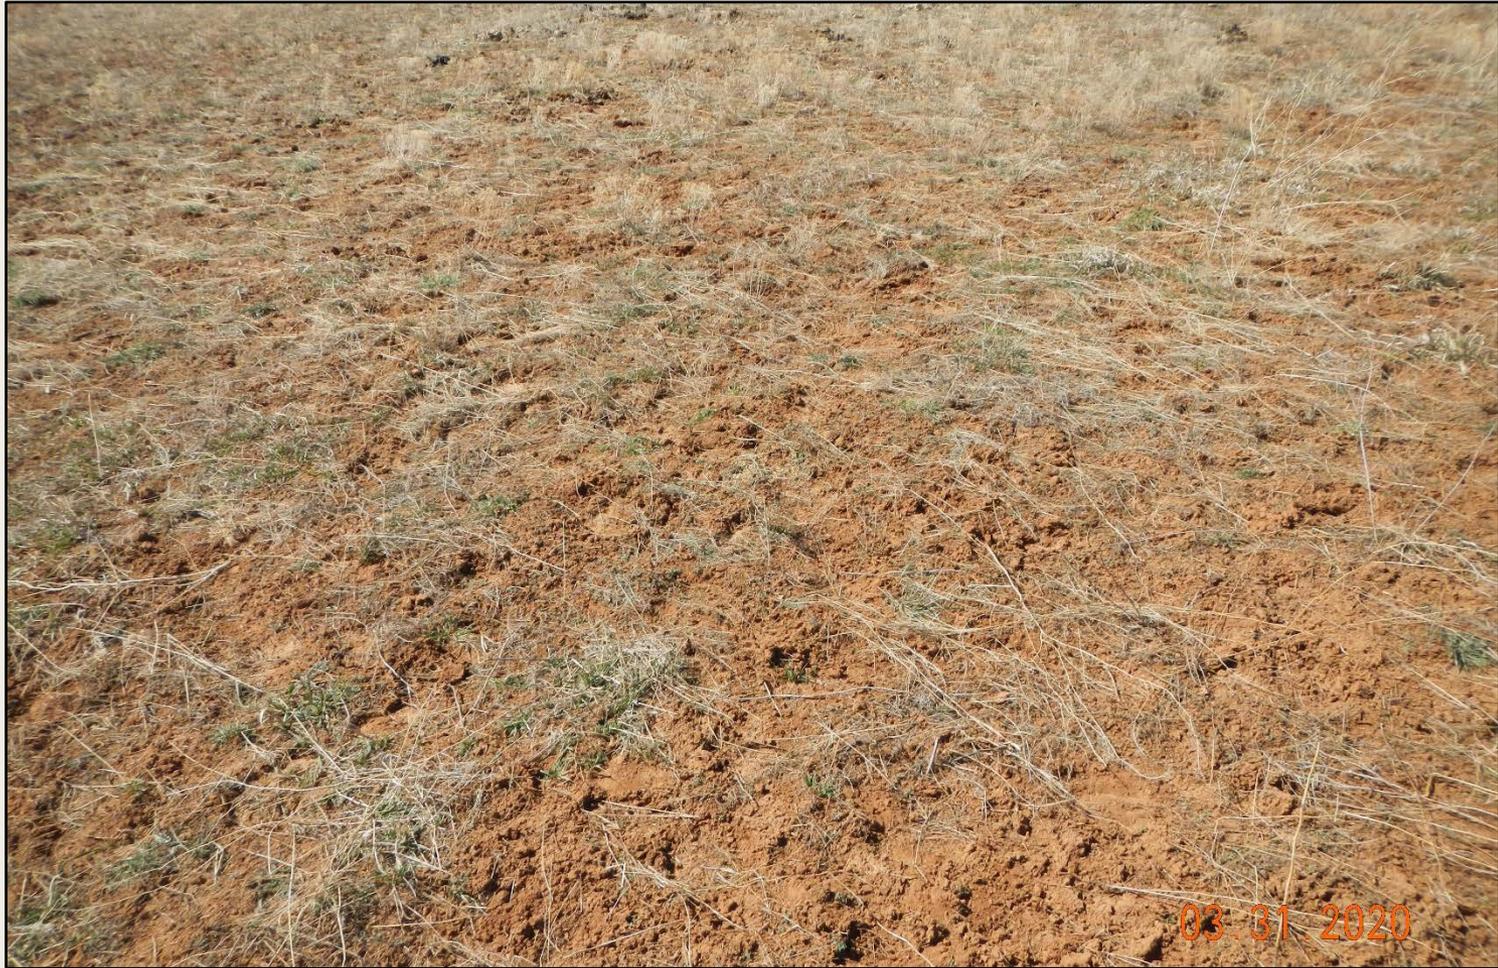
Photo 5. View of reference area vegetation within an open grass field, in a grazed condition. Grass species are not identifiable at this time.
