Inspection Photos

Operator: Hilcorp Energy
API#: 067-09086
Date: 4/3/2020

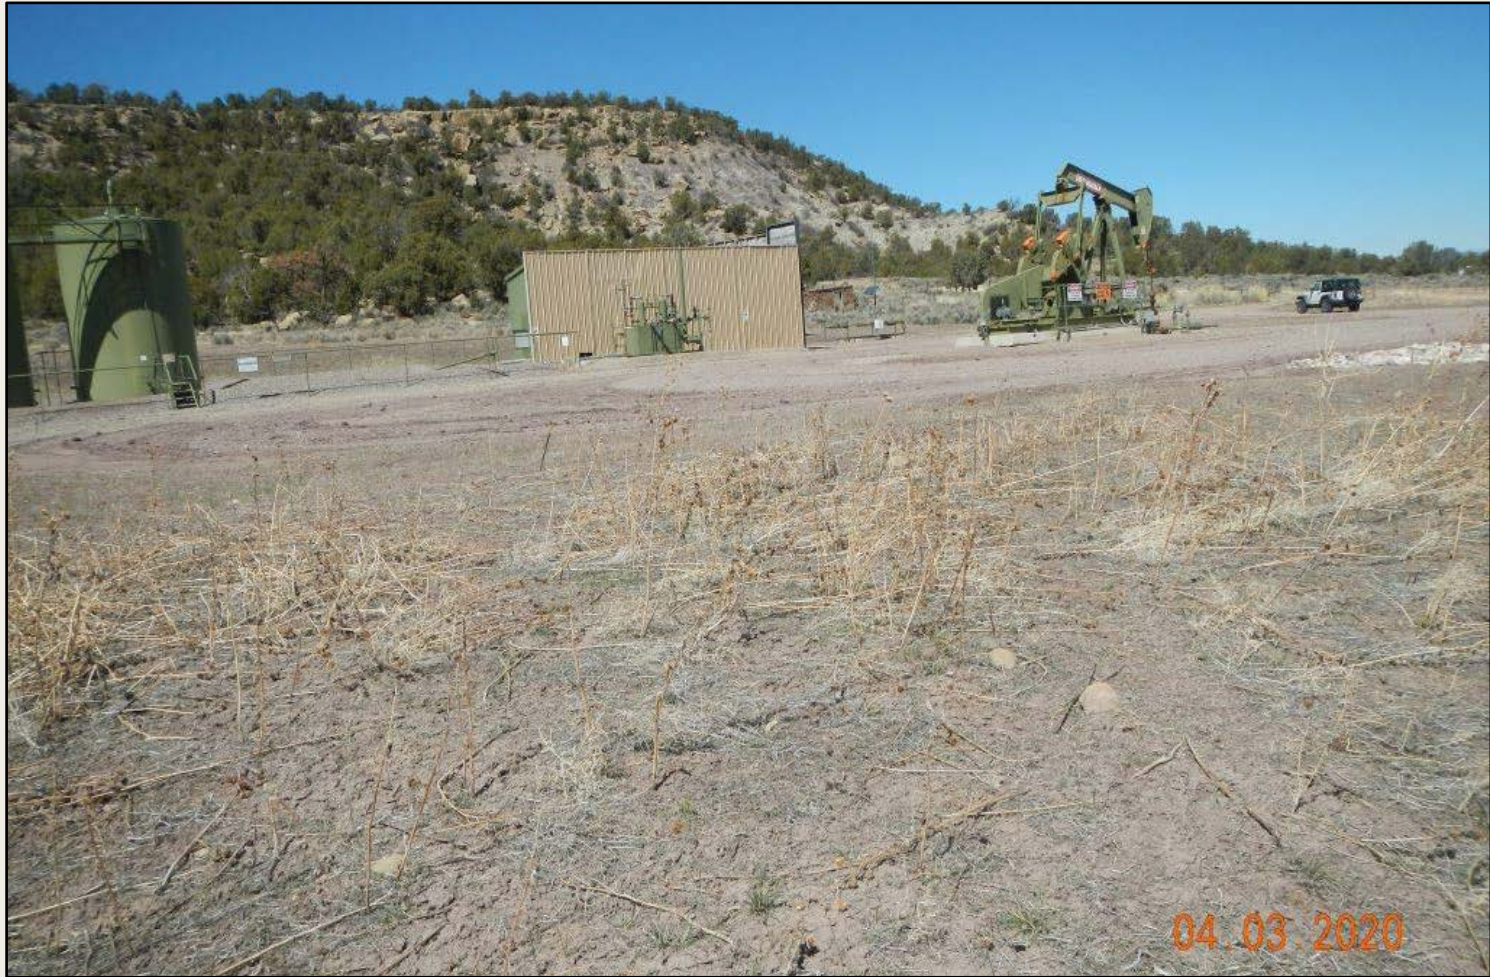
Photo 1. View of the project area from the southeastern corner facing center.

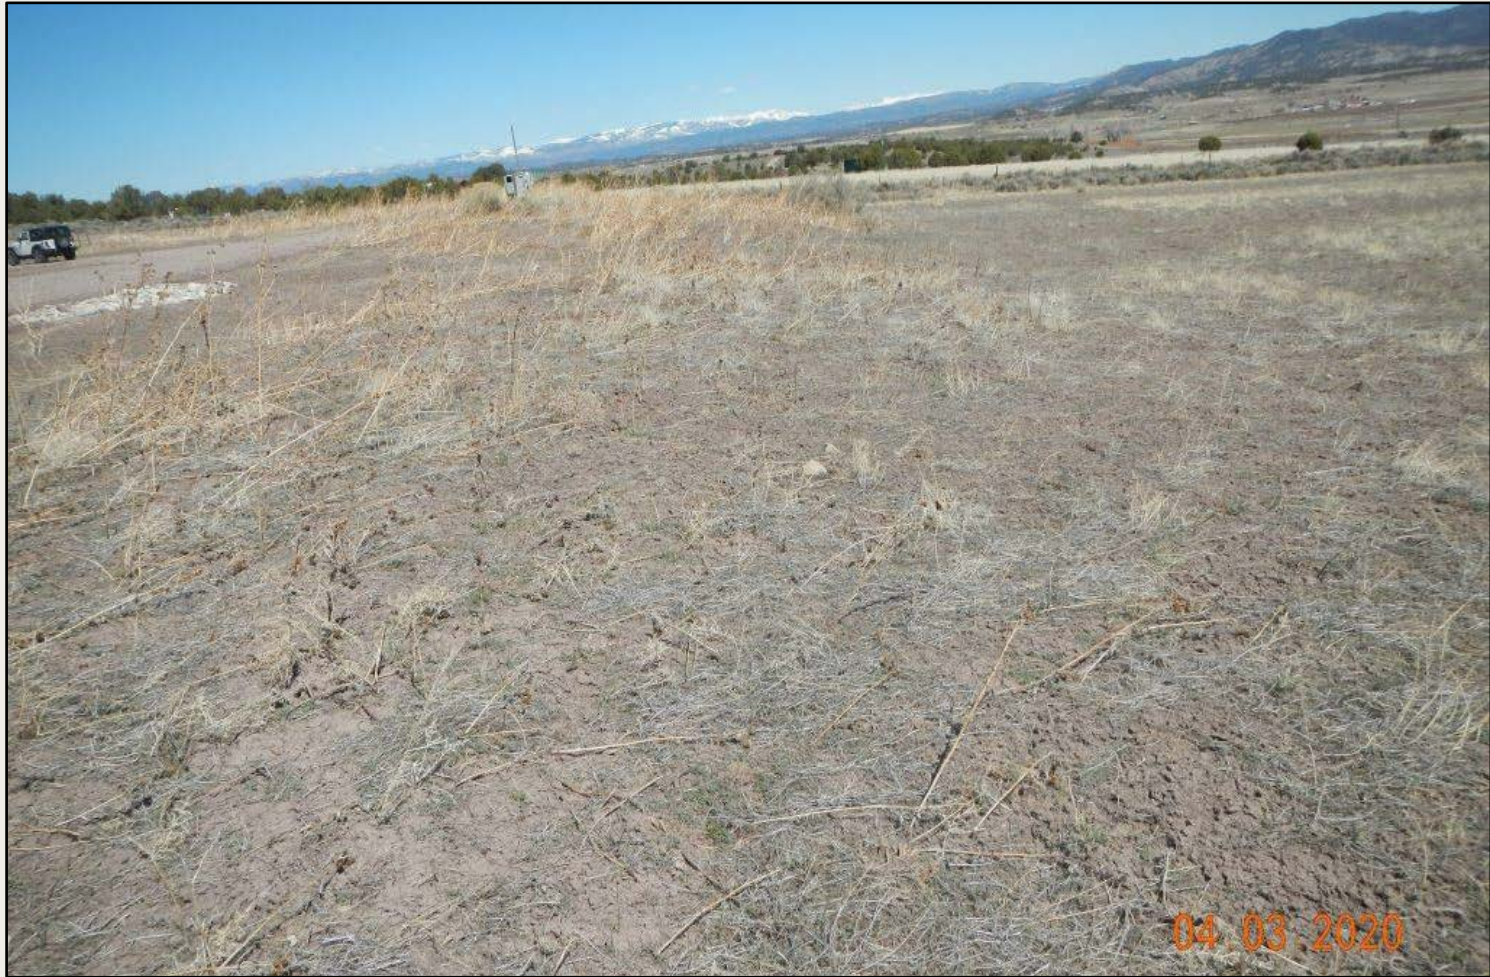
Photo 2. View of the eastern fill slope from the southeastern corner facing northward. Vegetation is grazed and in early season condition. Bunch grasses similar to reference area observed.

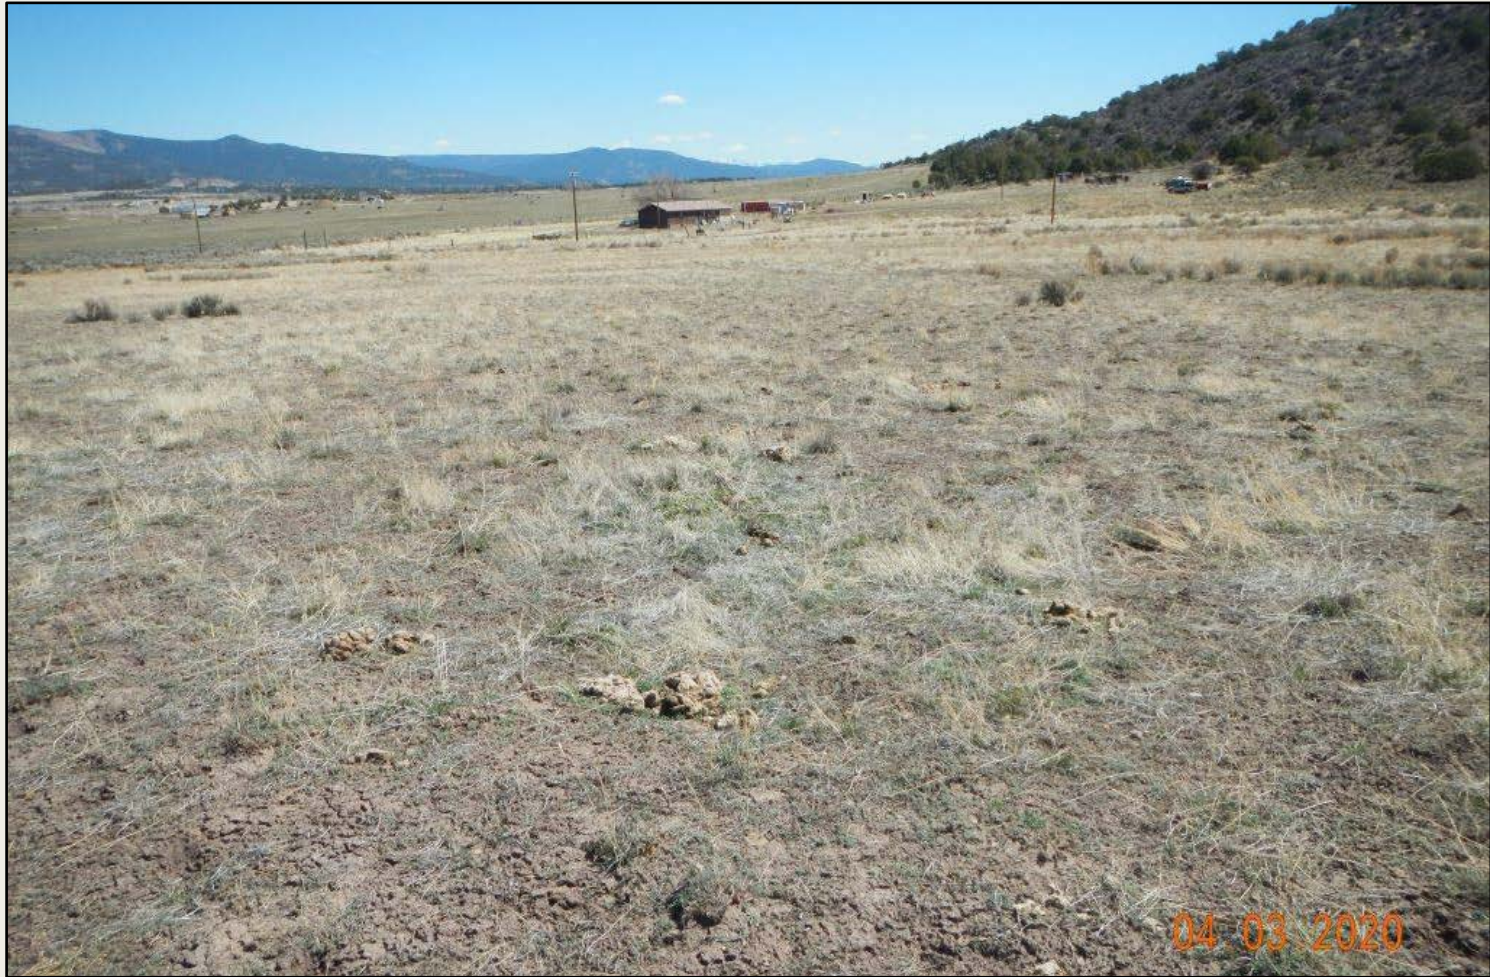
Photo 3. View of reference area vegetation comprised of grazed grass field, largely in a dormant condition with perennial bunch grasses.
