Inspection Photos

Operator: Hilcorp Energy
API#: 067-08759
Date: 4/3/2020

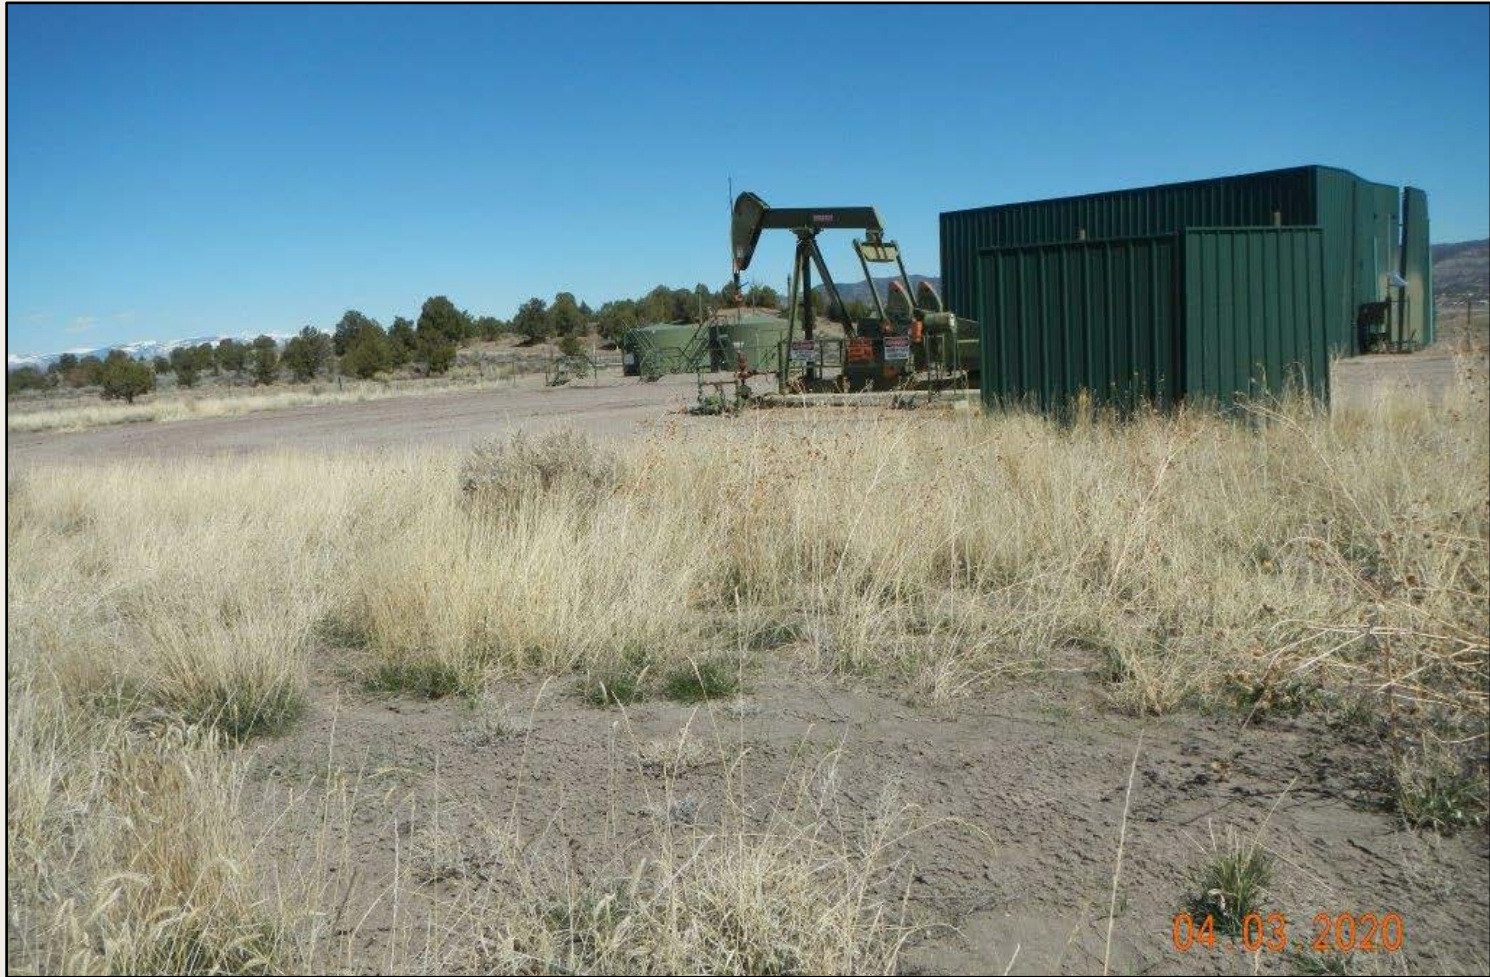
Photo 1. View of the project area from the southwestern corner facing center.

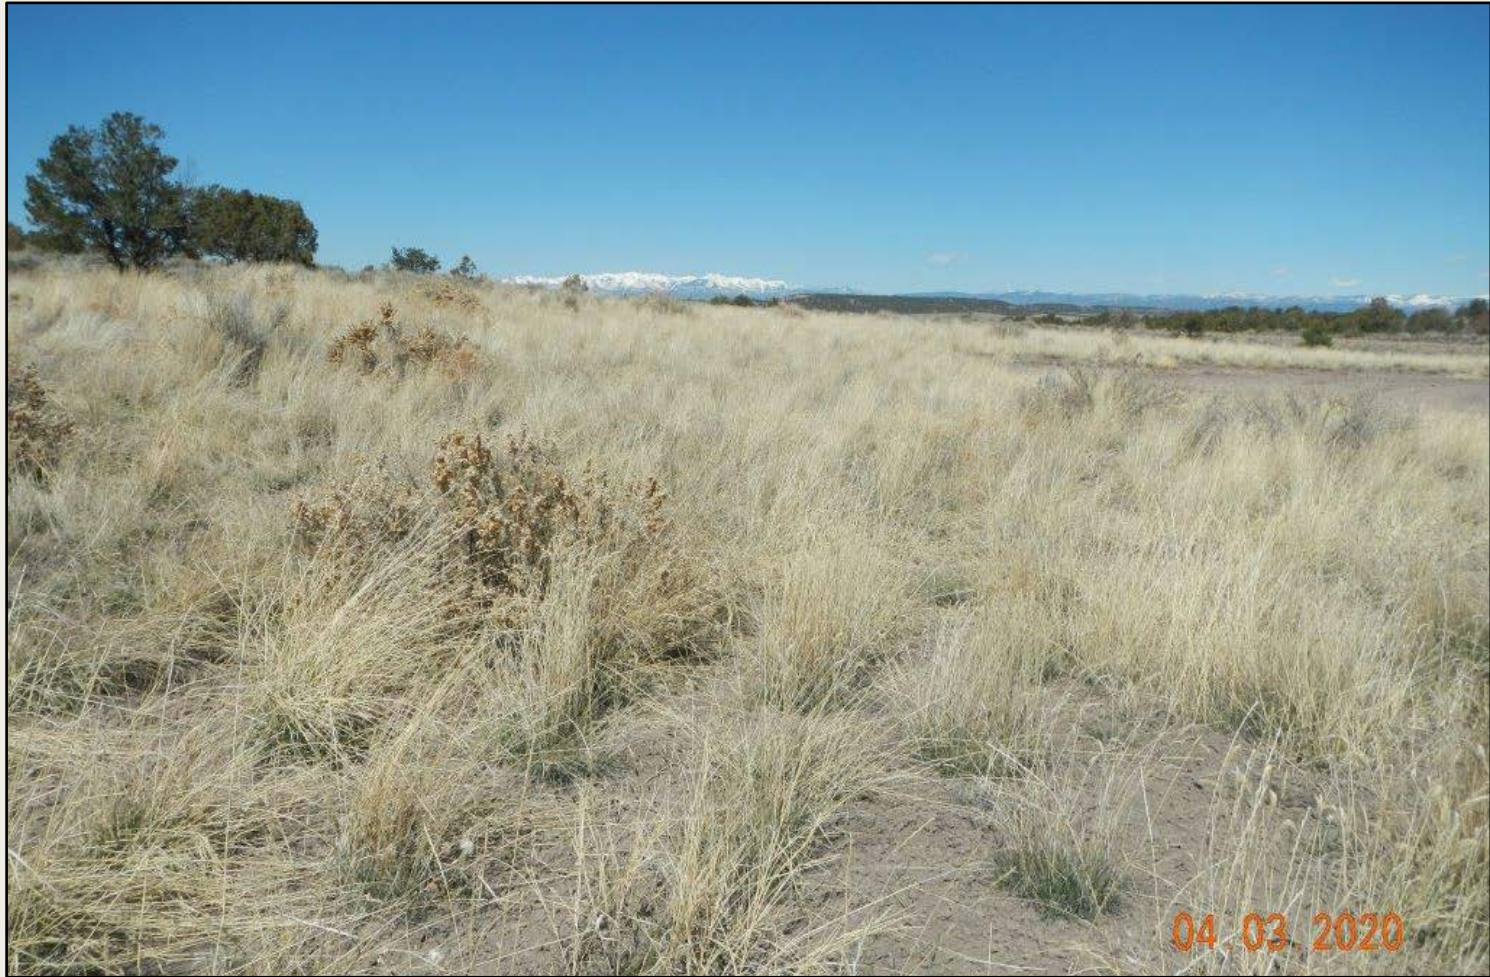
Photo 2. View of the western project area from the southwestern corner facing northward. Vegetation is comprised of bunchgrasses such as crested wheatgrass and shrubby fourwing saltbush.

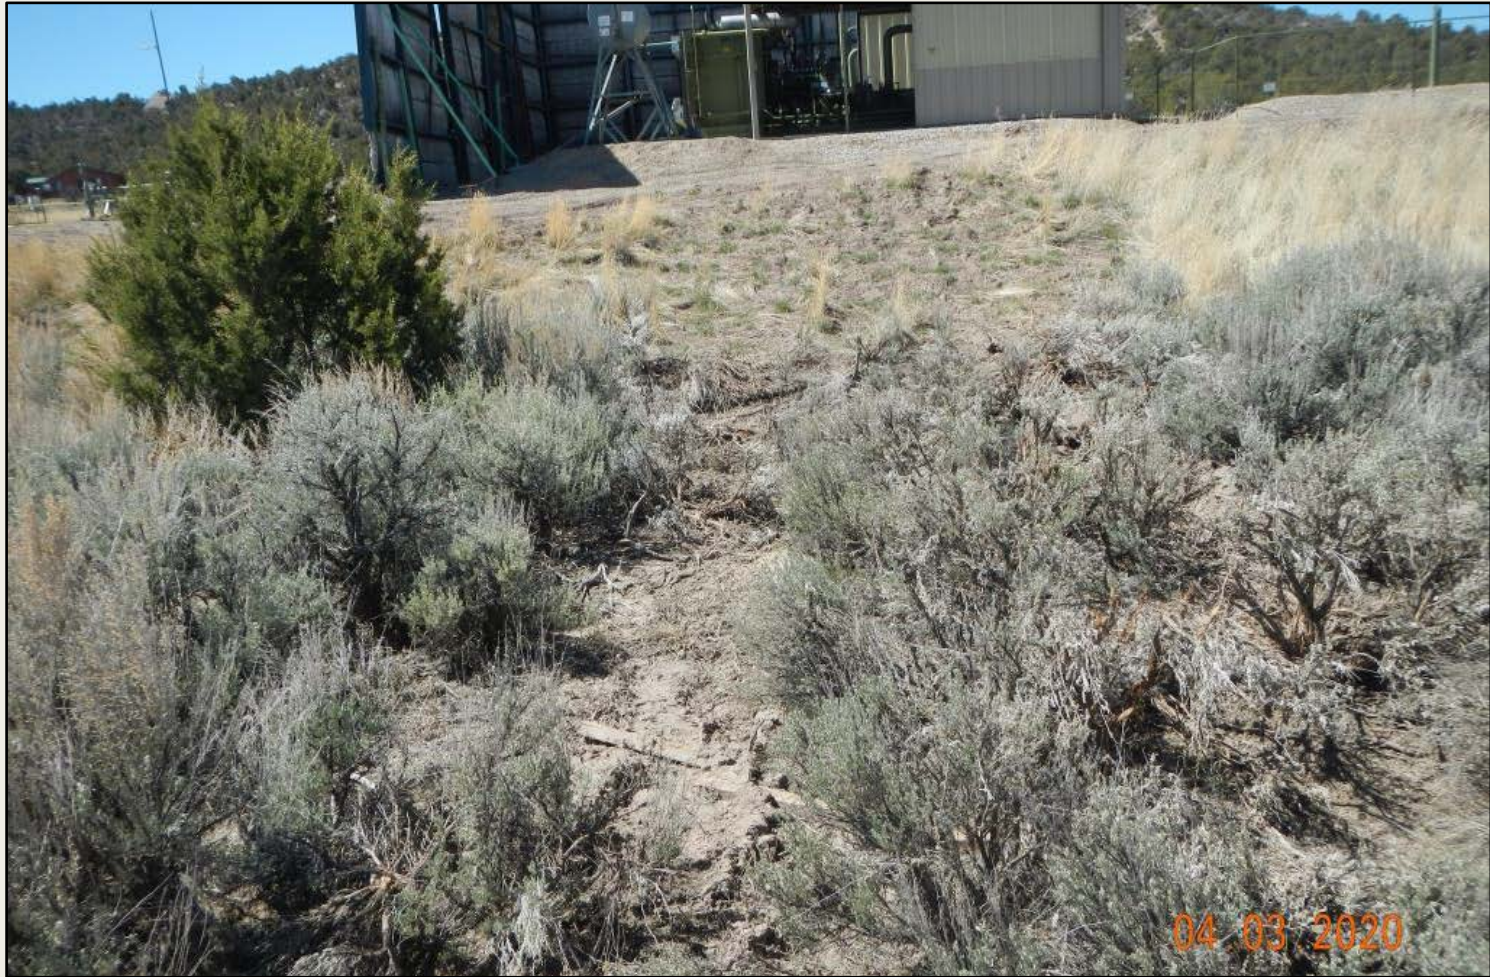
Photo 3. View of area where vegetation is damaged from vehicle tracking in the eastern project area.

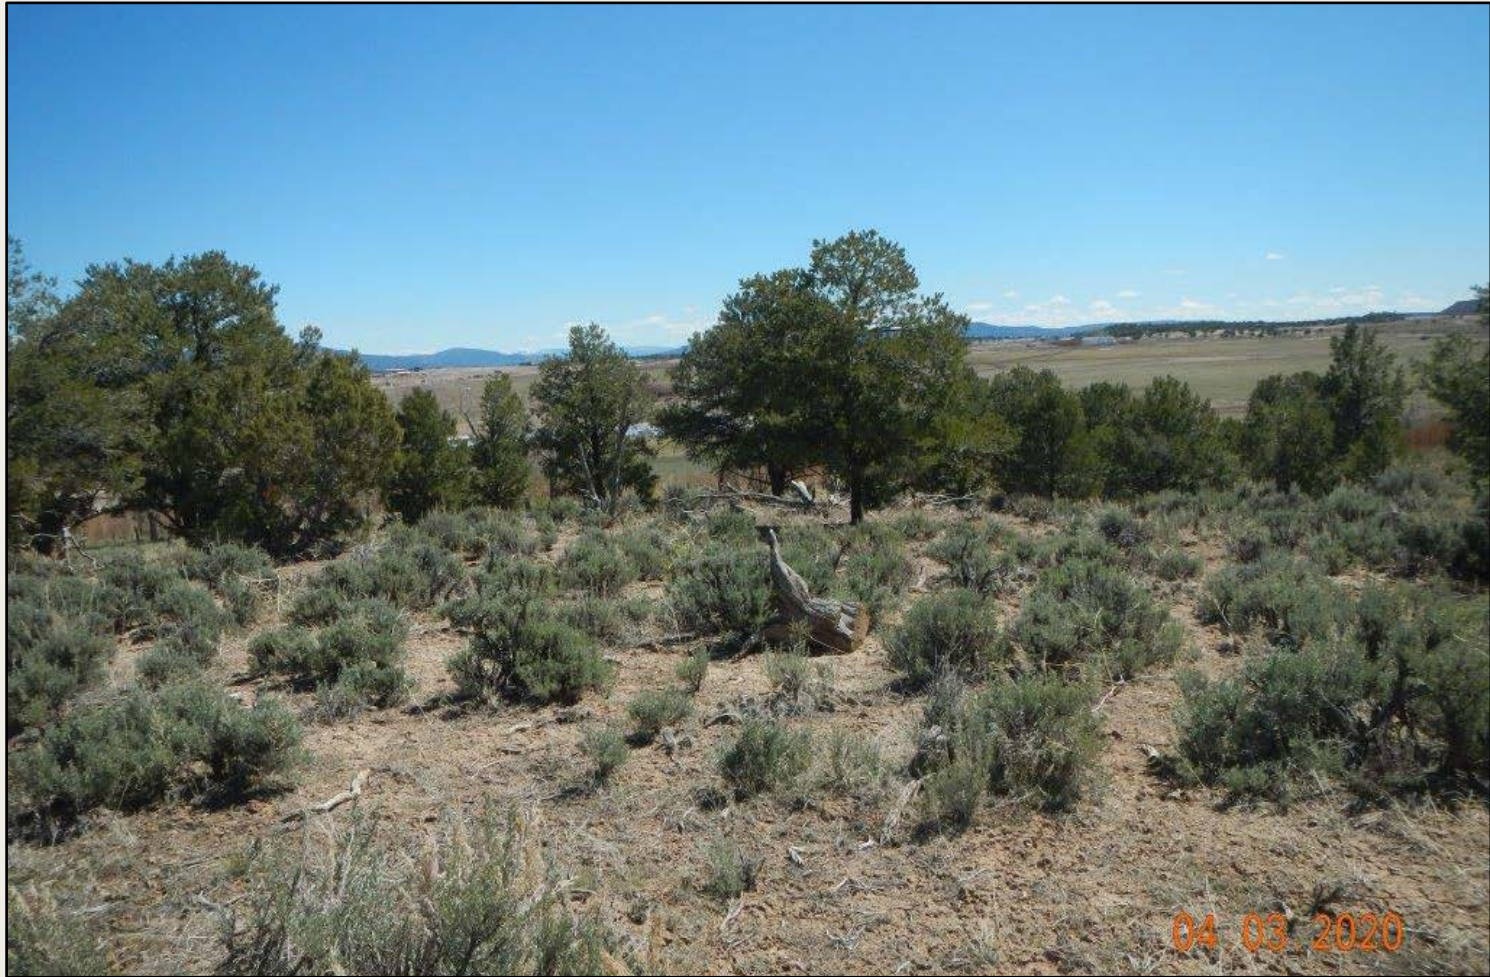
Photo 4. View of reference area vegetation comprised of sagebrush shrubland and pinyon juniper woodland.
