Inspection Photos
Location Name: Hall #1
API: 05-067-05343

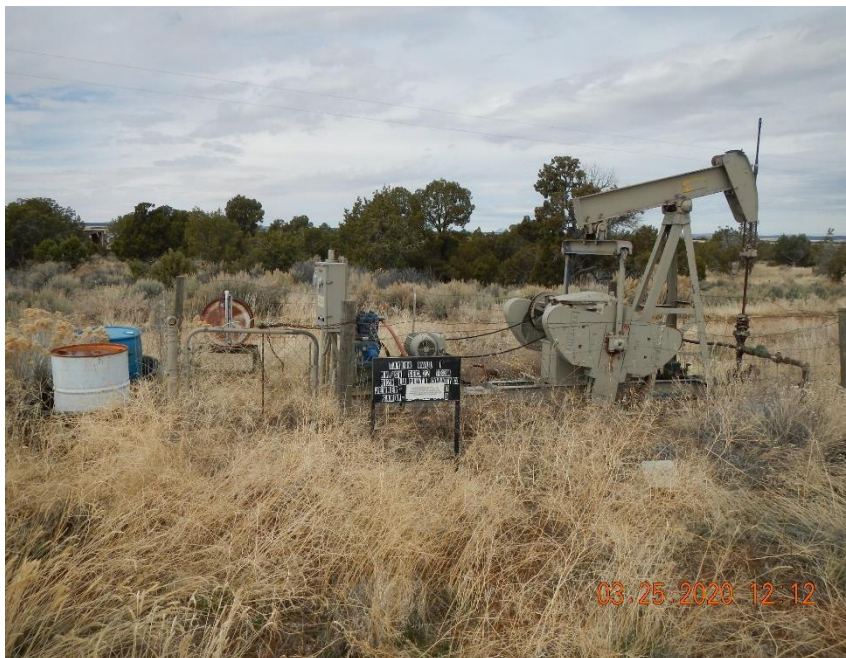
Taylor Hall #1 location photo.

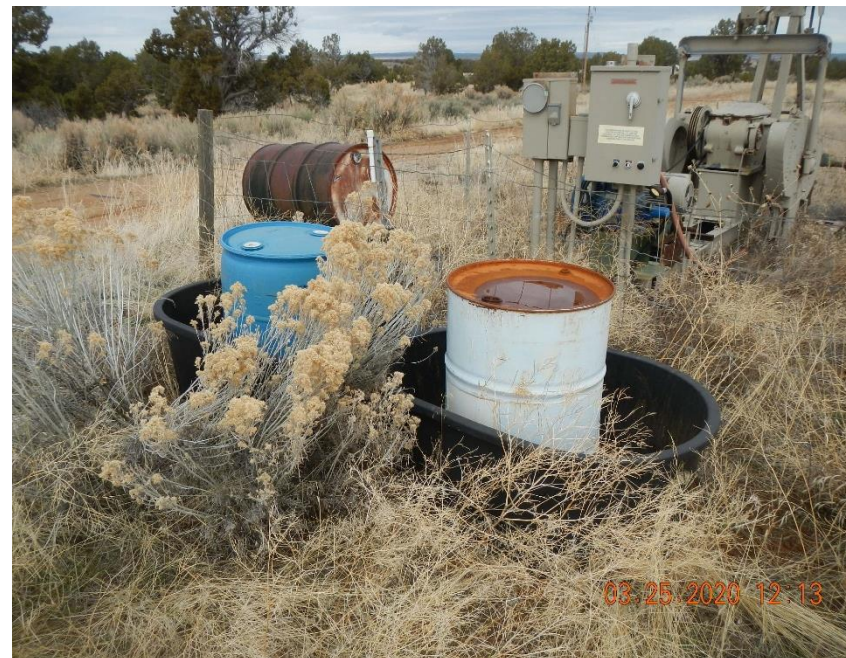
55 gal. drums left on location. Steel drums are empty.

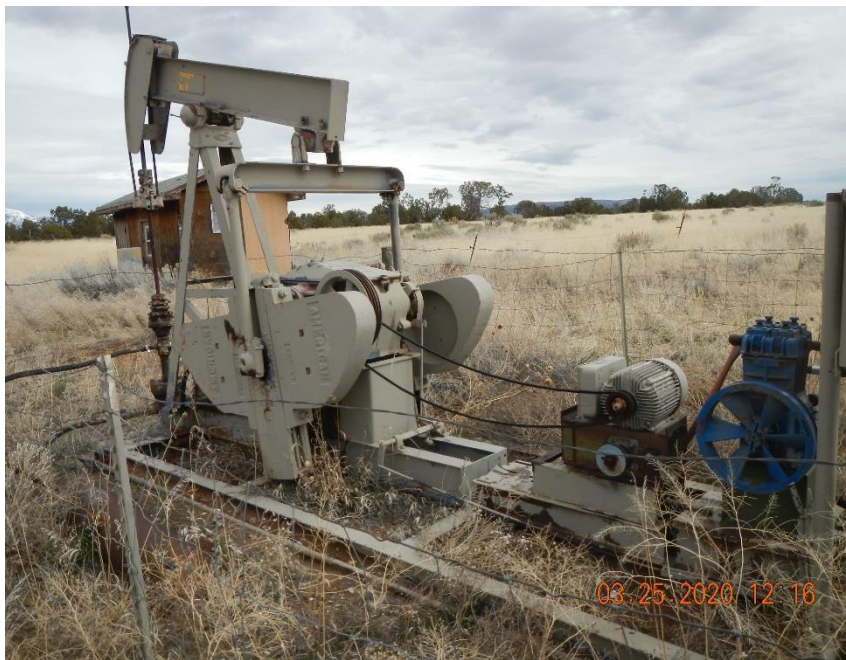
Hall #1 pump jack and electric prime mover.

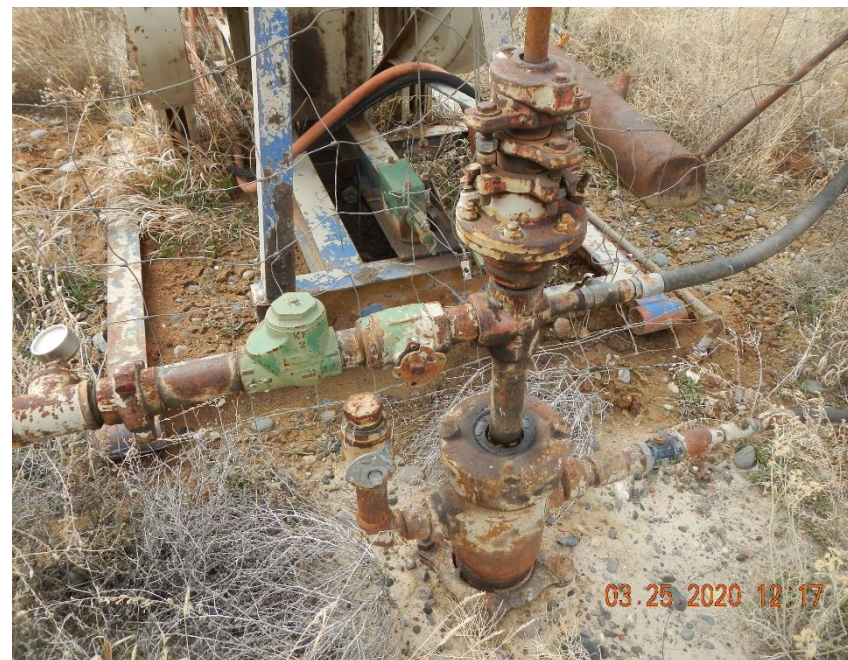
Hall #1 well head.

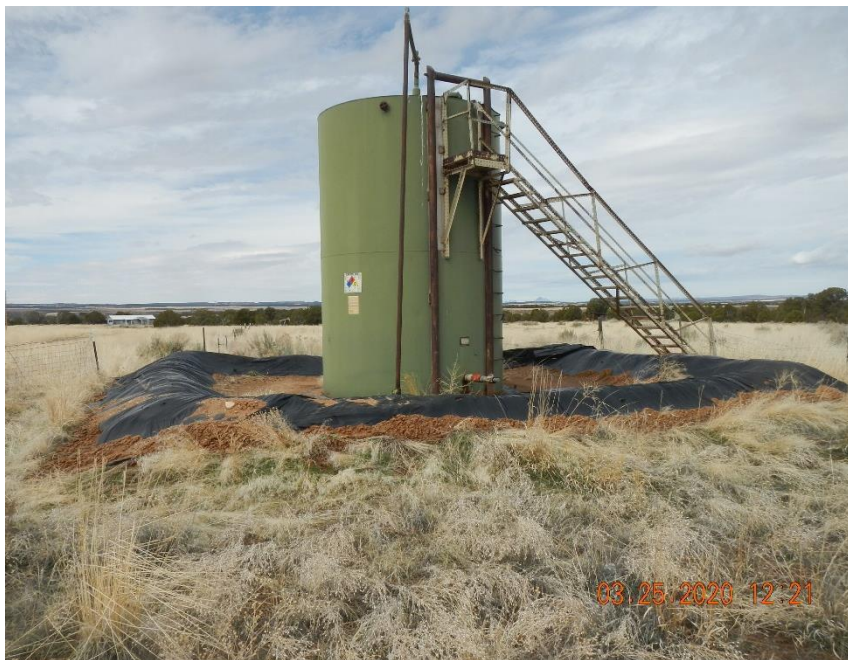
Taylor Hall #1 tank battery.

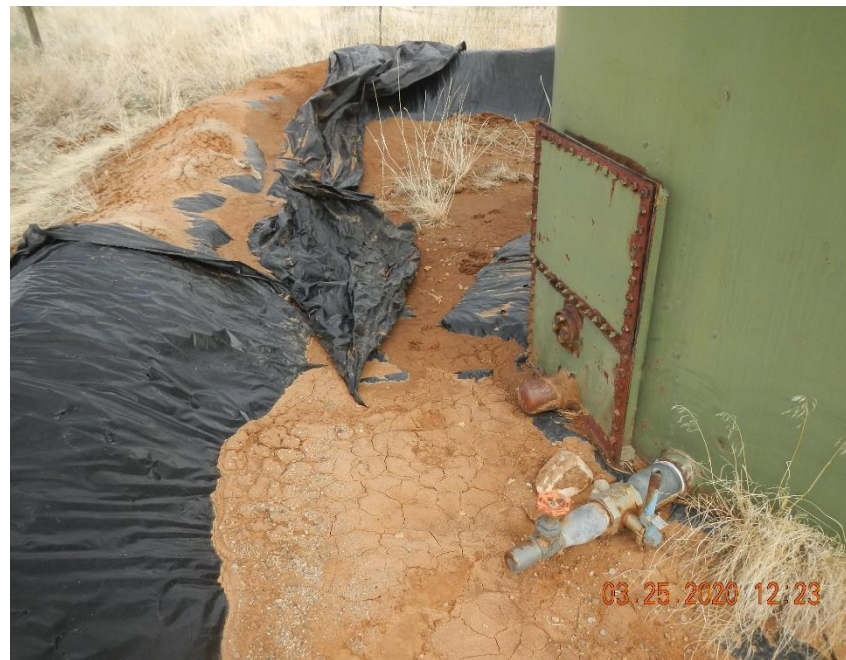
Compromised liner on secondary containment berm.
