# Inspection Photos

4/06/2020

Operator: CAERUS PICEANCE LLC

Location ID: 335922

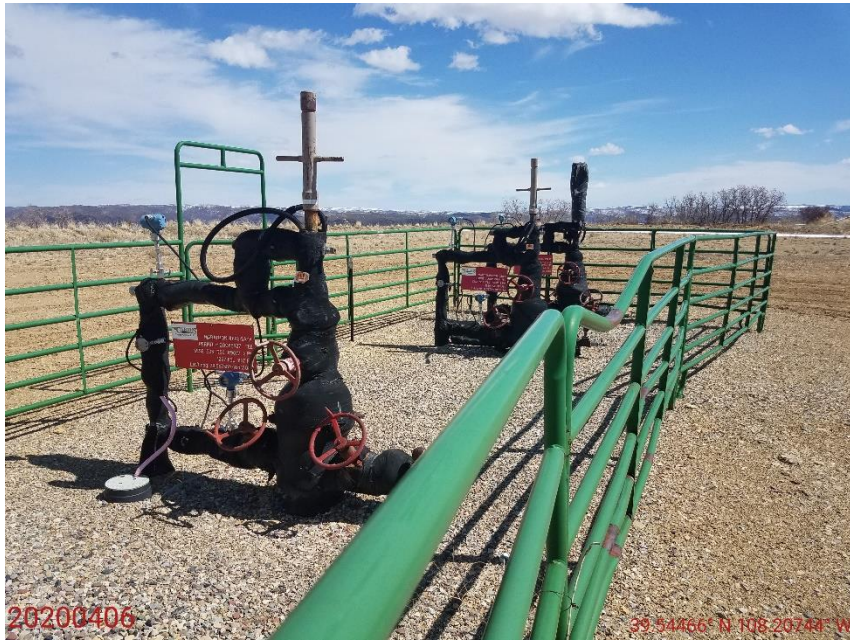
**Photo 1:** Photo shows the three (3) active wells on the Location. Records show well have produced since 2009.

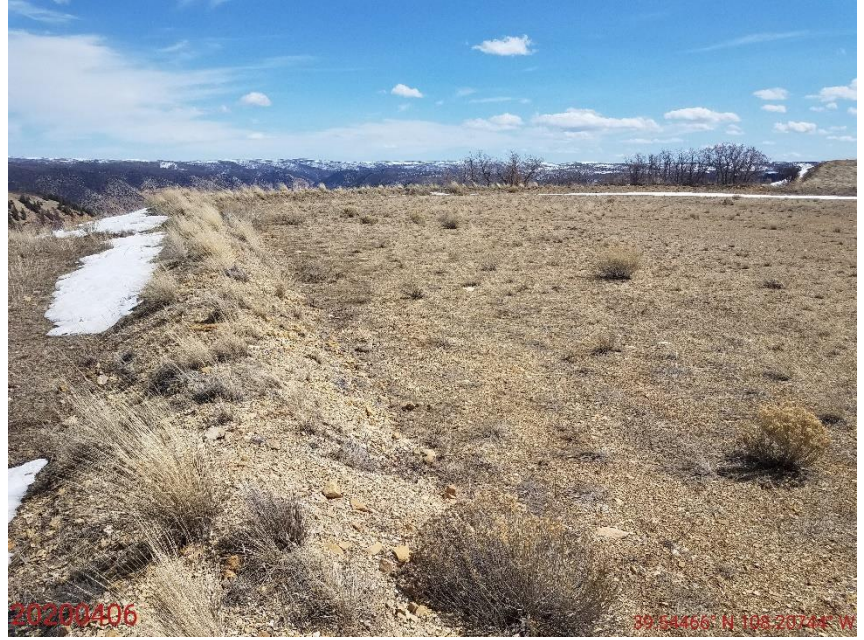
**Photo 2:** Photo taken from the north end of the Location, facing northeast. Photos 2-6 provide an overview of the Location from northeast, east, southeast, south, southwest to west. Photos show large areas of the current pad that do not appear to be necessary for production activities, and require reclamation.

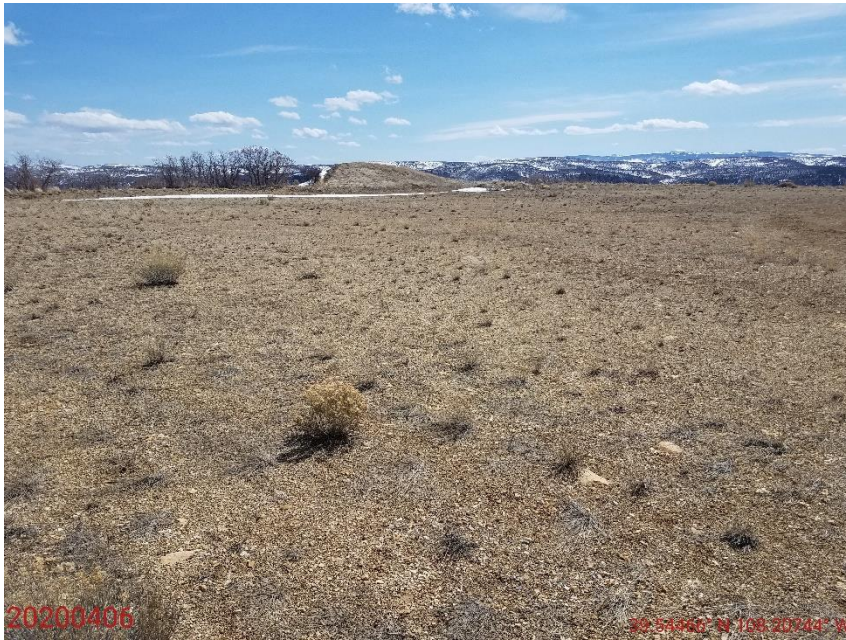
**Photo 3:** See comments under photo 2.

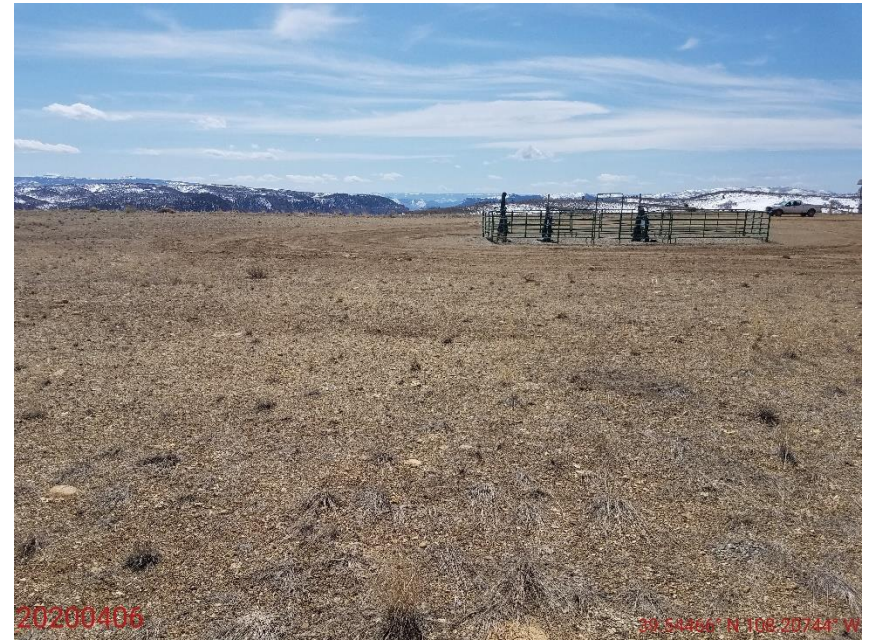
**Photo 4:** See comments under photo 2.

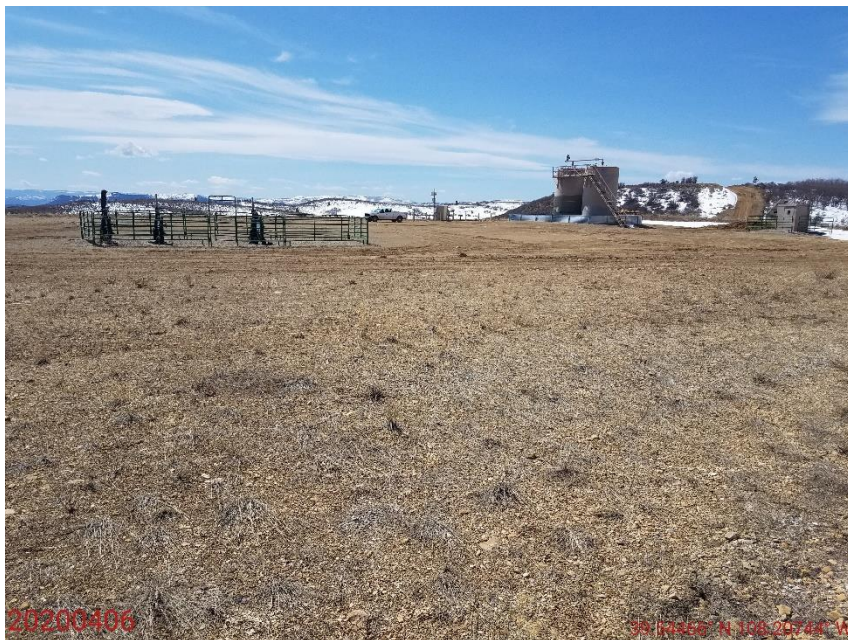
**Photo 5:** See comments under photo 2.

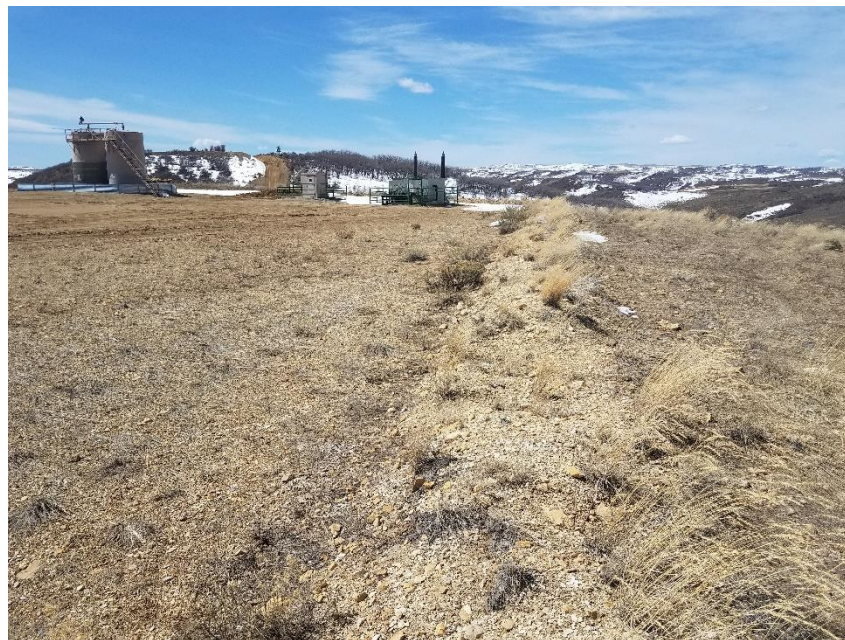
**Photo 6:** See comments under photo 2.

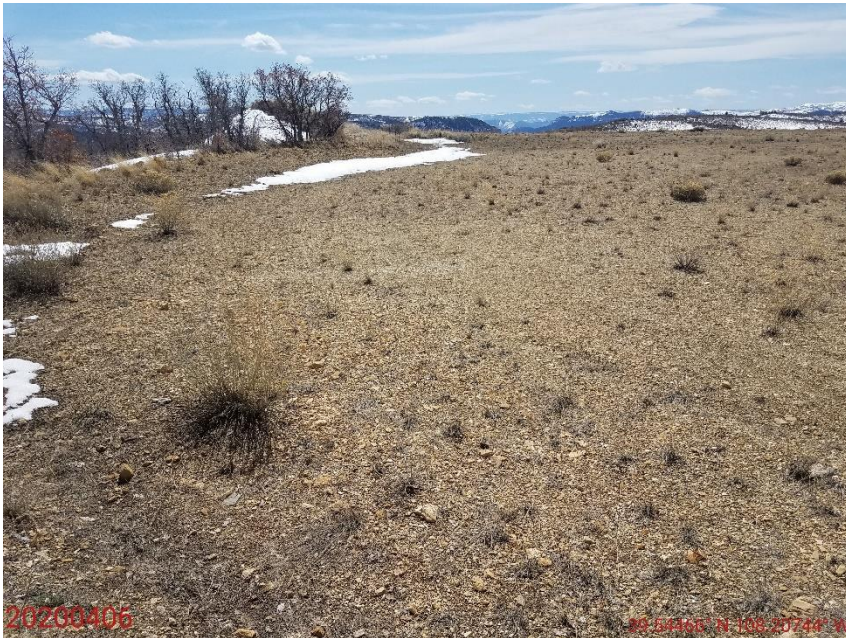
**Photo 7:** Photo taken from the northeast corner of the pad, facing south. Photos 7-9 provide an overview of the location from south, southwest to west. Photos show large areas of the current pad that do not appear to be necessary for production activities, and require reclamation.

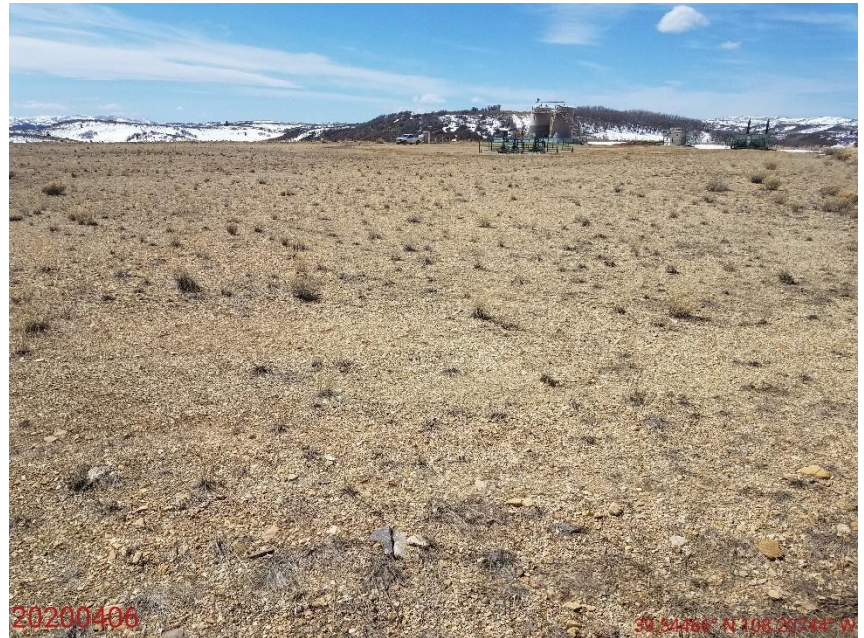
**Photo 8:** See comments under photo 7.

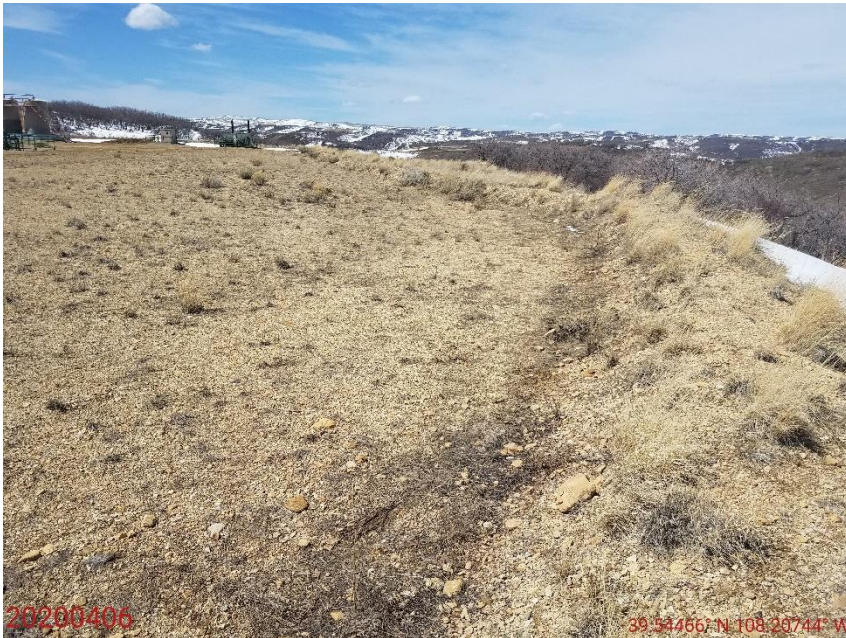
**Photo 9:** See comments under photo 7.

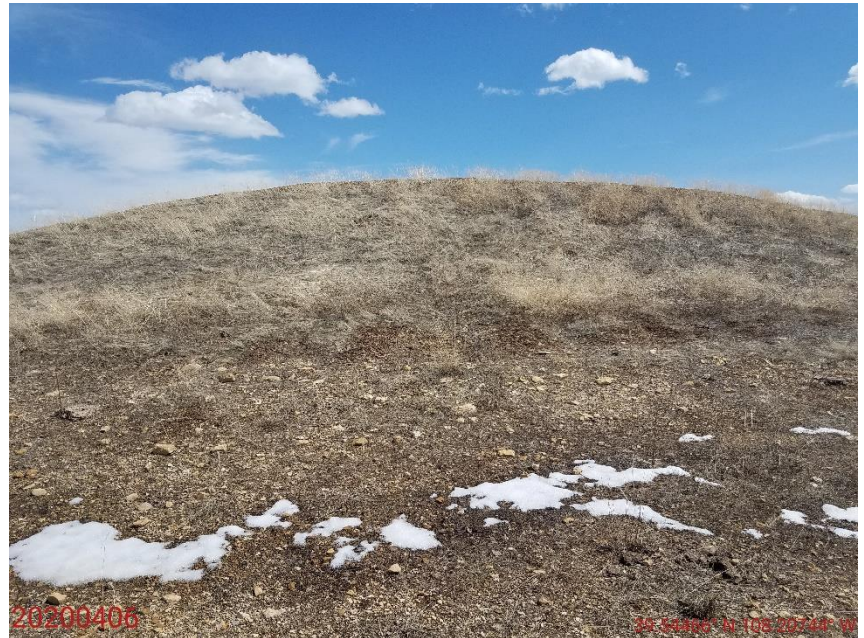
**Photo 10:** Photo taken from the southwest corner of the pad, facing east. Photo shows topsoil stockpile. Vegetation observed on the soil stockpile were predominantly undesirable weedy plant species such as *Bromus tectorum* in violation of Rule 1002.c

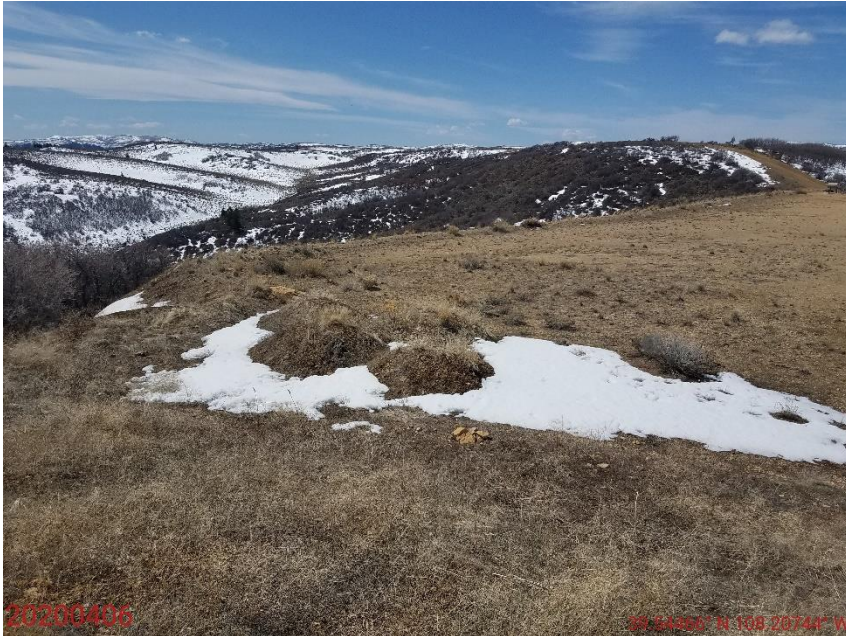
**Photo 11:** Photo taken from the southeast corner of the pad, facing southwest. Photos 11-13 provide an overview of the Location from southwest, west, to northwest. Photos show large areas of the current pad that do not appear to be necessary for production activities, and require reclamation.

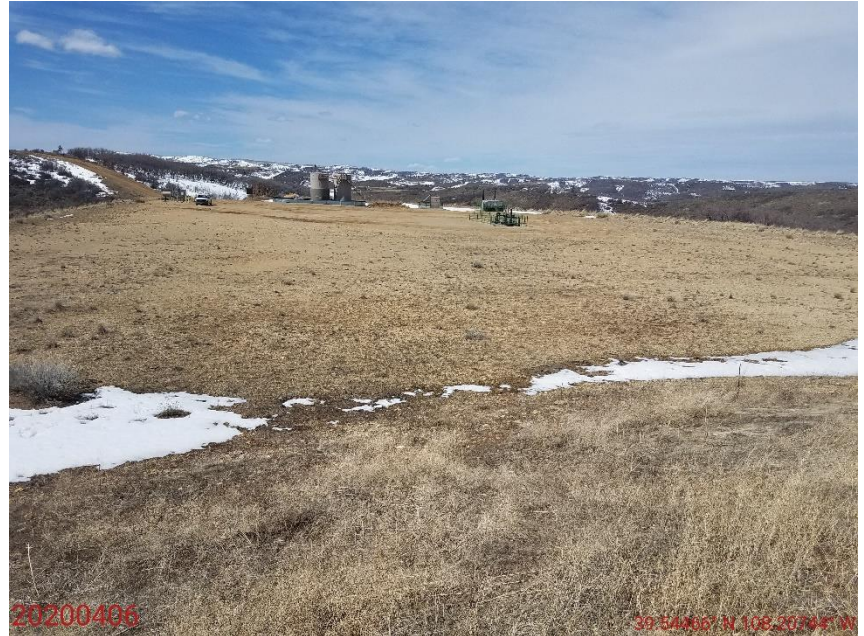
**Photo 12:** See comments under photo 11.

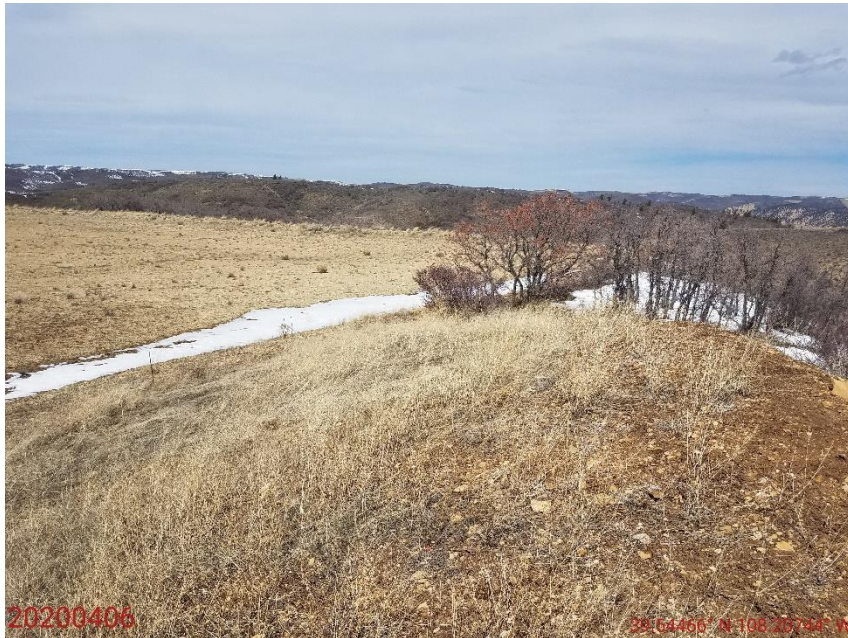
**Photo 13:** See comments under photo 11.

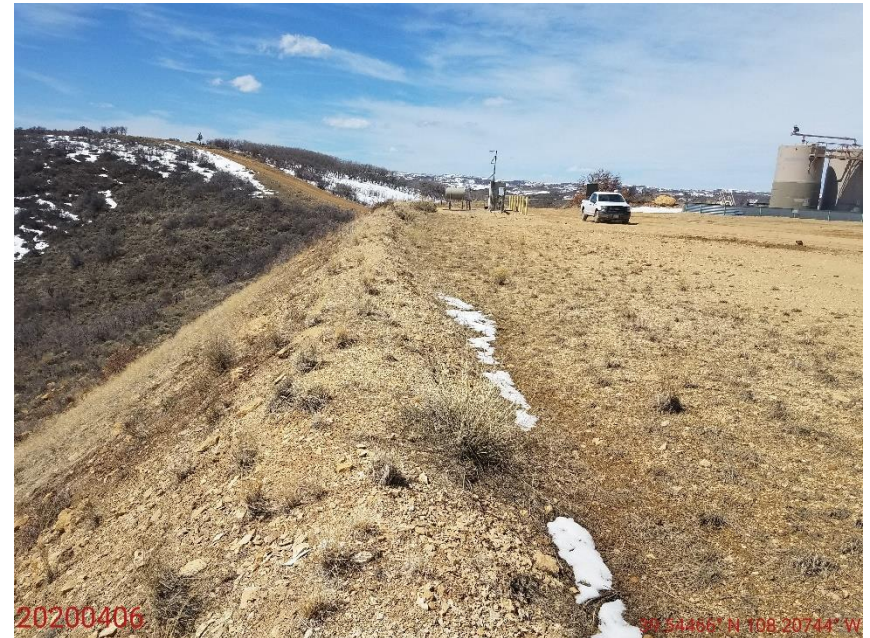
**Photo 14:** Photo taken from the south end of the pad facing west. Photos 14- 18 provide an overview of the Location from west, northwest, north, northeast to east. Photos show large areas of the current pad that do not appear to be necessary for production activities, and require reclamation.

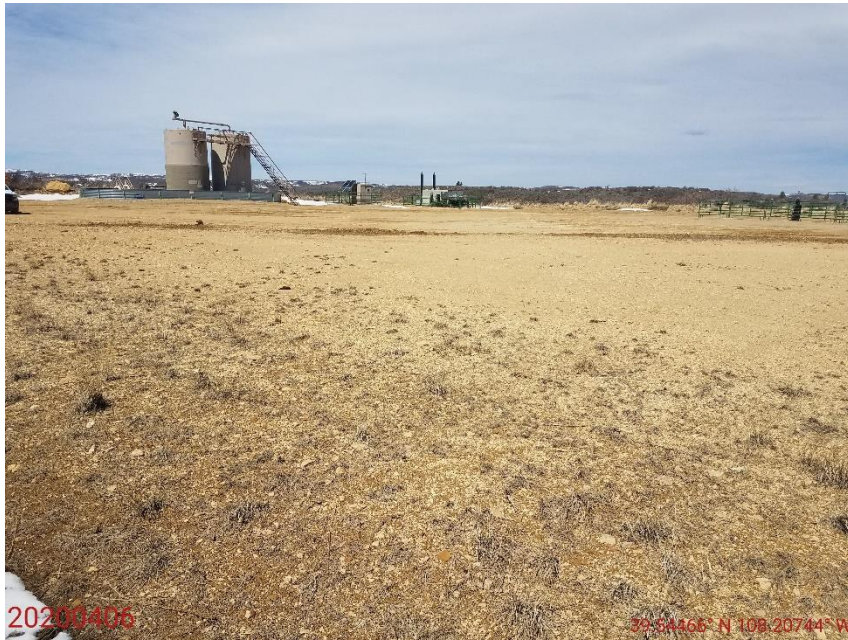
**Photo 15:** See comments under photo 14.

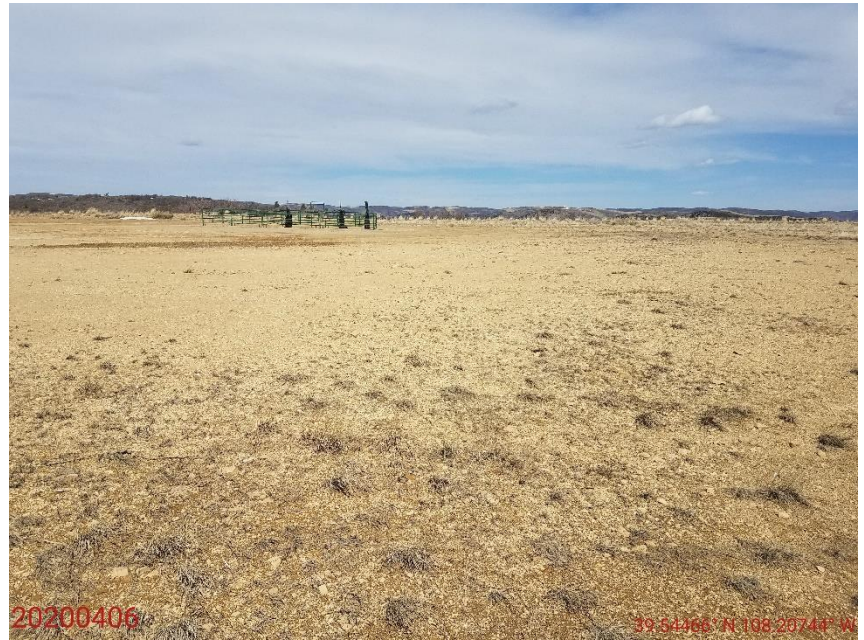
**Photo 16:** See comments under photo 14.

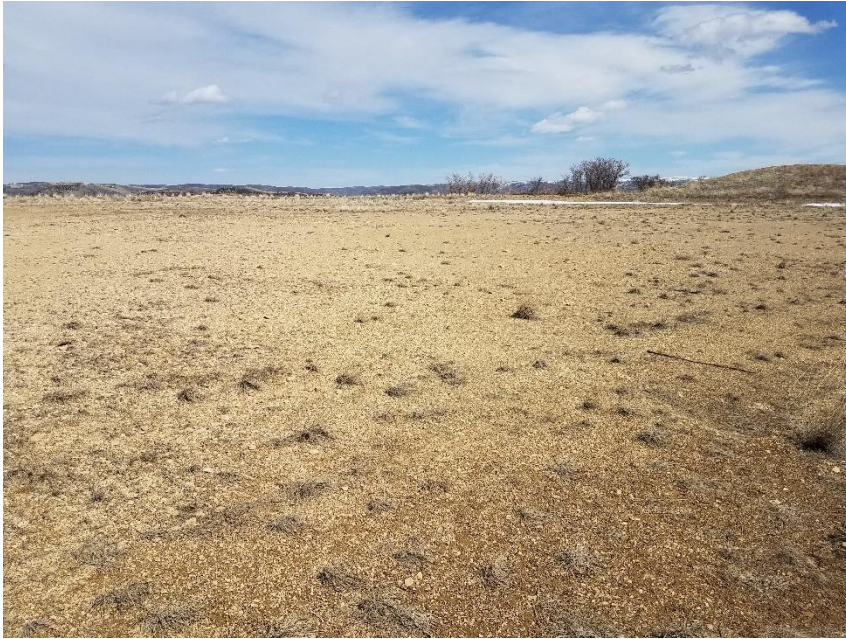
**Photo 17:** See comments under photo 14.

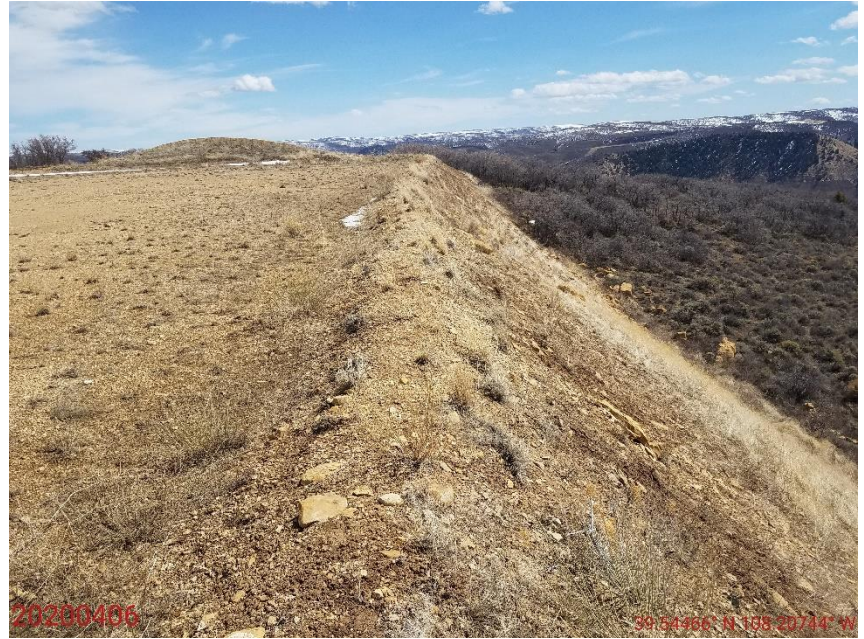
**Photo 18:** See comments under photo 14. Photo also shows fill areas of the Location that will require contouring and regrading to the former topography.

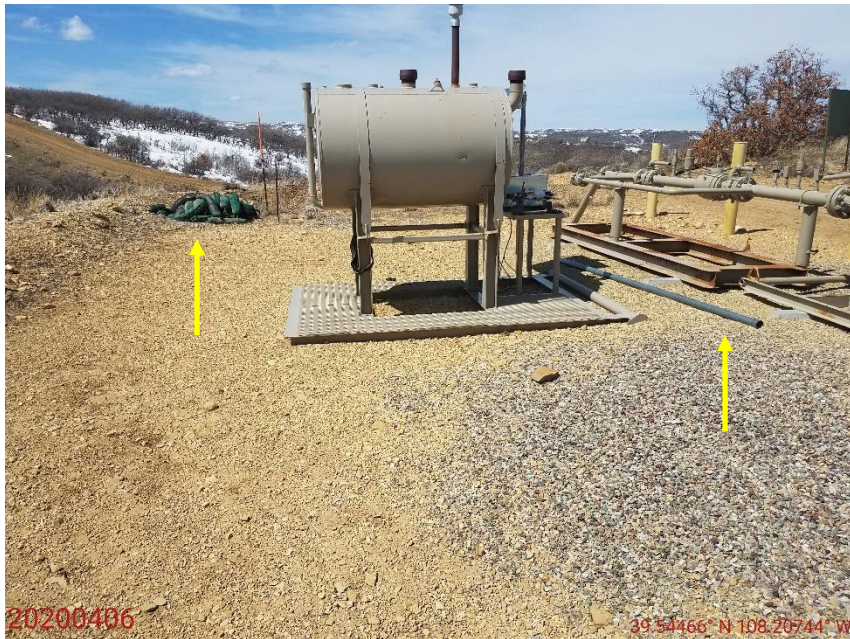
**Photo 19:** Photo taken from the southwest corner of the Location. Photo shows unused equipment (rock socks, pipe) being stored on the Location. Equipment/materials require removal and proper storage in accordance with 603.f

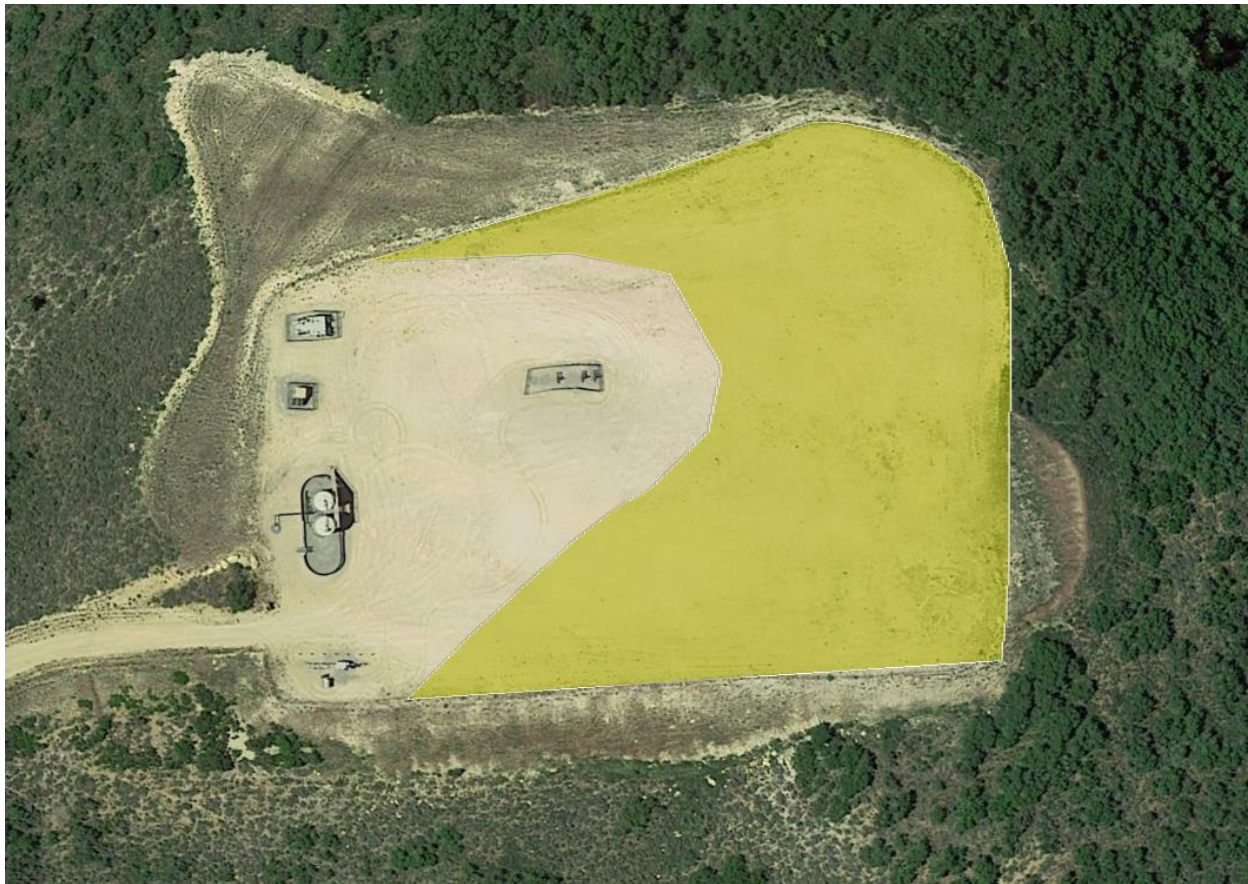
**Photo 21:** 2016 Google Earth Aerial imagery; most current available google earth imagery. Photo shows large areas (~1.8 acres) of the current production area that do not appear to be necessary for production activities, and require reclamation in accordance with Rule 1003.b.
