Inspection Photos

Location Name: MARALEX RESOURCES INC SOUTH SHALE RIDGE-68S98W/23SWNW

Location ID: 312610

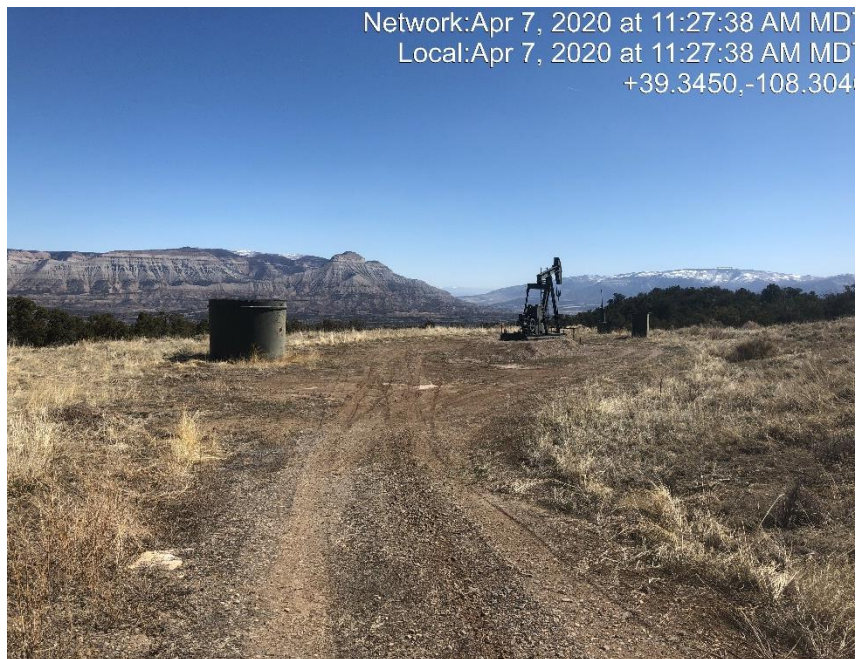
Photo #0917 from entrance to location

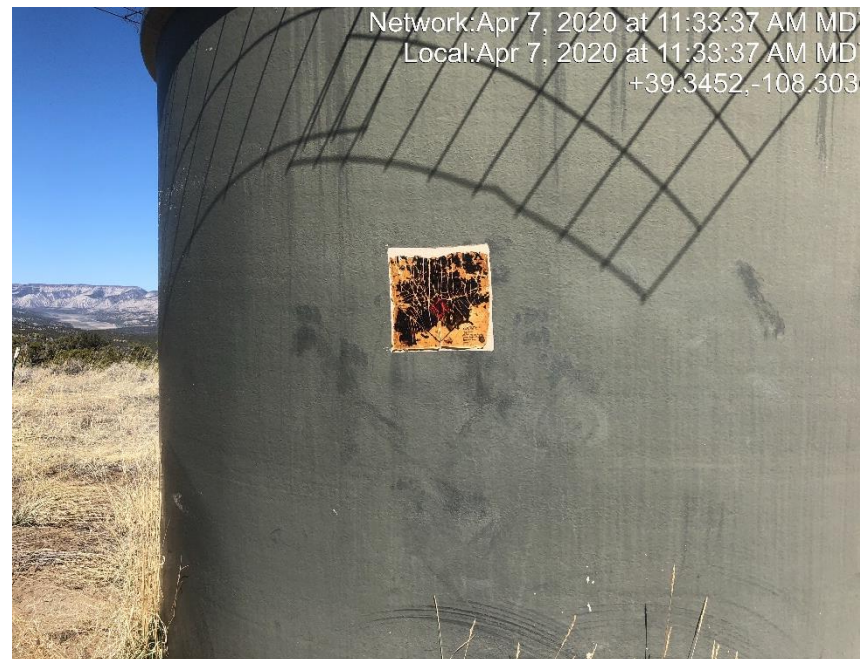
Photo #0921 Tank NFPA label weathered and not legible.

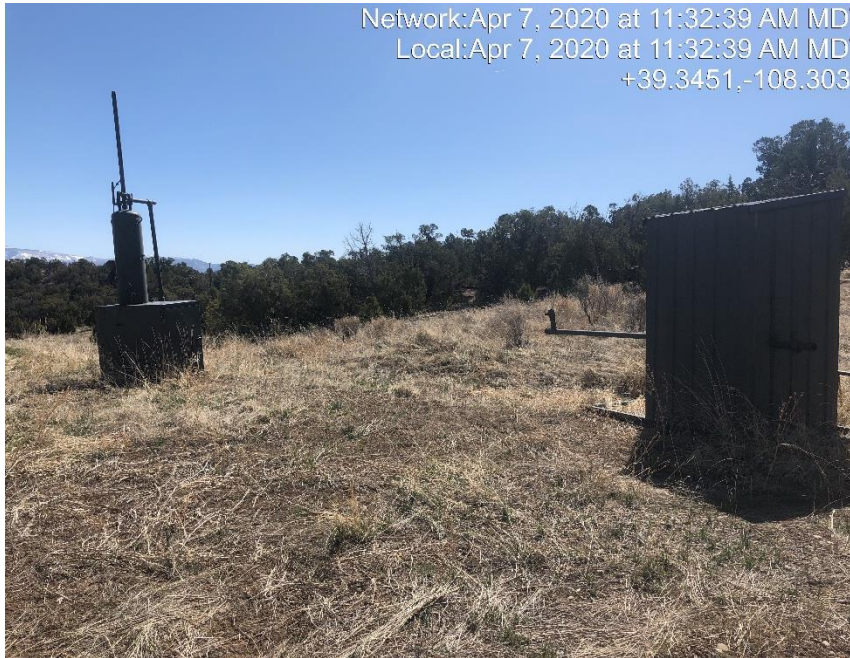
Photo #0920 Multiple places with unused equipment on location.

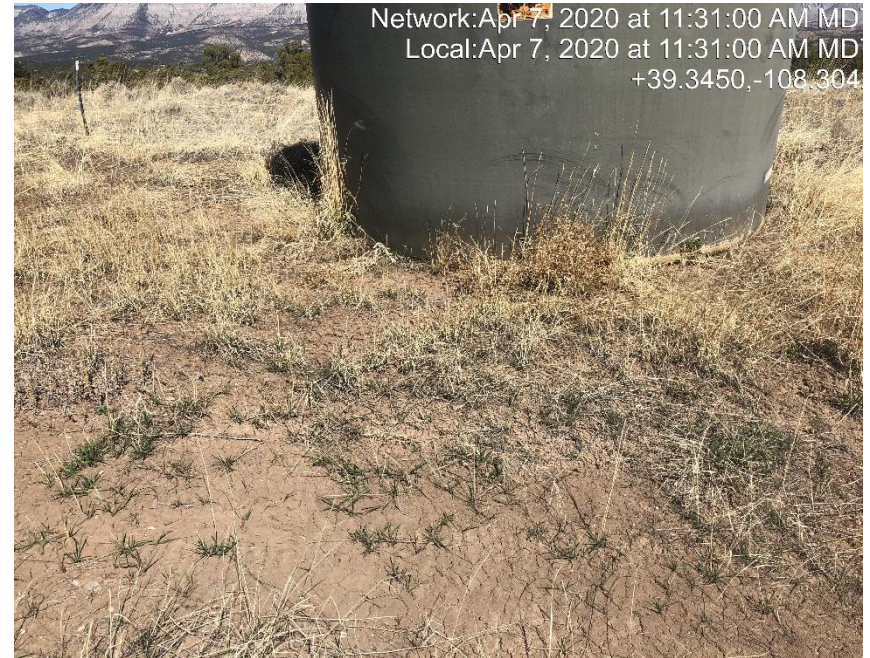
Photo #0918 Debris on location.

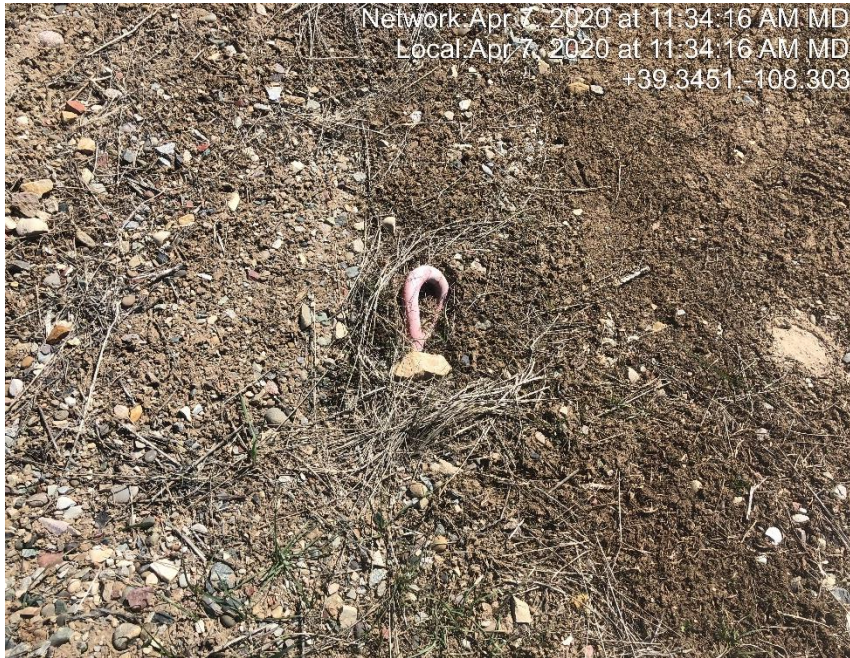
Photo #0922 Unmarked deadman.

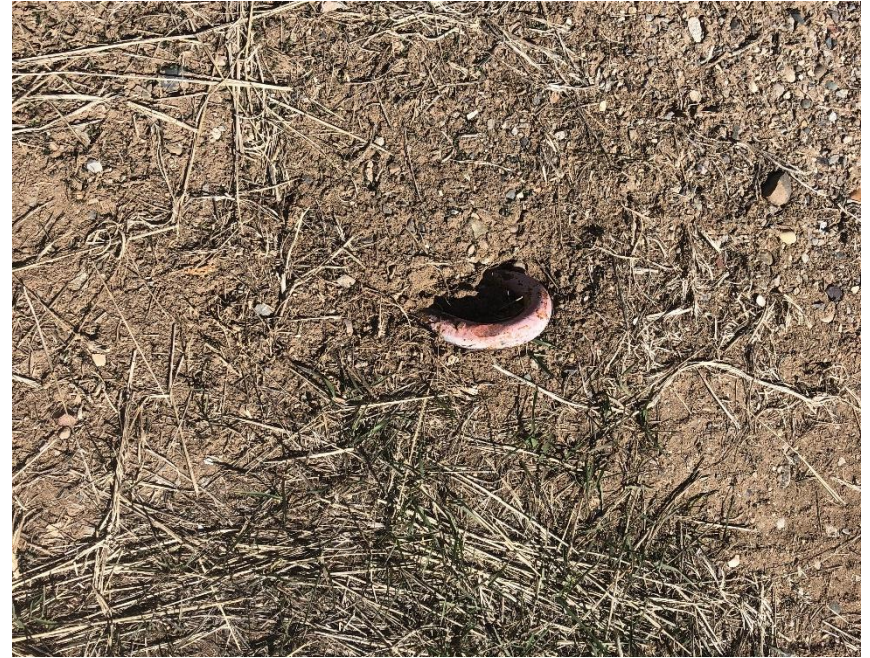
Photo #0923 Unmarked deadman.
