Inspection Photos
Operator: BP America
API#: 067-07014
Date: 4/3/2020

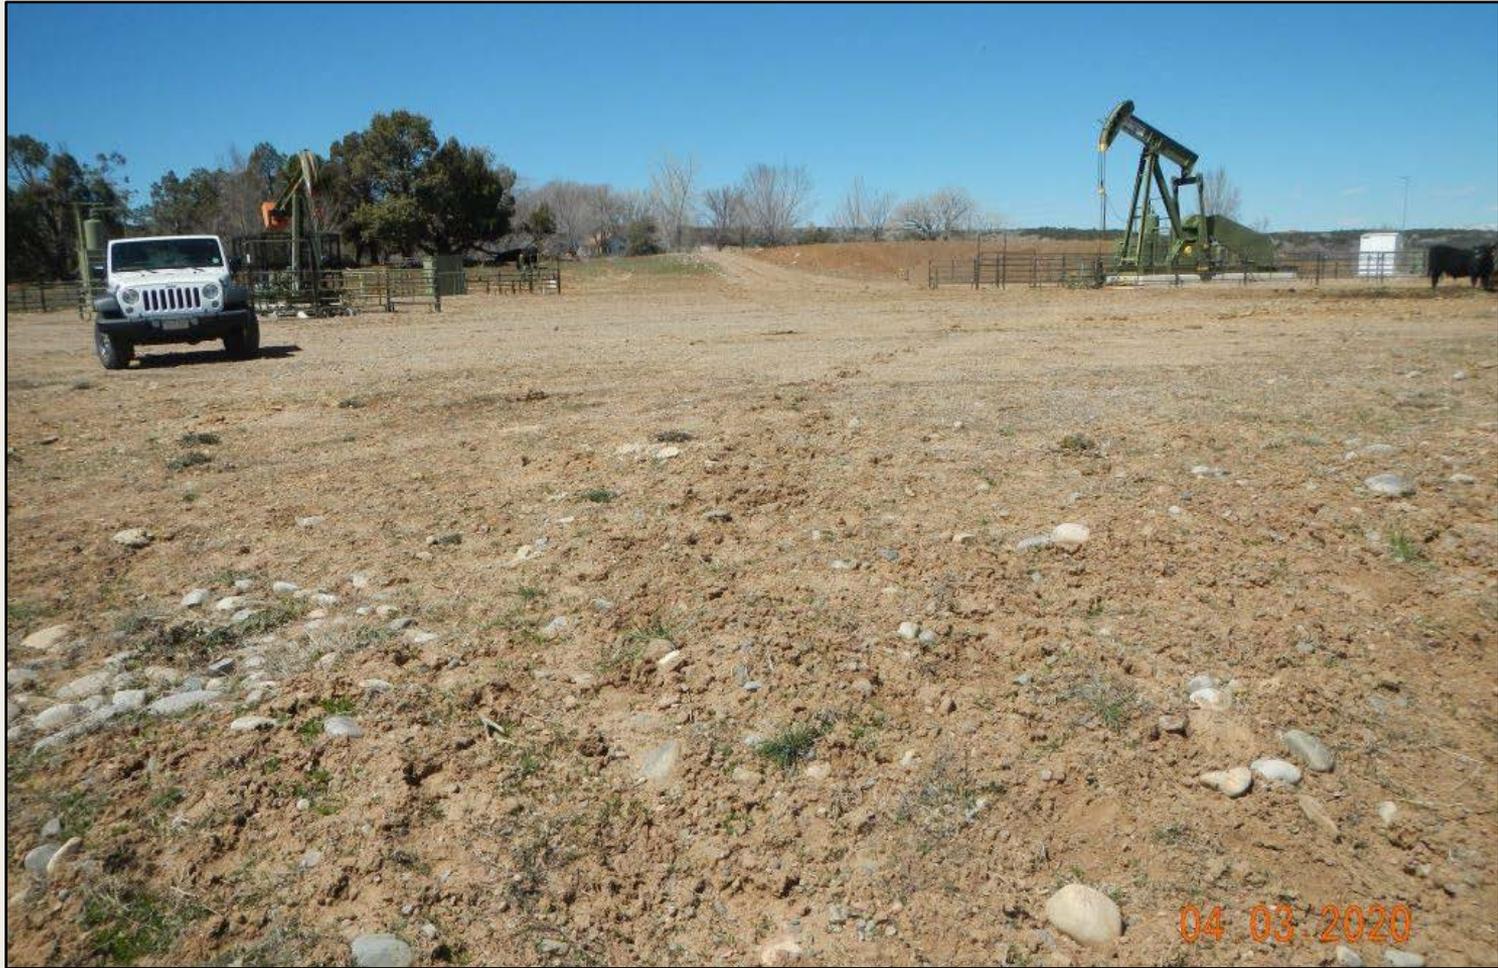
Photo 1. View of the project area from the southeastern corner facing center.

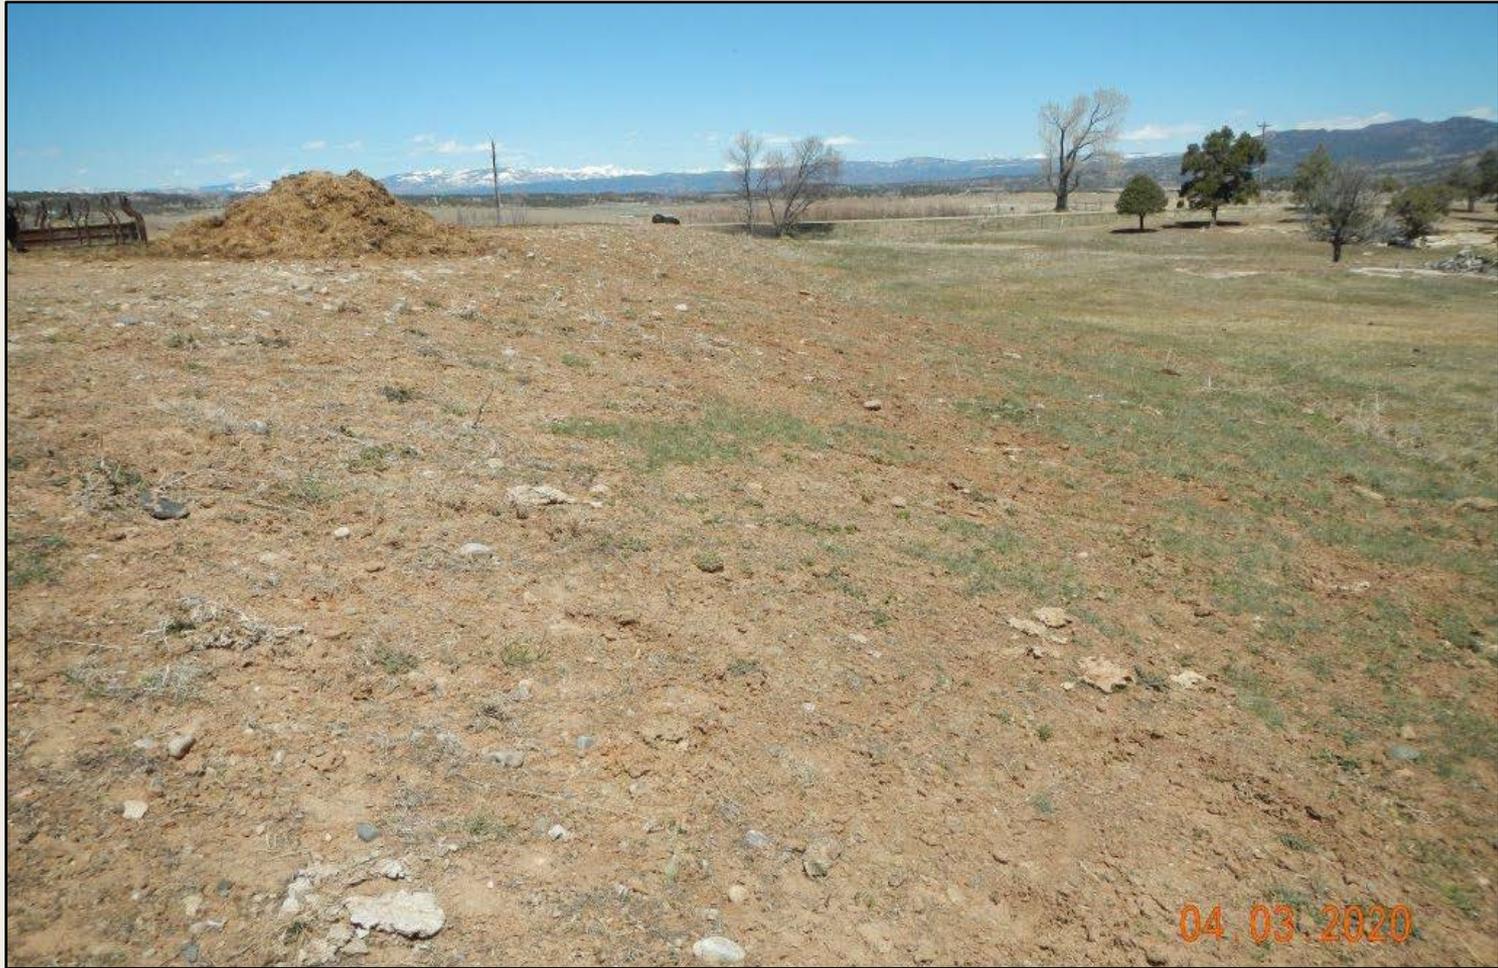
Photo 2. View of the eastern fill slope from the southeastern corner facing northward. Vegetation is grazed and in a condition similar to surrounding reference area.

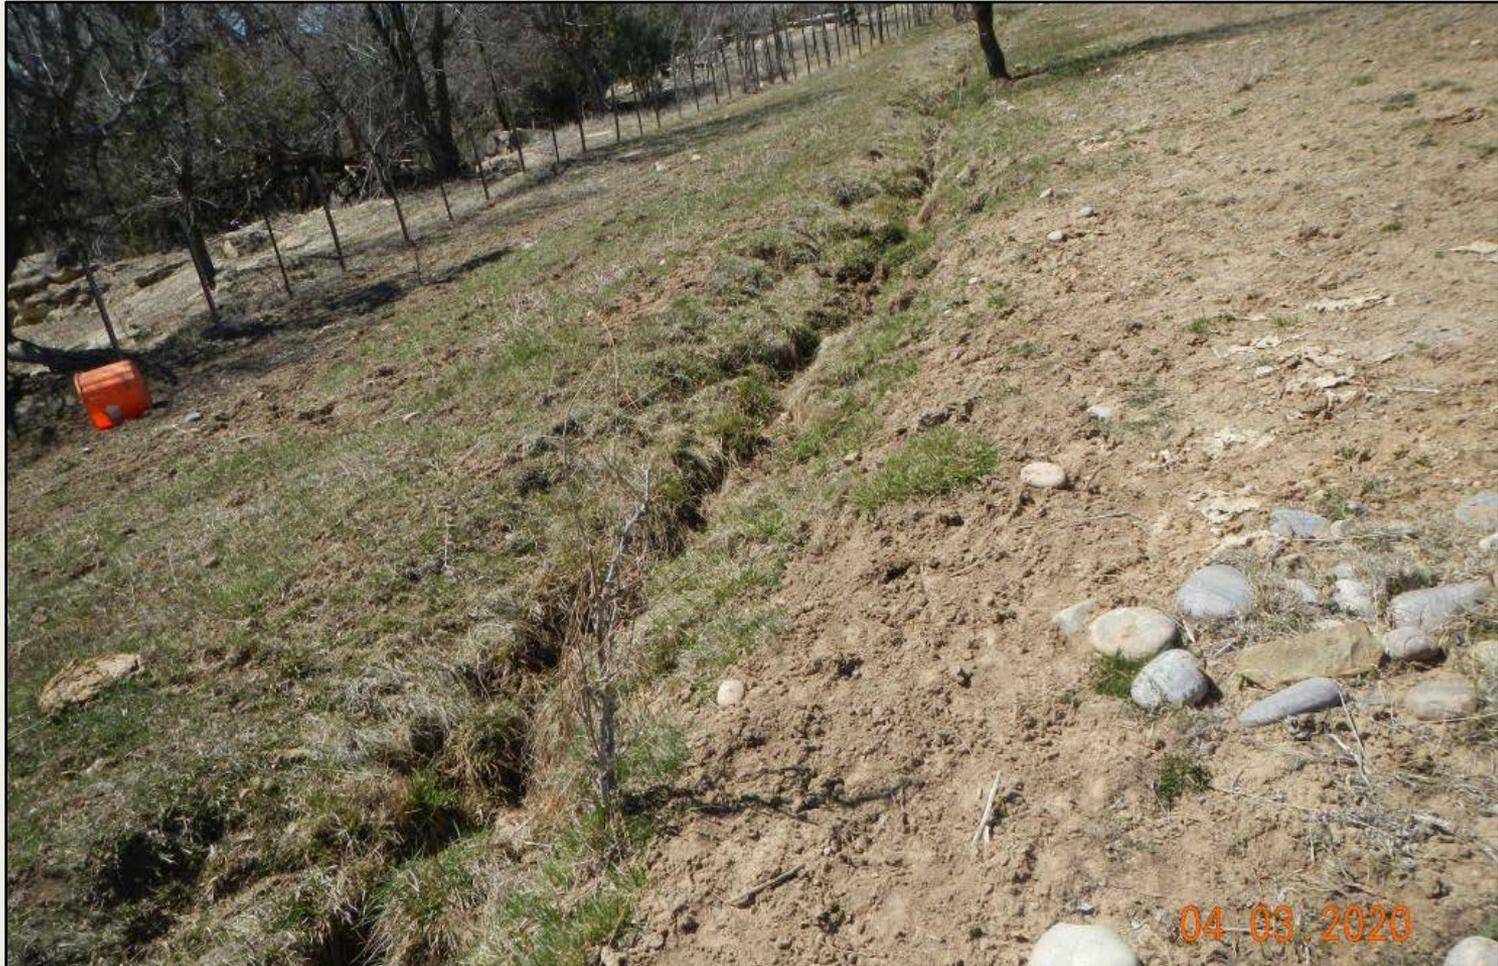
Photo 3. View of the southern project area from the southeastern edge facing westward. Irrigation ditch runs adjacent to southern edge of working area.

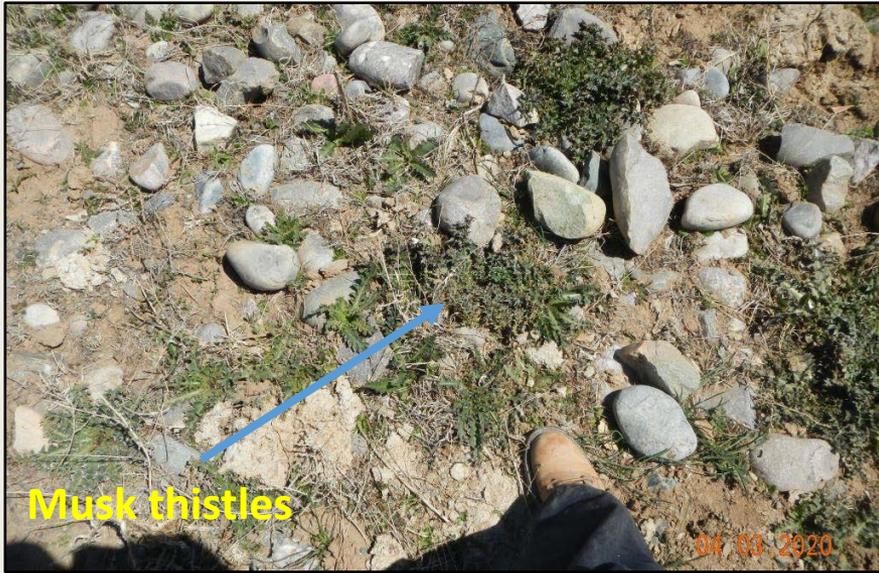
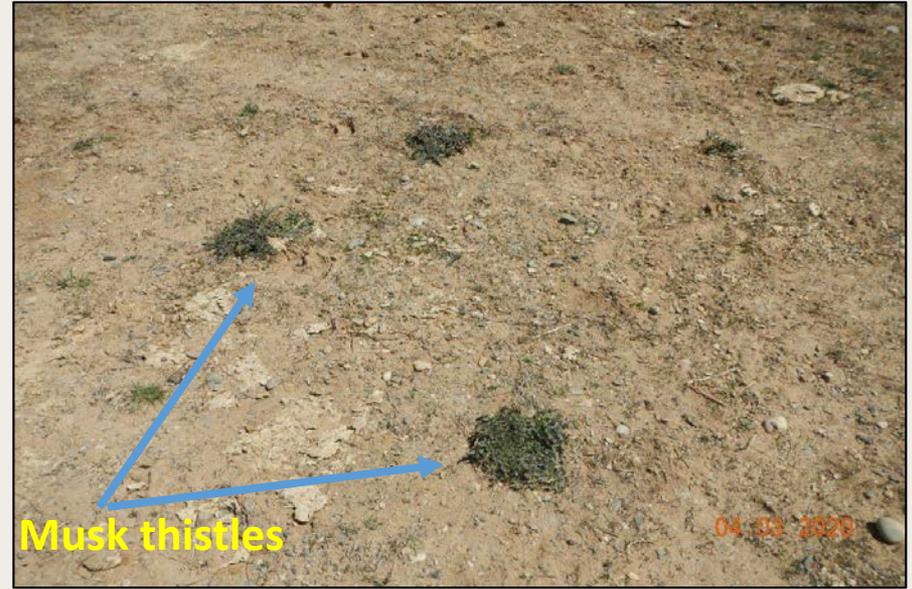
Photo 4. View of musk thistles within the project area.

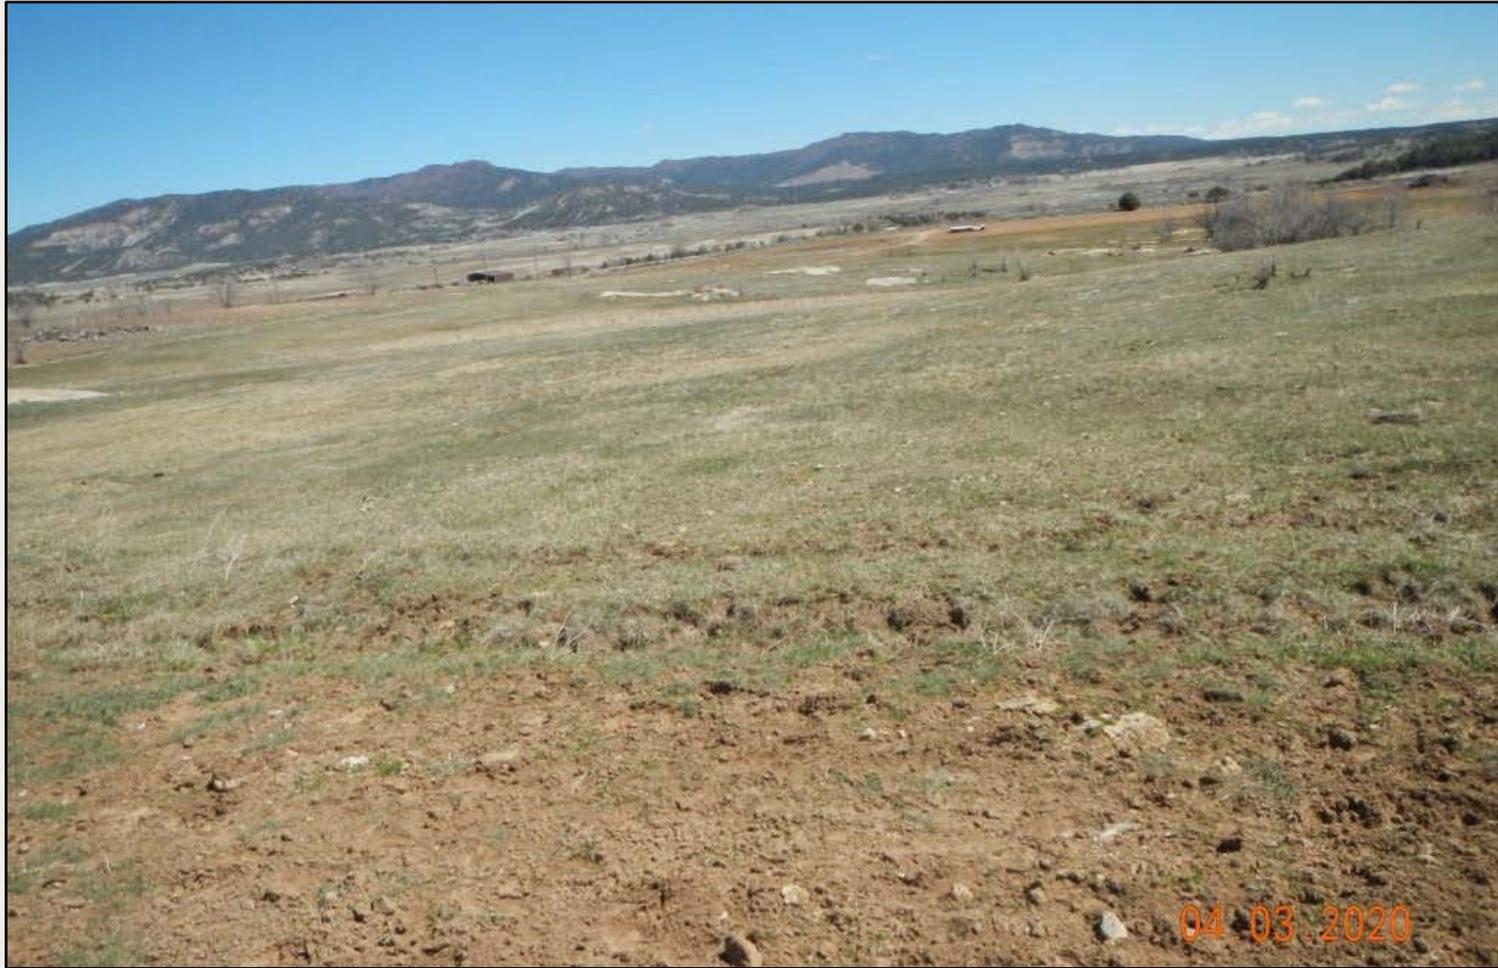
Photo 5. View of reference area vegetation, comprised of irrigated grass field, largely in grazed condition.
