Inspection Photos

API: 071-07204

Operator: TIMBER CREEK OPERATING

Inspection Date: 4/6/2020

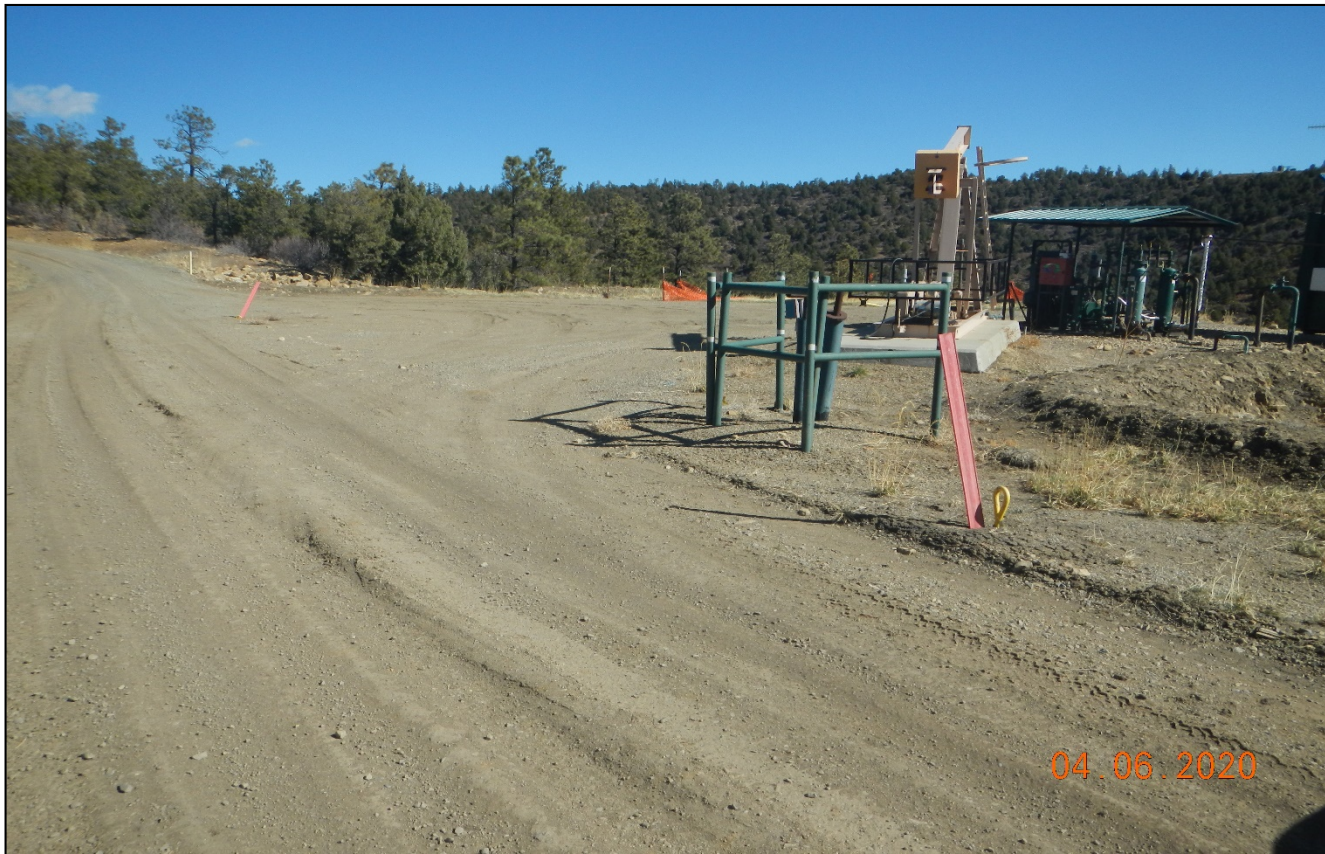
Photo 1. Facing northeast toward the location.

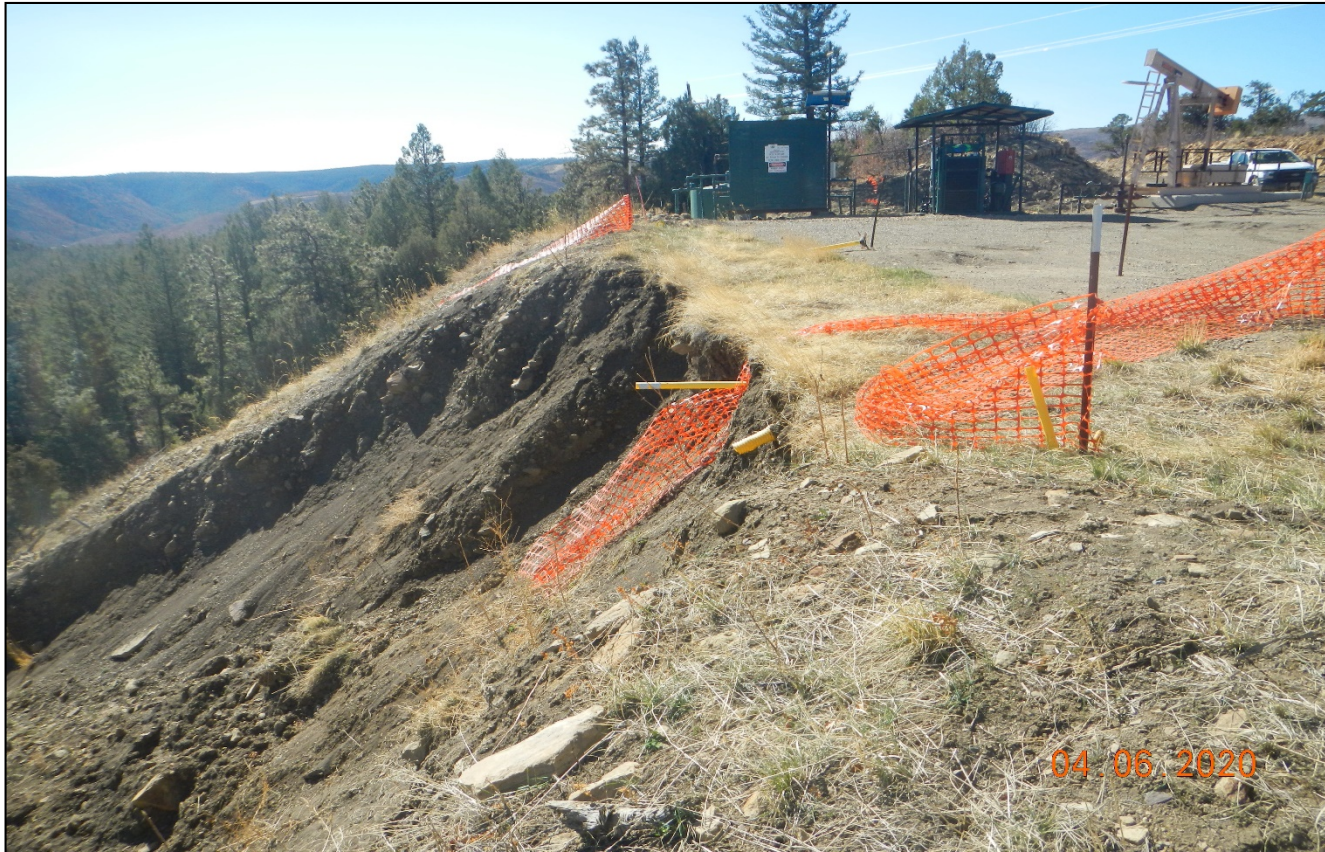
Photo 2. Facing south at the east side of the location. The area of soil slough has not been repaired. Safety fencing was installed in this area but is now degraded. Corrective action of previous inspection was not completed.

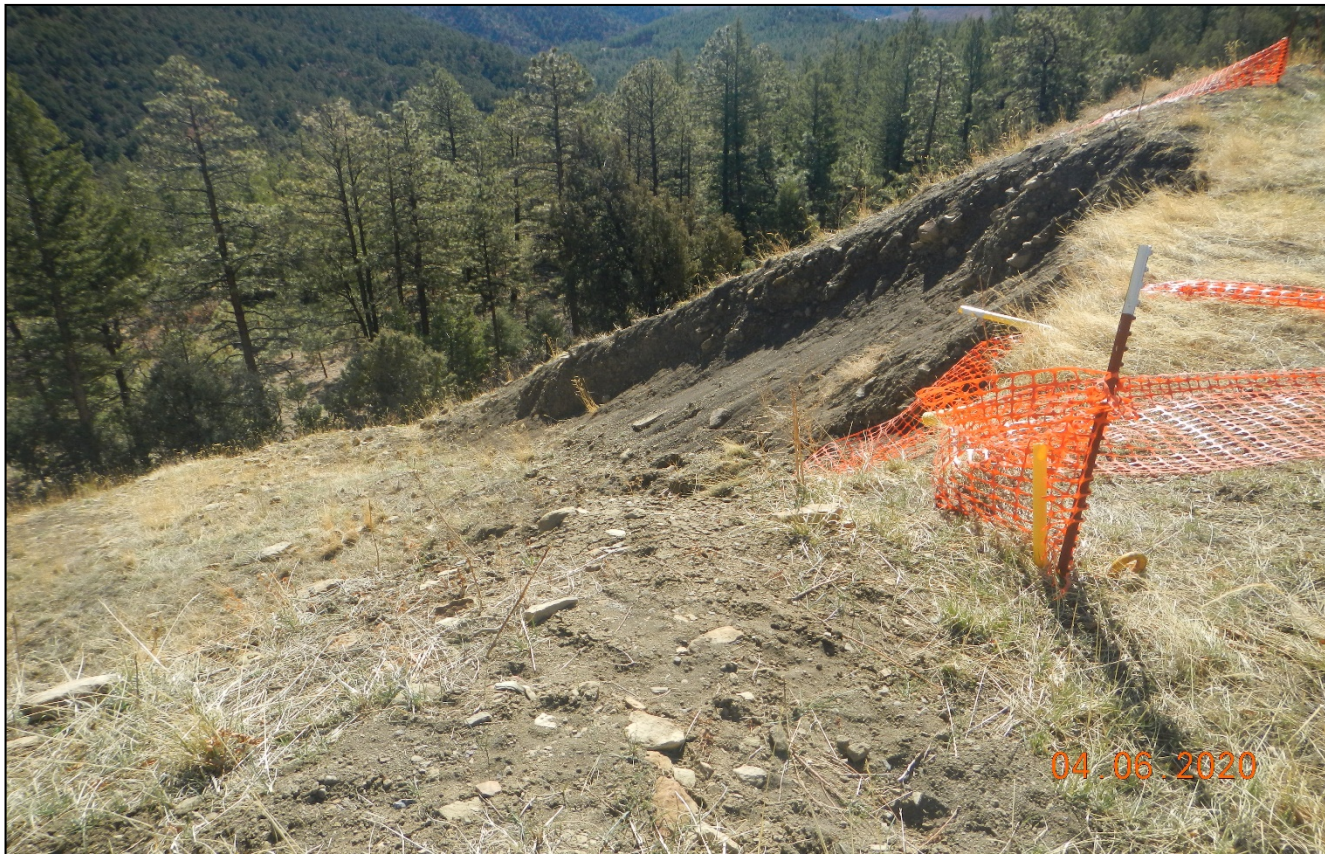
Photo 3. Facing southeast toward the fill slope which has sloughed.

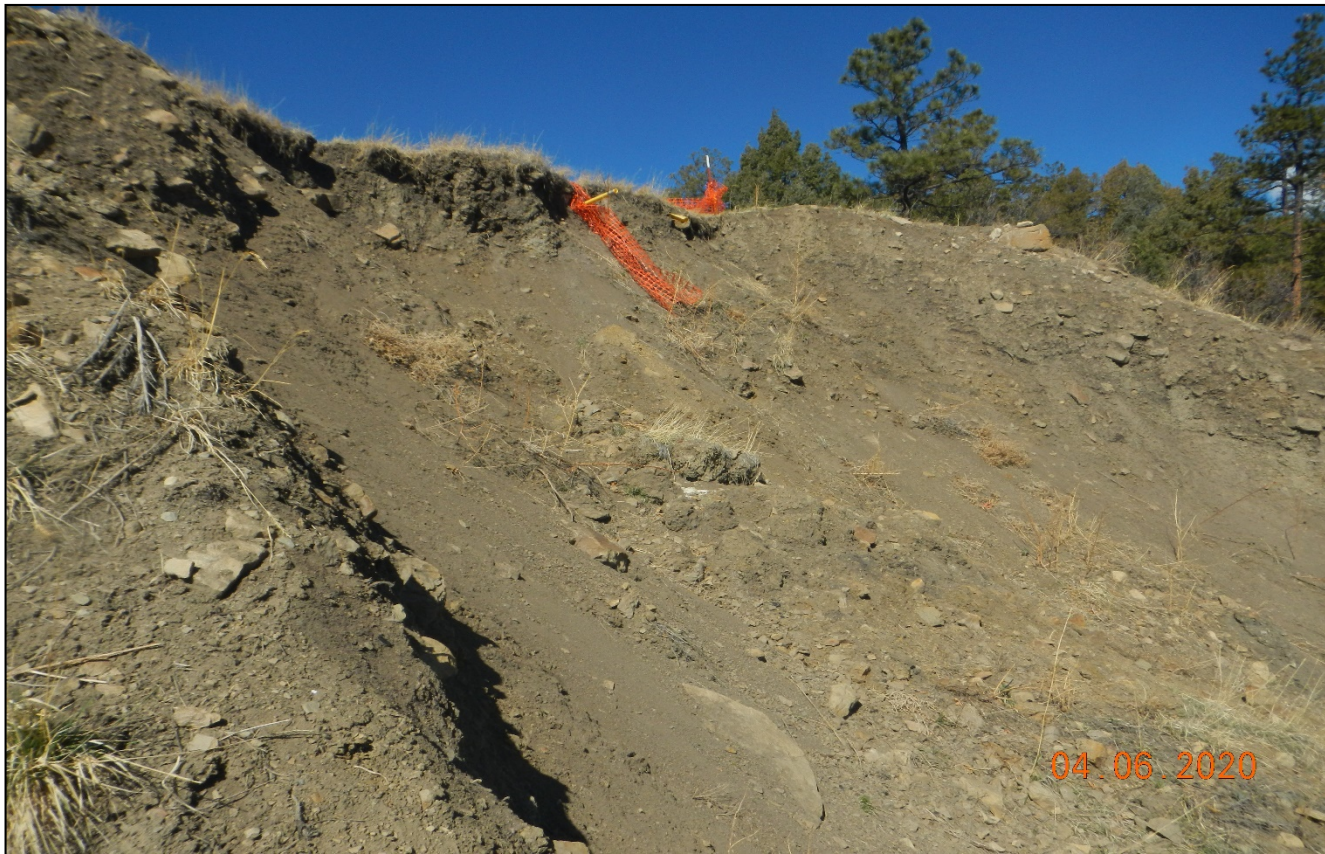
Photo 4. Facing toward the fill slope where soil sloughing occurred.

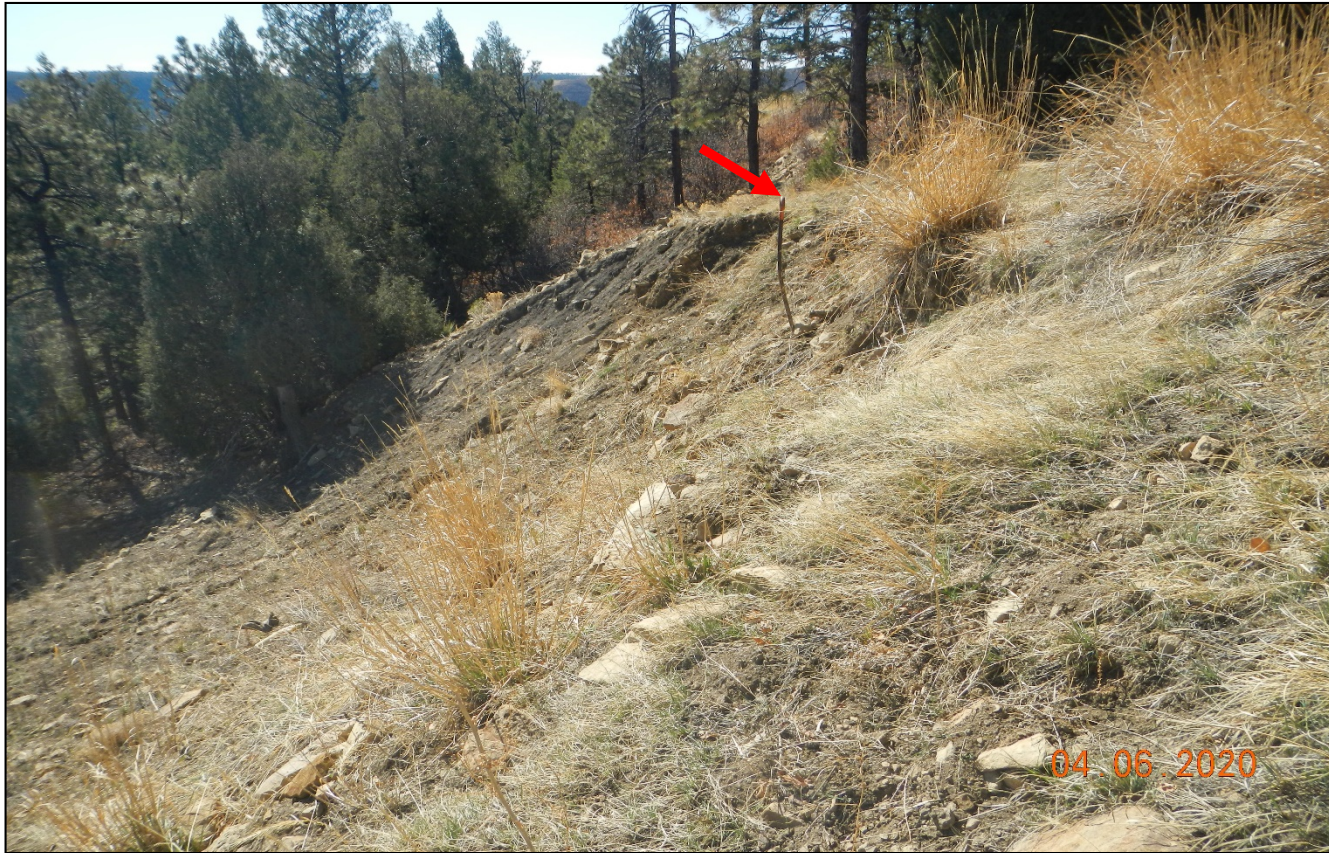
Photo 5. Facing toward the southeast side of the location. This area has also sloughed which has exposed the guyline anchor shown at arrow.
