# Inspection Photos

Two E Ranches 1 & Aloysius C34-32D

Location ID: 317659

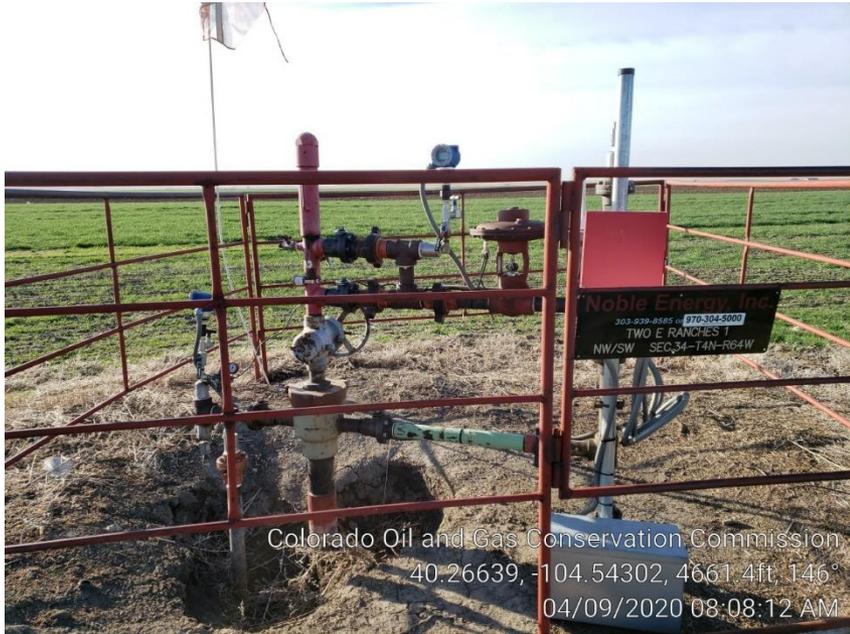
Photo #1 Well & Sign

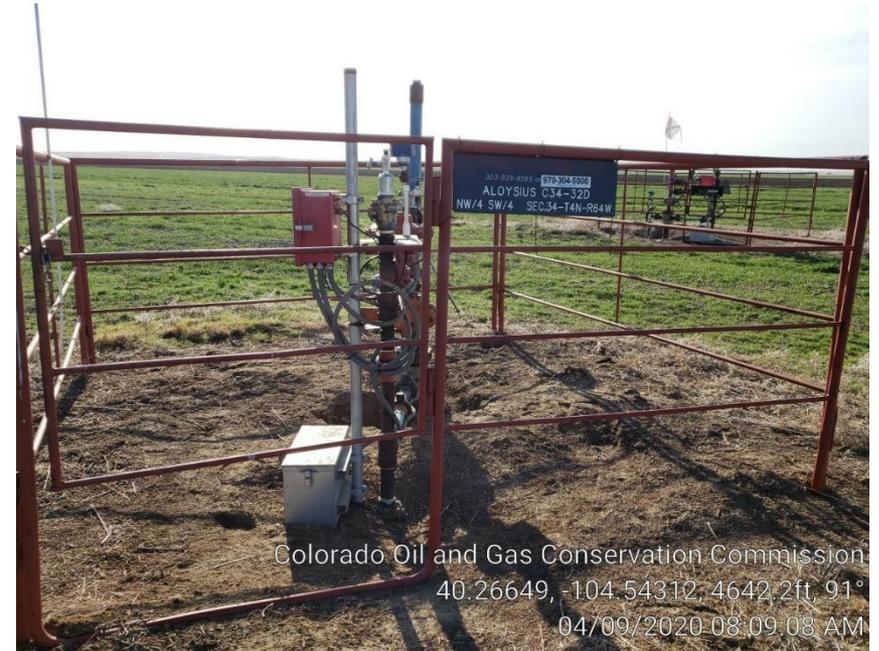
Photo #2 Well & Sign

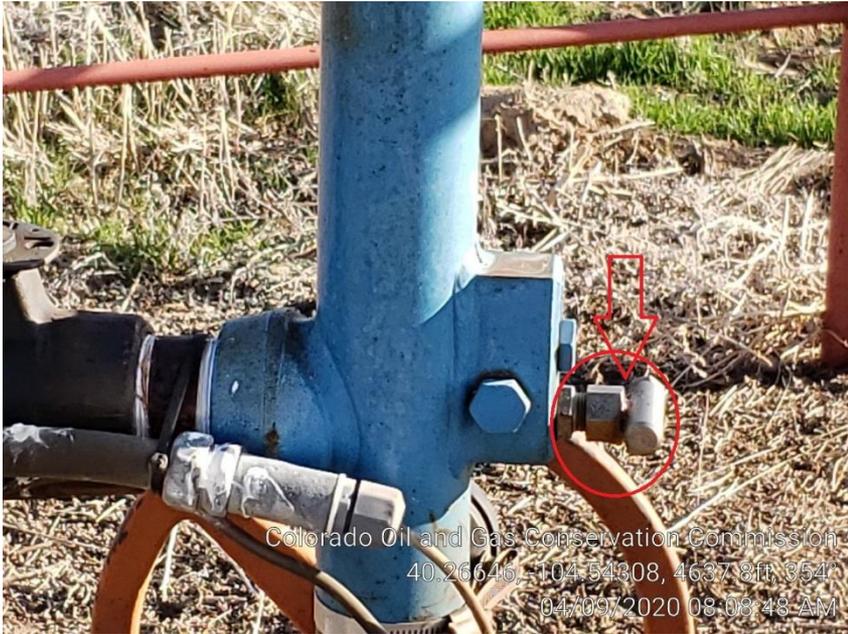
**Photo #3 Lubricator plunger catcher is leaking**

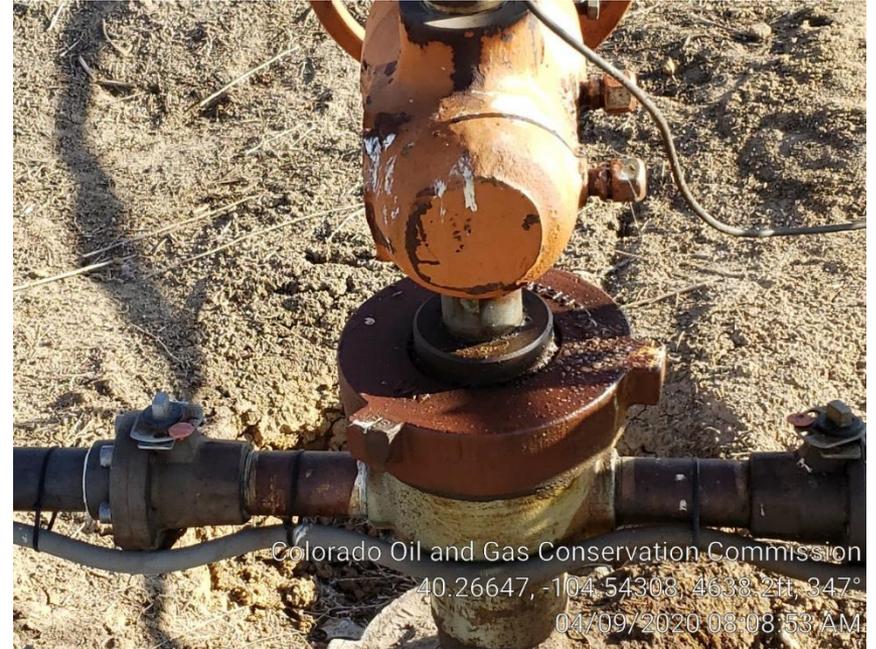
**Photo #4 fluid on surface casing from leak**
