Inspection Photos
Location Name: Graham Unit #2
Location ID:336415

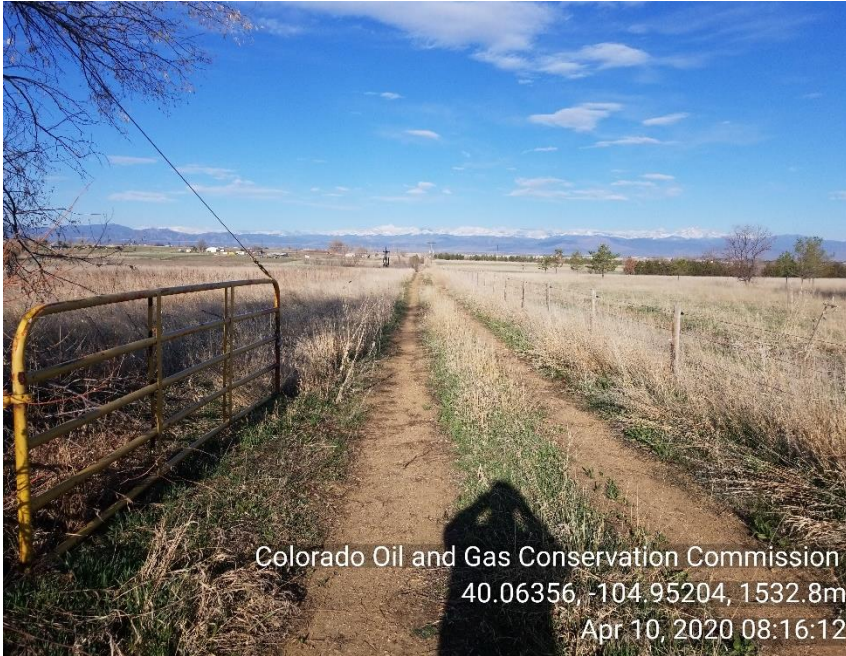
Photo 1 Access road over grown with dead weeds

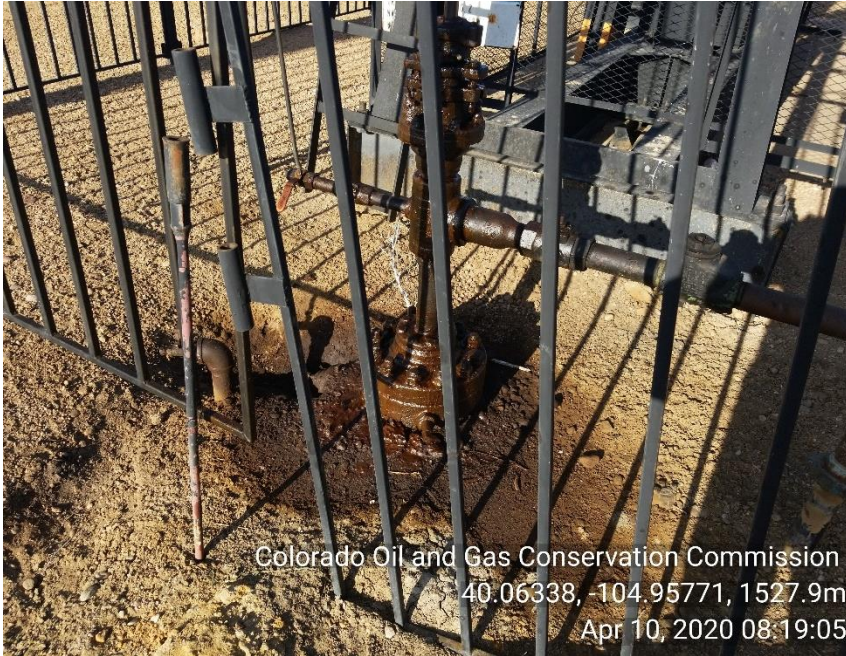
Photo 3 Mechanical issue and stained soil around well head

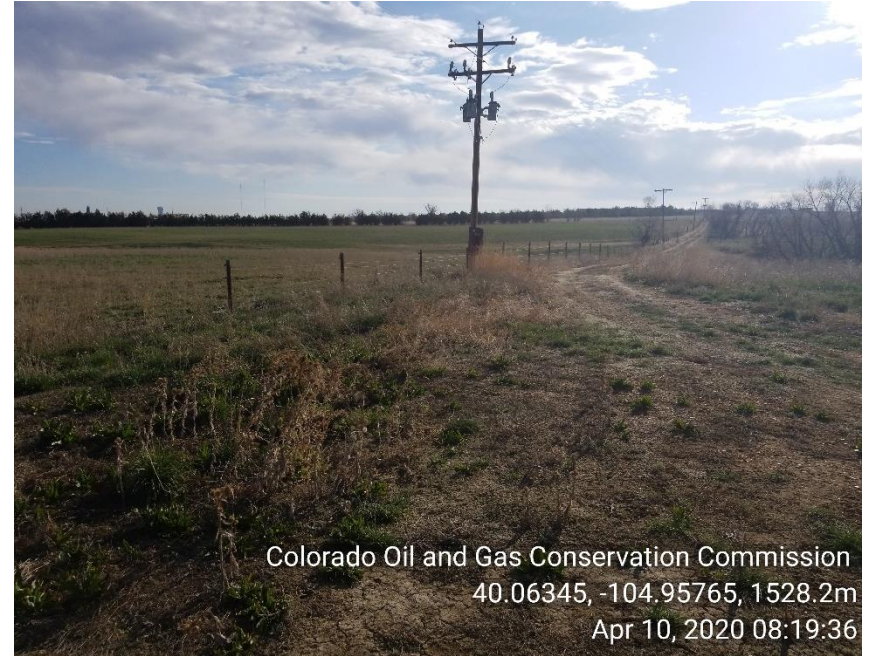
Photo 4 Debris: dead weeds on location and around electric breaker panel.
