Inspection Photos  
Operator: Logos Operating  
API#: 067-05469  
Date: 4/8/2020

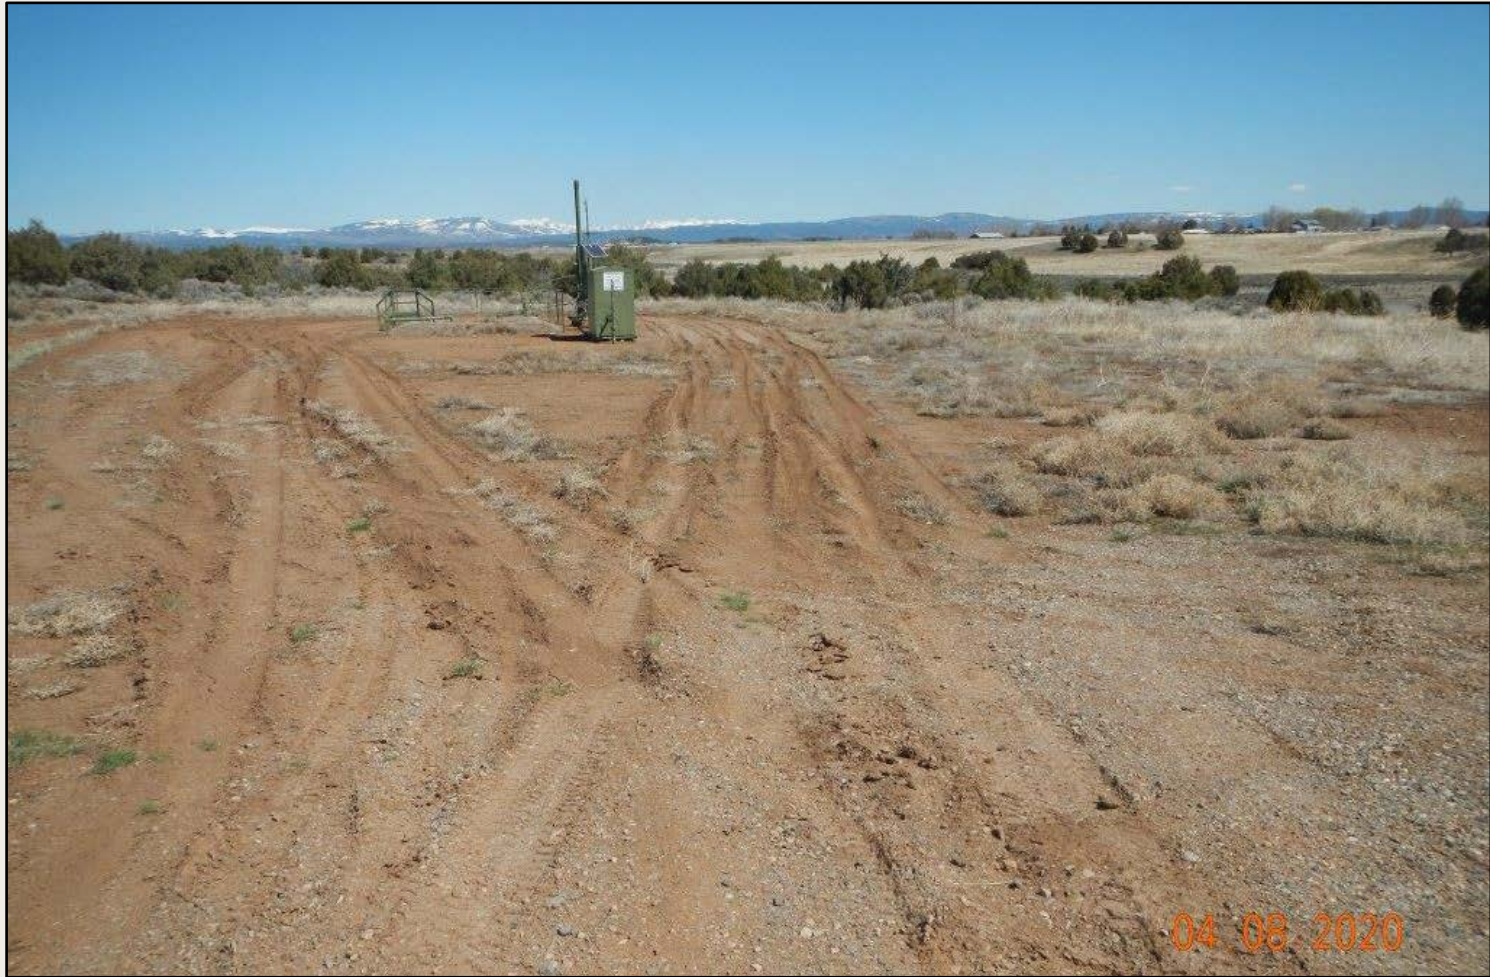
Photo 1. View of the project area from the well pad entrance facing center.

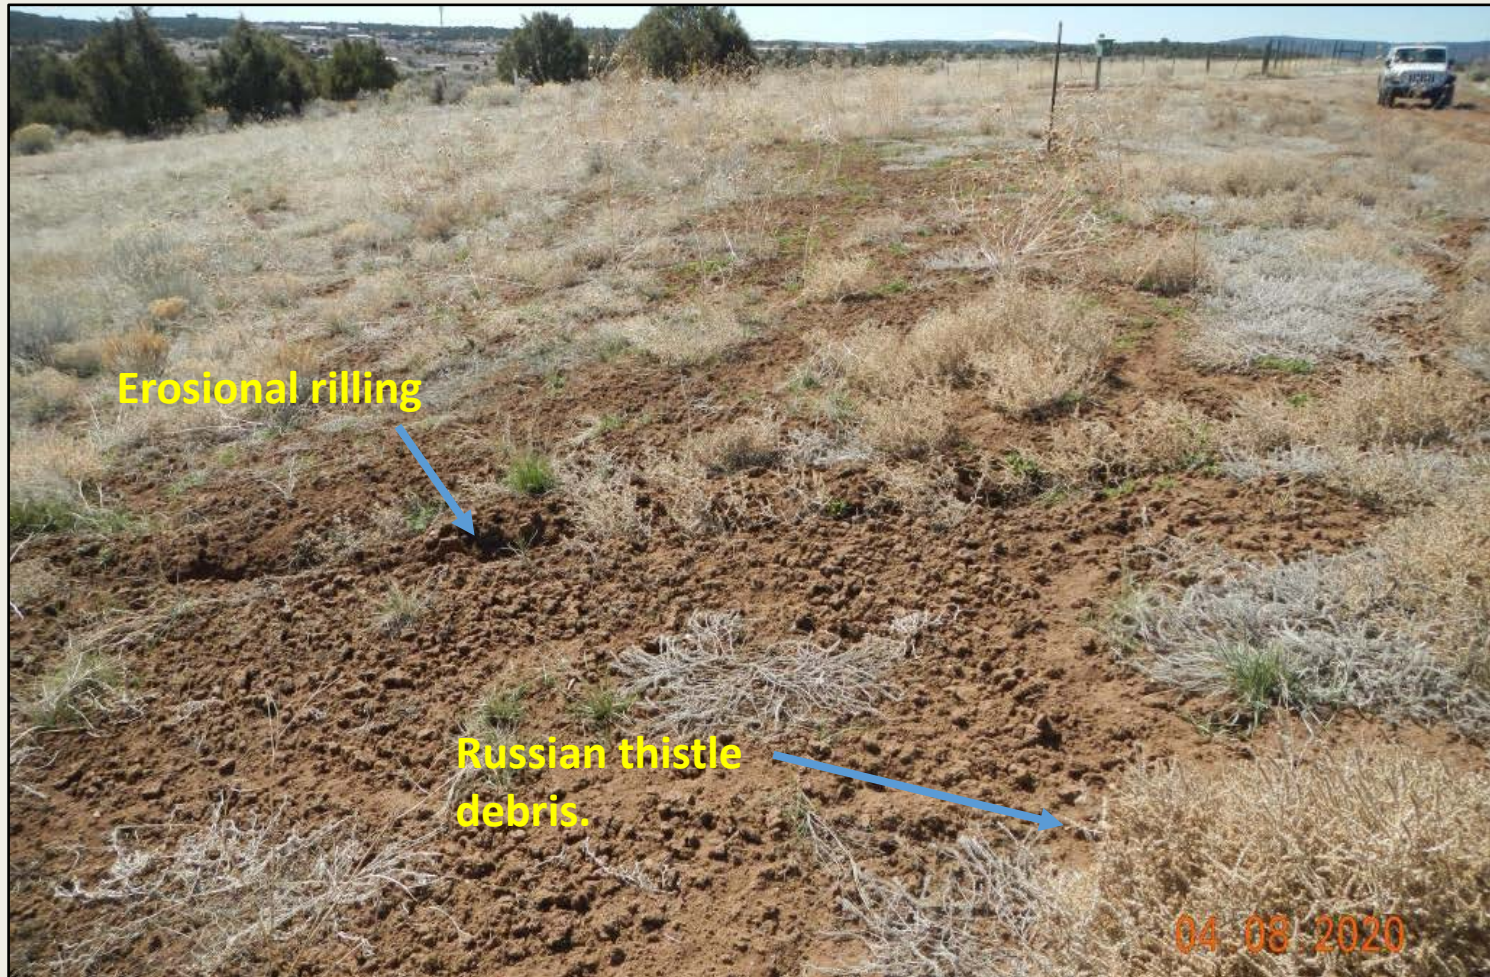
Photo 2. View of the eastern fill slope from the northeastern corner facing southward. Desirable vegetation is sparse and area is weedy. Little desirable vegetation present. Erosional rilling occurring in destabilized soils along the slope.

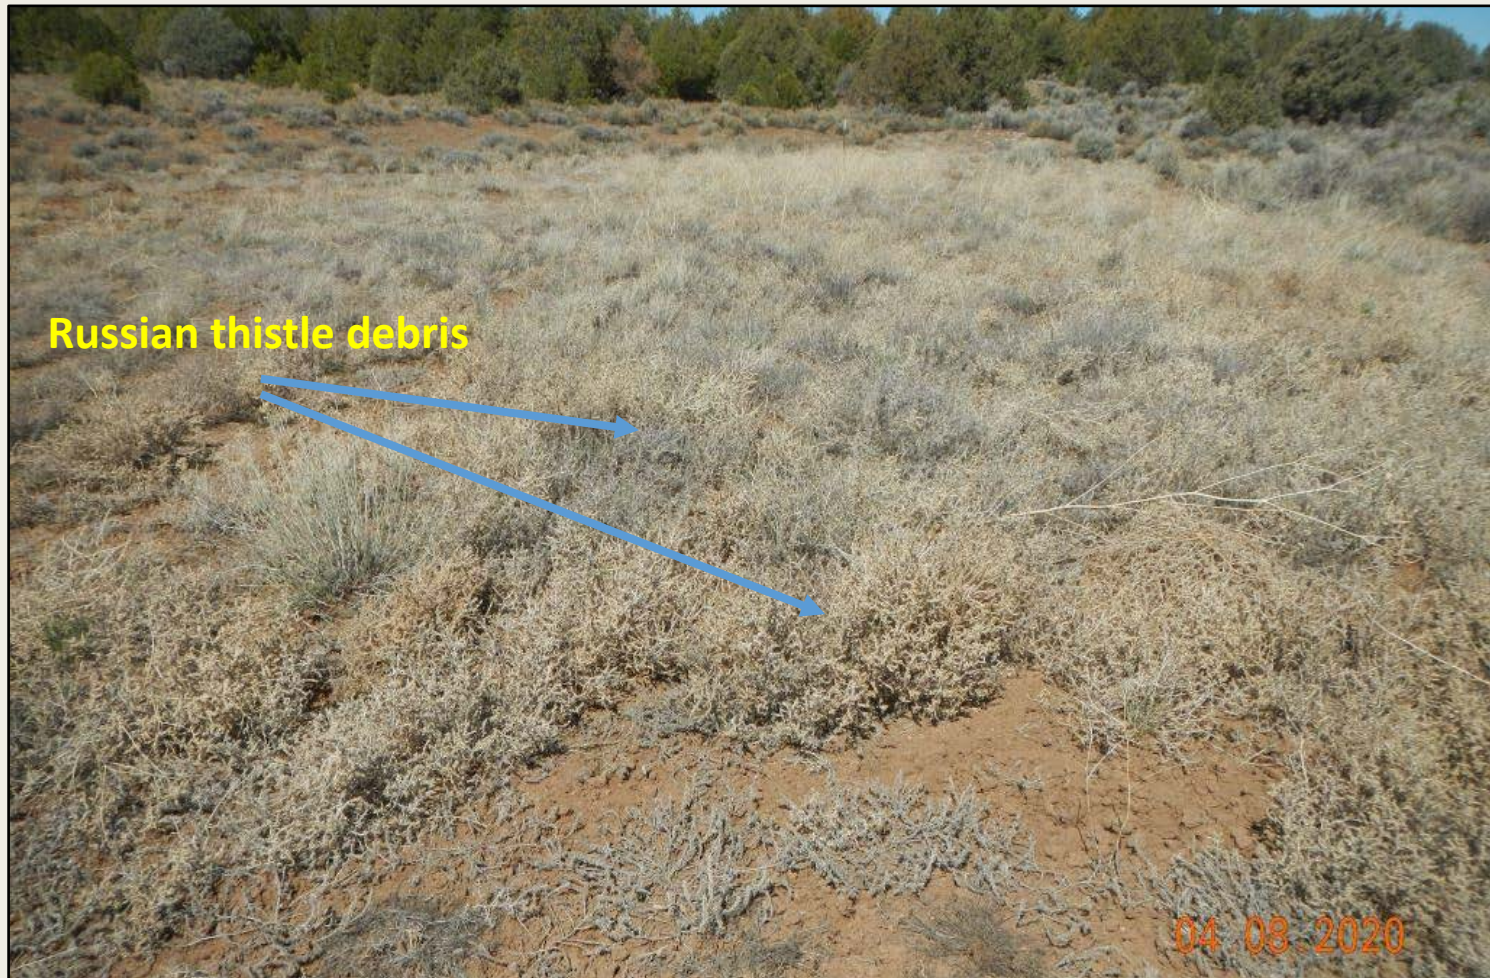
Photo 3. View of dense Russian thistle in the northern project area. Little desirable vegetation present.

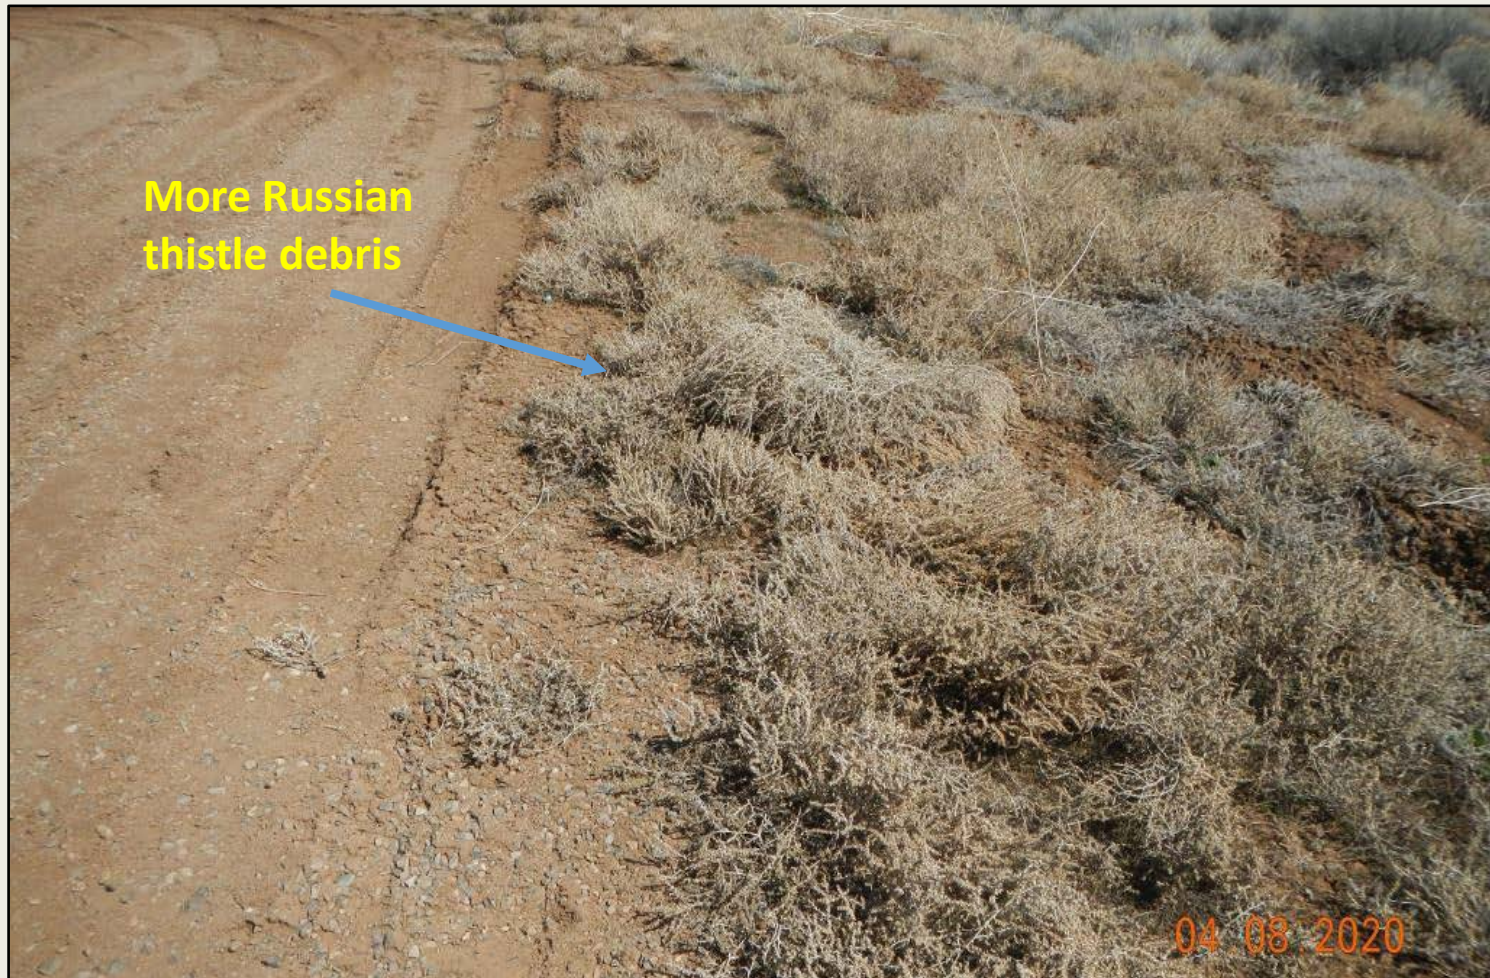
Photo 4. View of more Russian thistle debris along the eastern edge of the working area.

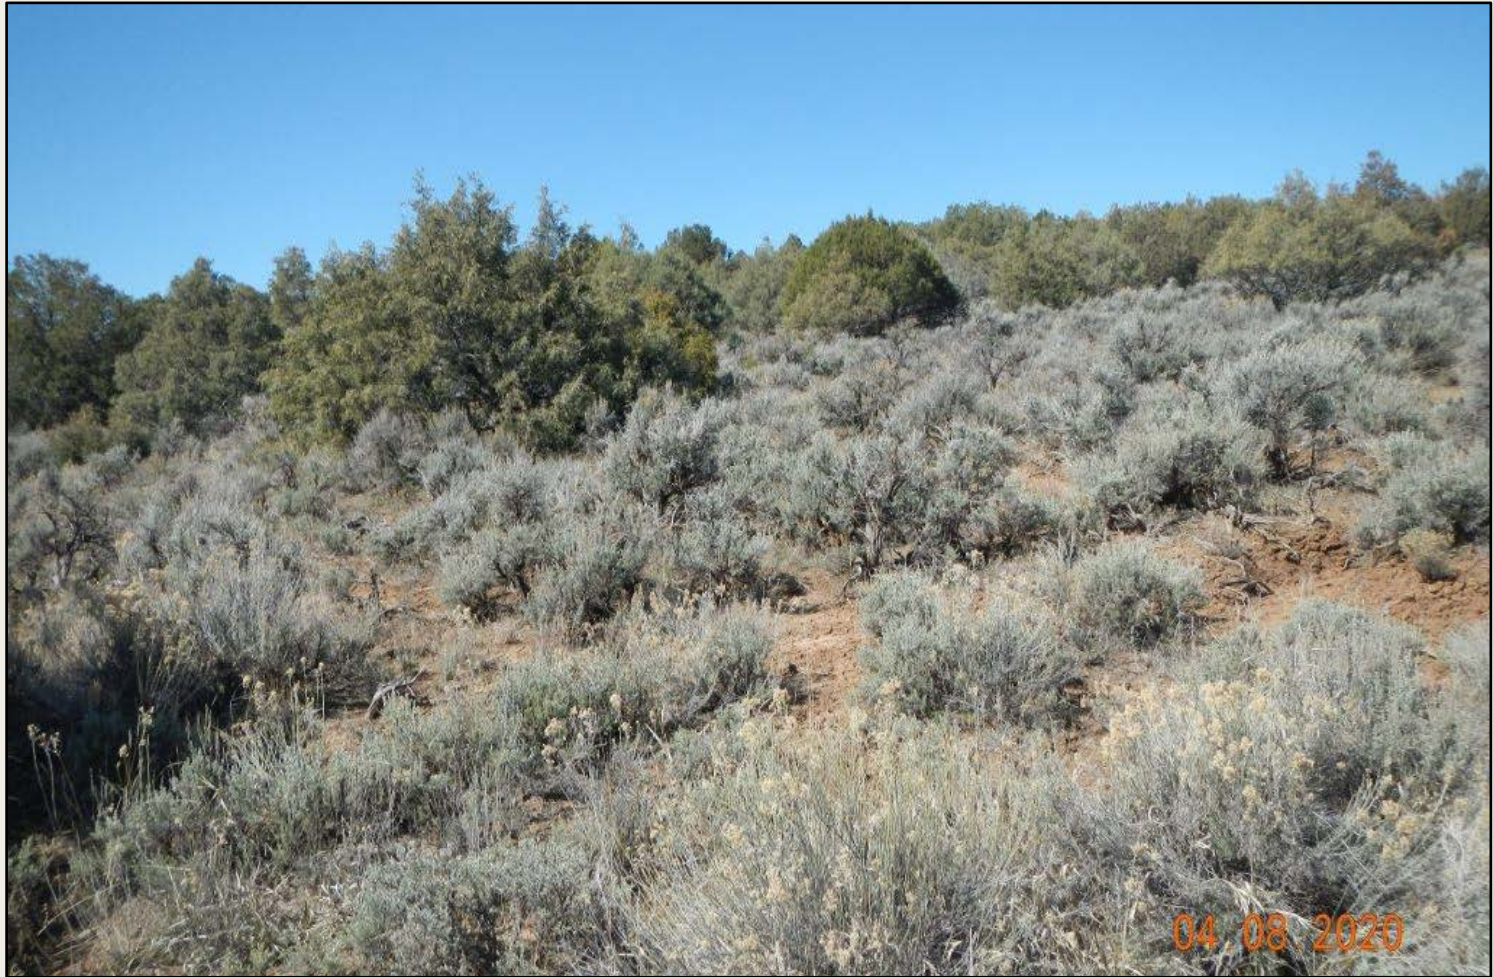
Photo 5. View of reference area comprised of open pinyon-juniper woodland with sagebrush shrubland understory.
