Inspection Photos
Operator: Logos Operating
API#: 067-08088
Date: 4/8/2020

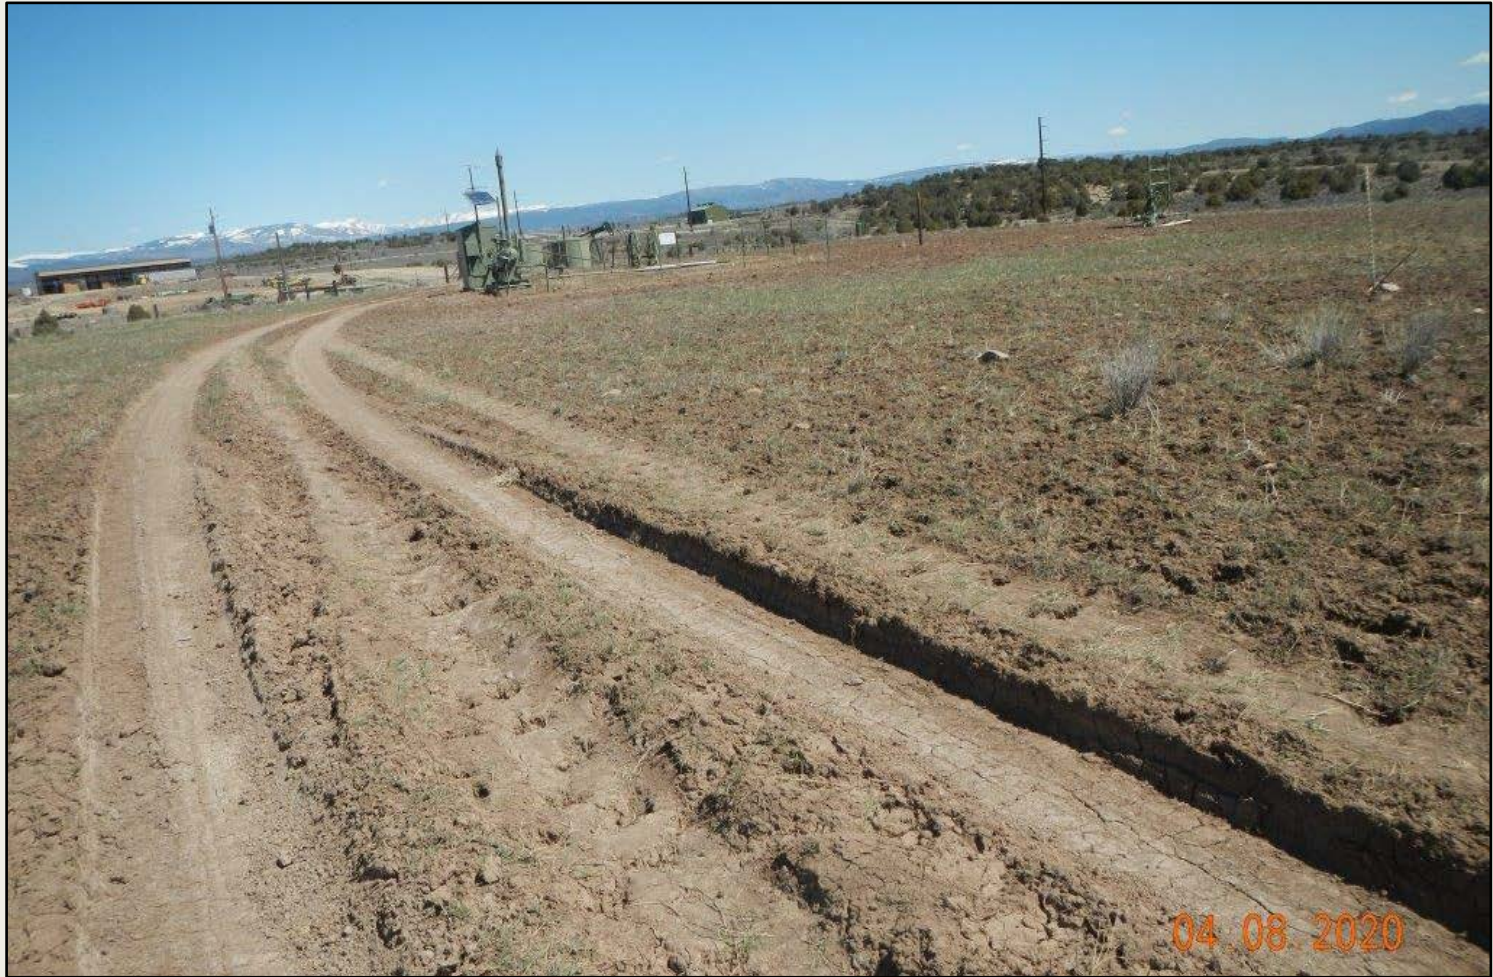
Photo 1. View of the project area from the northeastern corner facing center.

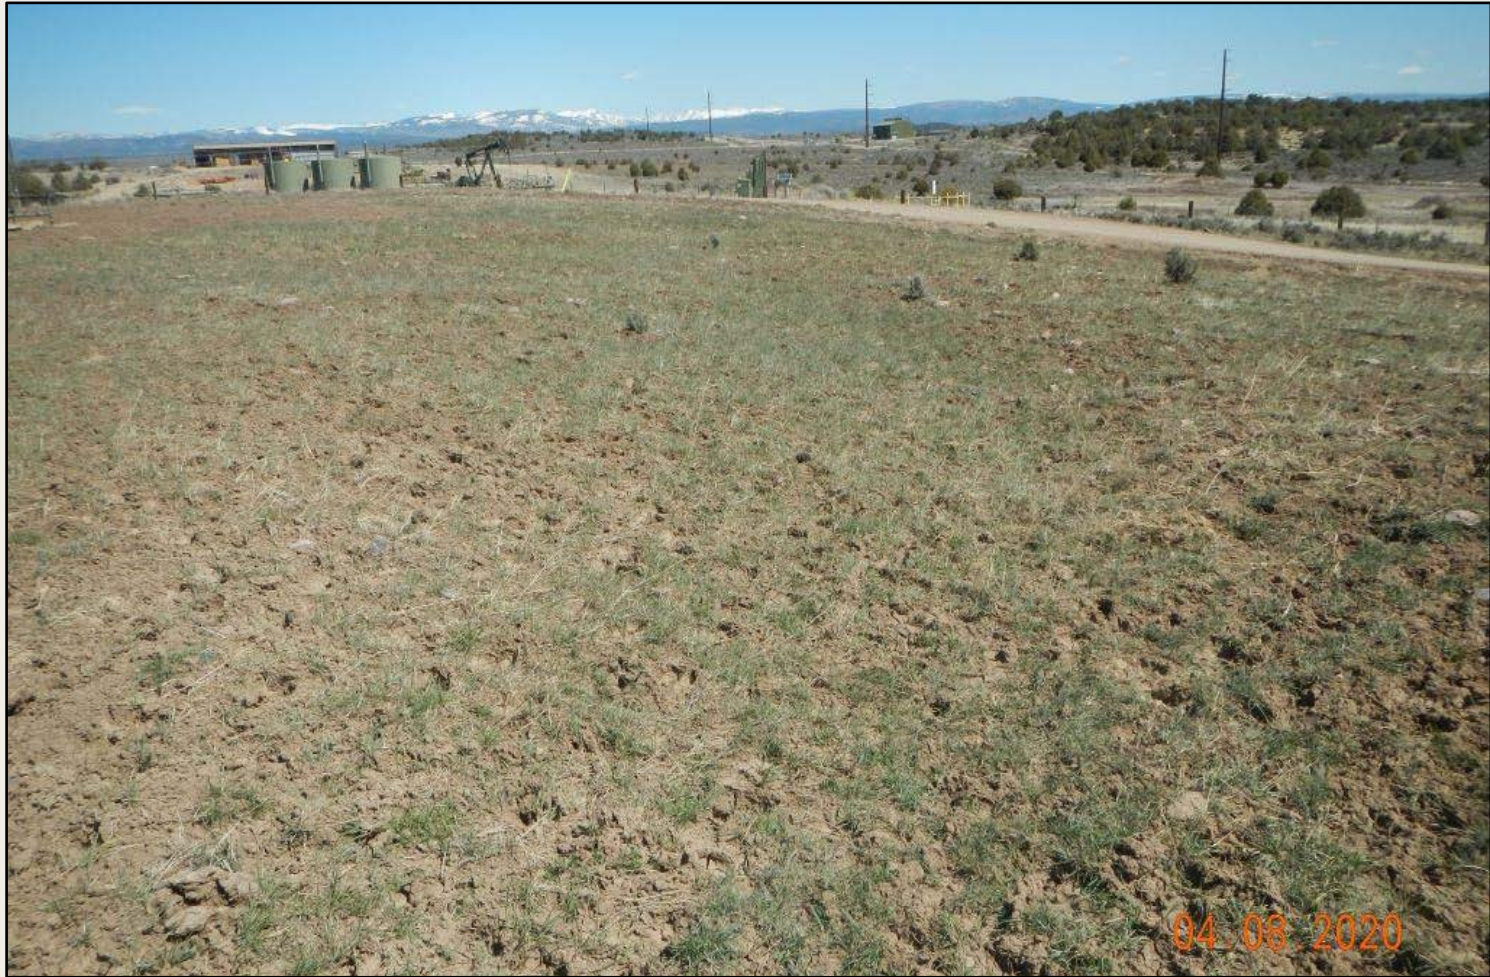
Photo 2. View of the eastern fill slope from the southeastern corner facing northward. Revegetation is in a grazed condition and comprised of western wheatgrass.

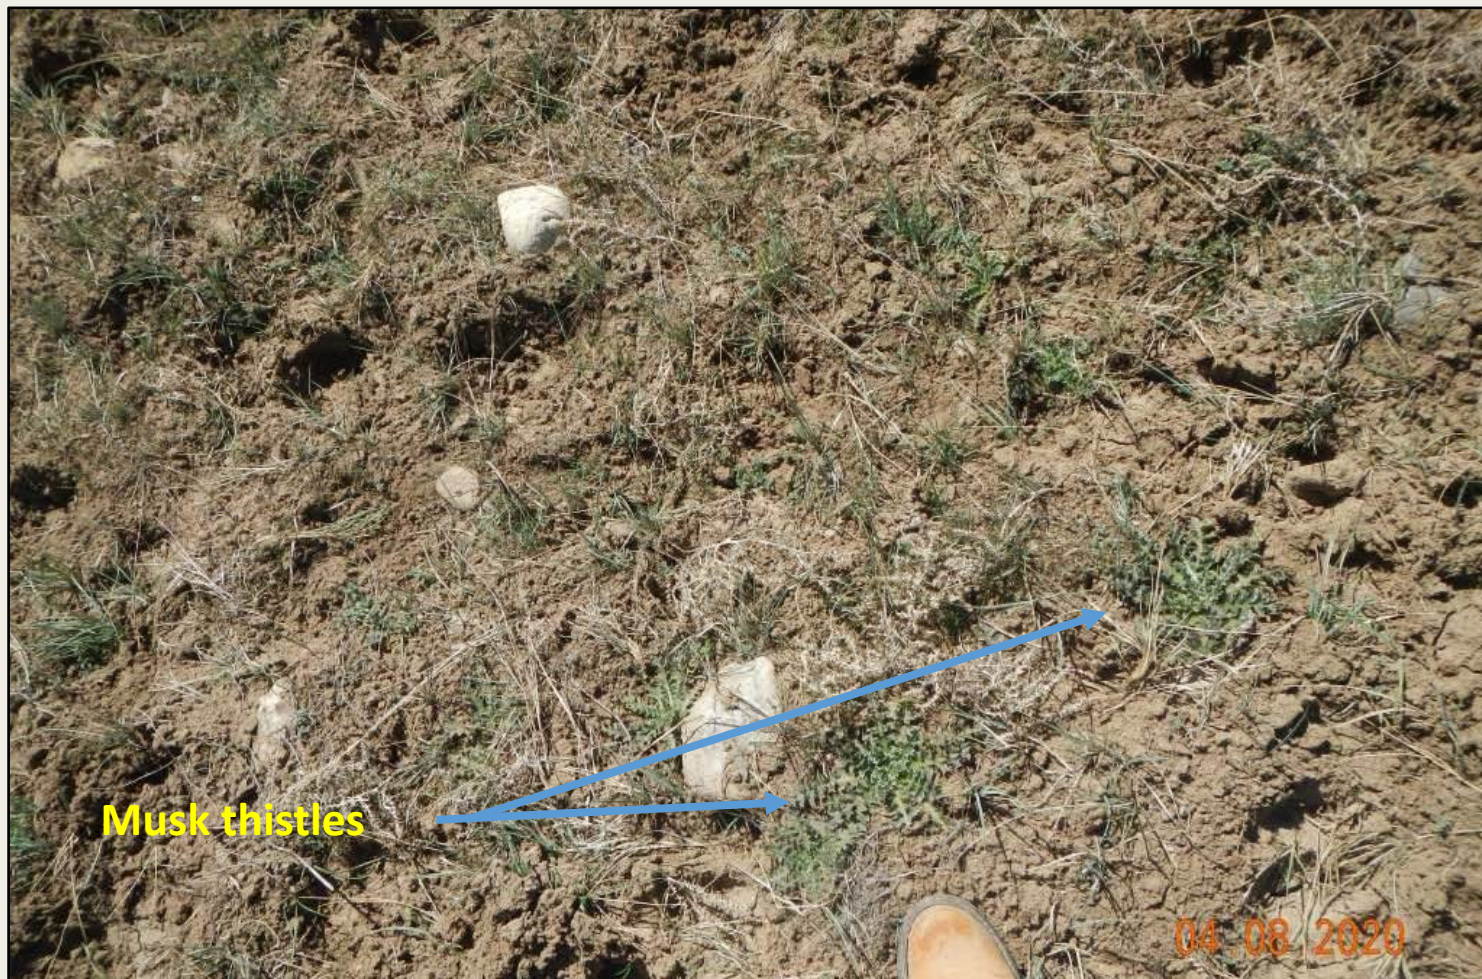
Photo 3. View of musk thistles within the interim reclamation area, approximately 50 individuals observed.

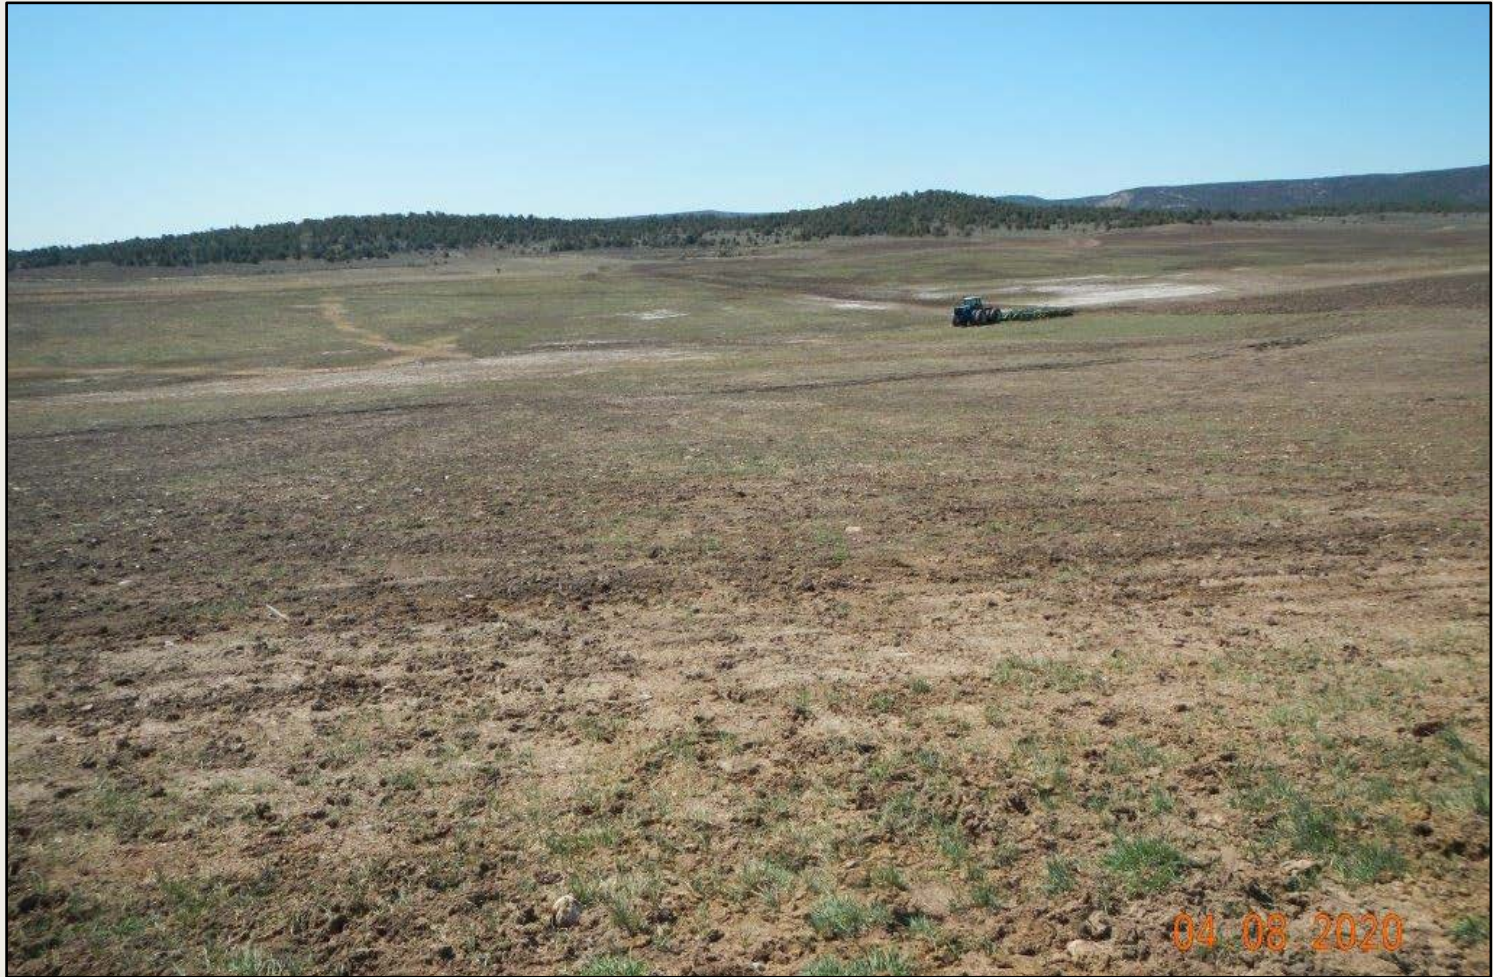
Photo 4. View of reference area, comprised of irrigated grass field in a grazed condition.
