Inspection Photos
Location Name: Kelsall 33-7 #4-4
API: 05-067-09880

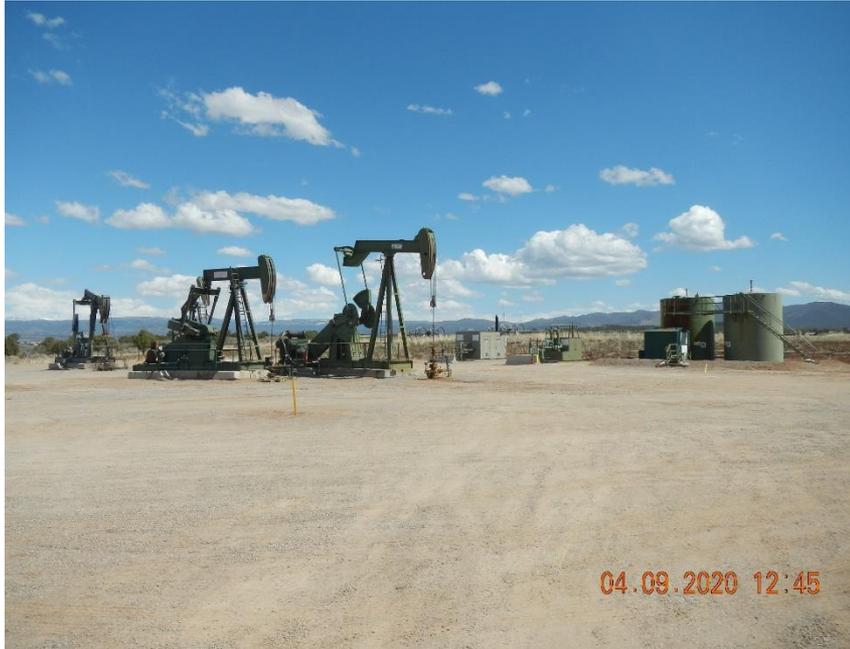
Kelsall 33-7 #4-4 location photo.

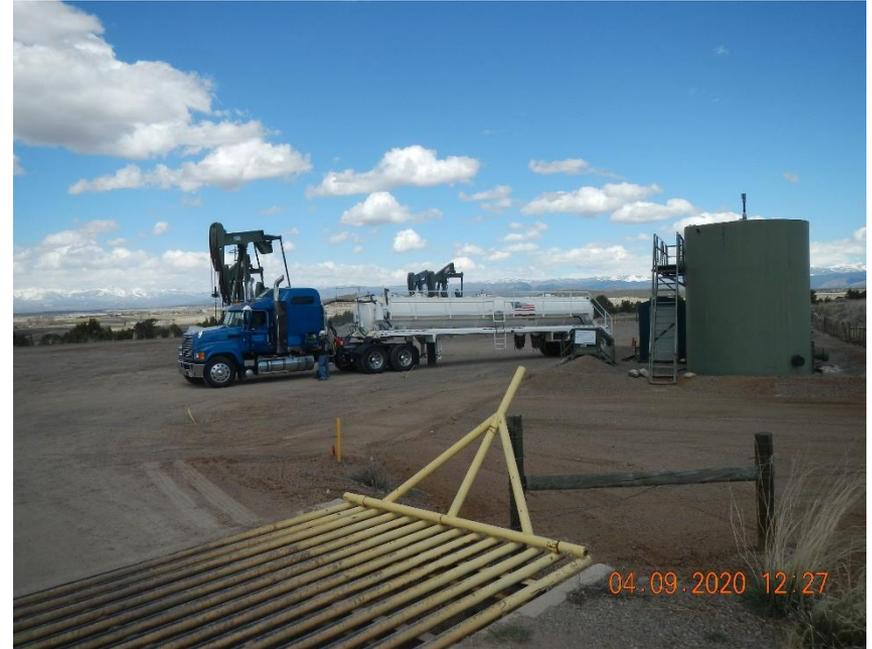
Overright Trucking water hauler on location during this inspection.

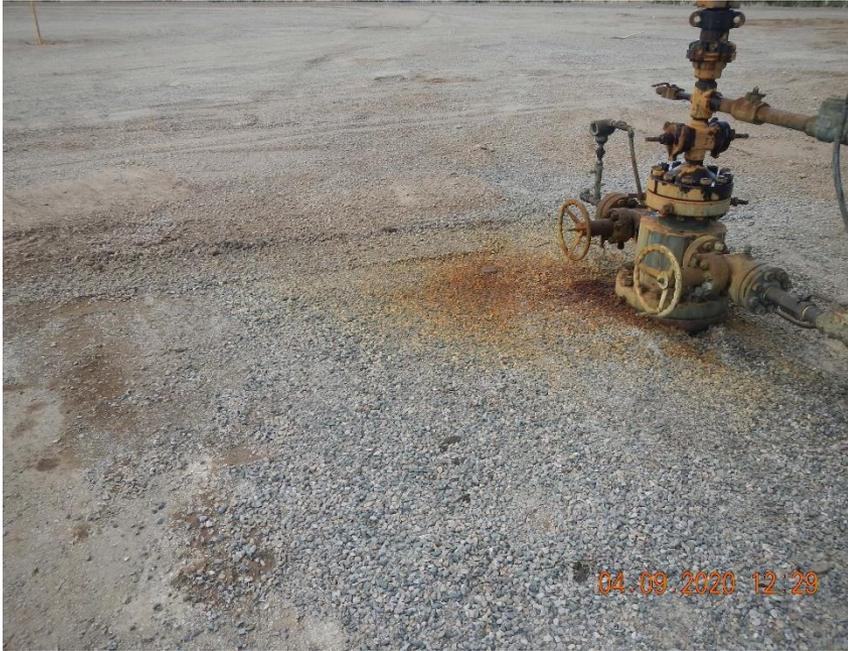
Wet and stained soil and gravel around #4-4 well head.

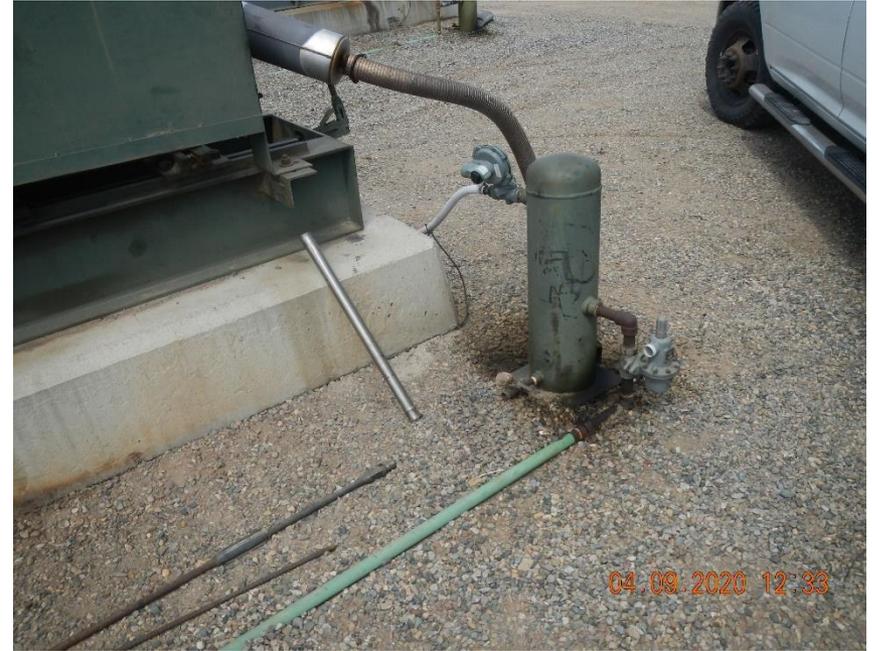
Stained soil near prime mover exhaust for #4-2.

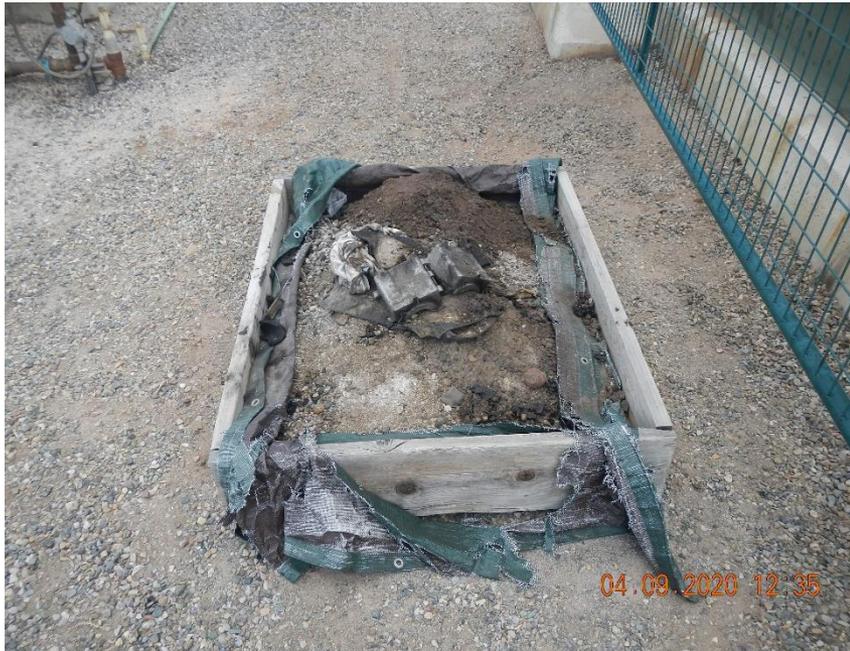
Stained soil on pallet near #4-2 pump jack.

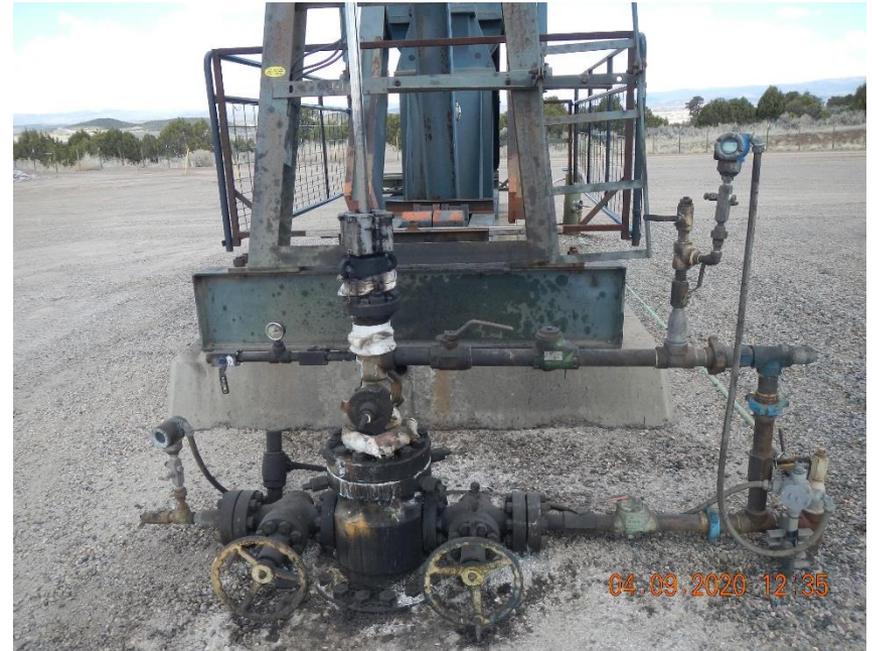
Stained well head and surroundings at #4-1.

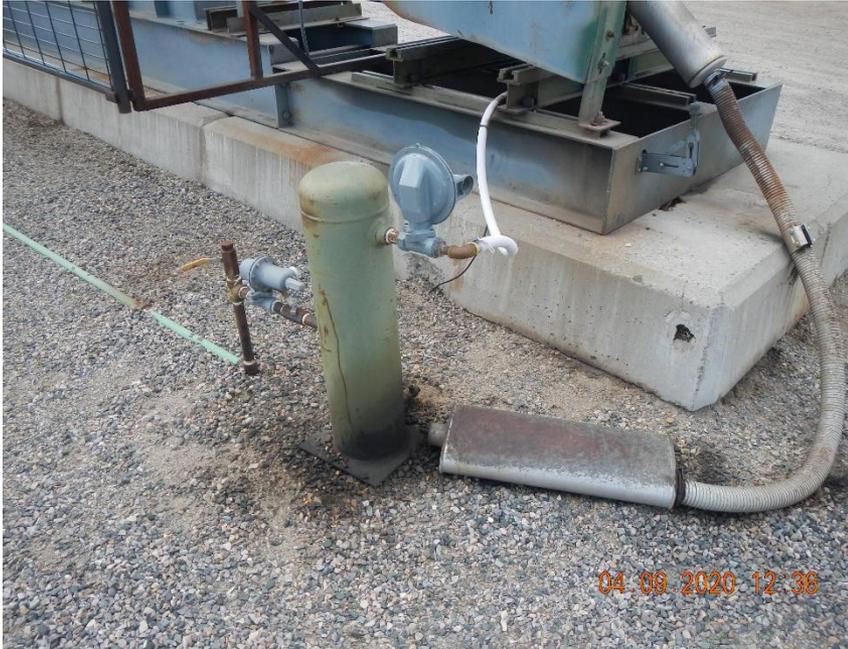
Stained soil at prime mover exhaust for the #4-1.

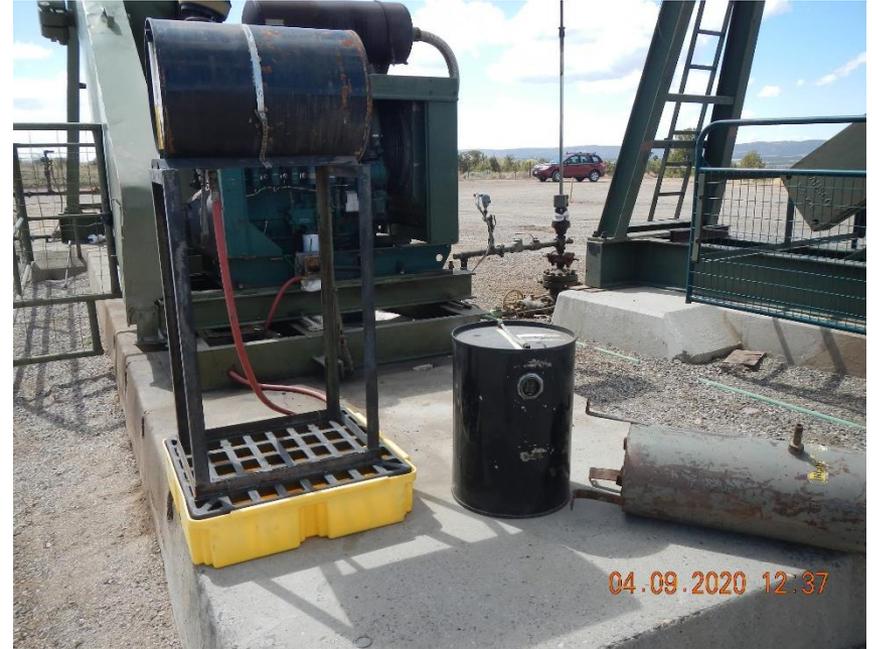
Unused lube oil container at #4-4.

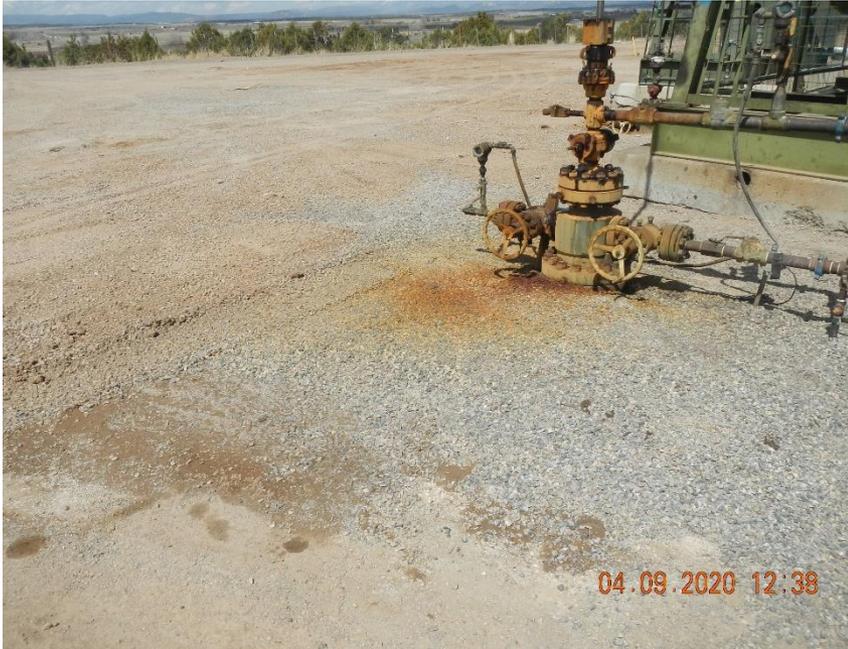
Wet and stained gravel near the #4-4.

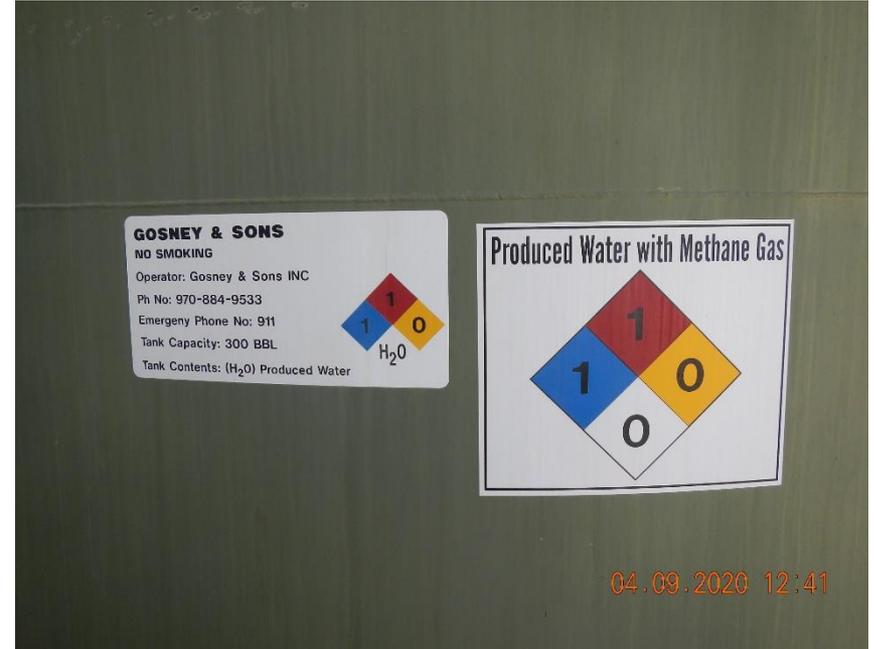
Previous operator listed on tank label.

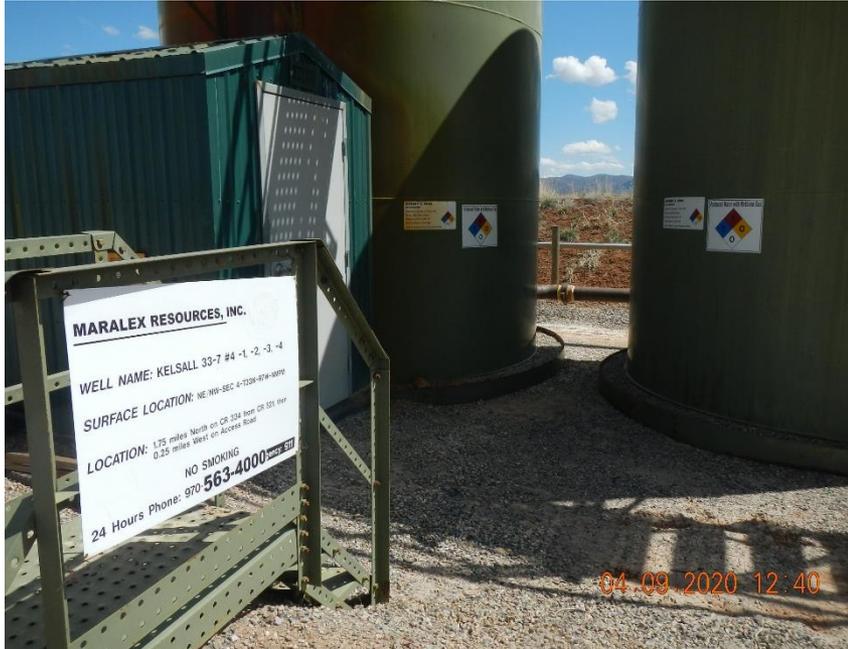
Tank battery sign mounted to stairway railing.

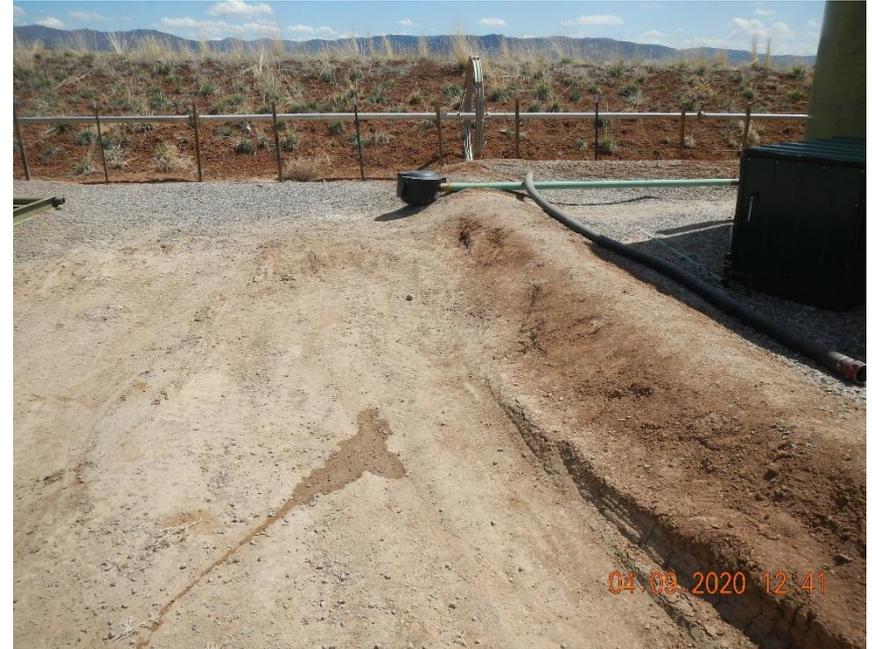
Produced water spilled while disconnecting transfer hose.

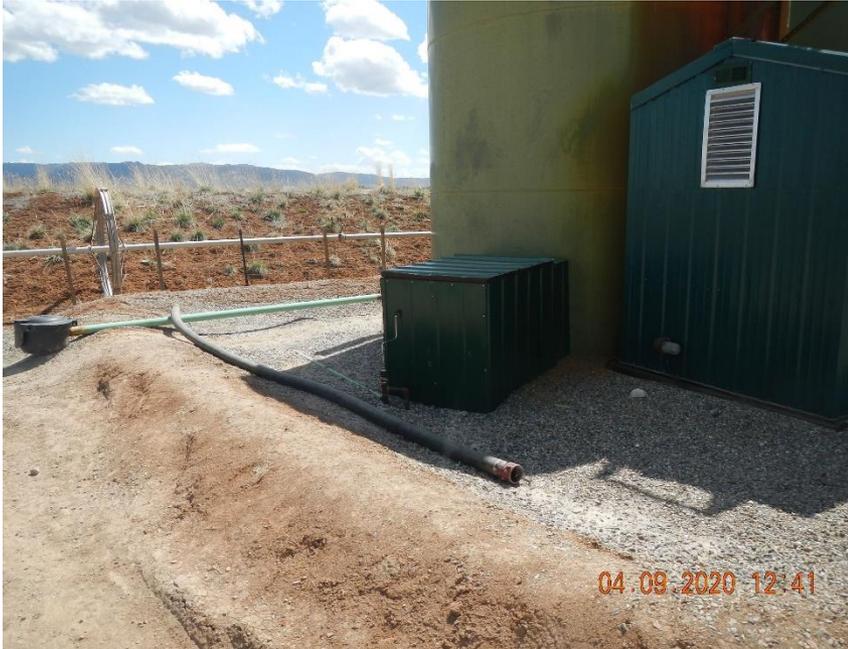
Hose stored in secondary containment for tank battery.

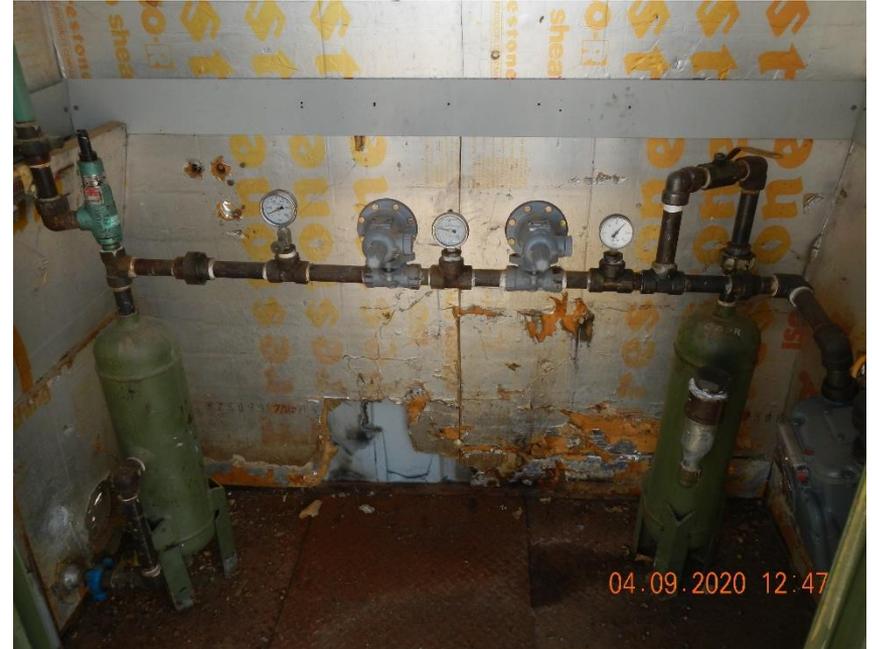
Domestic tap #463853.
