Inspection Photos

4/09/2020

Operator: CAERUS PICEANCE LLC # 10456

Location ID: 448472

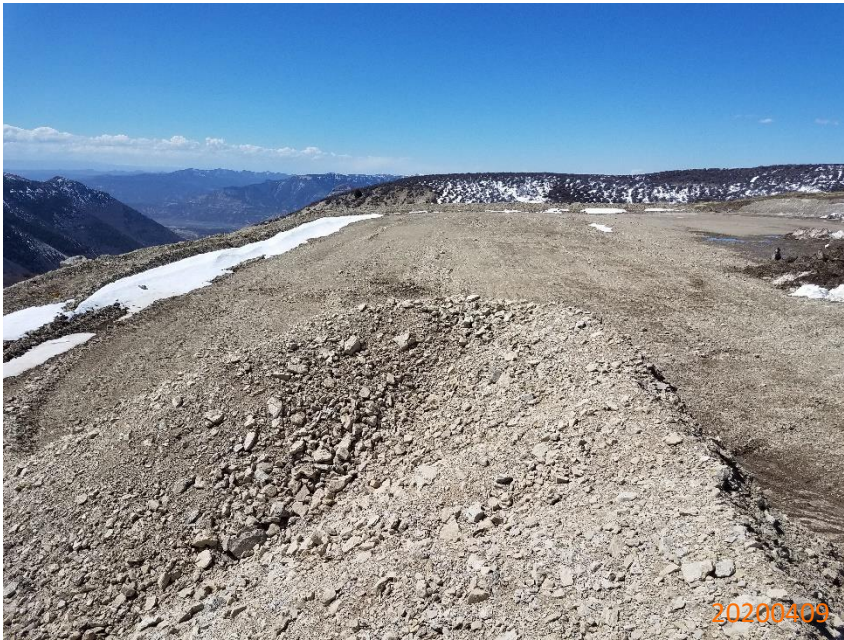
Photo 1: Photo taken from the southern end of the Location, facing southwest. Photos 1-4 provide an overview of the Location from southwest, west, northwest, to north. Photos show large areas of the Location that are not needed for production activities have not been reclaimed in accordance with 1003 rules.

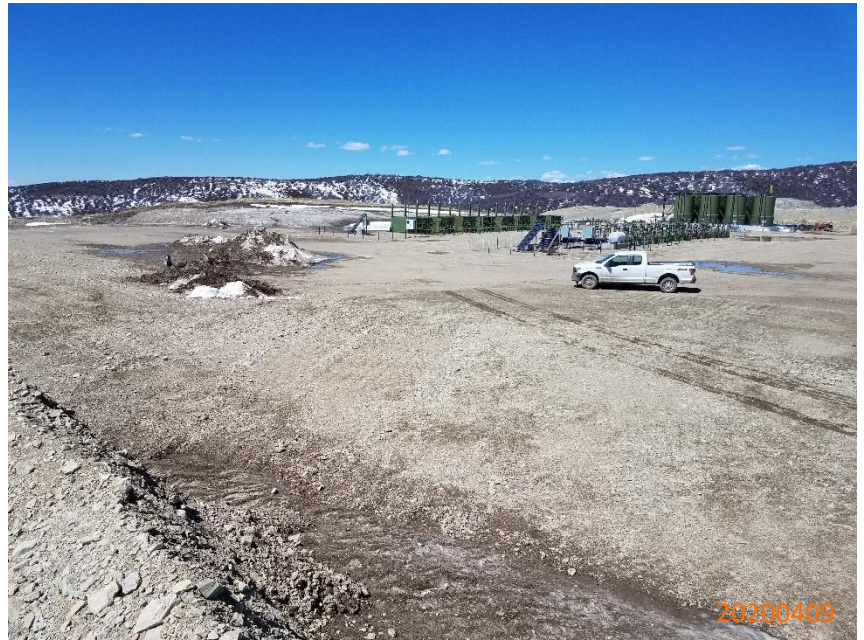
Photo 2: See comments under photo 1.

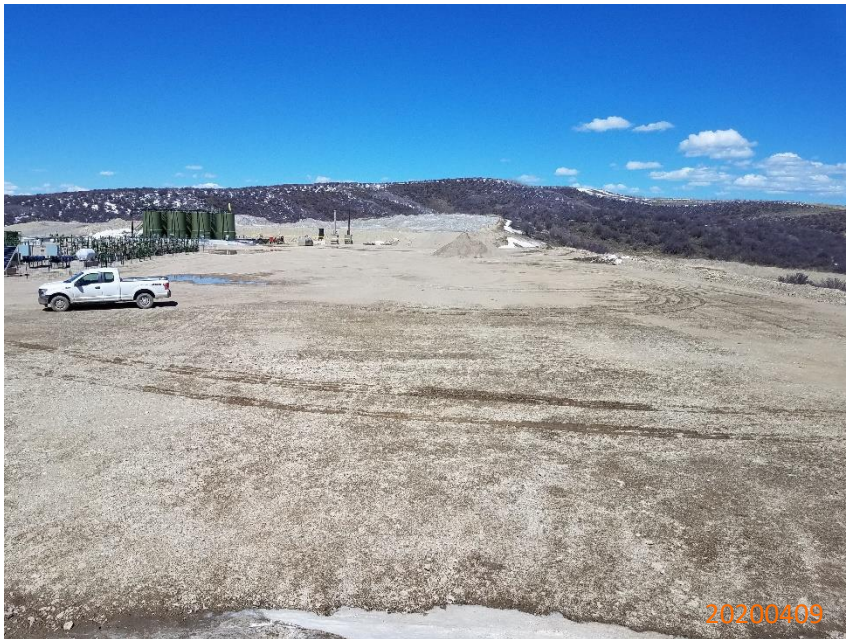
Photo 3: See comments under photo 1.

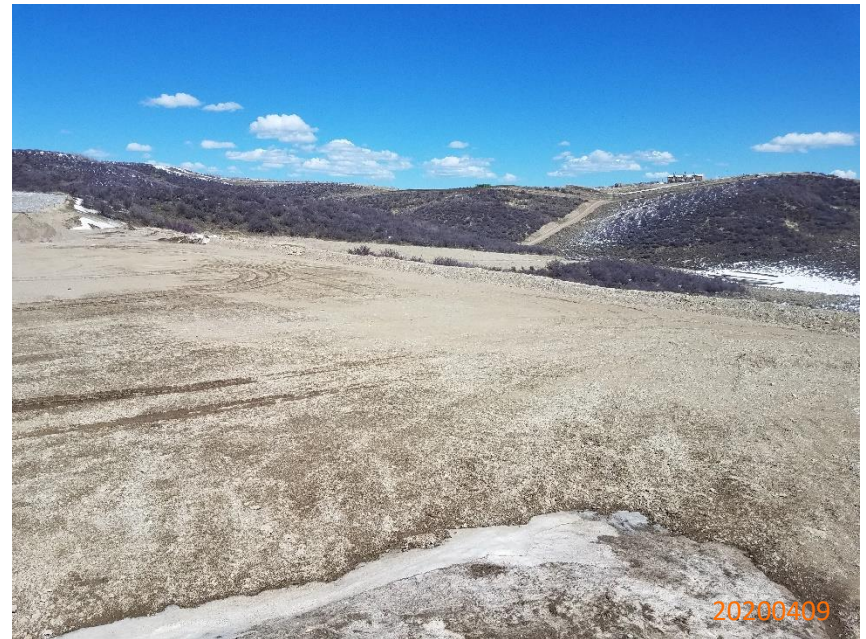
Photo 4: See comments under photo 1.

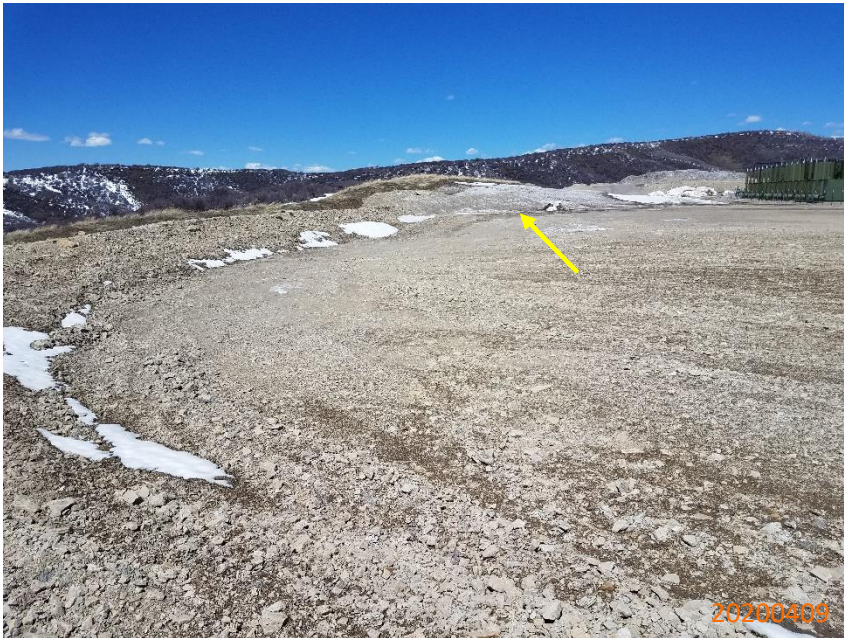
Photo 5: Photo taken from the southeast corner of the Location, facing north. Photos 5-7 provide an overview of the Location. Photos show large areas of the Location that are not needed for production activities have not been reclaimed in accordance with 1003 rules.

Photo also shows the topsoil stopckpile on the southwest end of the Location. Operator appears to have tracked drill cutting onto the soil stockpile.

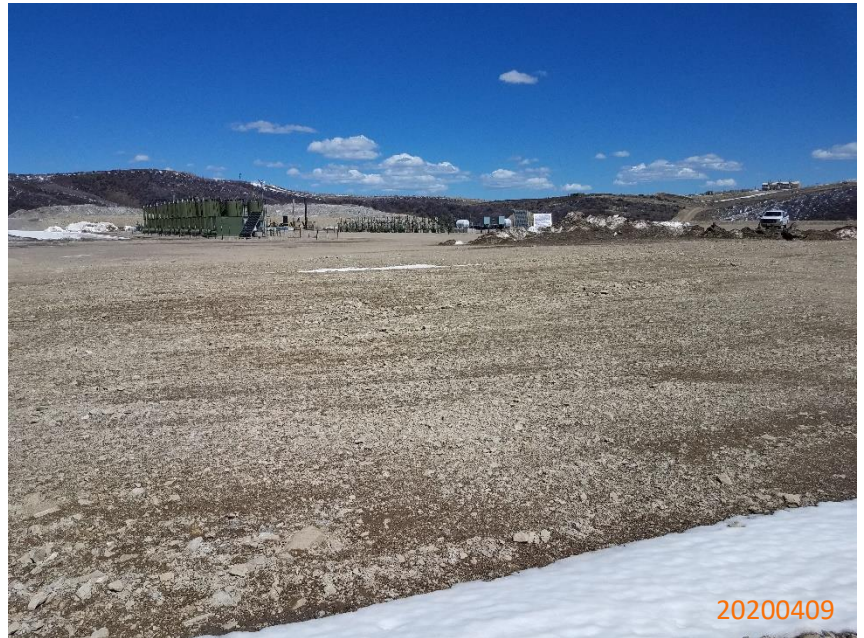
Photo 6: See comments under photo 5.

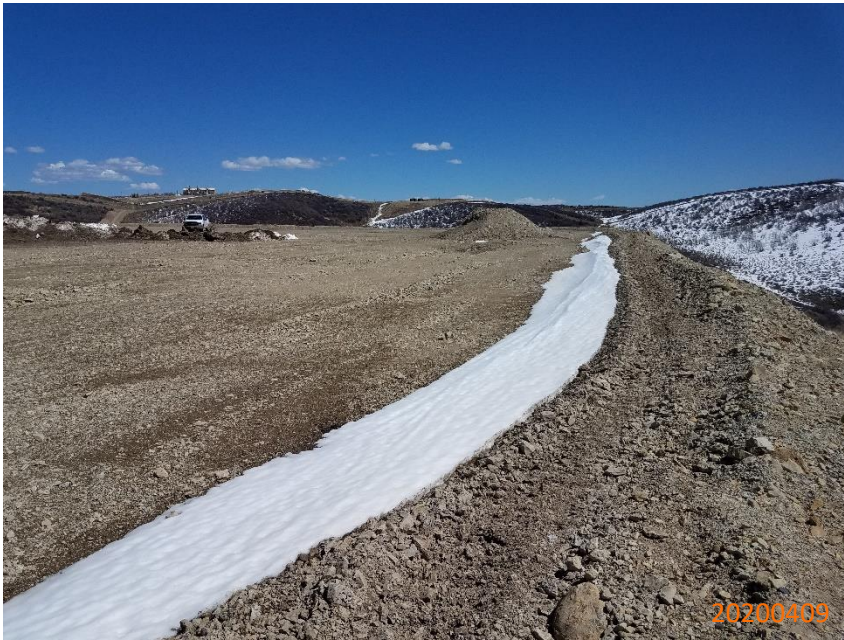
Photo 7: See comments under photo 5.

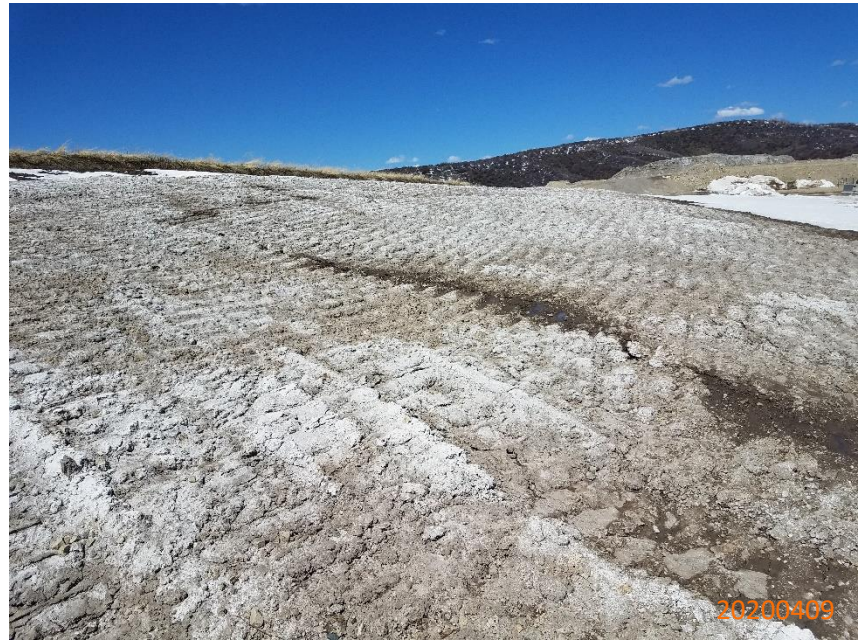
Photo 8: Photo taken from the west end of the Location. Doc. #401115672 identifies this soil stockpile as the “Topsoil Stockpile” that was salvaged from the Location during construction operations. Document #402174440 under sundry doc. #402163224 shows the topsoil pile was to be used for cuttings placement; Operator appears to have placed the drill cuttings upon the Topsoil stockpile in violation of Rule 1002.b(2) and 1002.c

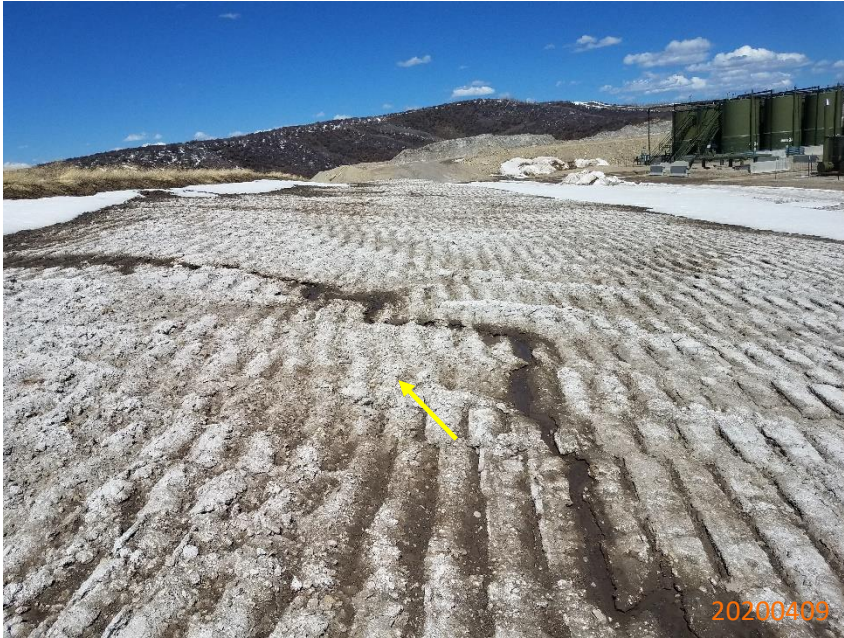
Photo 9: See comments under photo 8. Note- White material (arrow) observed on tracked soils (drill cuttings) in photo is not snow.

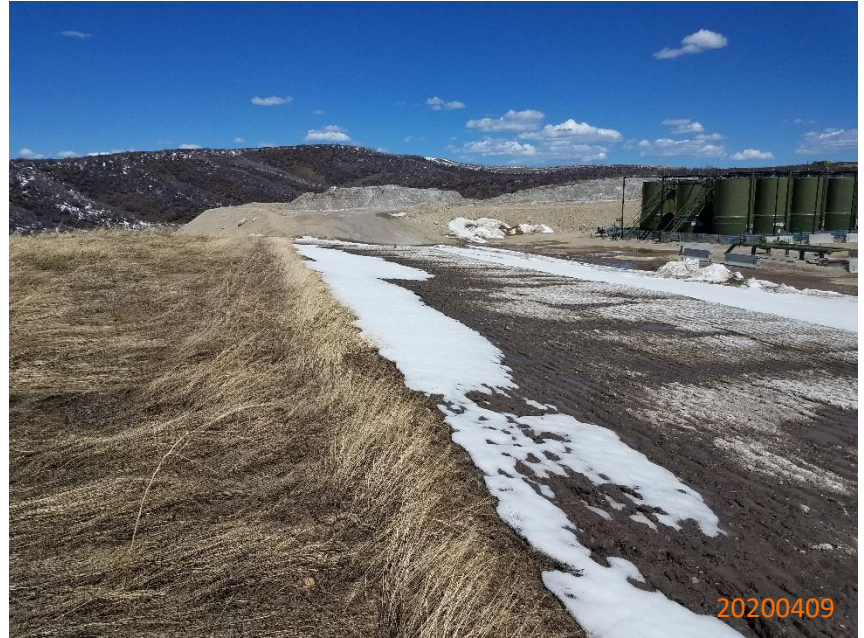
Photo 10: Photo taken from the topsoil stockpile on the west end of the Location, facing northwest. Photos 10-14 provide an overview of the Location from north, northeast, east, southeast to south. Photos show overview of the Location, including areas that are not needed for production activities have not been reclaimed in accordance with 1003 rules. Photos also shows areas where drill cuttings were placed and tracked upon the topsoil stockpile.

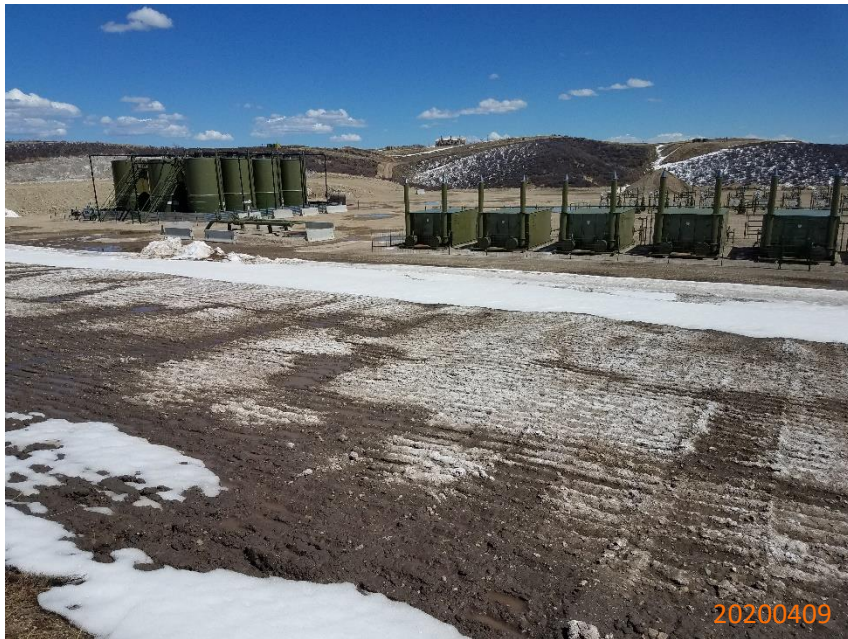
Photo 11: See comments under photo 10.

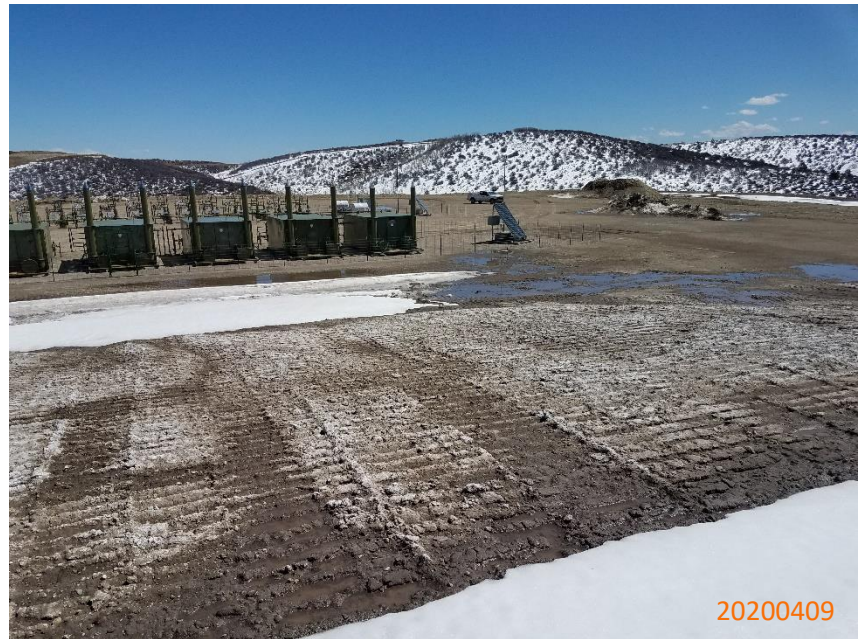
Photo 12: See comments under photo 10.

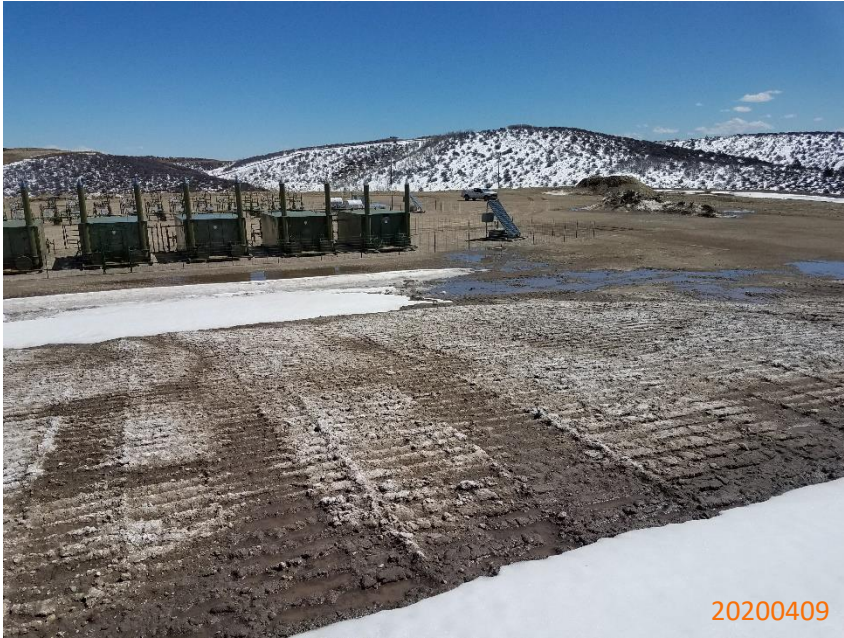
Photo 13: See comments under photo 10.

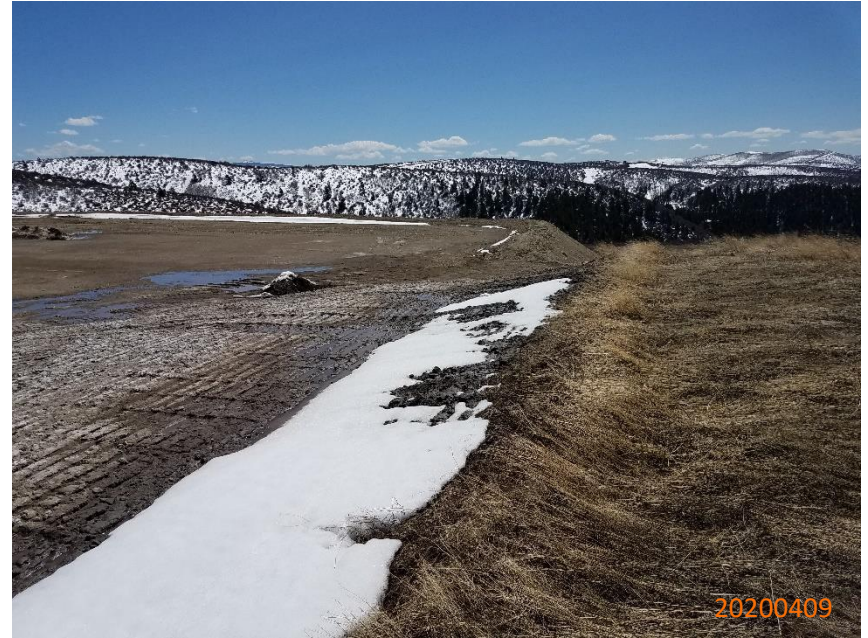
Photo 14: See comments under photo 10.

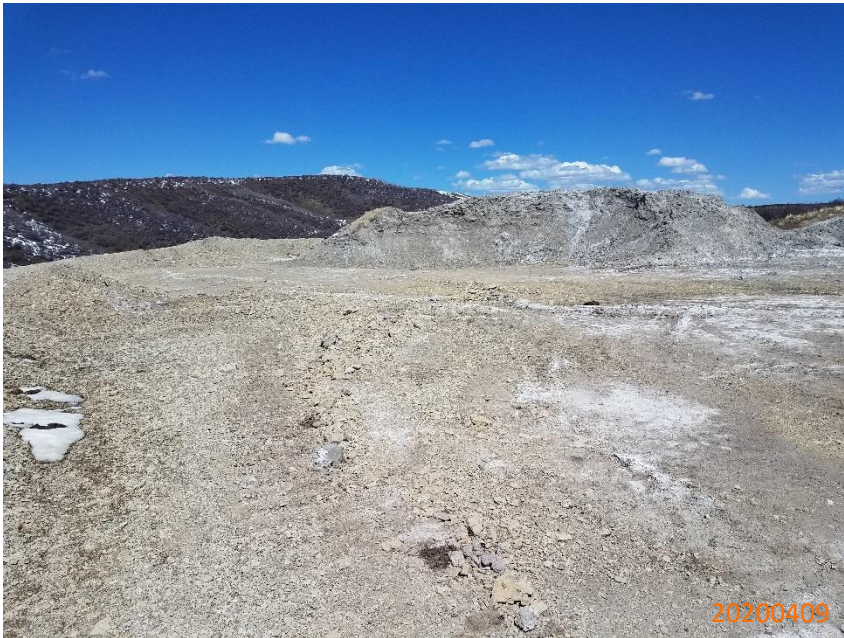
Photo 15: Photo taken from the northwest end of the Location, facing north. Photo shows areas of the Location not needed for production activities have not been reclaimed. Photo also shows areas where drill cutting are being stored.

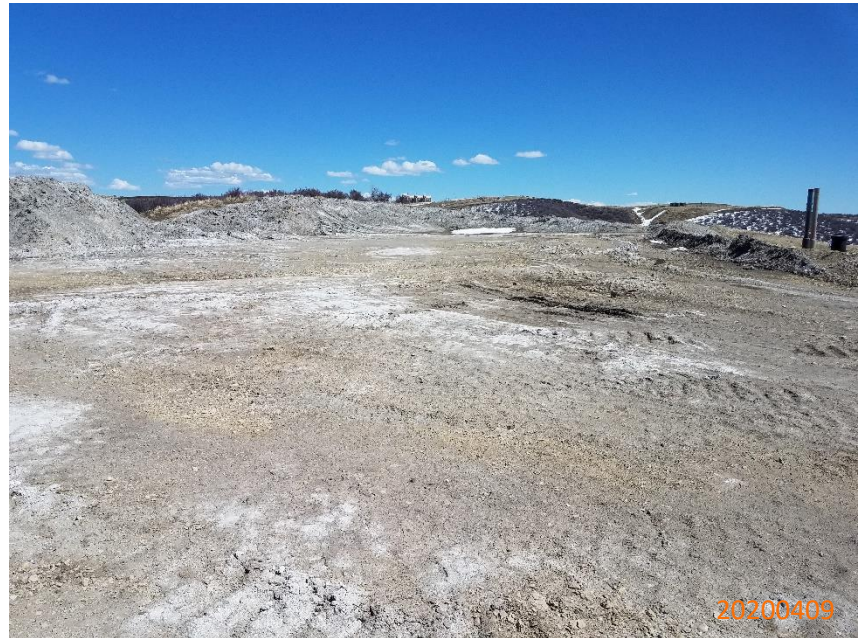
Photo 16: Photo taken from the northwest end of the Location, facing northeast. See comments under photo 15.

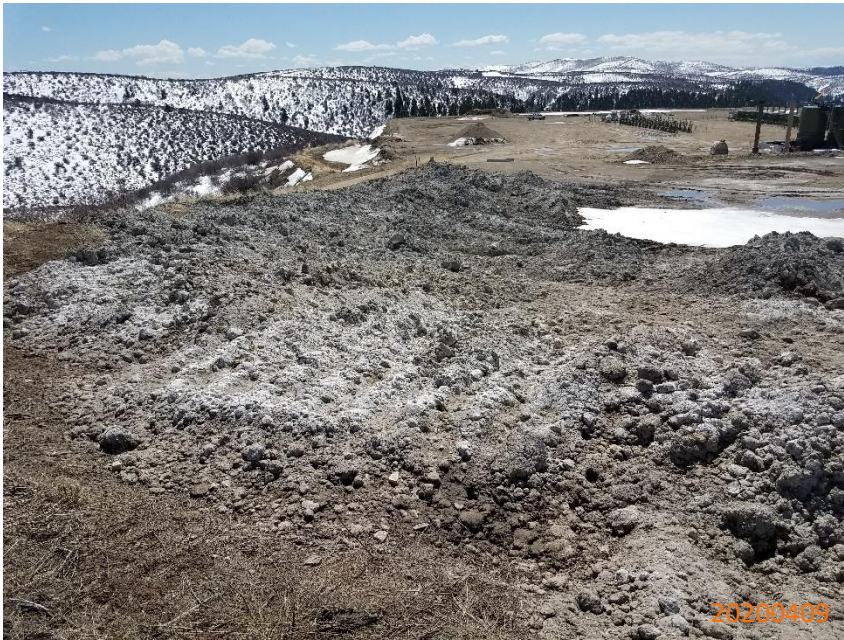
Photo 17: Photo taken from the northern corner of the Location, facing southeast. Photo shows areas where Operator appears to have pushed drill cuttings onto the perimeter of the Location, and on onto areas designated as topsoil (Doc. #401115667). It was observed that no additional BMPs have been installed to prevent cuttings from being transported/discharged off the Location onto the adjacent lands.

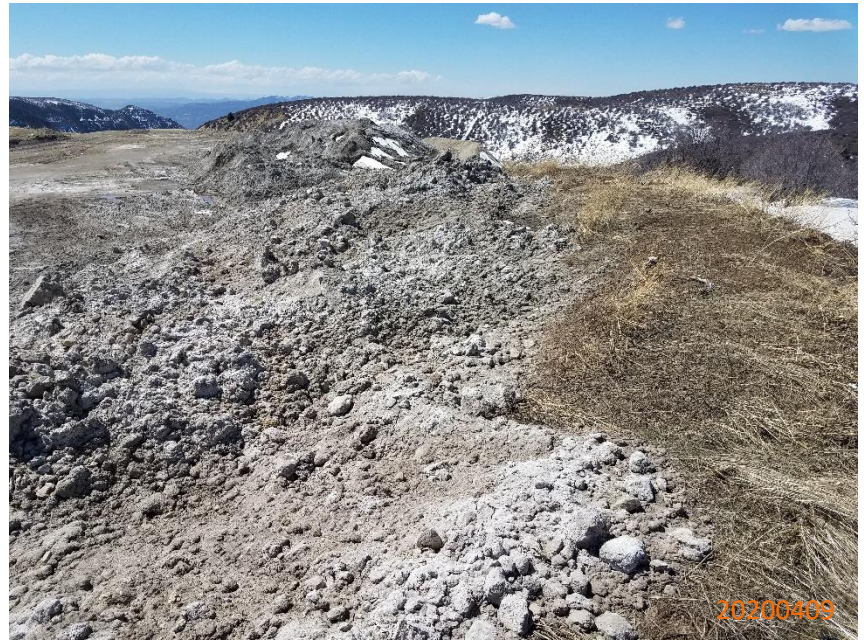
Photo 18: Photo taken from the northern corner of the Location, facing southwest. See comments under photo 17.

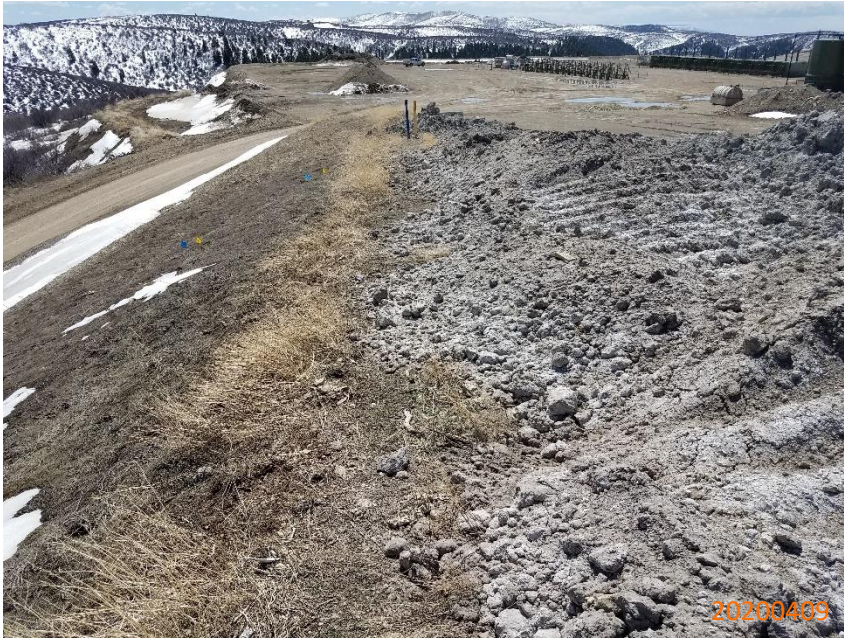
Photo 19: Photo taken from the northern corner of the Location, facing southeast. Photo shows areas where Operator appears to have pushed drill cuttings onto the perimeter of the Location, and on onto areas designated as topsoil (Doc. #401115667). It was observed that no additional BMPs have been installed to prevent cuttings from being transported/discharged off the Location onto the adjacent lands.

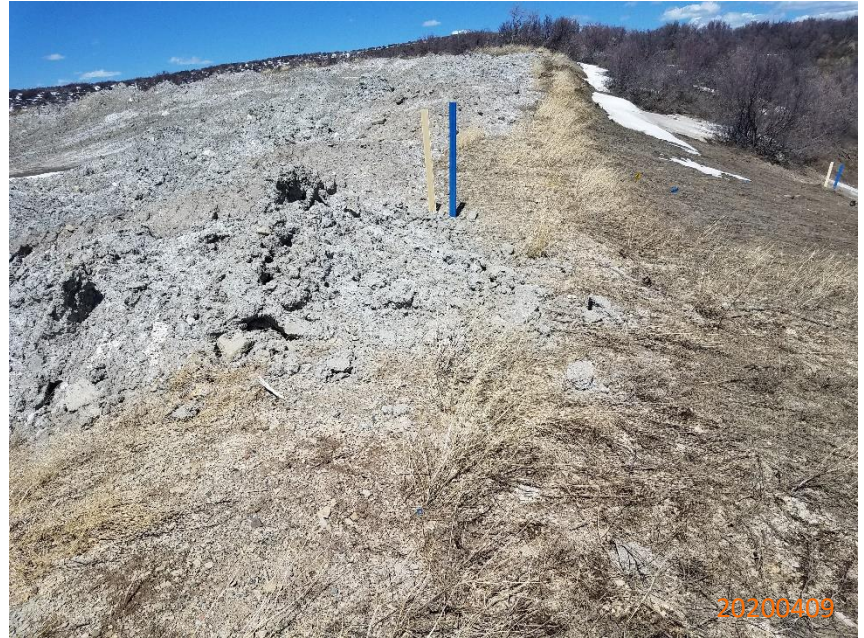
Photo 20: Photo taken from the northeastern area of the Location, facing northwest. See comments under photo 19.

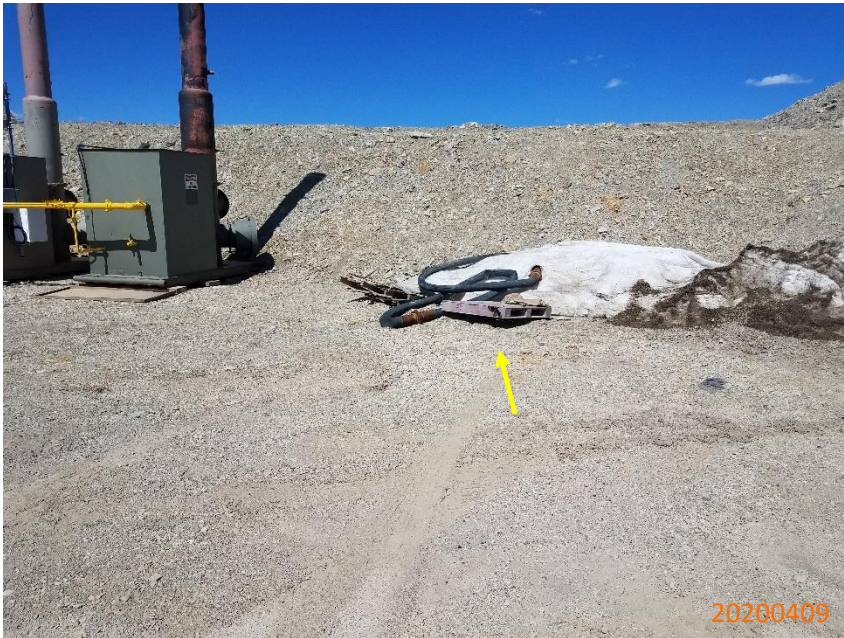
Photo 21: Photo taken from the north end of the Location, facing north. Photo shows unused equipment and/or trash debris stored on the Location.

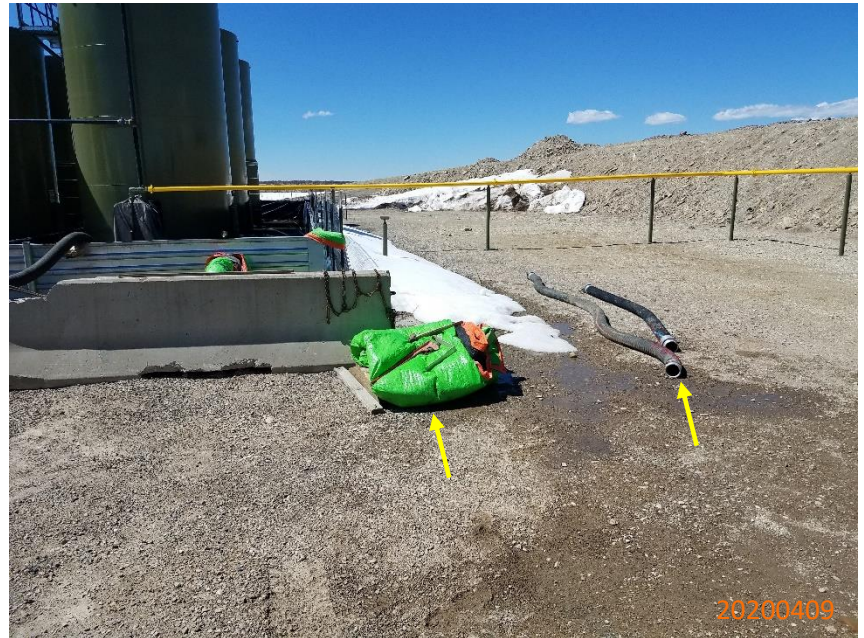
Photo 22: Photo taken from the east of the tank battery, facing west. Photo shows unused equipment and/or trash debris stored on the Location.

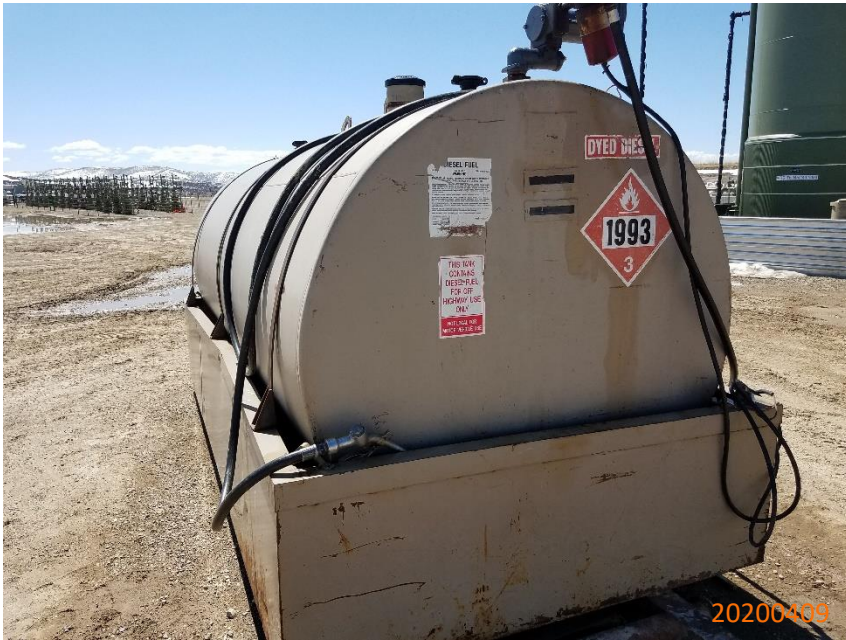
Photo 23: Photo of diesel tank stored to the east of the battery. If tank is not needed for production activities, it needs to be removed per Rule 603.f. Secondary containment at tank appears to be in proper functioning condition.

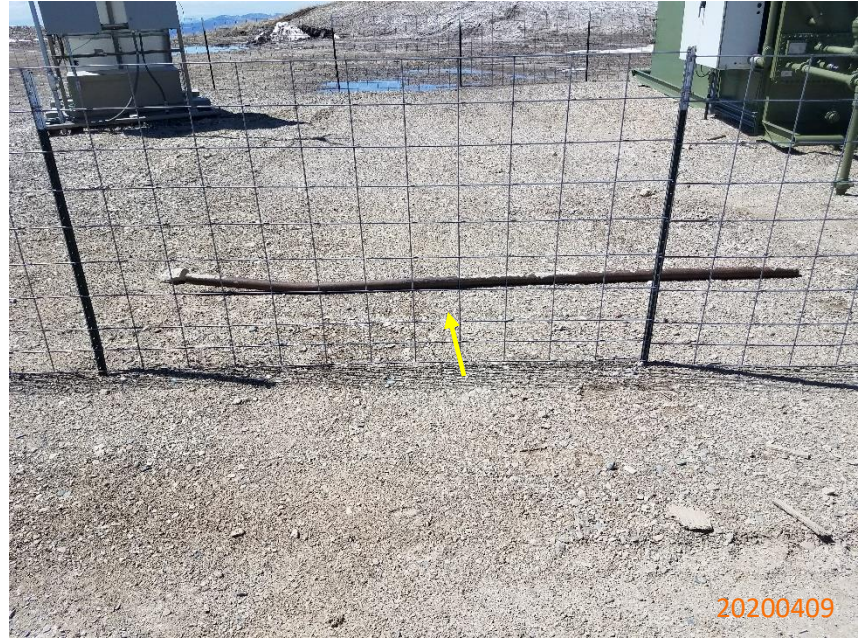
Photo 28: Photo taken from the south of the separators.
Photo shows pipe equipment/trash debris stored on location.

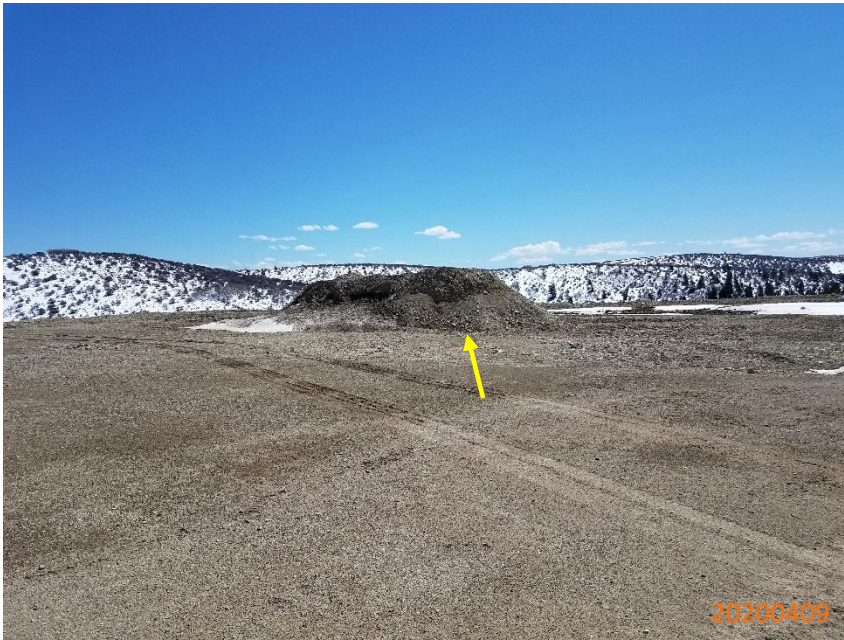
Photo 29: Photo taken from the south end of the location, facing southeast. Photo shows rock material stored on the location.

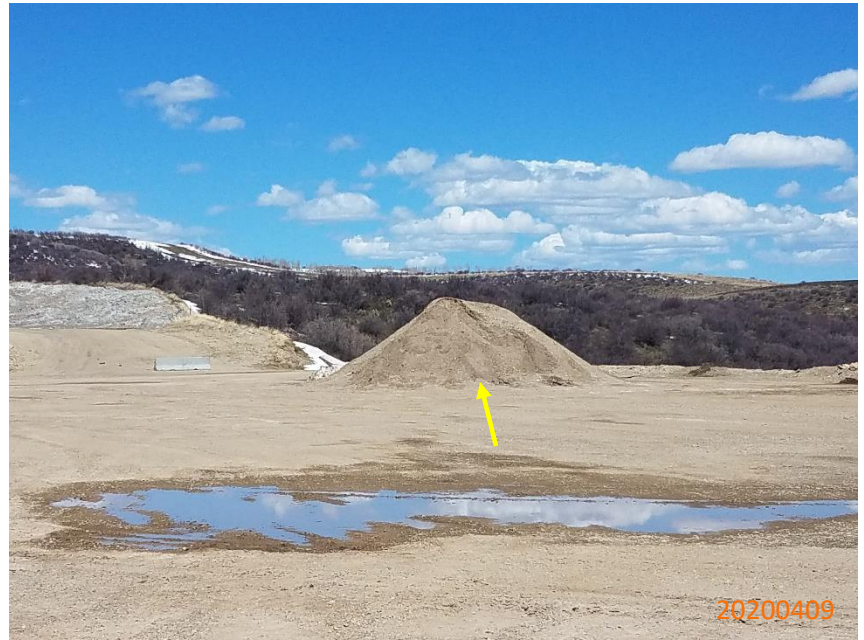
Photo 30: Photo taken from the eastern area of the location, facing northeast. Photo shows rock material stored on the location.

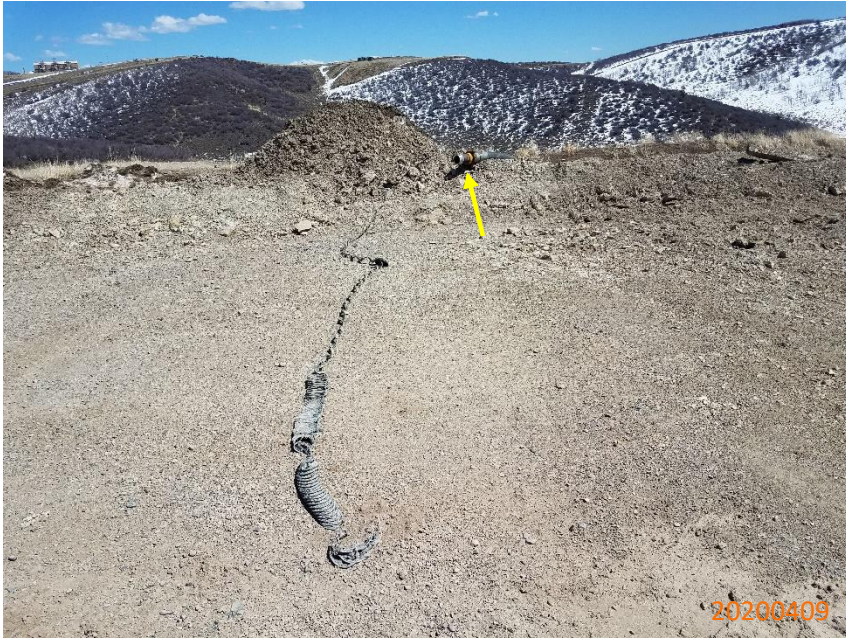
Photo 31: Photo taken from the east end of the Location, facing east. Photo shows trash debris that appears to be related to a hose (arrow, see photo 32). Trash debris and unused equipment requires removal in accordance with 603.f and 1003.a

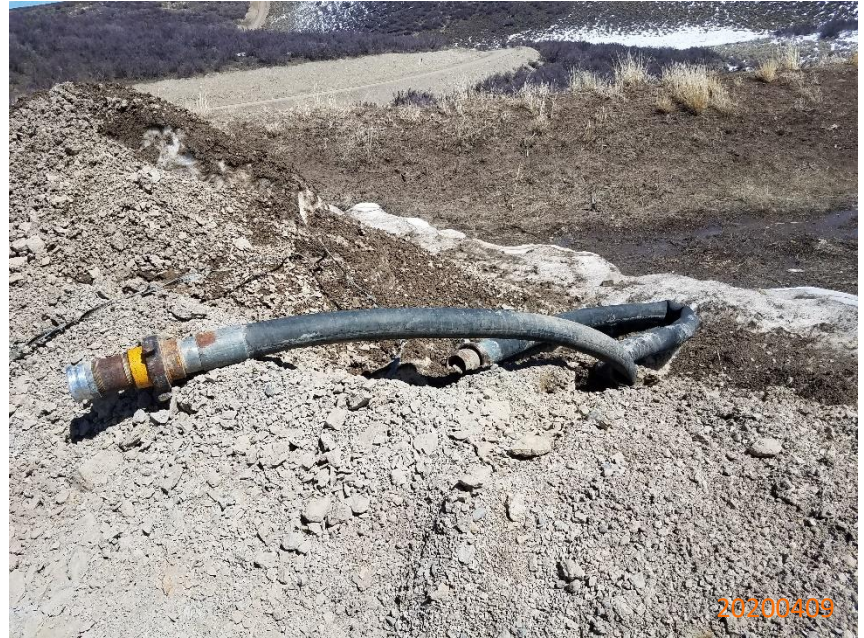
Photo 32: See comments under photo 30.

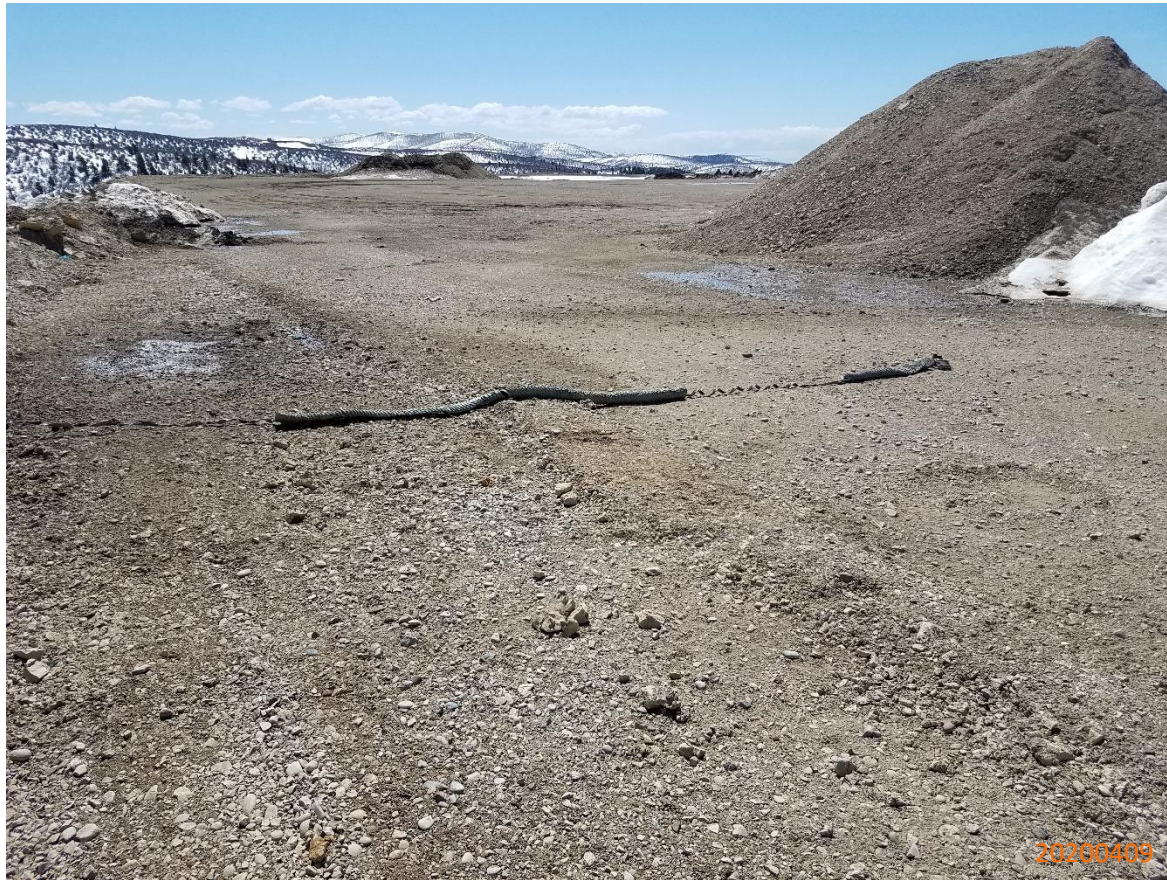
Photo 33: Photo taken from the east end of the Location, facing south. Photo shows trash debris on the Location.
