Inspection Photos

Location Name: MARALEX RESOURCES INC FEDERAL-68S98W /35SENW

Location ID: 312511

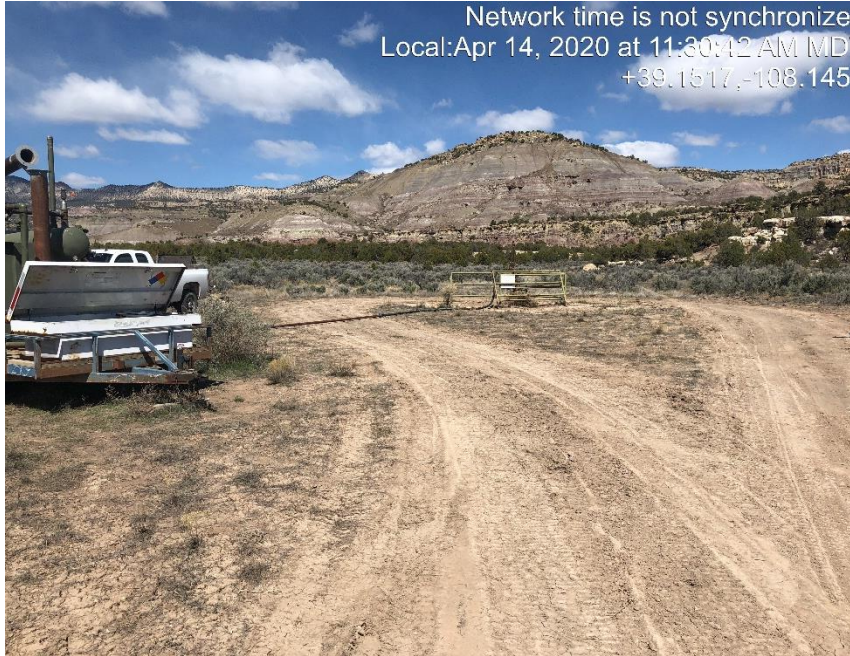
Photo #0961 from entrance to location

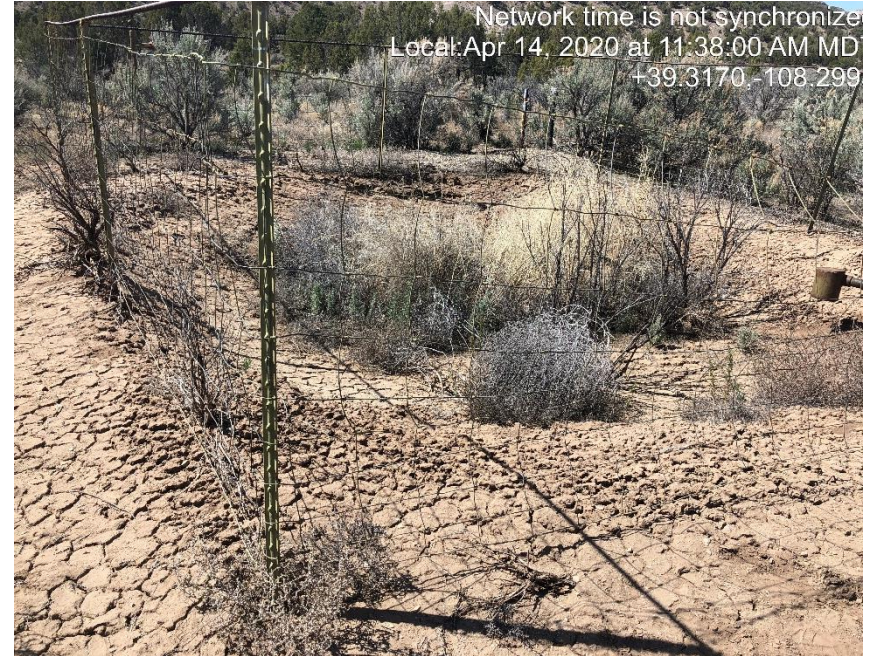
Photo #0962 Debris inside both pits. No netting on pits.

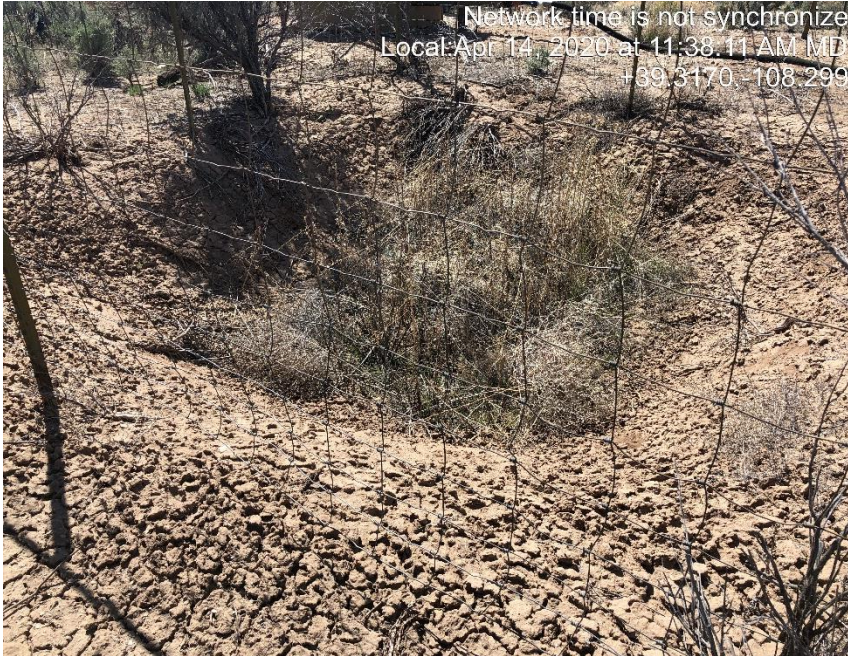
Photo #0963 Debris inside both pits. No netting on pits.

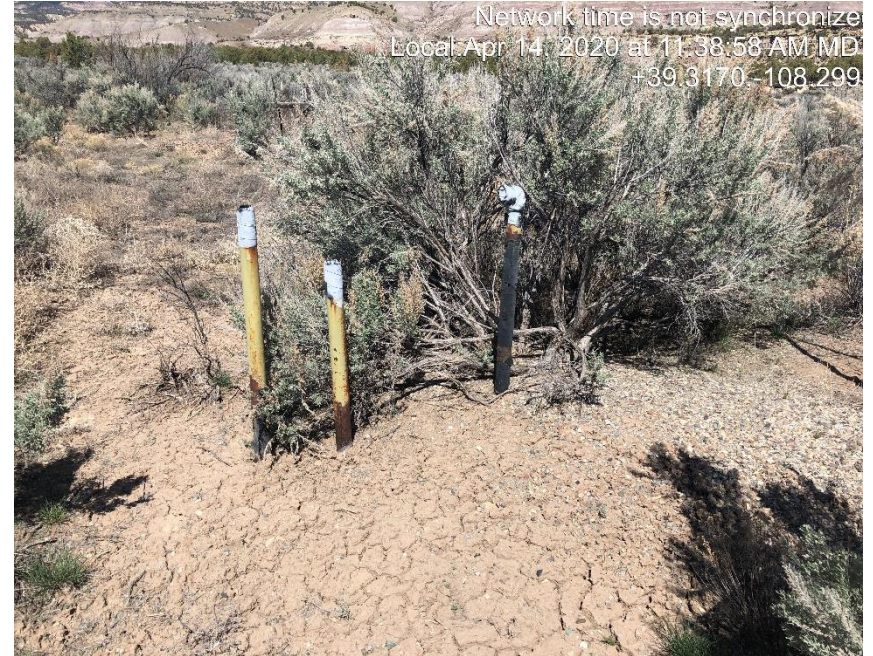
Photo #0964 Multiple flowline risers not LO/TO.

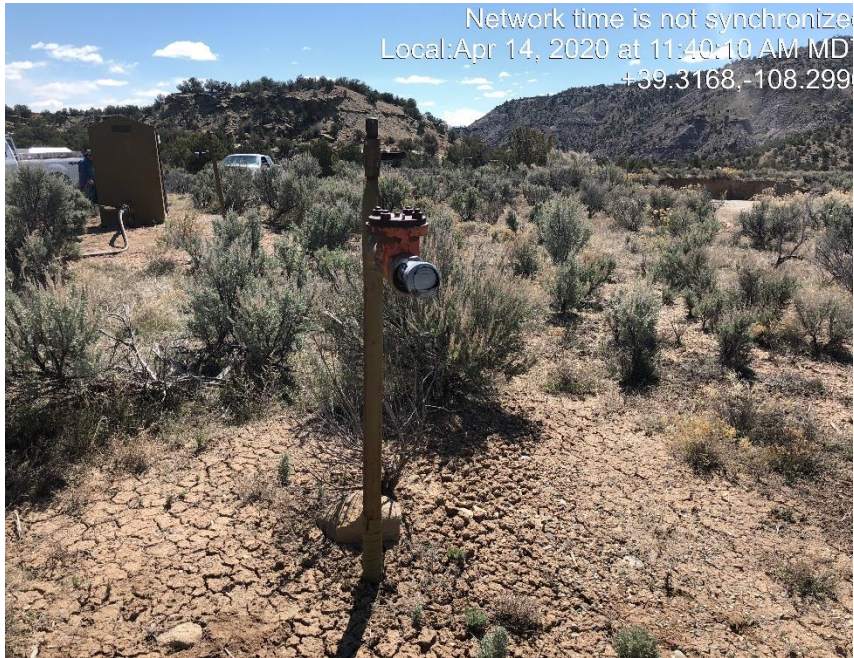
Photo #0965 Multiple flowline risers not LO/TO.
