Inspection Photos

Operator: Enduring Resources
API#: 067-07914
Date: 4/14/2020

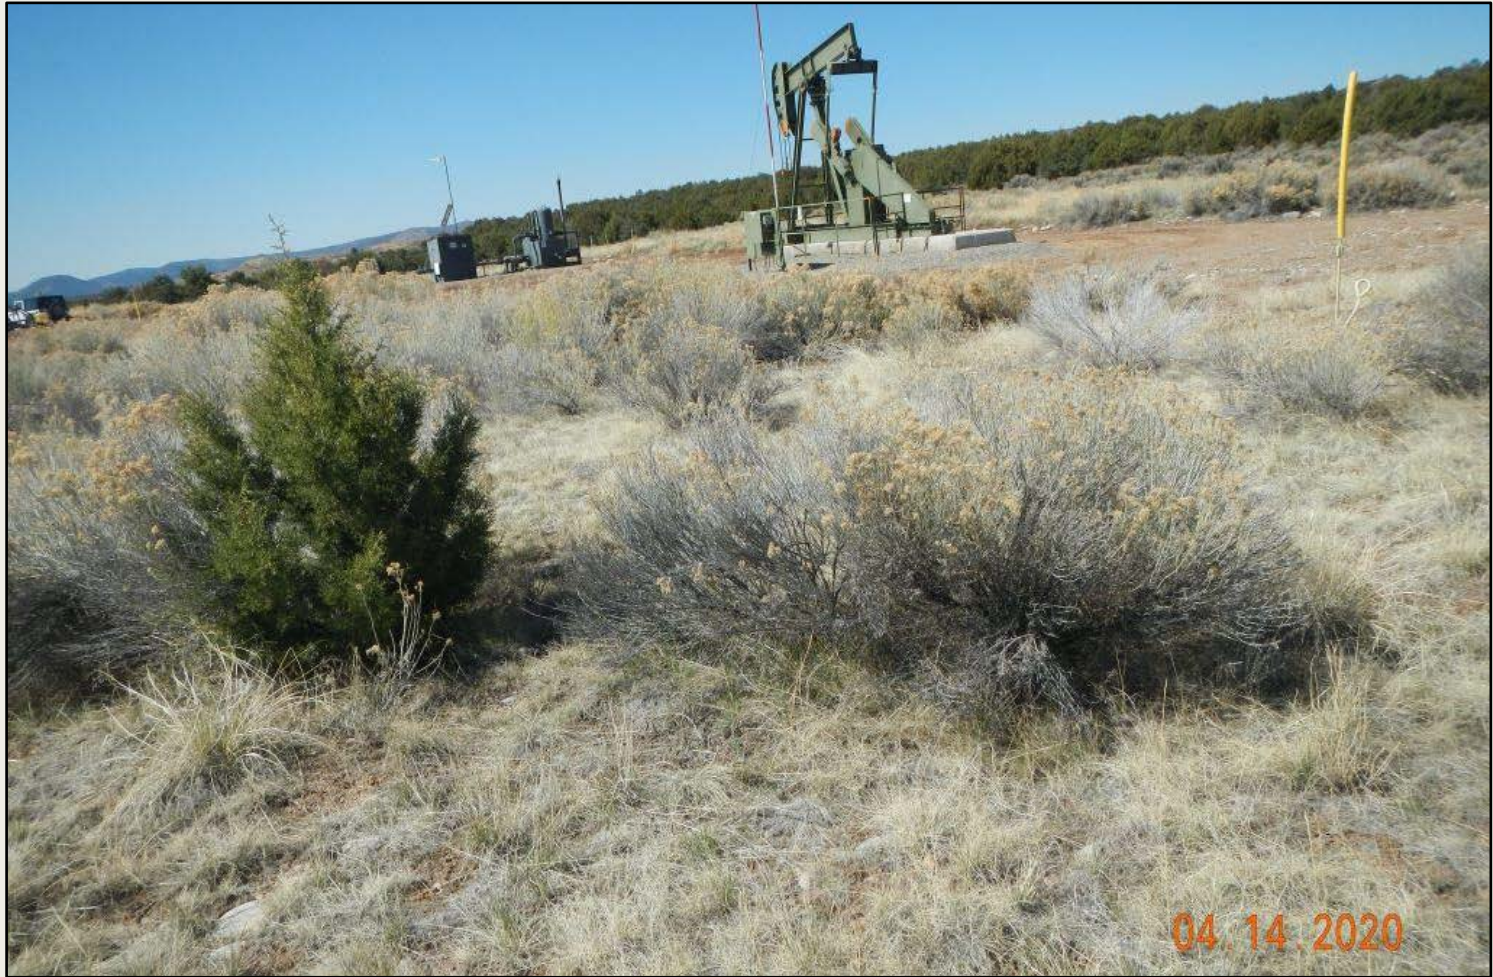
Photo 1. View of the project area from the northeastern corner facing center.

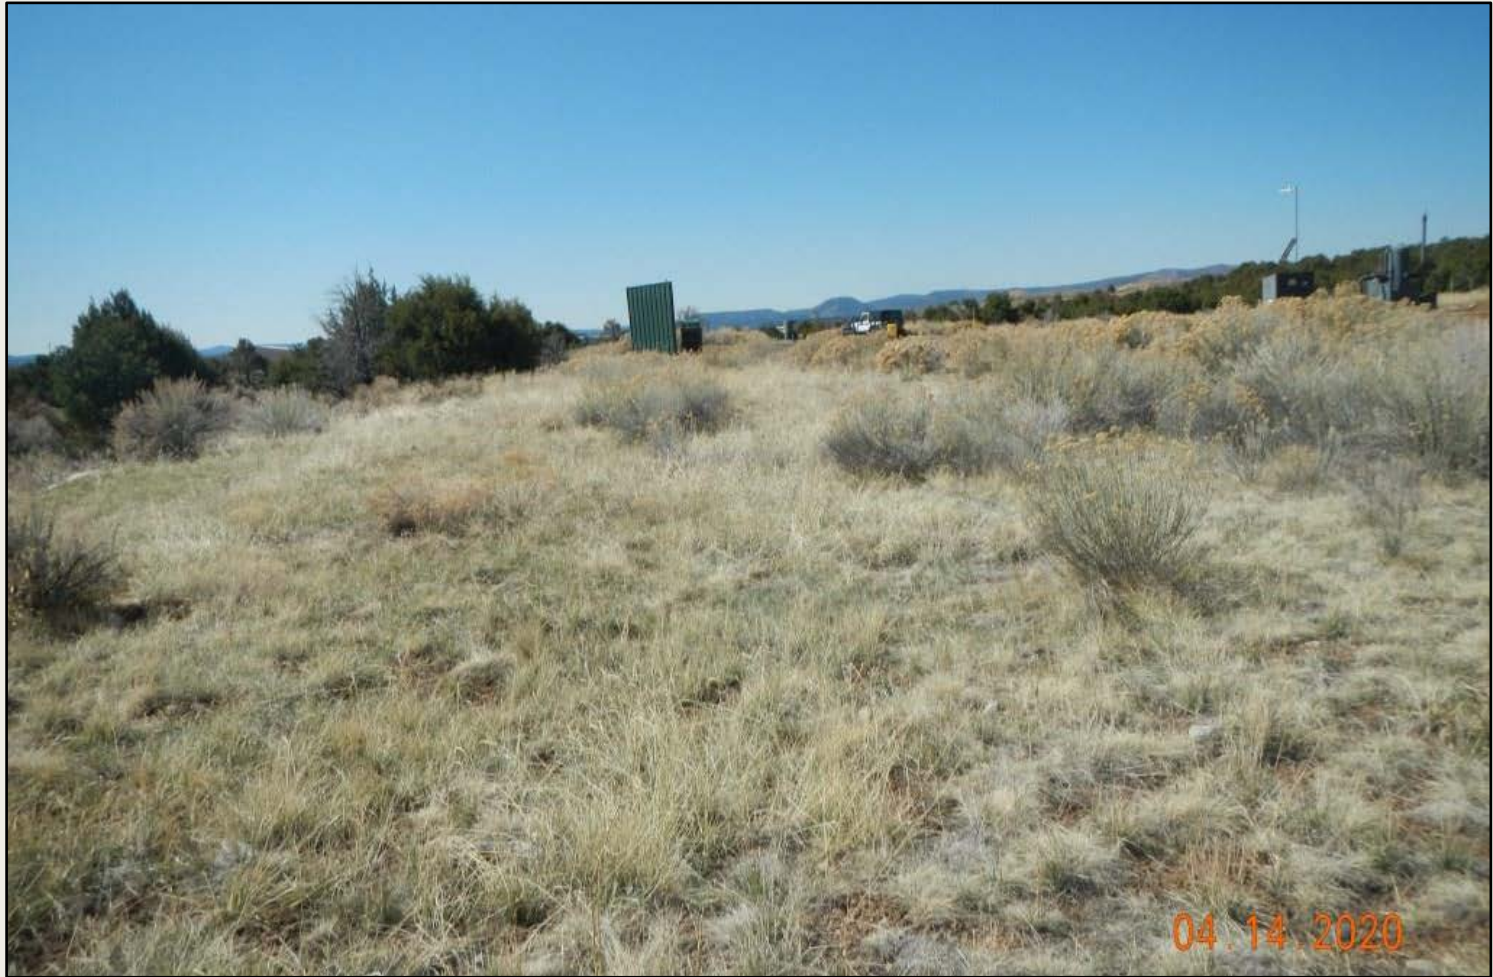
Photo 2. View of the eastern fill slope from the northeastern corner facing southward. Revegetation is progressing here with grasses and shrubs such as western wheatgrass, sand dropseed, and rubber rabbitbrush.

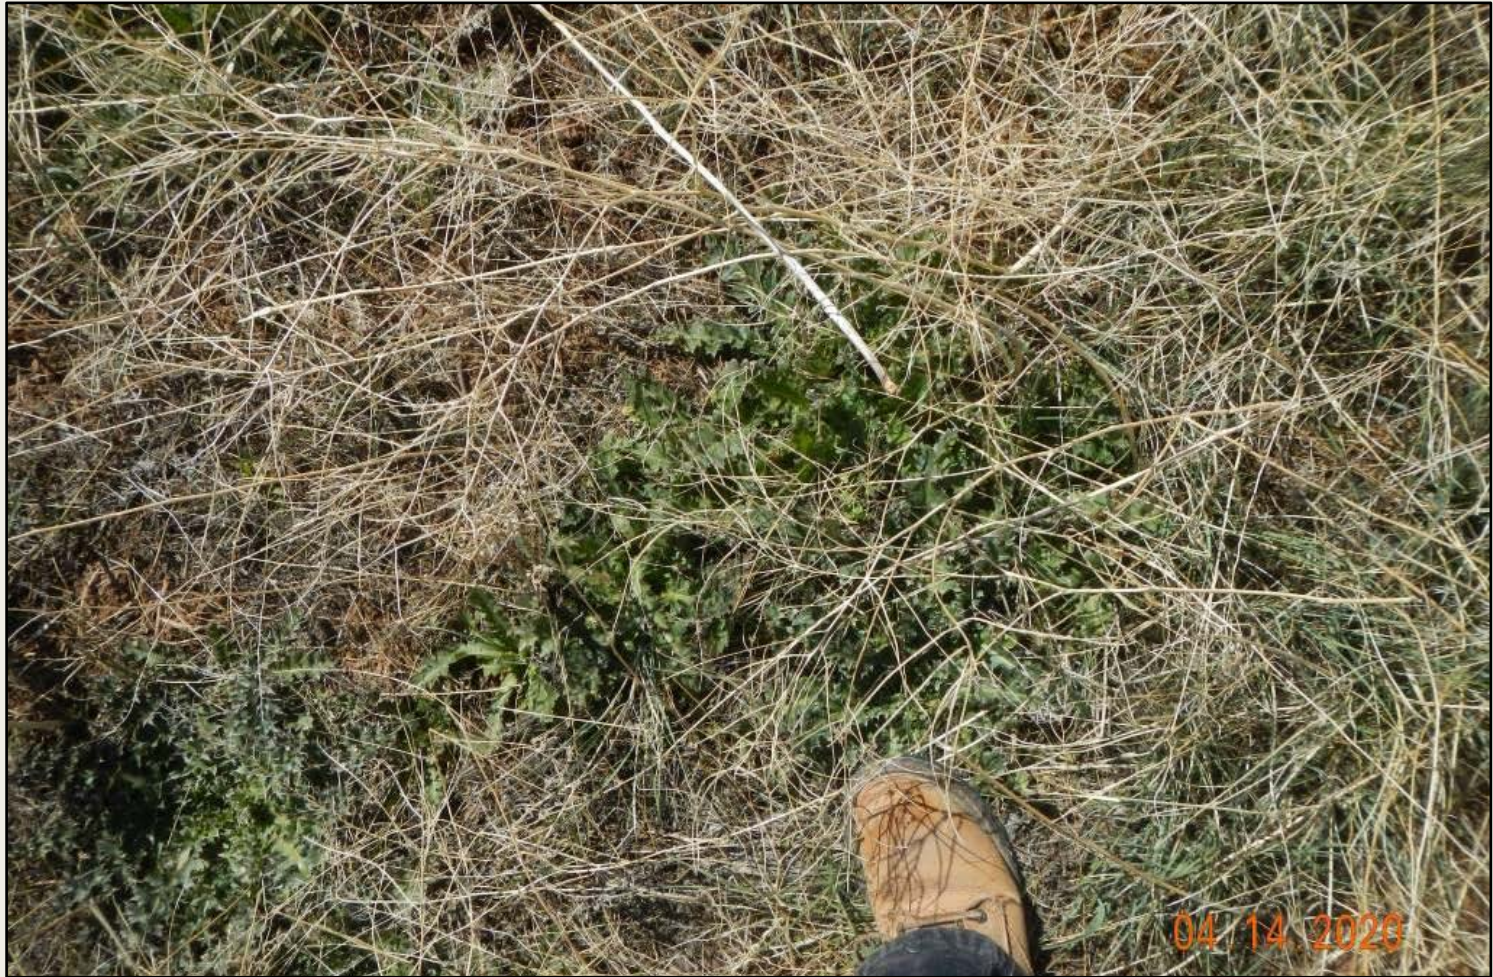
Photo 3. View of dense musk thistles within the southwestern portion of the project area.

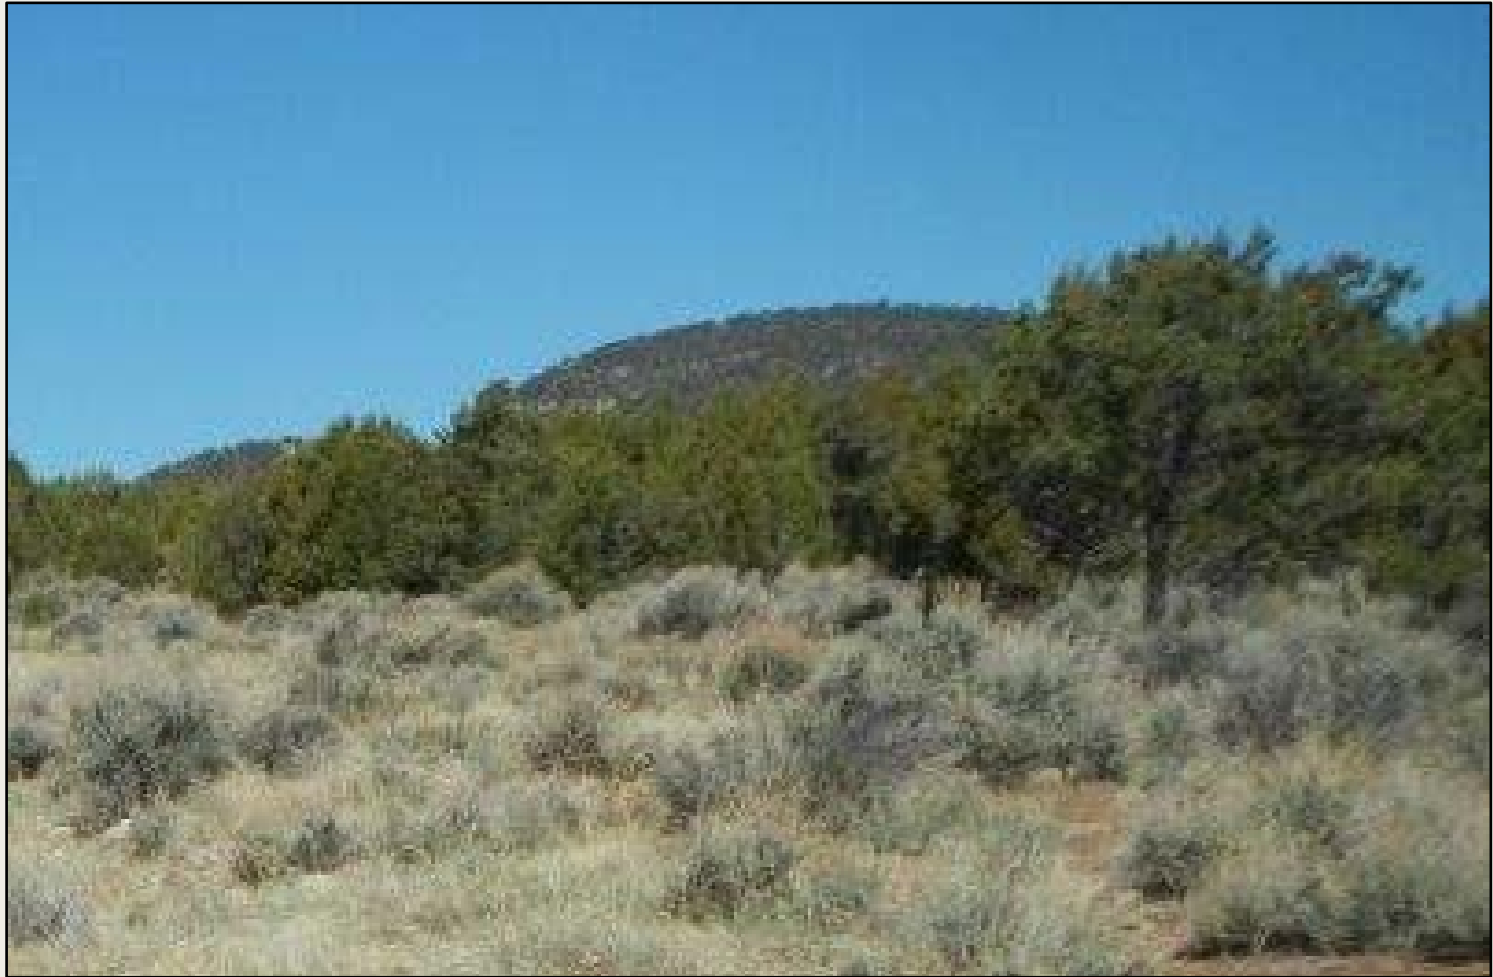
Photo 4. View of reference area, comprised of pinyon-juniper woodland with understory of sagebrush and grasses and forbs such as blue grama and snakeweed.
