**Inspection Photos**  
**Operator: Enduring Resources**  
**API#: 067-06692**  
**Date: 4/14/2020**

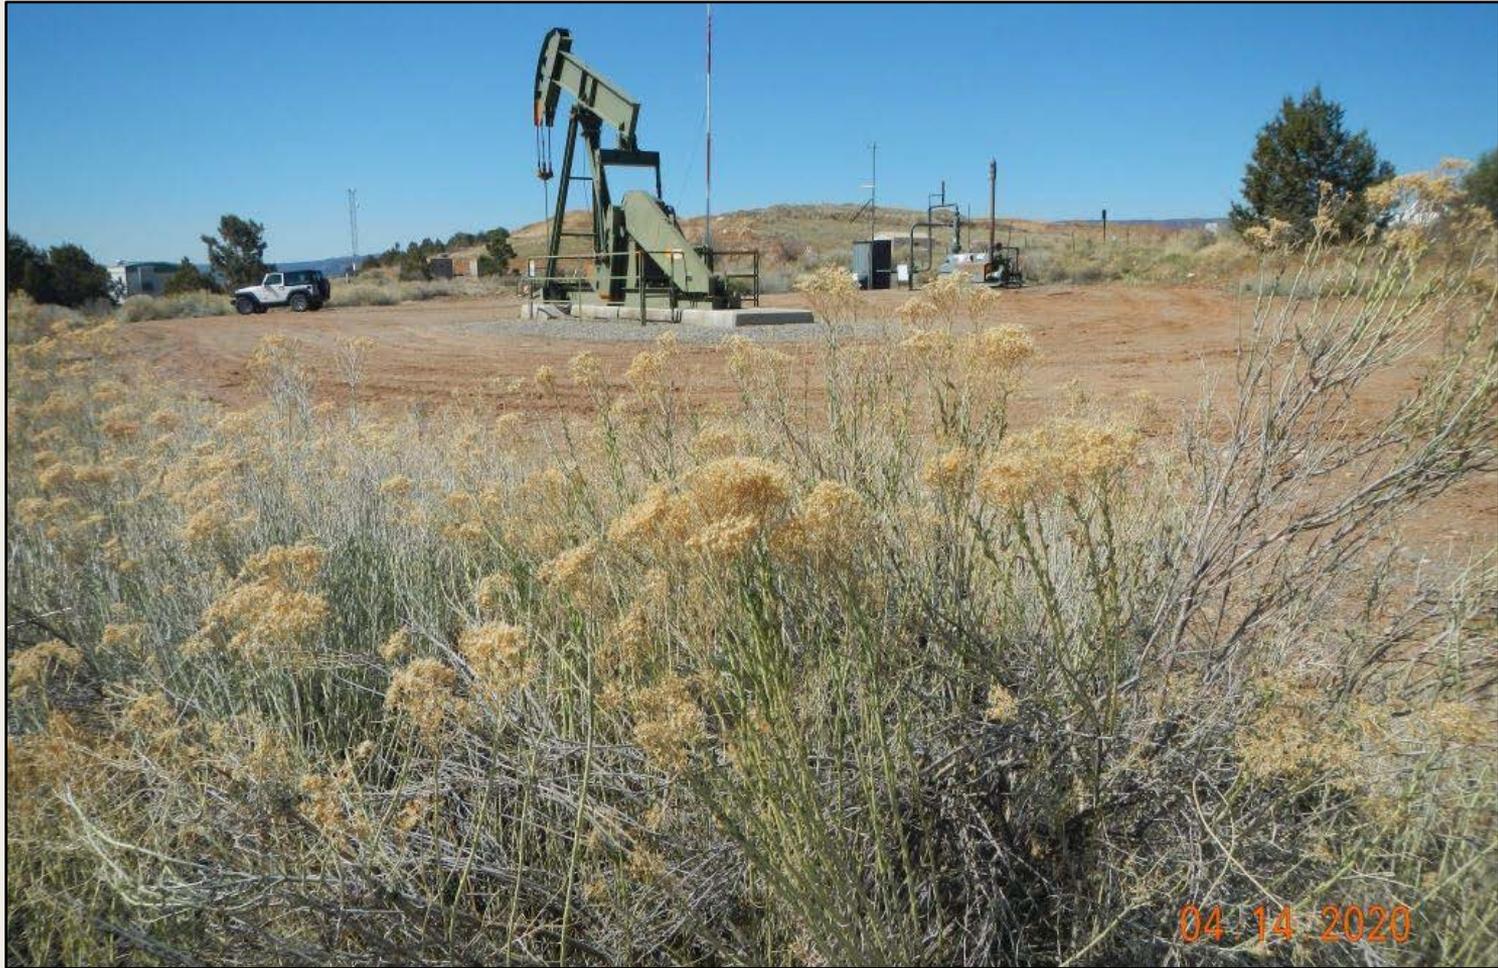
Photo 1. View of the project area from the northeastern corner facing center.

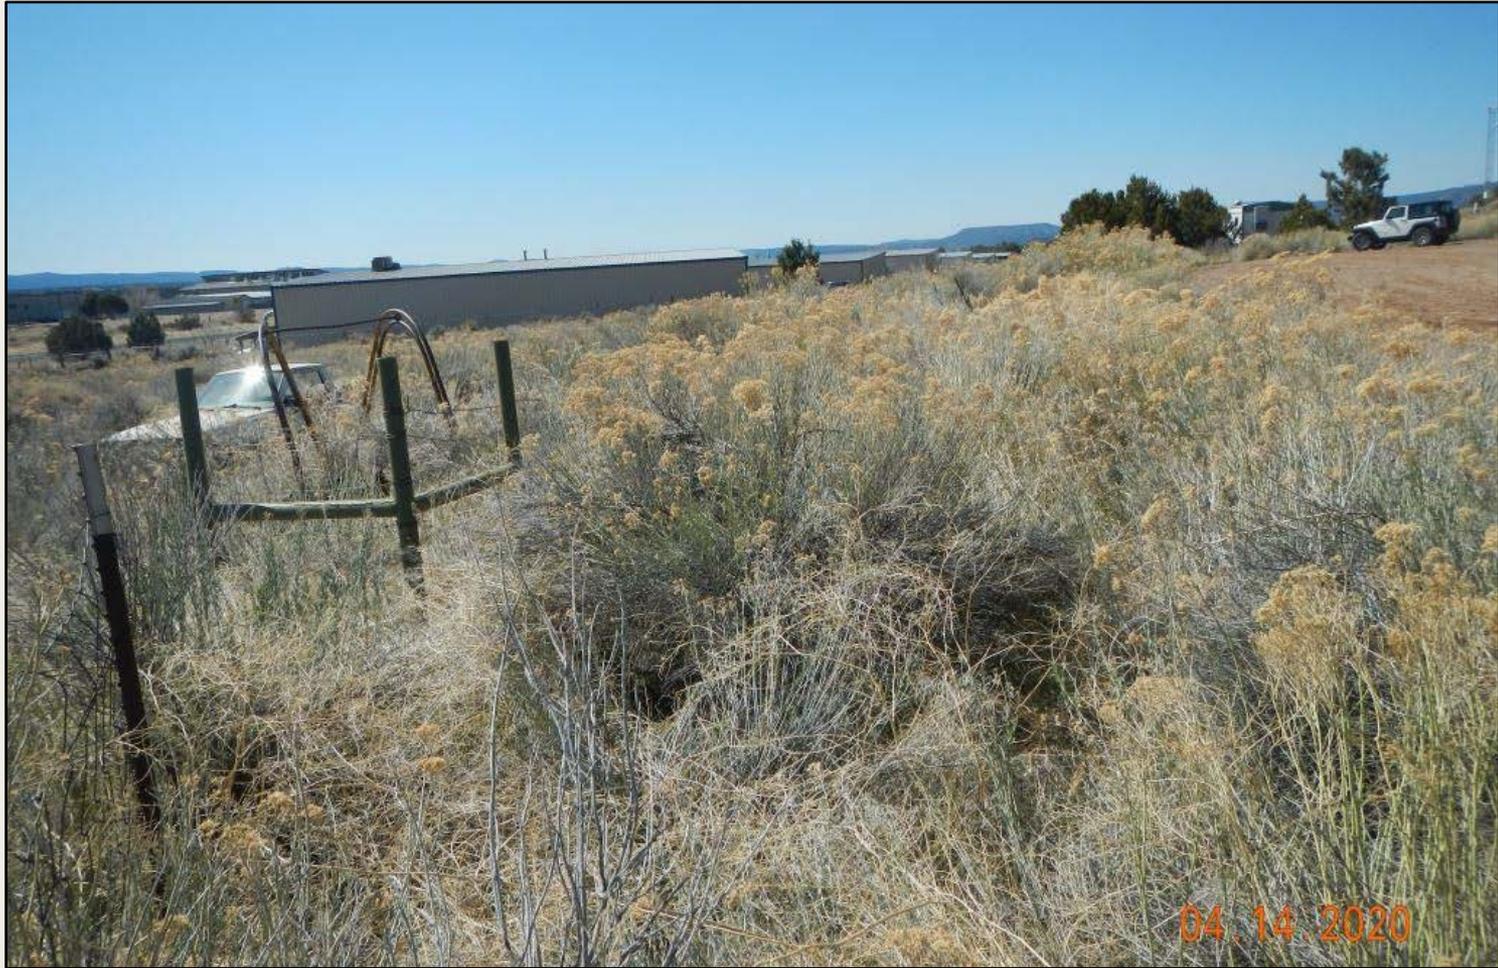
Photo 2. View of the eastern fill slope from the northeastern corner facing southward. Revegetation is progressing here with grasses and shrubs such as western wheatgrass, and smooth brome.

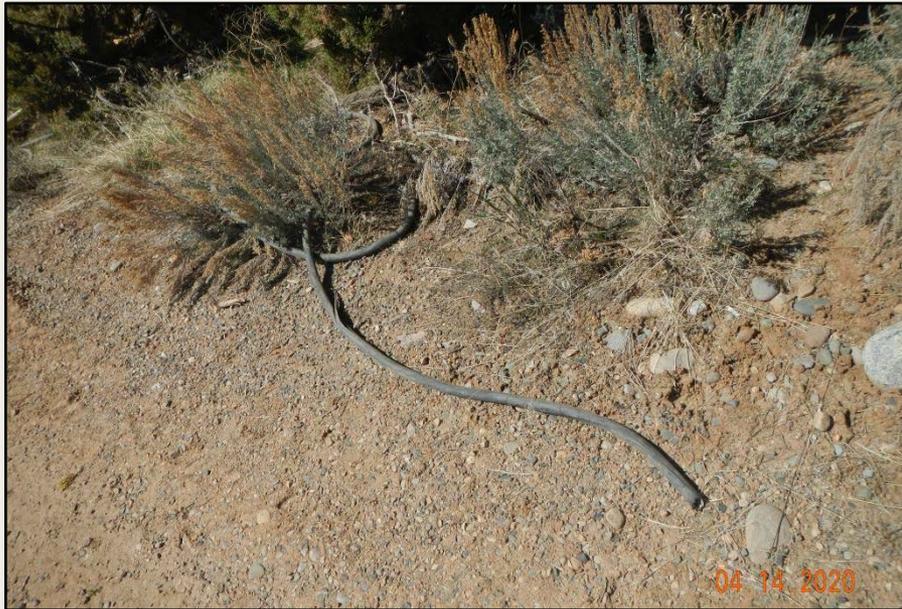
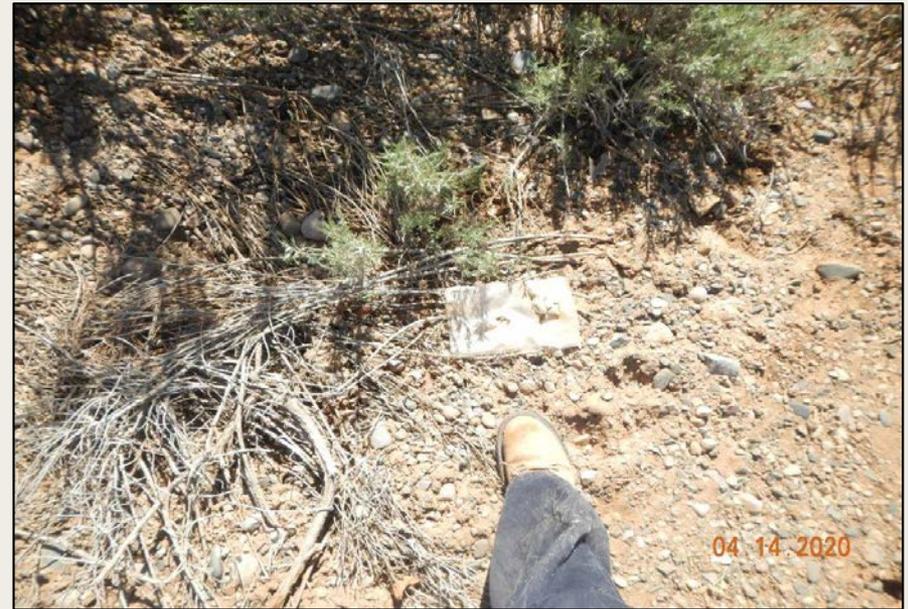
Photo 3/4. View of rubber hose at access gate and plastic debris within the interim reclamation area.

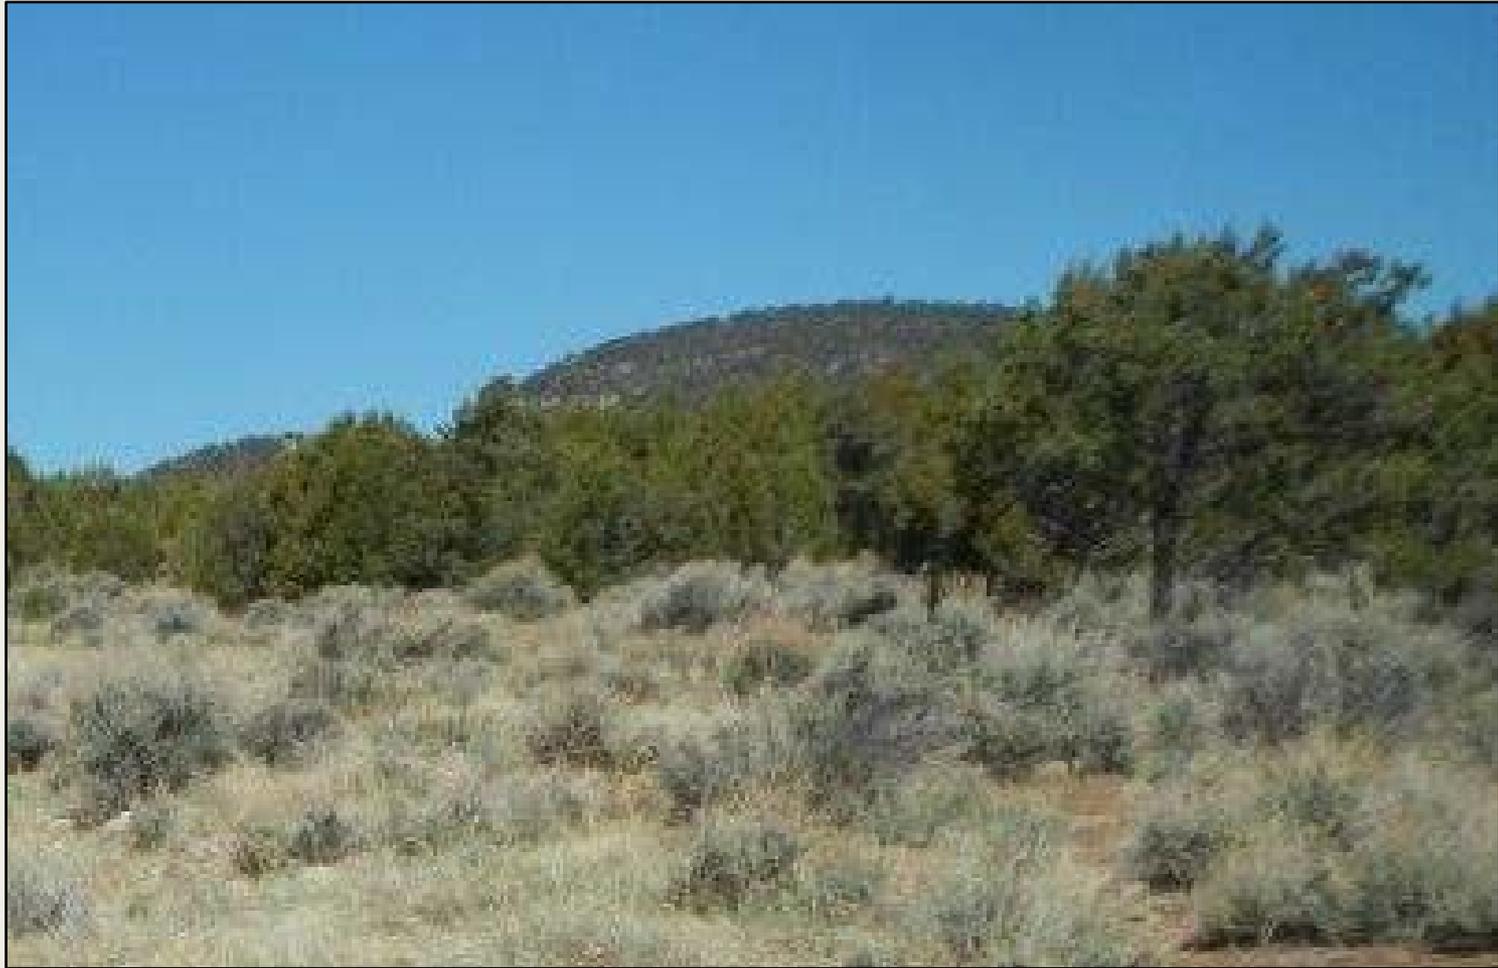
Photo 5. View of reference area, comprised of pinyon-juniper woodland with understory of sagebrush and grasses and forbs such as blue grama and snakeweed.
