# Inspection Photos

Operator: Enduring Resources  
API#: 067-07864  
Date: 4/14/2020

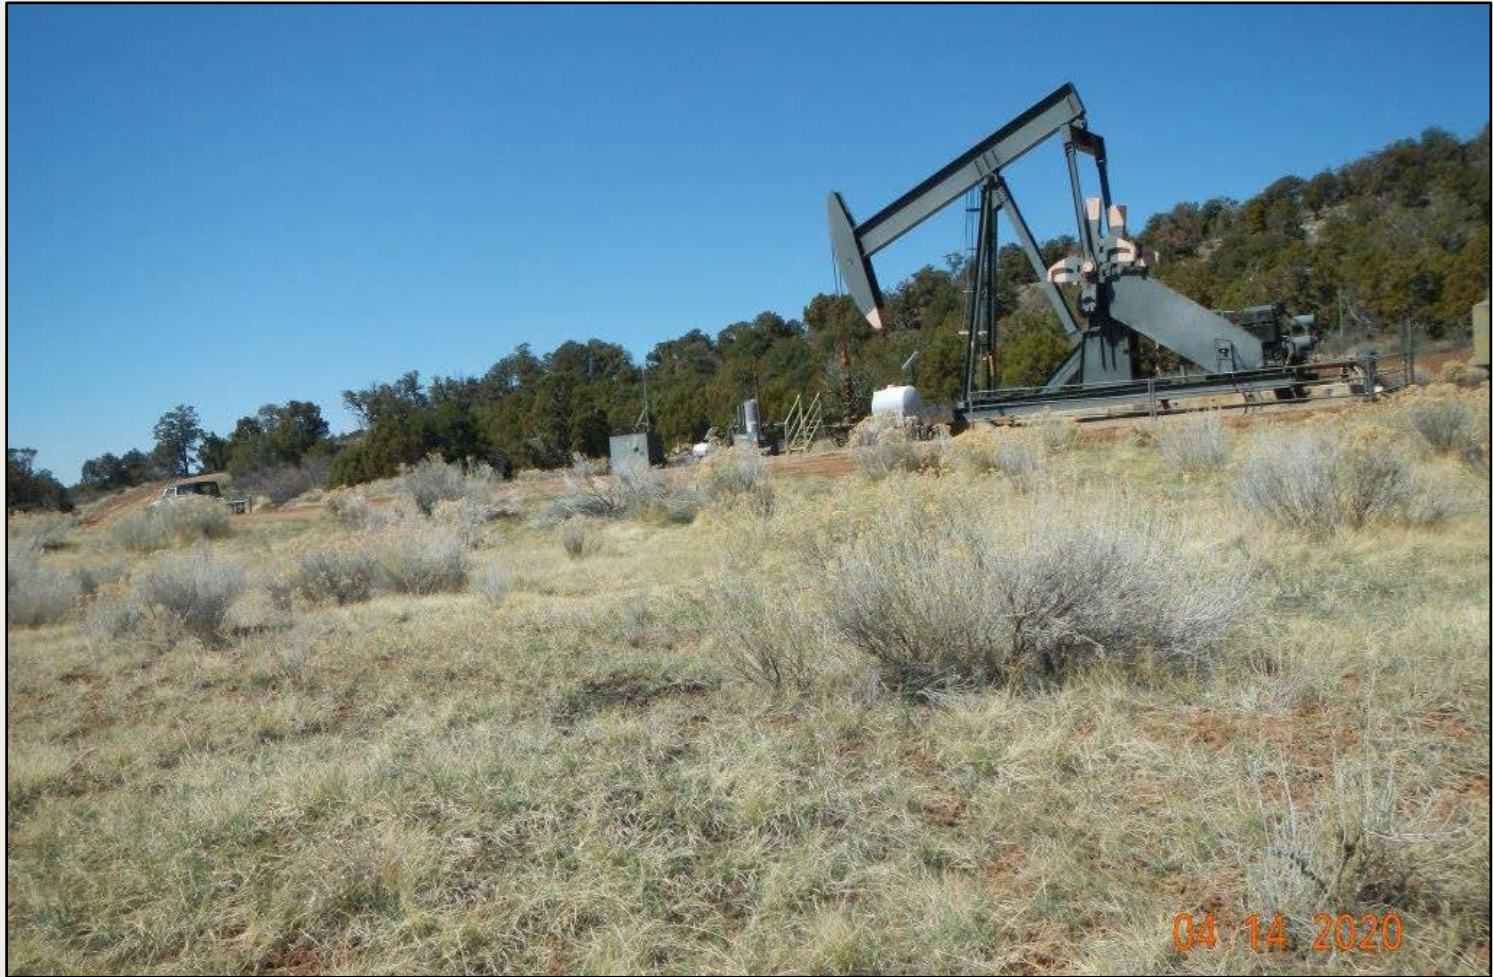
Photo 1. View of the project area from the northeastern corner facing center.

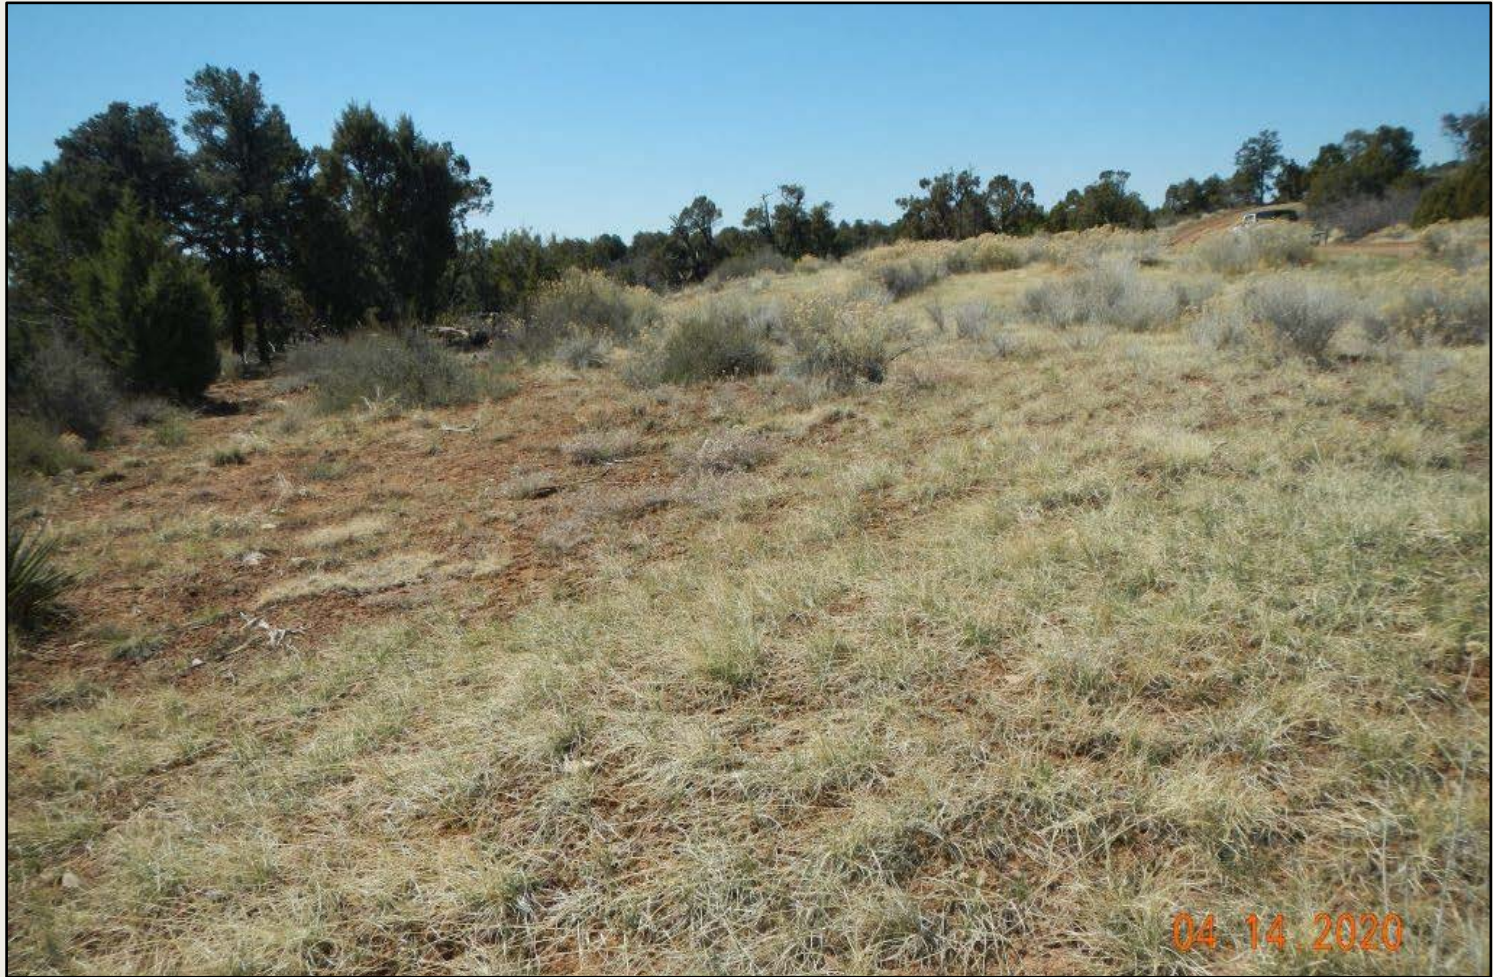
Photo 2. View of the eastern fill slope from the northeastern corner facing southward. Revegetation is progressing here with grasses and shrubs such as western wheatgrass, and rubber rabbitbrush.

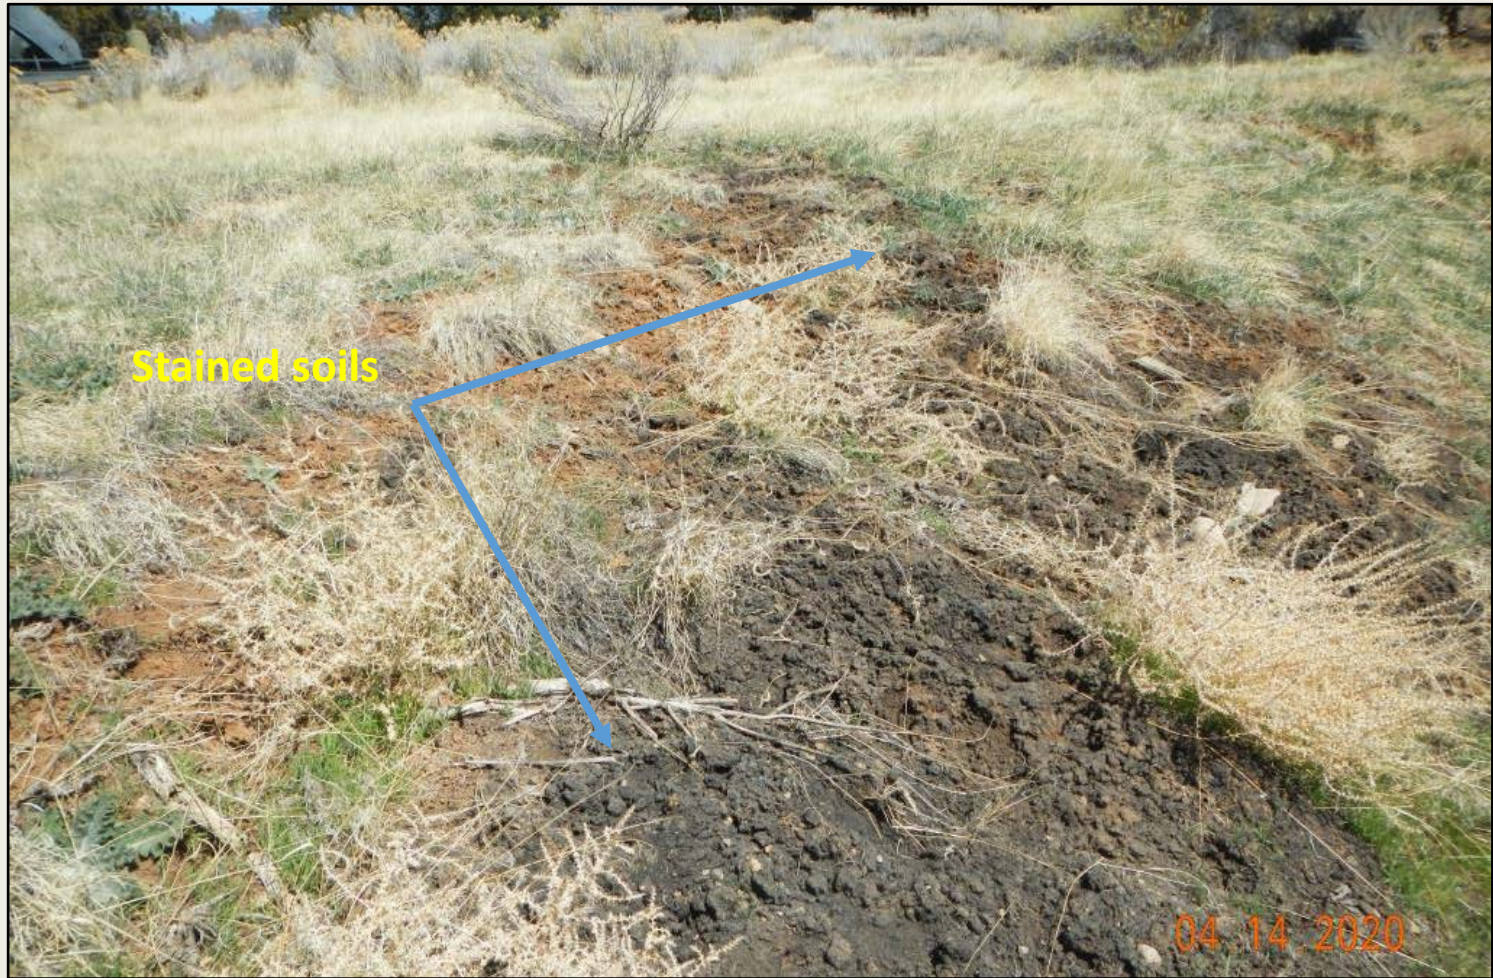
Photo 3. View of stained soils approximately 20 feet long and 6 feet wide, placed within the eastern portion of the interim reclamation area.

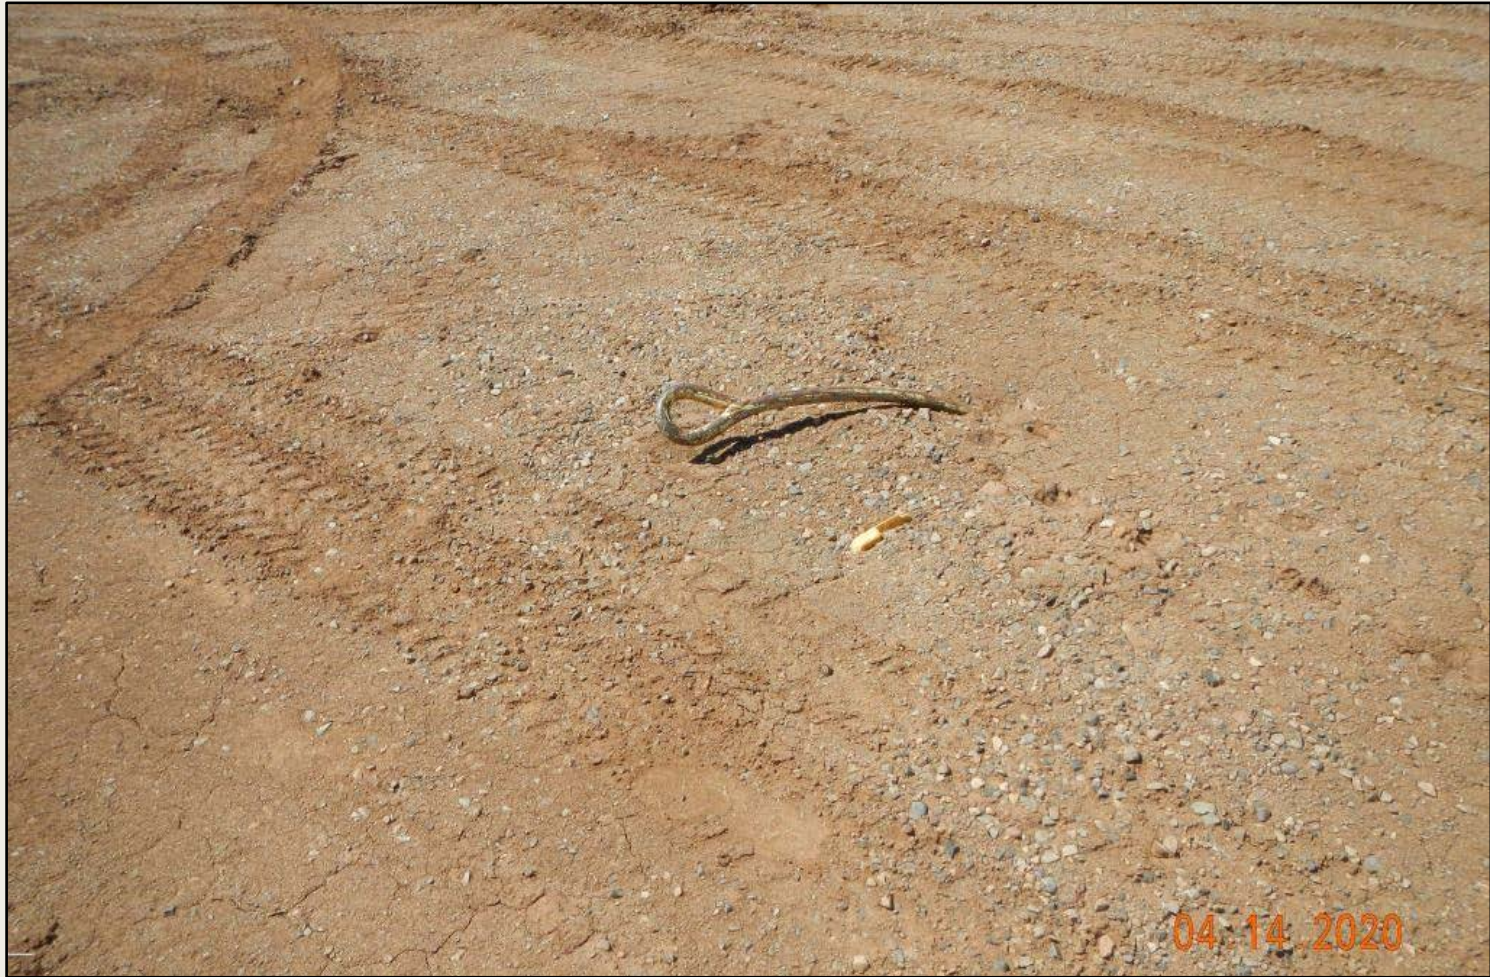
Photo 4. View of unmarked rig anchor on the well pad.

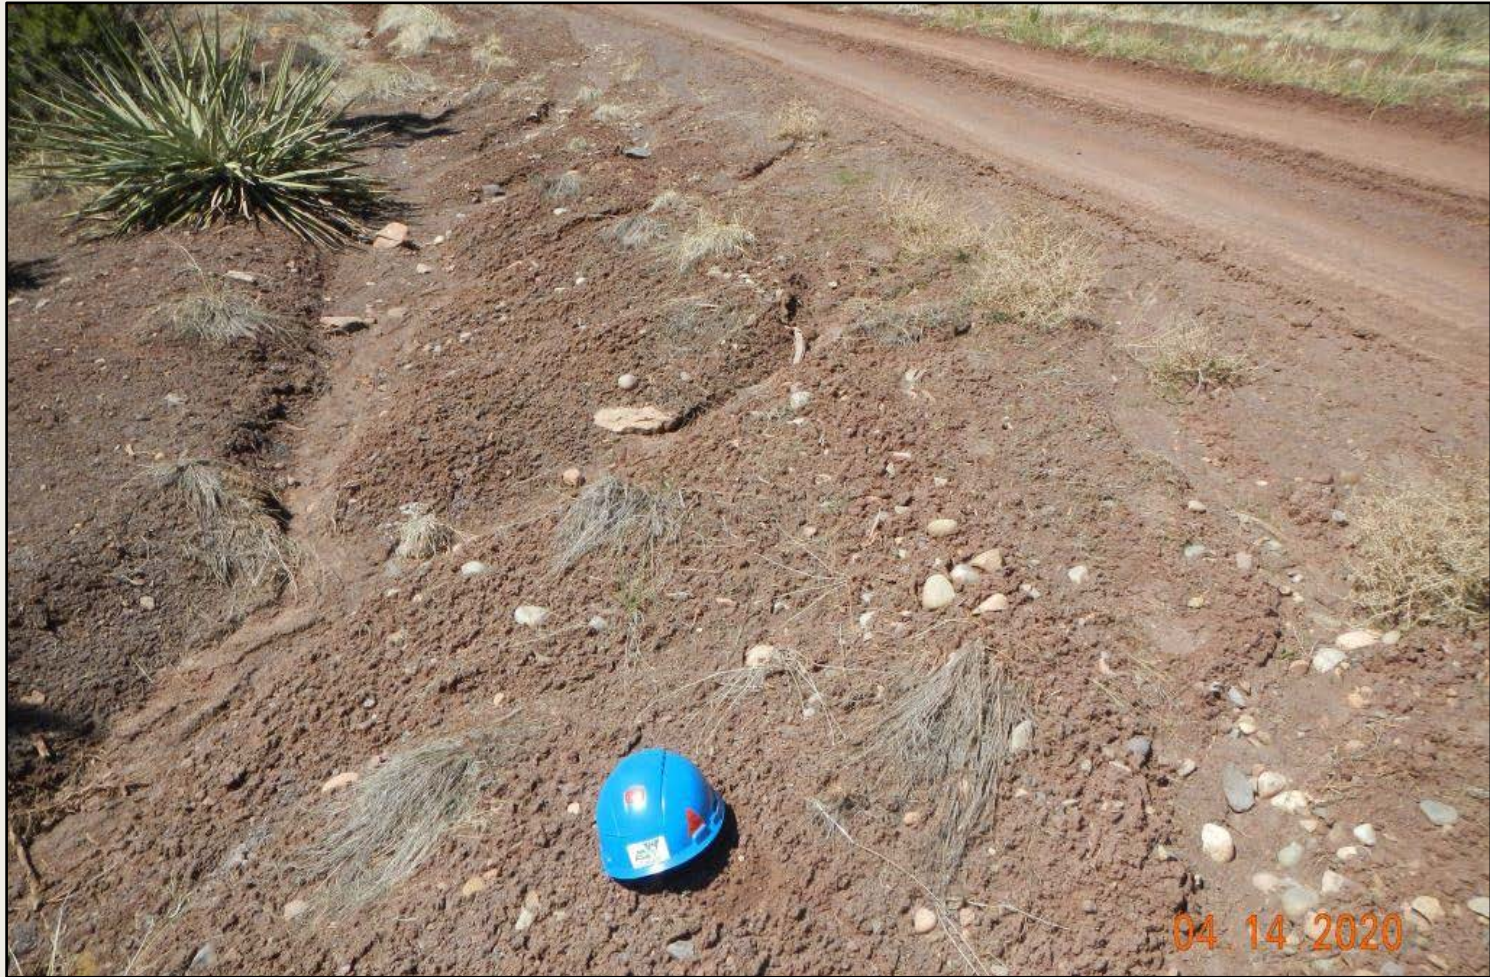
Photo 5. View of erosional rilling and channeling, approximately 2 feet wide and deep, occurring along the access road. Hard hat in place for scale reference.

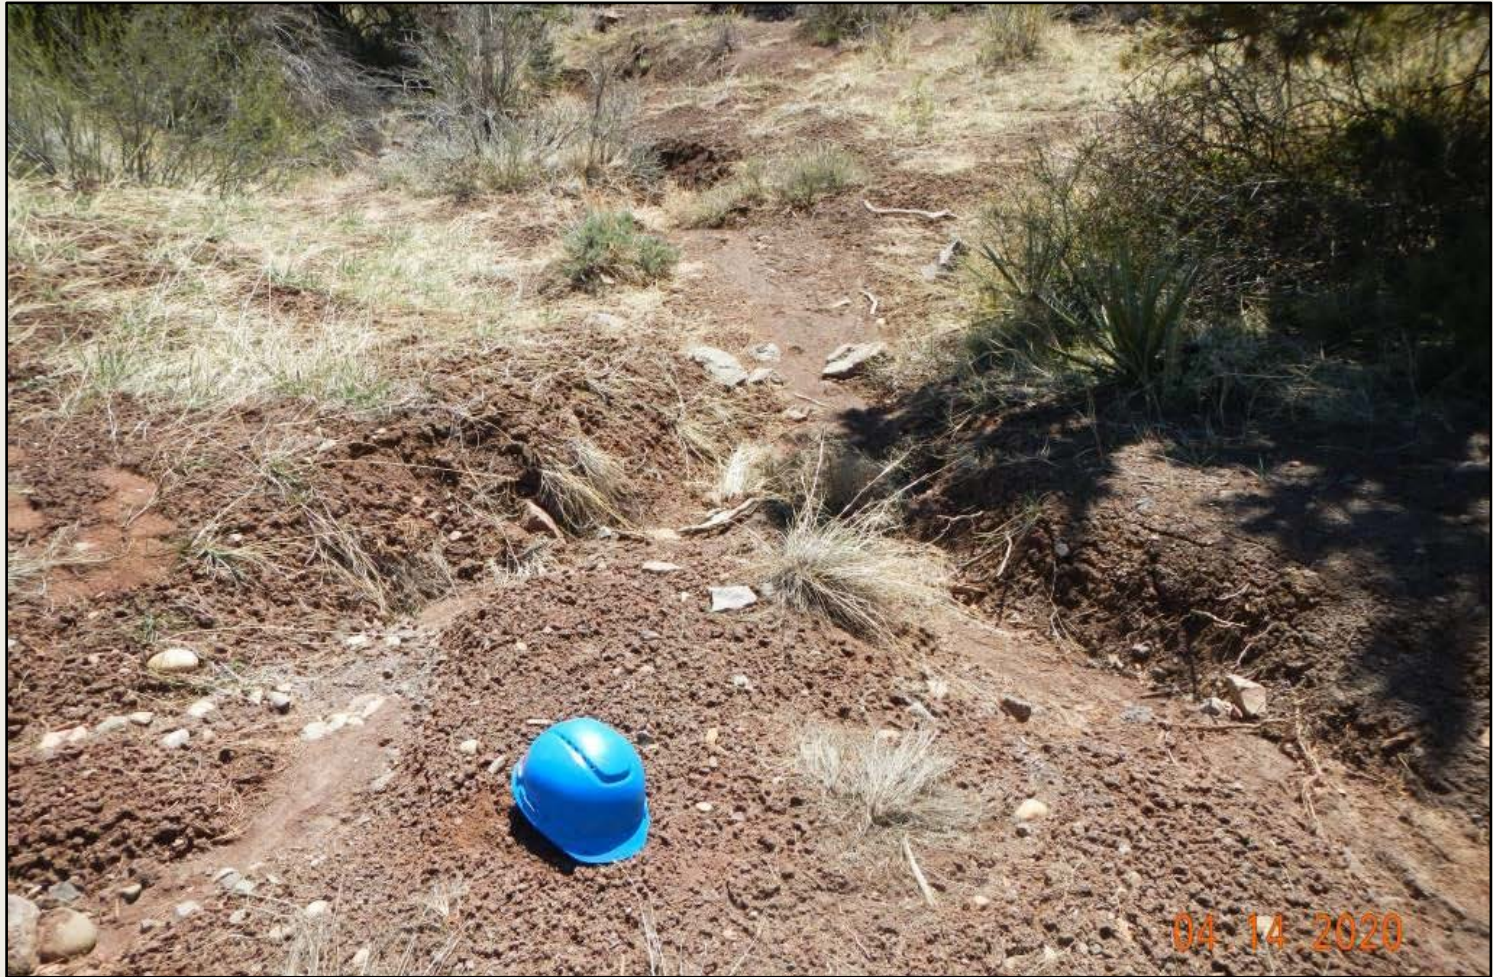
Photo 6. View of area downstream from photo 5 where erosional channeling is occurring from diverted stormwater flowing off of the access road.

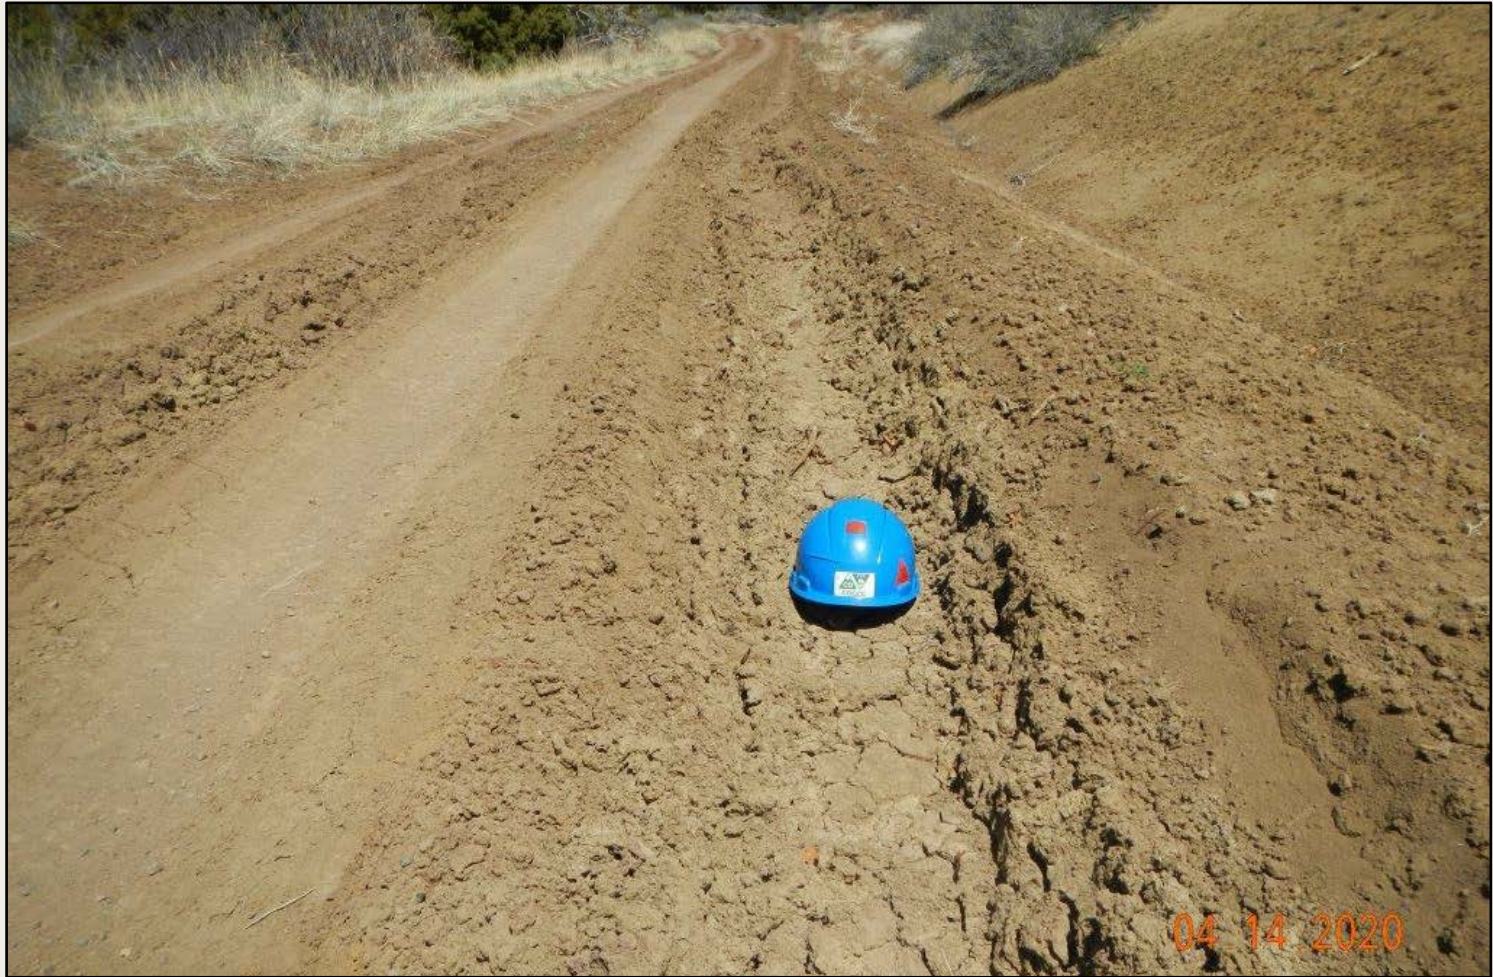
Photo 7. View of rutting on the access road, approximately 1.5 feet deep.

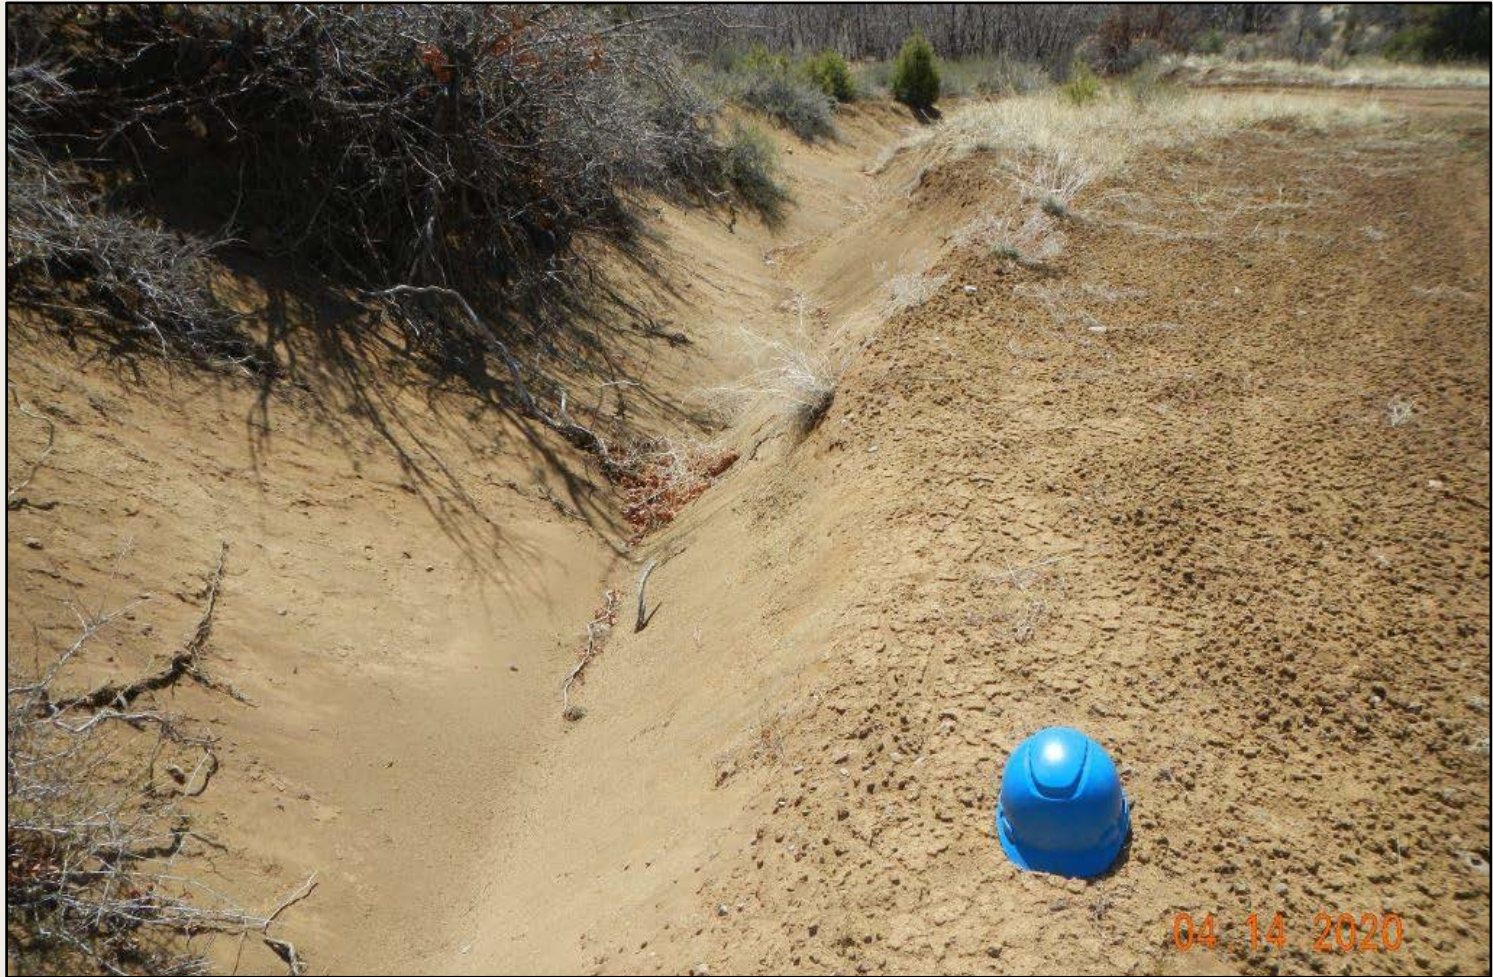
Photo 8. View of roadside ditch along access, that is not stabilized. Significant downcutting is observed, as ditch is approximately 4 feet wide and deep.

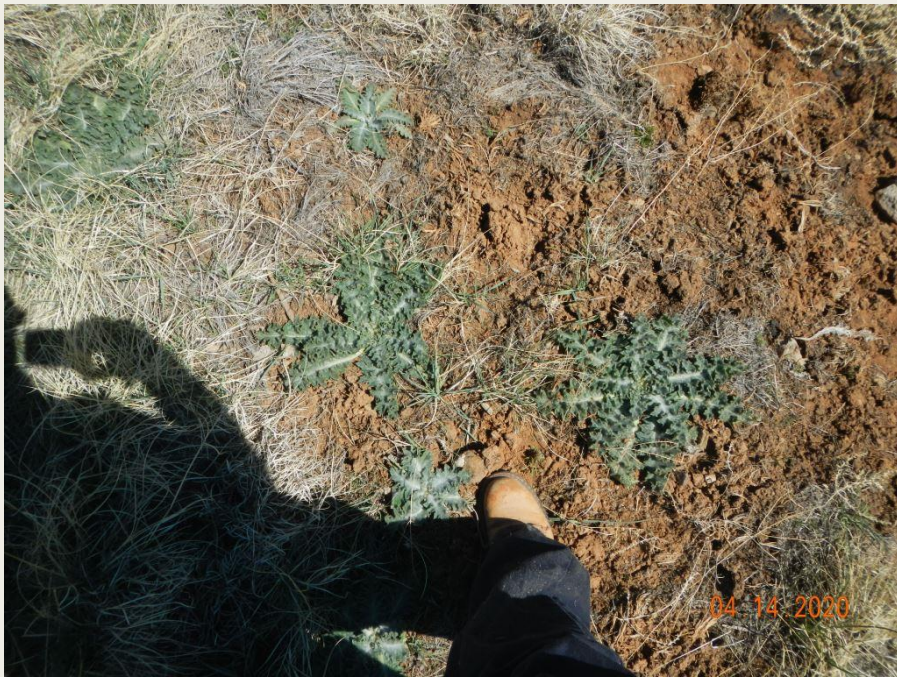
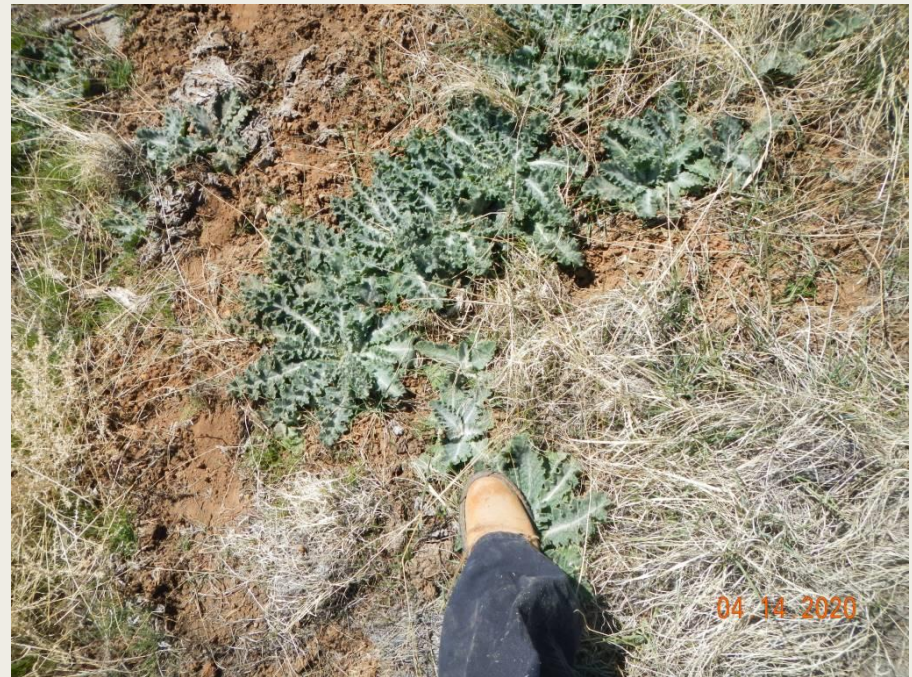
Photos 9/10. View of Scotch thistles within the project area, also observed along access. Approximately 300 individuals observed.

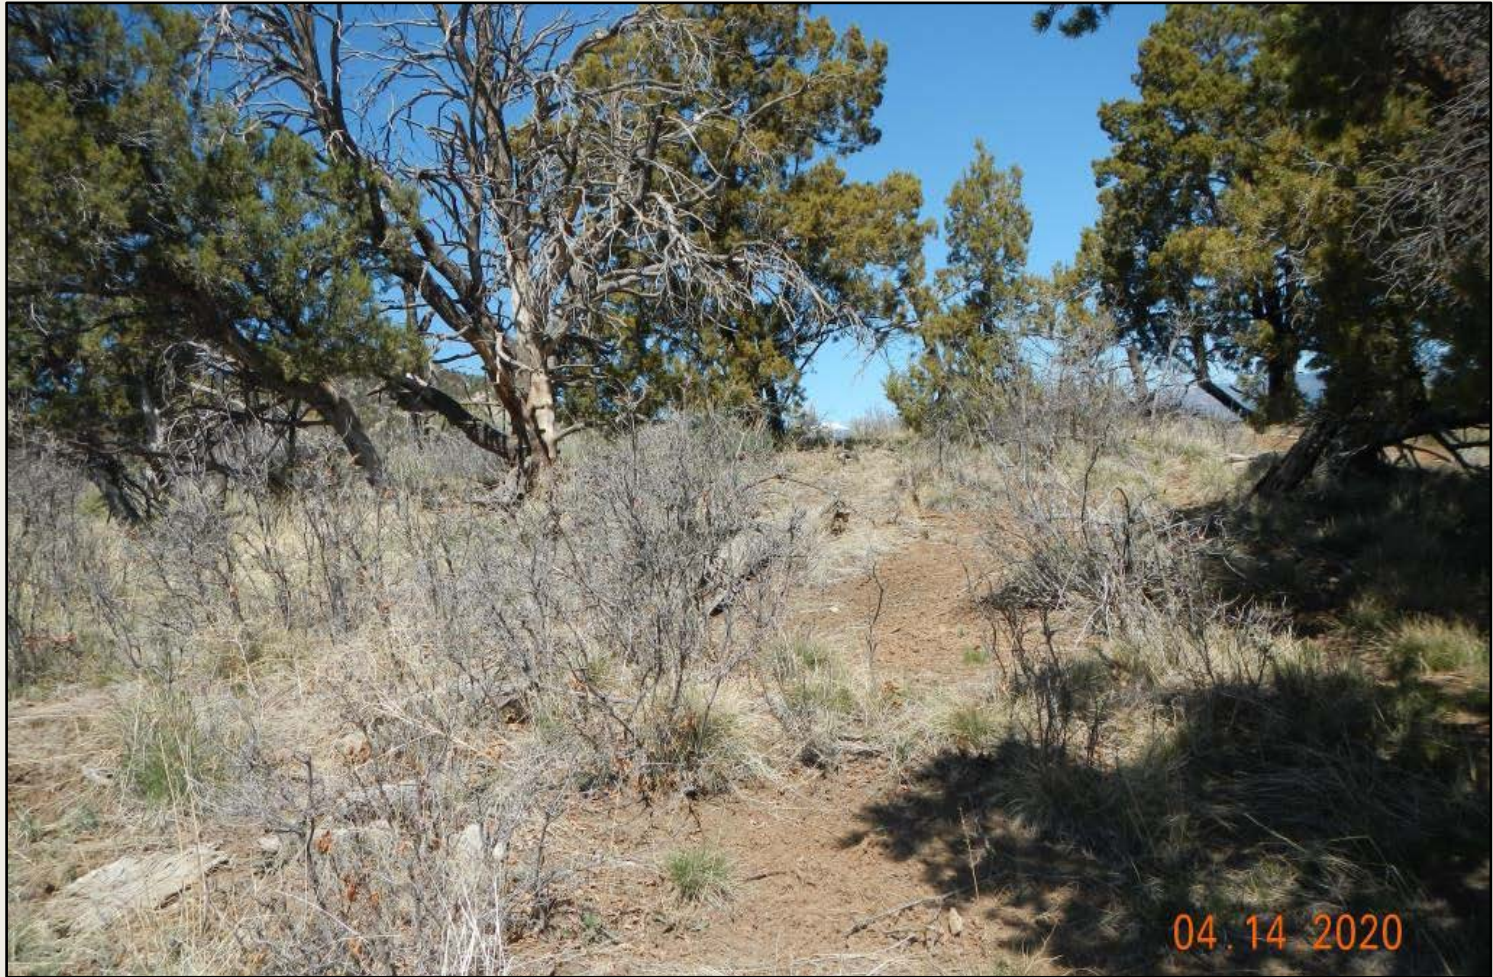
Photo 11. View of reference area, comprised of pinyon-juniper woodland with understory of gambel oak and mountain mahogany with grasses such as Arizona fescue.
