**Inspection Photos**  
**Operator: Enduring Resources**  
**API#: 067-08658**  
**Date: 4/14/2020**

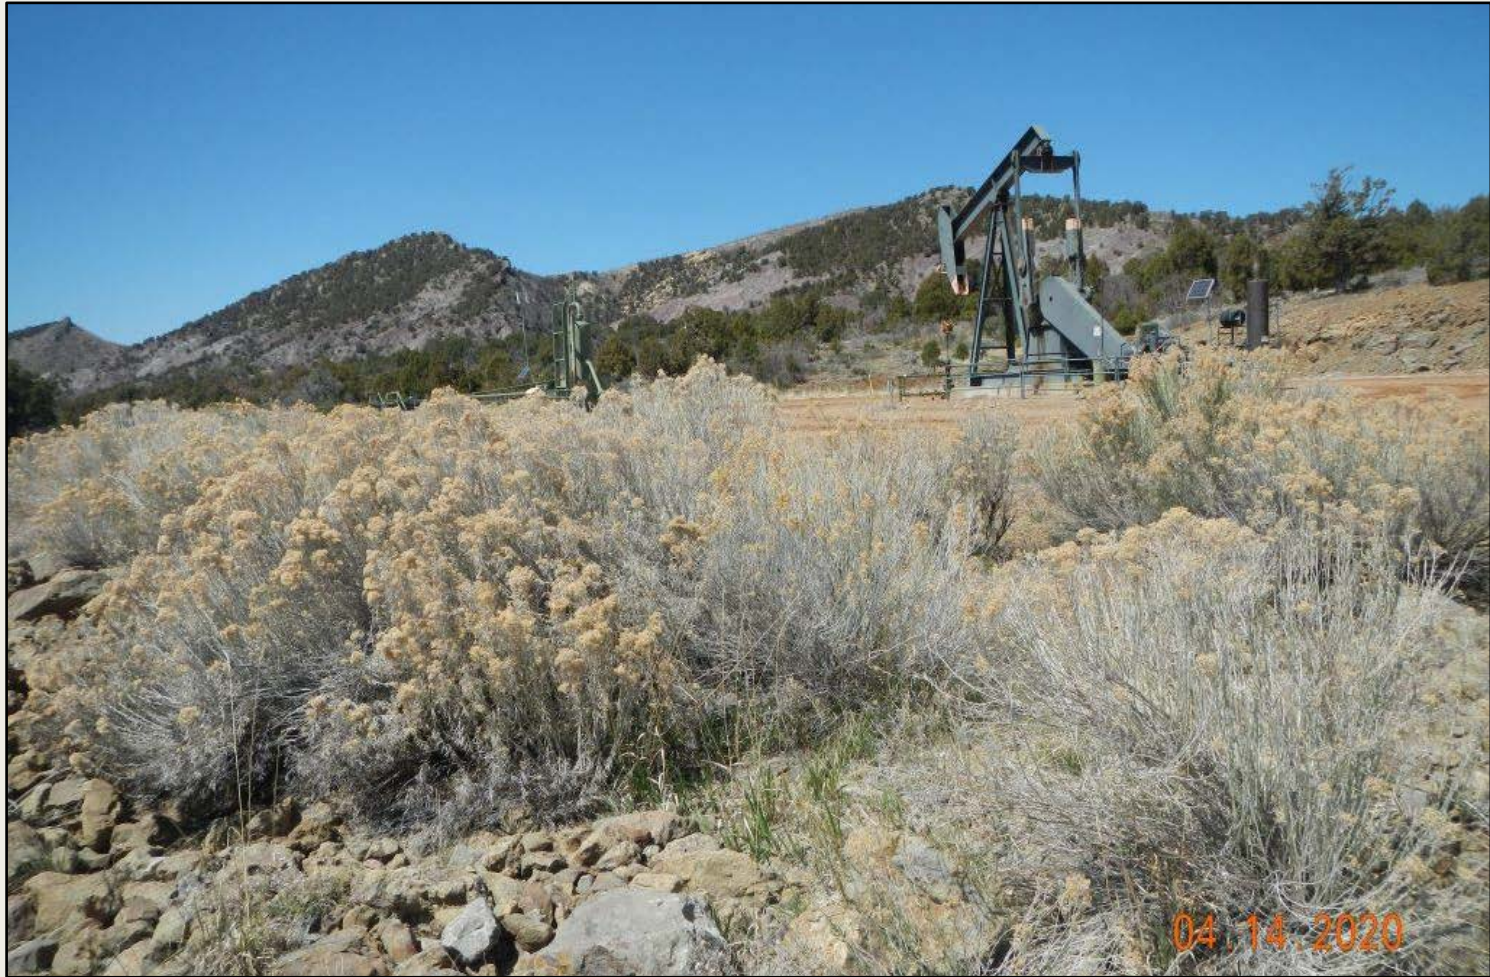
Photo 1. View of the project area from the southeastern corner facing center.

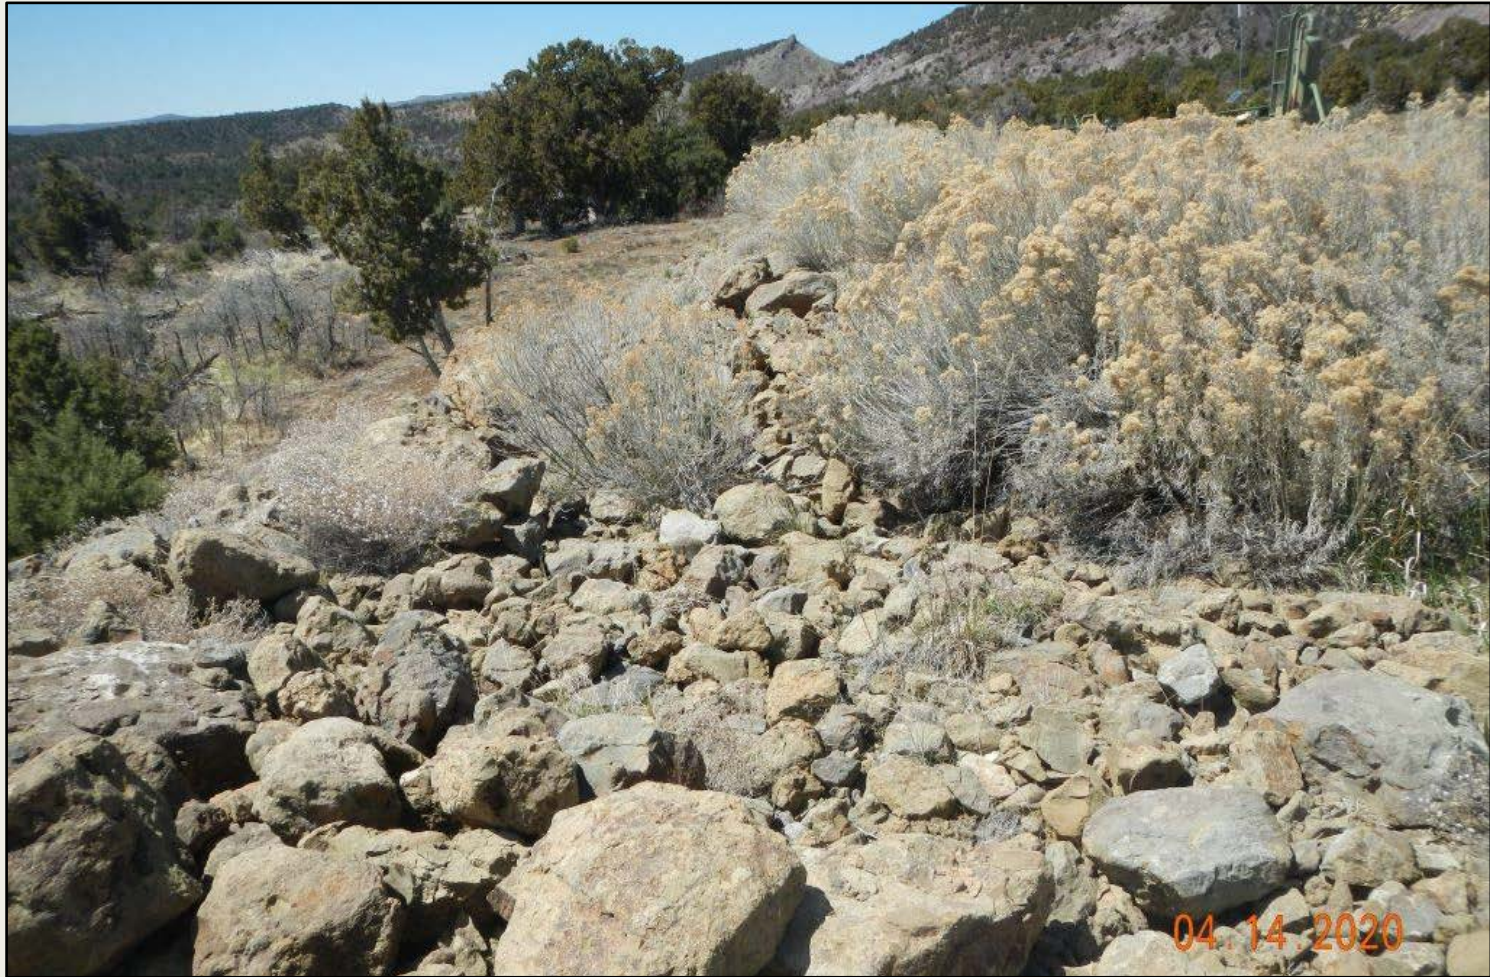
Photo 2. View of the southern fill slope from the southern corner facing westward. Revegetation is with rubber rabbitbrush and western wheatgrass. Interim reclamation area, is largely rock fill.

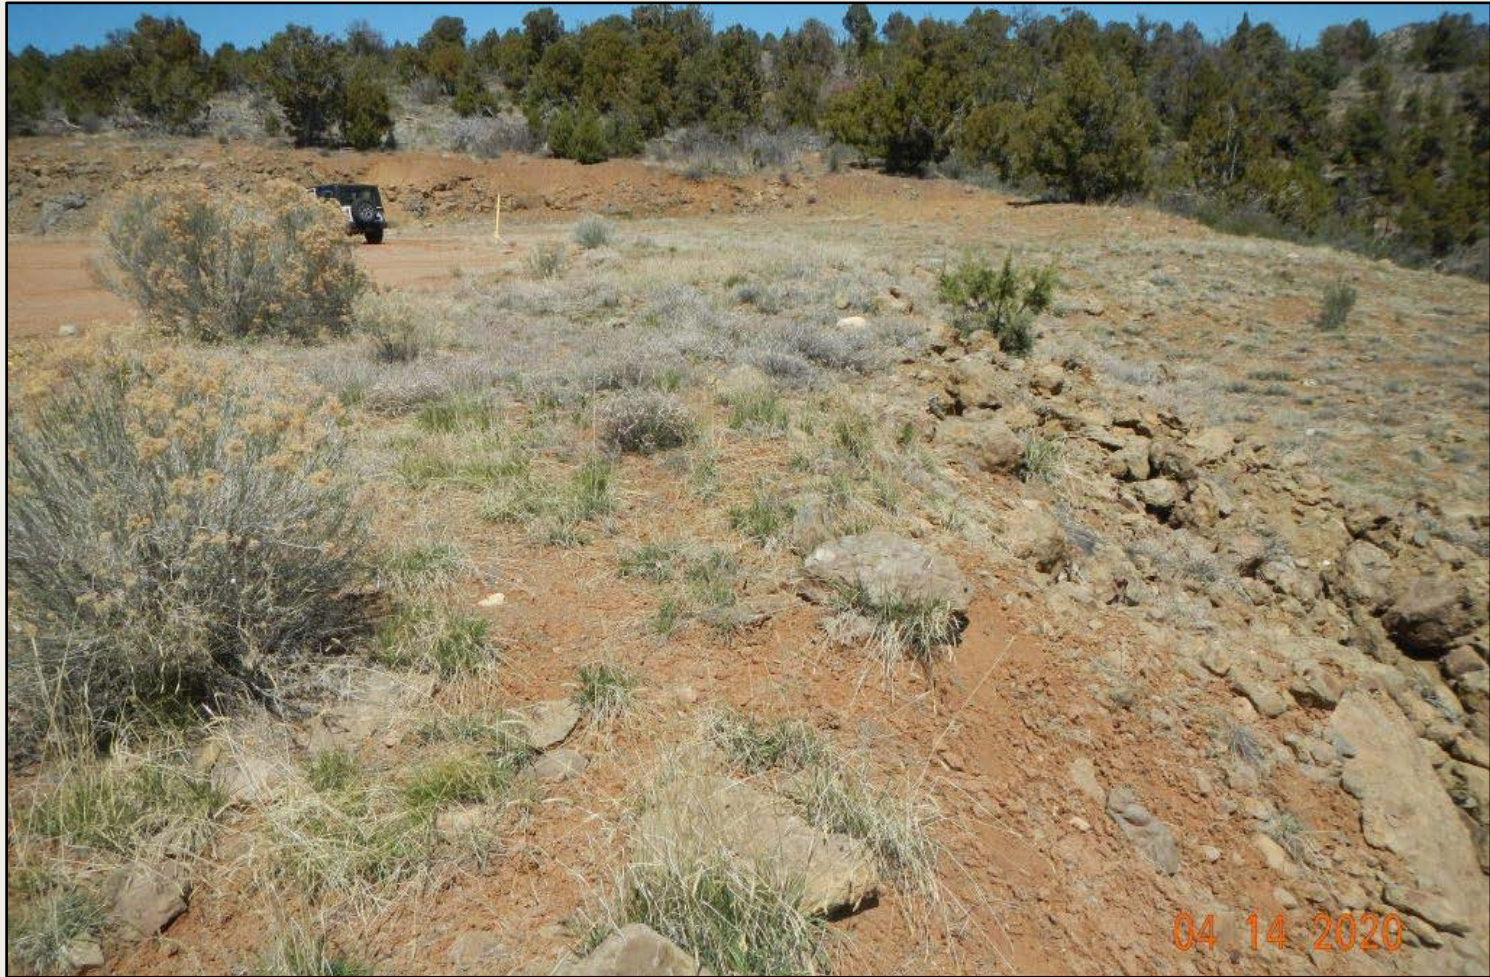
Photo 3. View of the eastern fill slope from the southeastern corner facing northward.

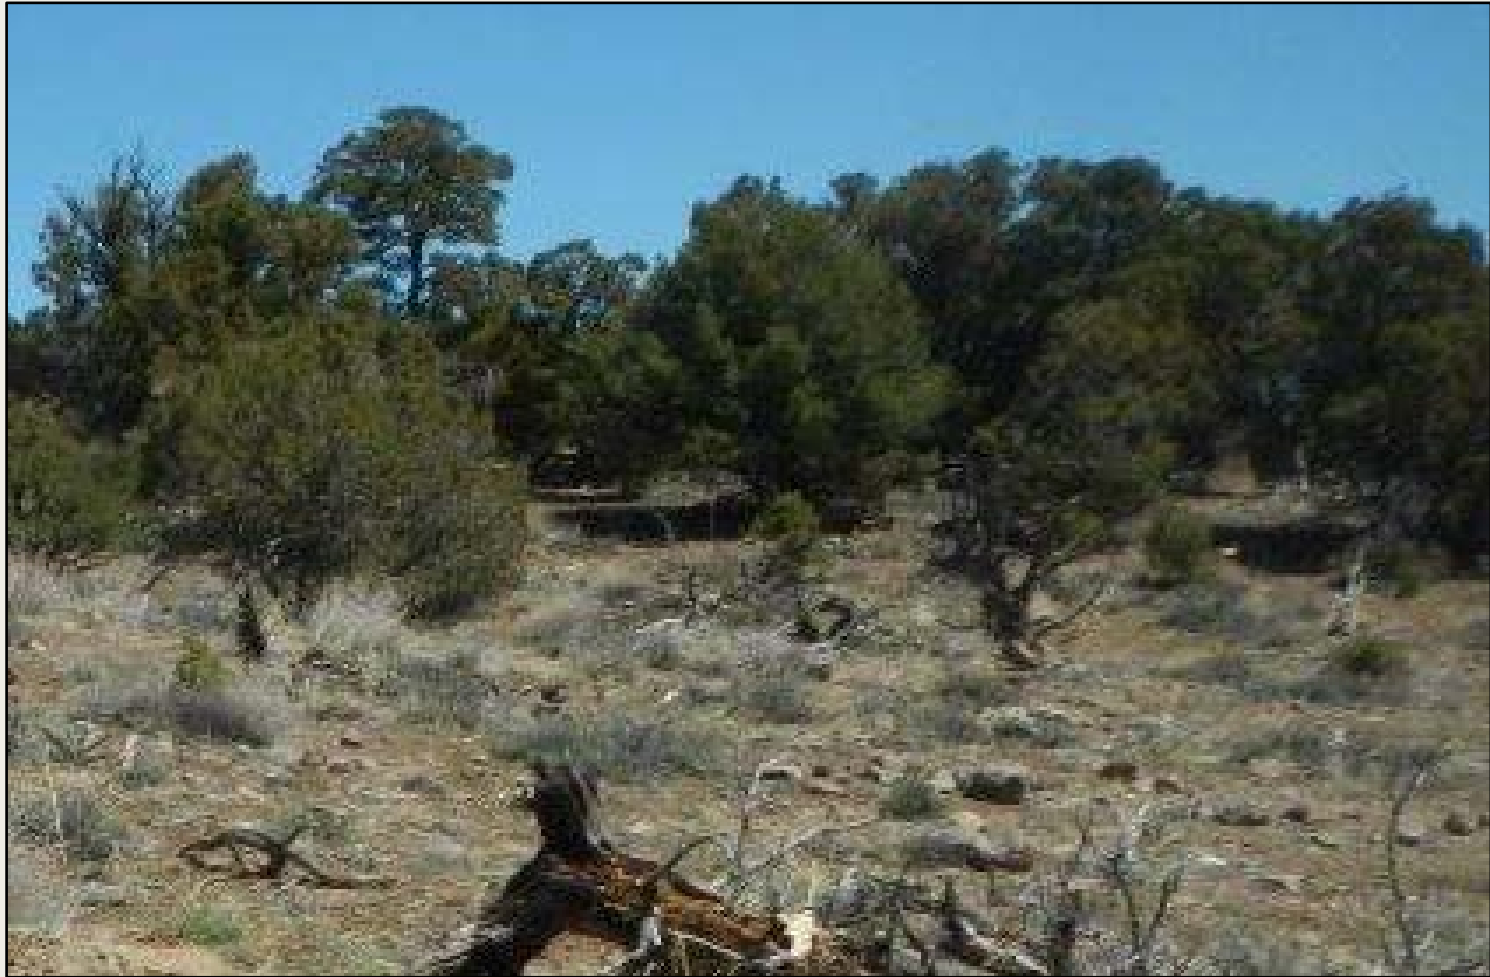
Photo 4. View of reference area, comprised of pinyon-juniper woodland with understory of sagebrush, antelope bitterbrush, and a mixture of grasses and forbs.
