Inspection Photos
Operator: Enduring Resources
API#: 067-07636
Date: 4/14/2020

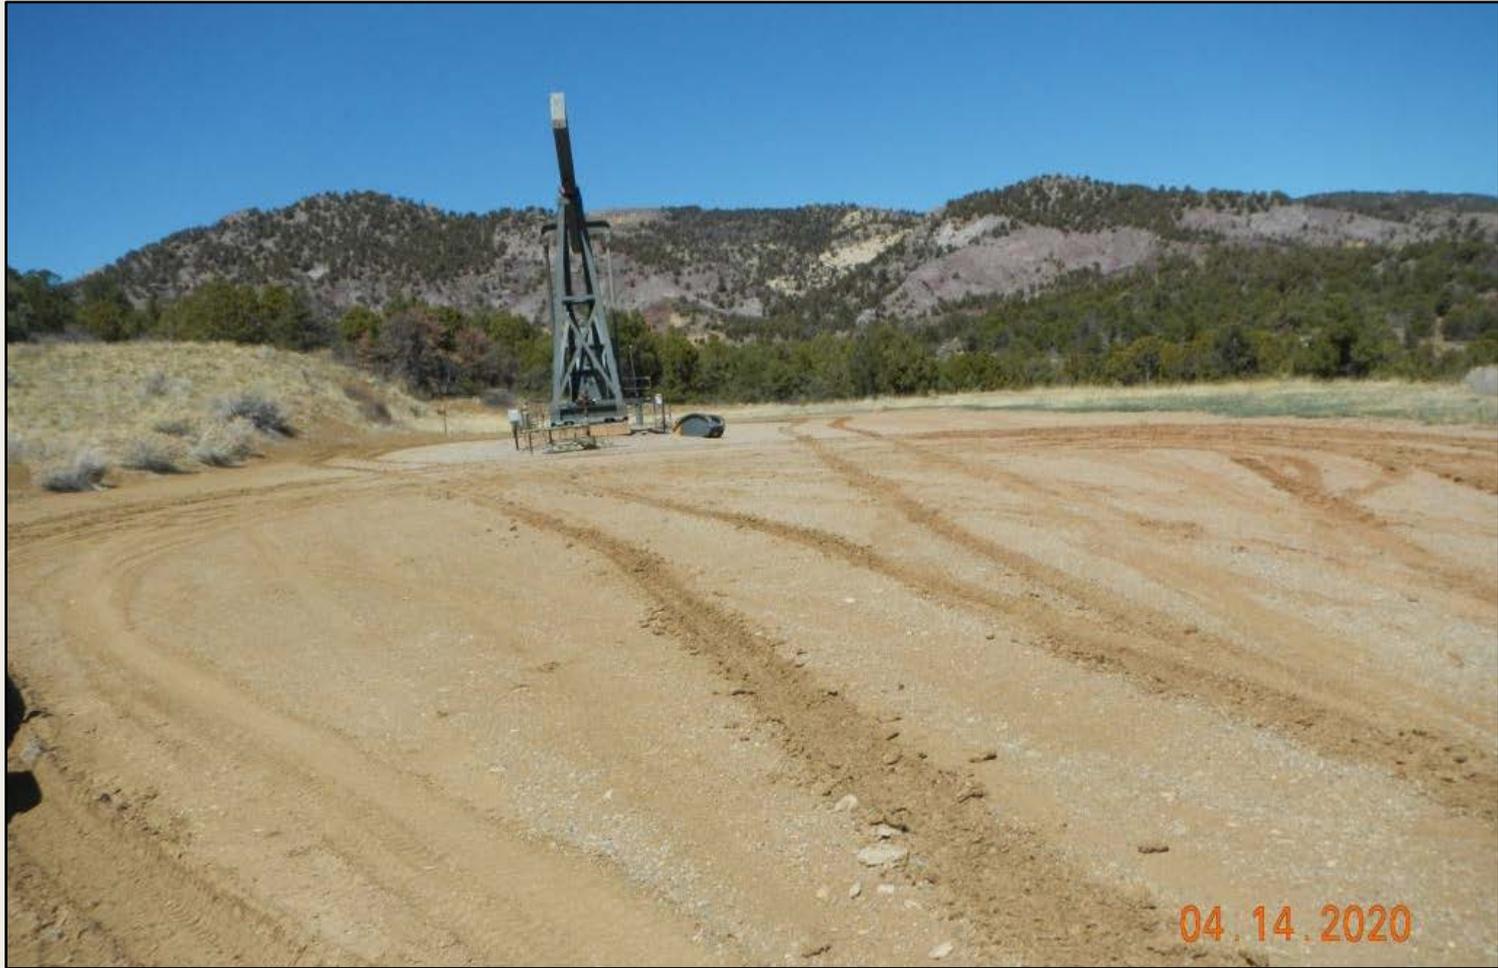
Photo 1. View of the project area from the well pad entrance facing center.

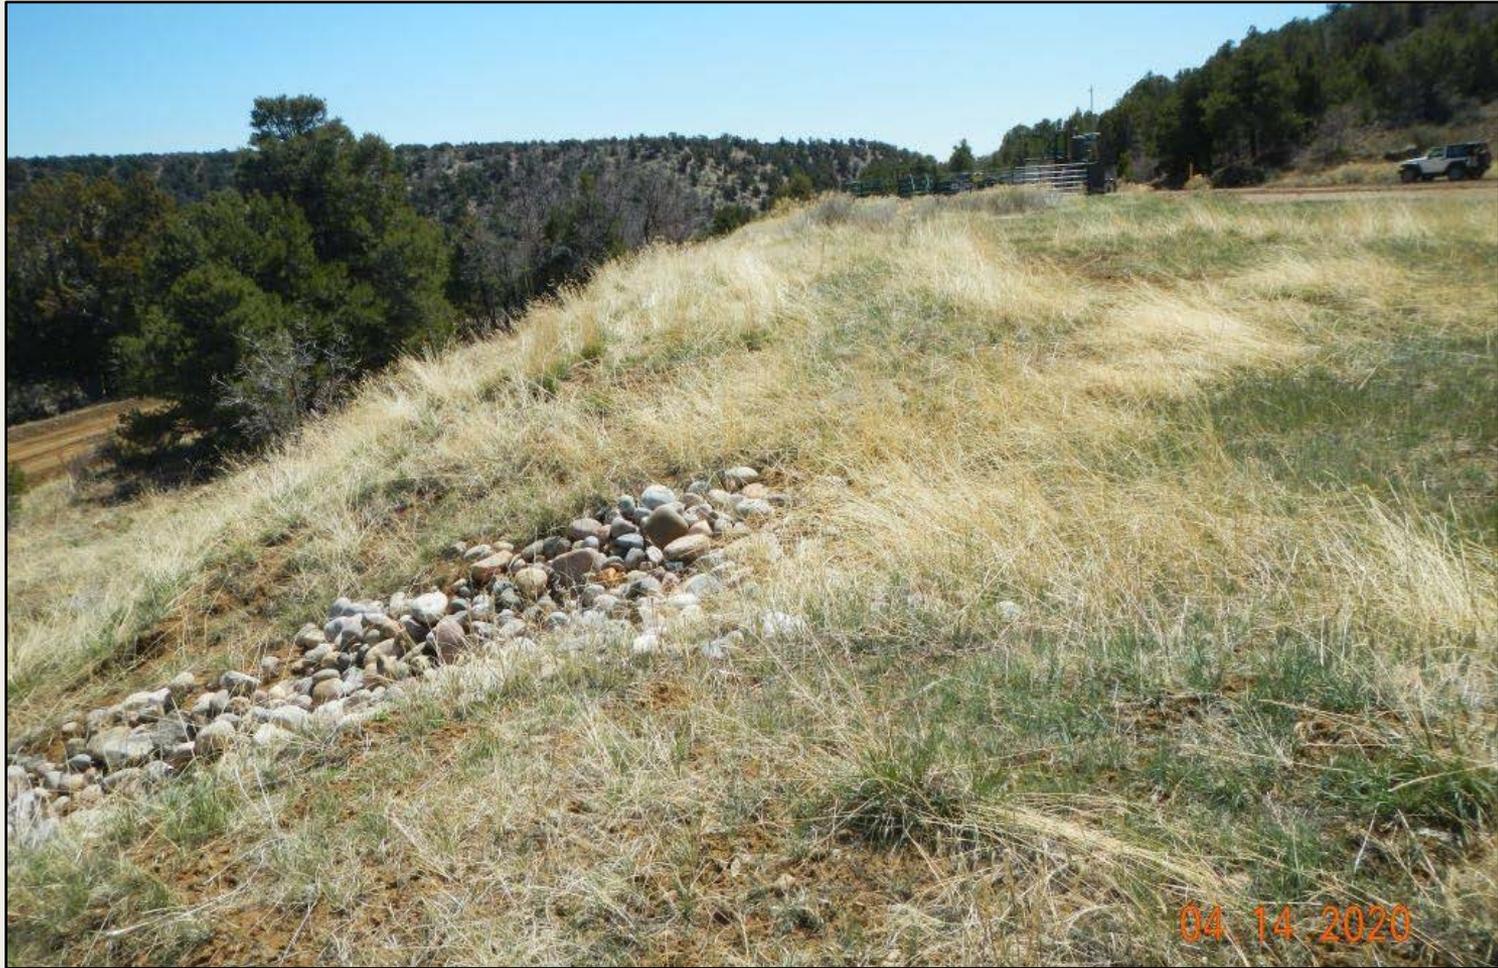
Photo 2. View of the northeastern fill slope from the northern corner facing southeastward. Revegetation is progressing, largely with western wheatgrass and sand dropseed.
