Inspection Photos

API: 071-09853

Operator: TIMBER CREEK OPERATING

Inspection Date: 4/15/2020

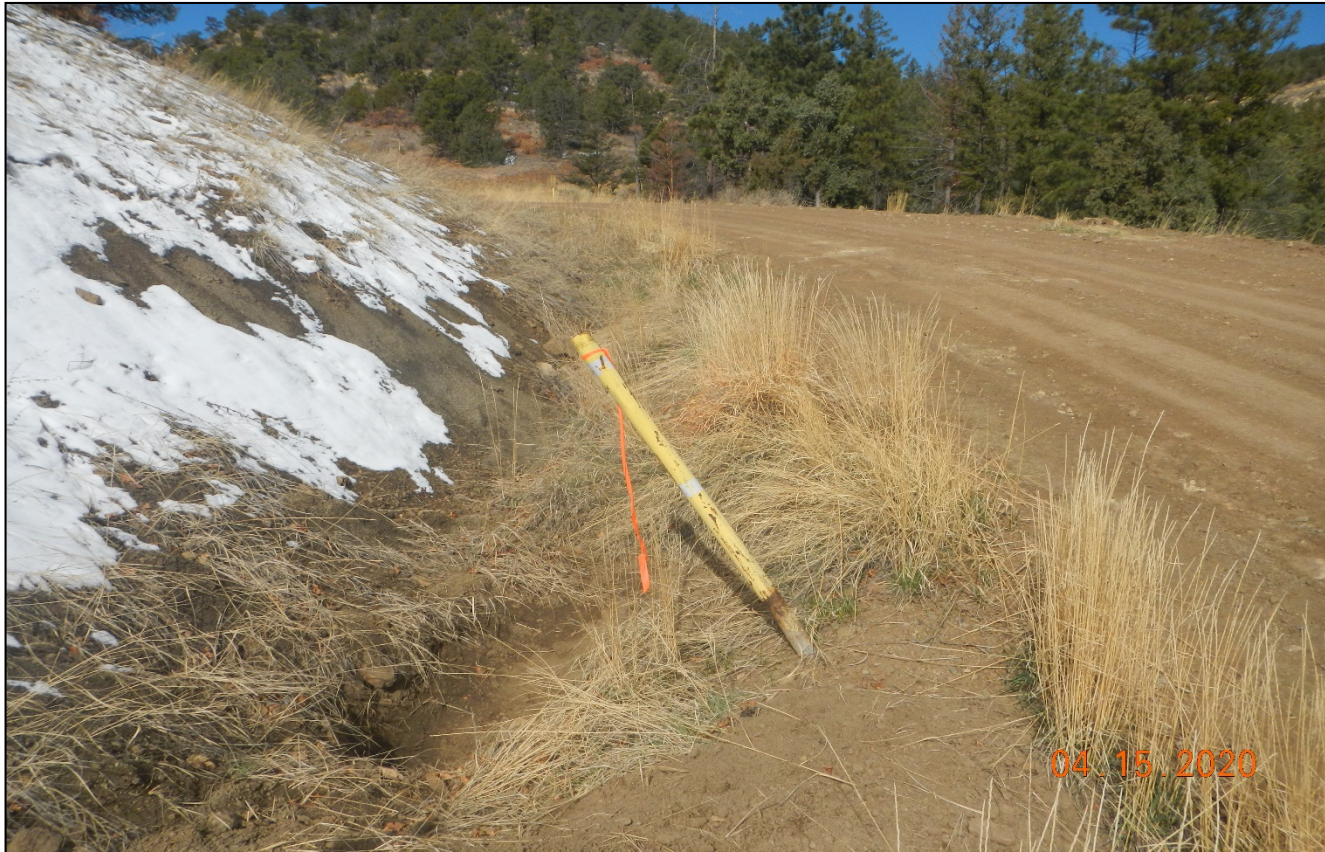
Photo 1. The culvert along the main lease road has been maintained.

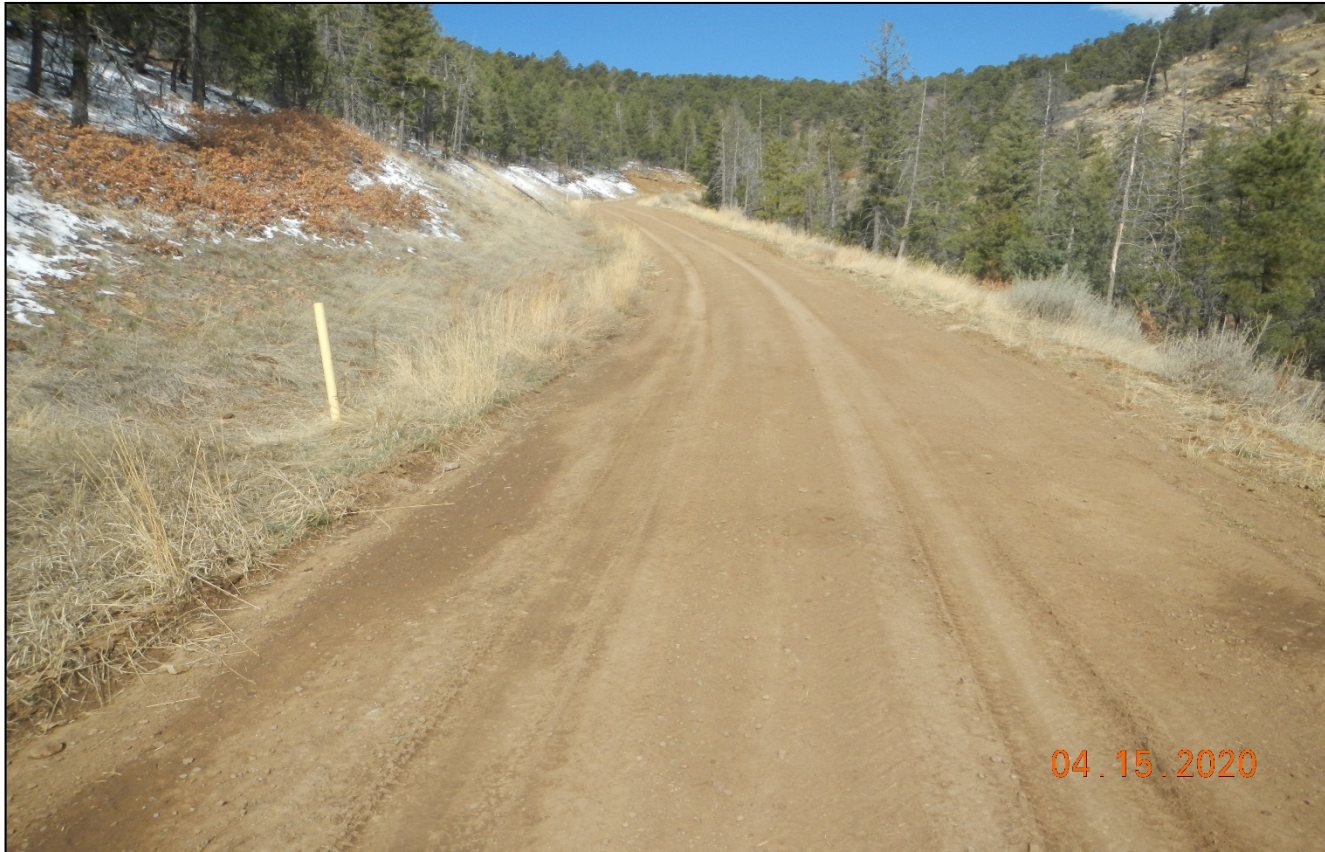
Photo 2. Facing northwest along the main lease road ascending the hill. The road has been regraded.

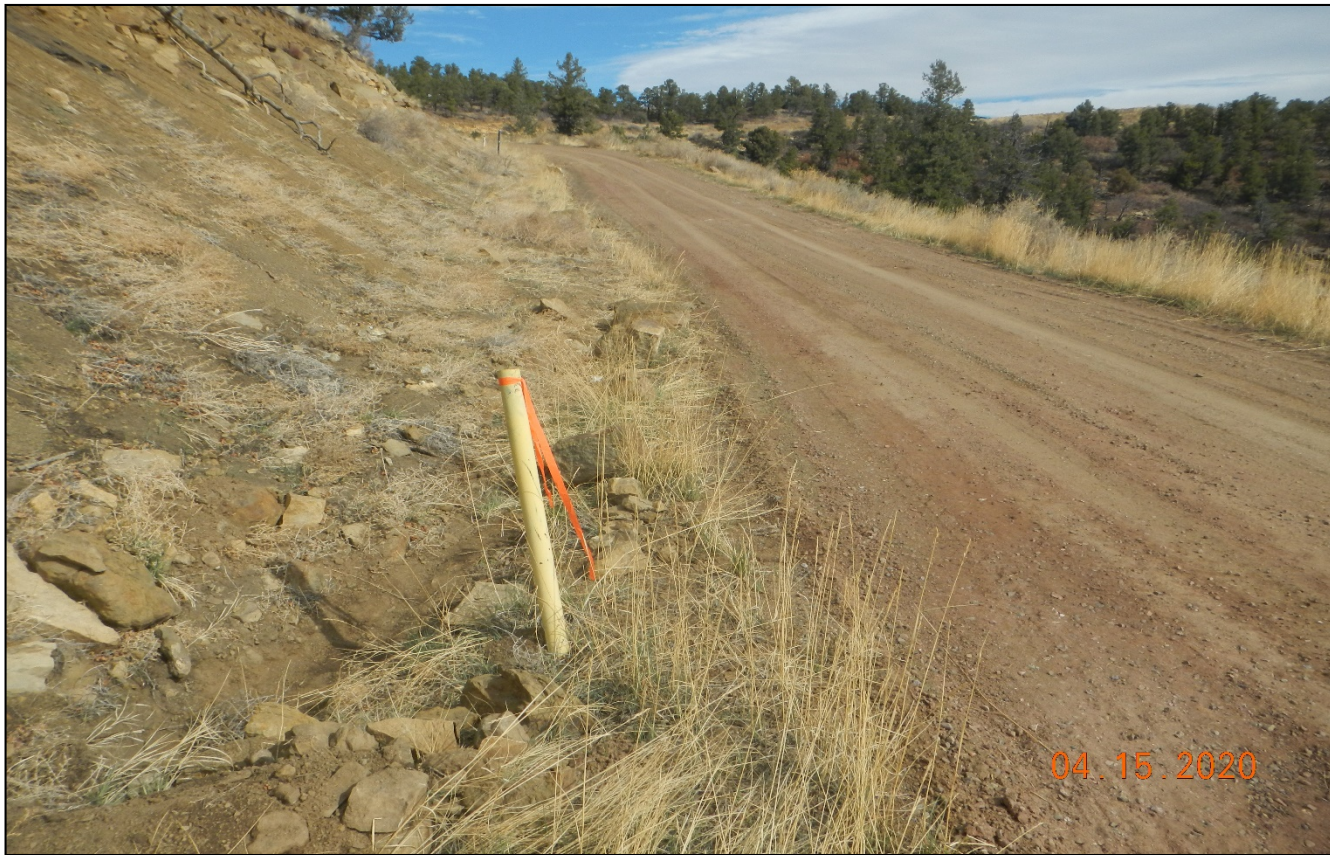
Photo 3. The culvert along the main lease road has been maintained.

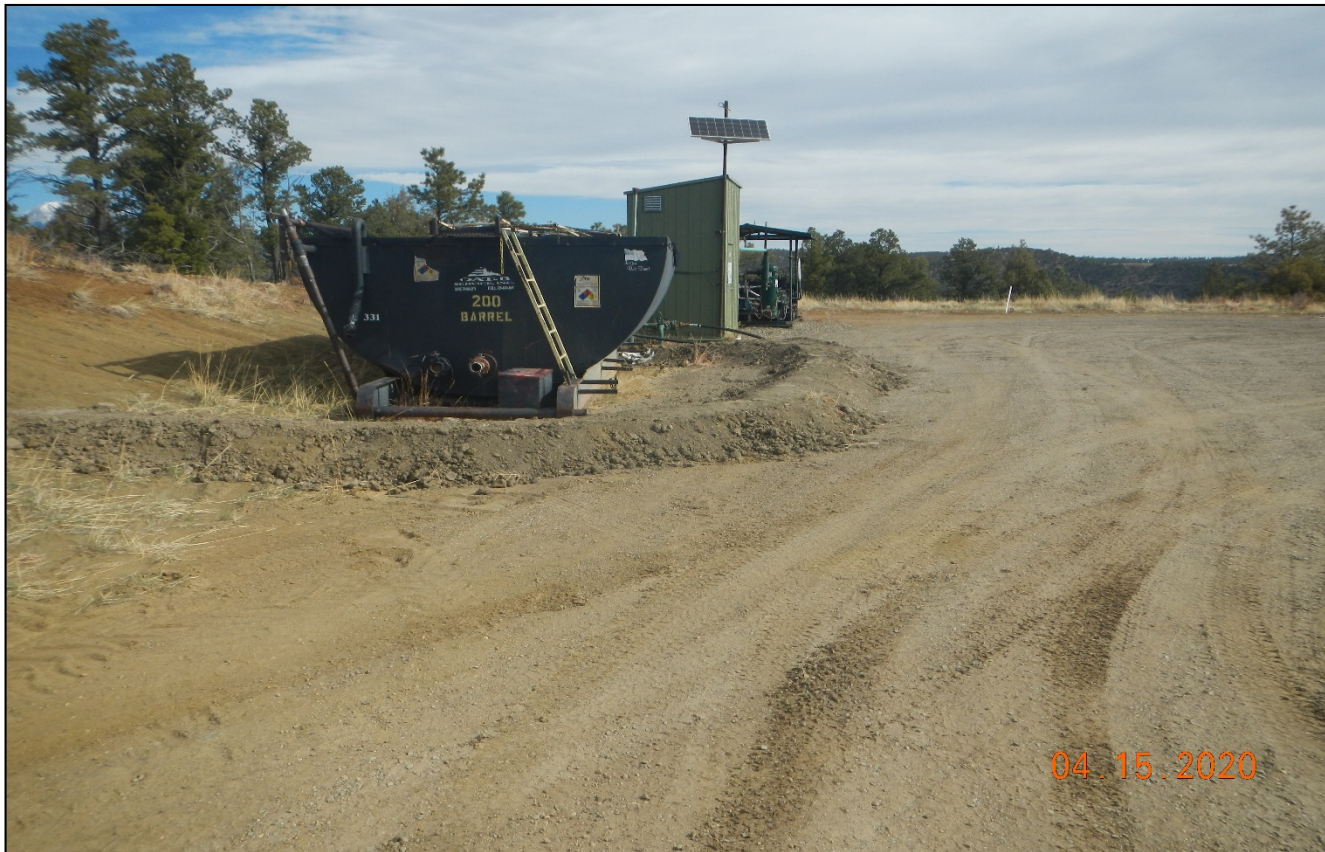
Photo 4. A berm has been installed around the open topped tank.

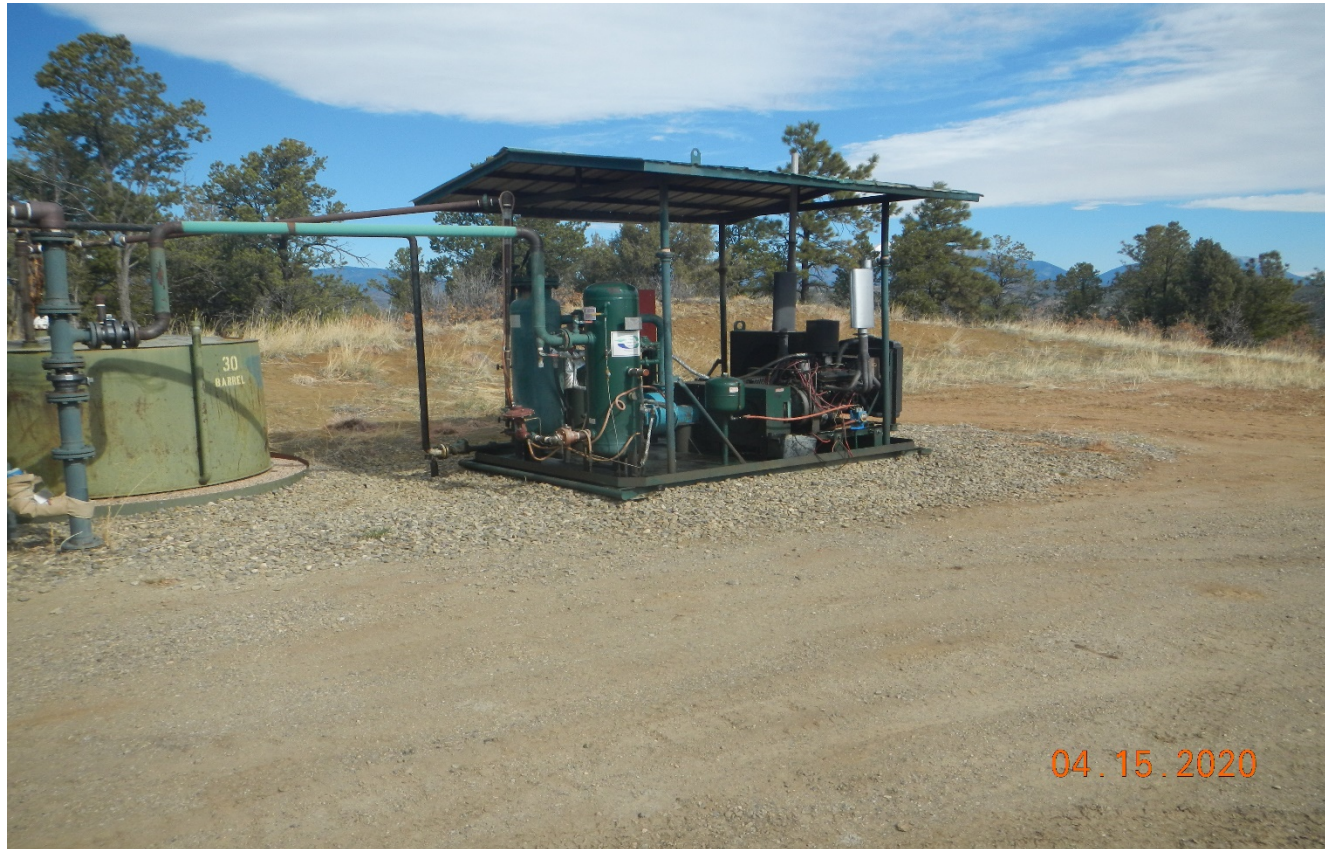
Photo 5. The exhaust pipe which was laying on the ground has been removed.
