# Inspection Photos

Operator: Enduring Resources  
API#: 067-08647  
Date: 4/14/2020

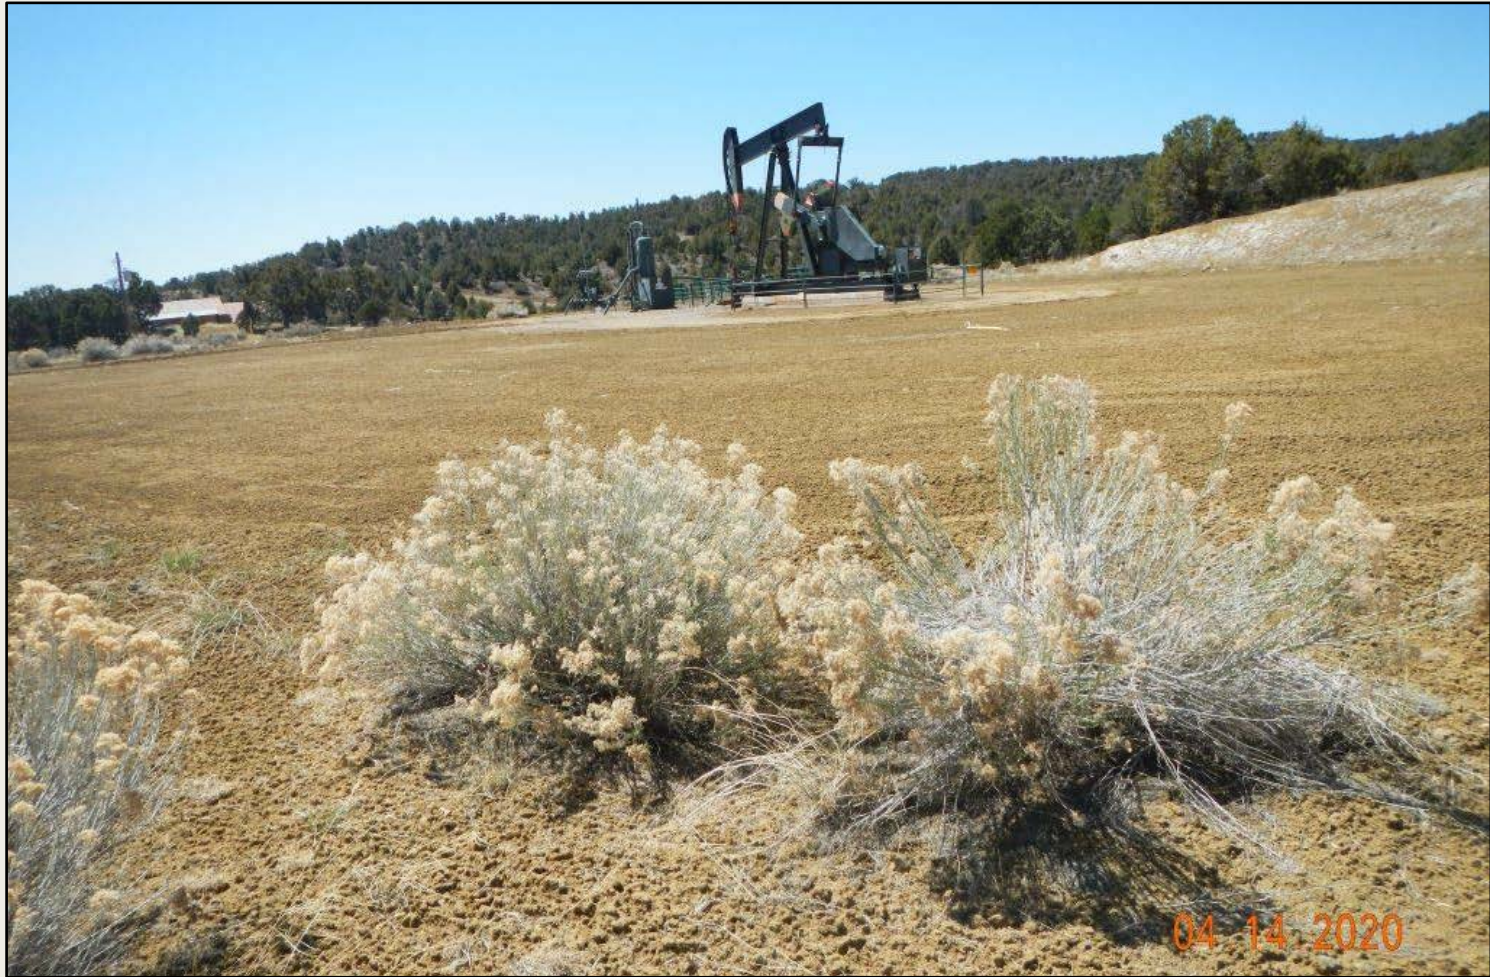
Photo 1. View of the project area from the northeastern corner facing center.

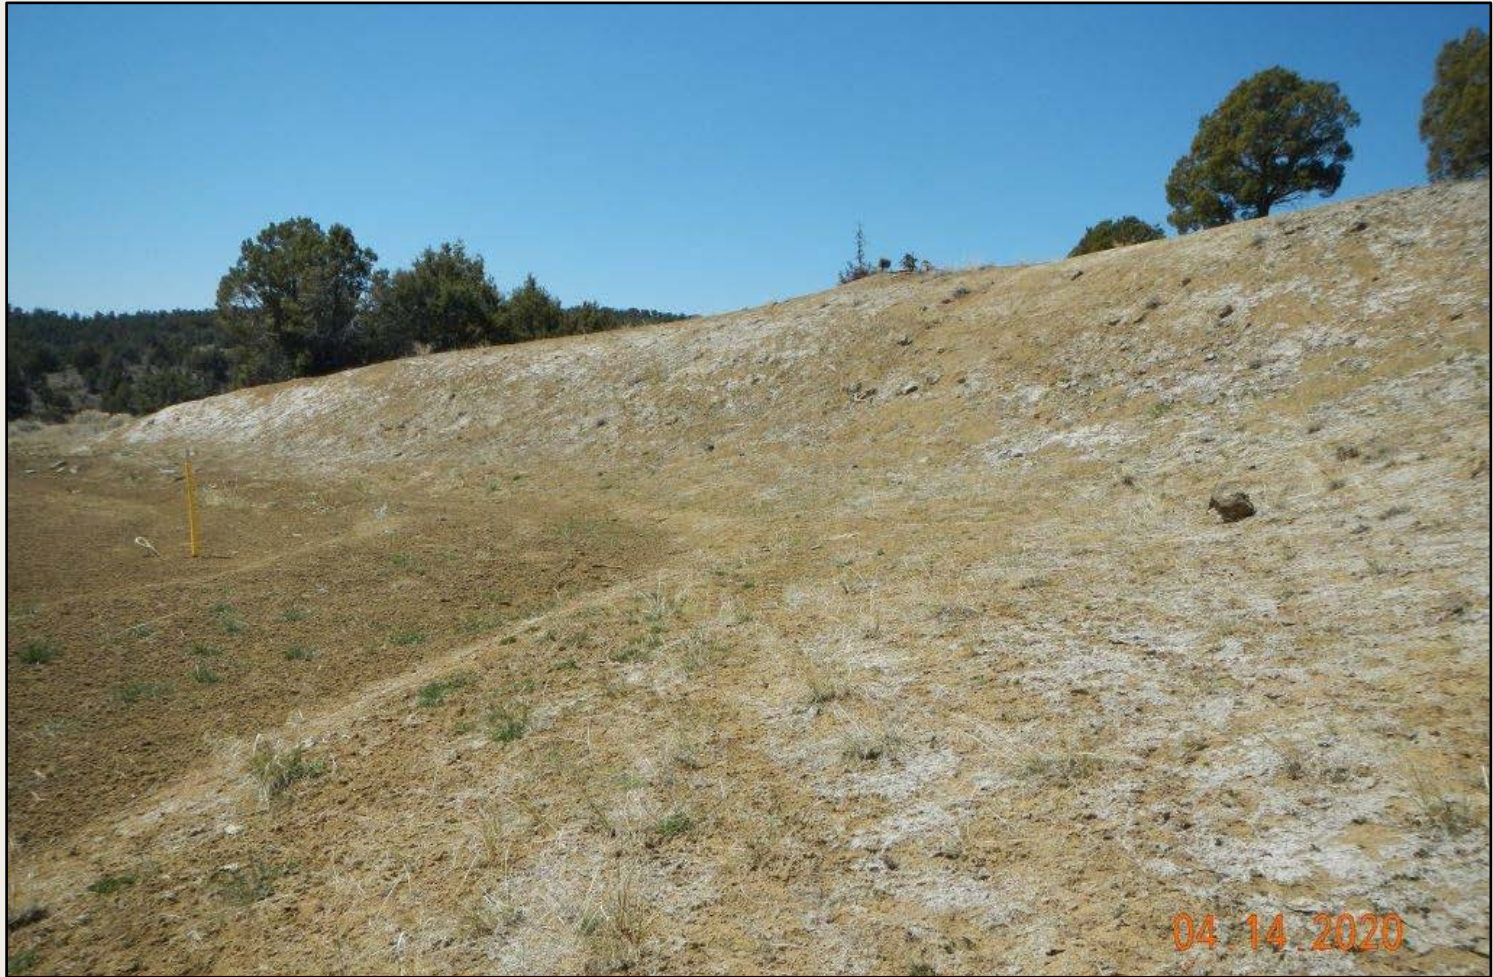
Photo 2. View of the northwestern project area facing southward. Cut-slopes appear to be re-seeded, hydromulch remains on slope.

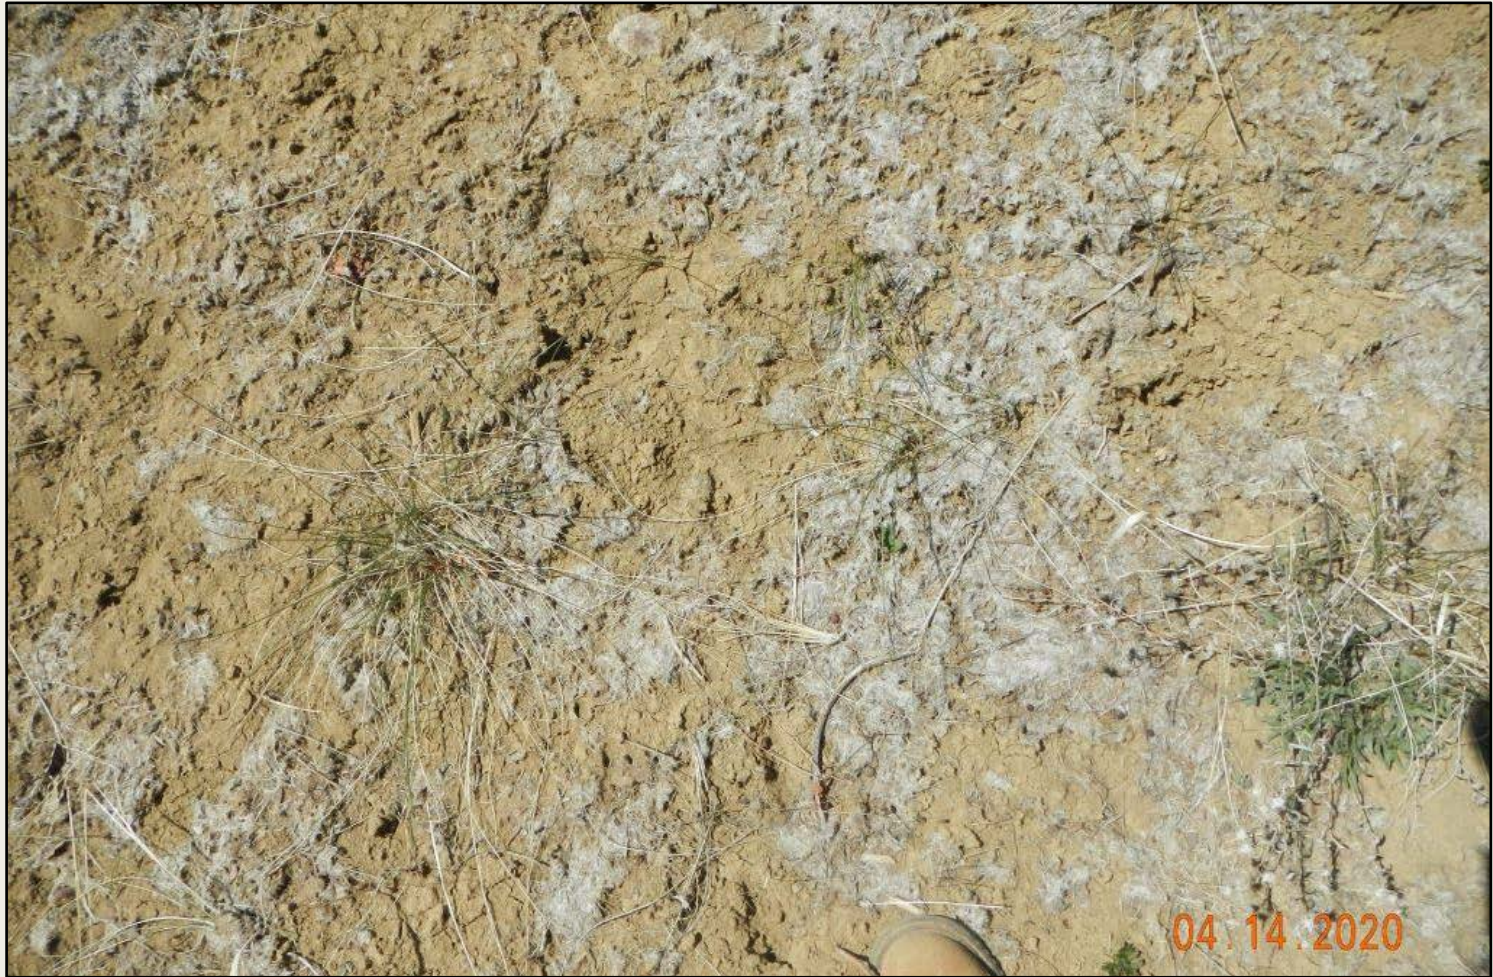
Photo 3. Birdseye view of young grasses observed within revegetation area.

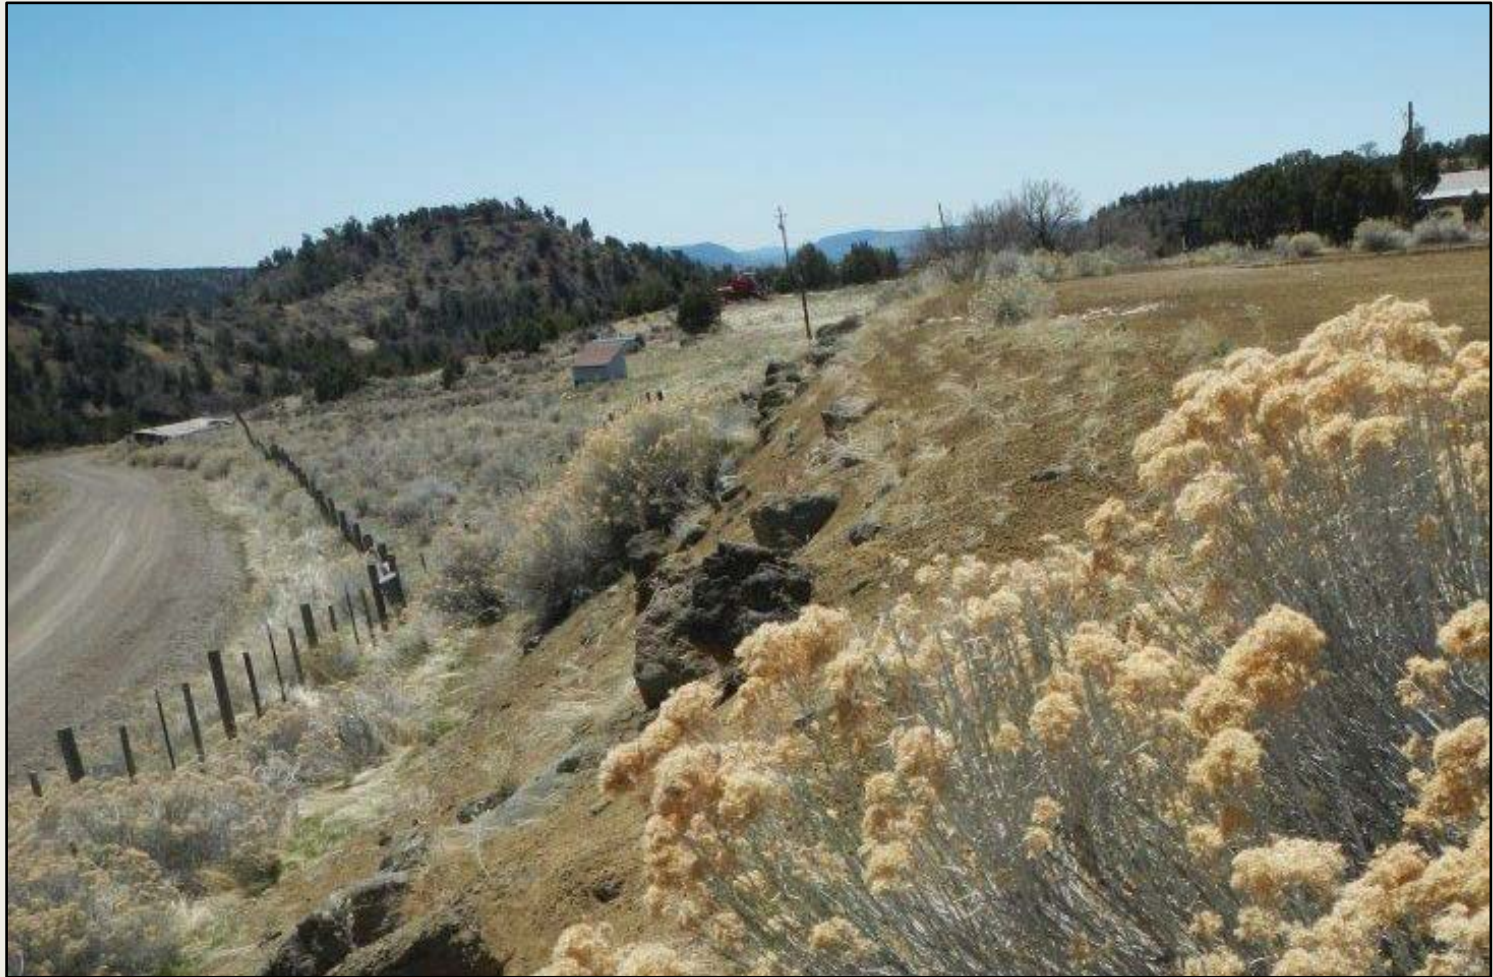
Photo 4. View of the eastern fill slope from the northeastern corner facing southward.

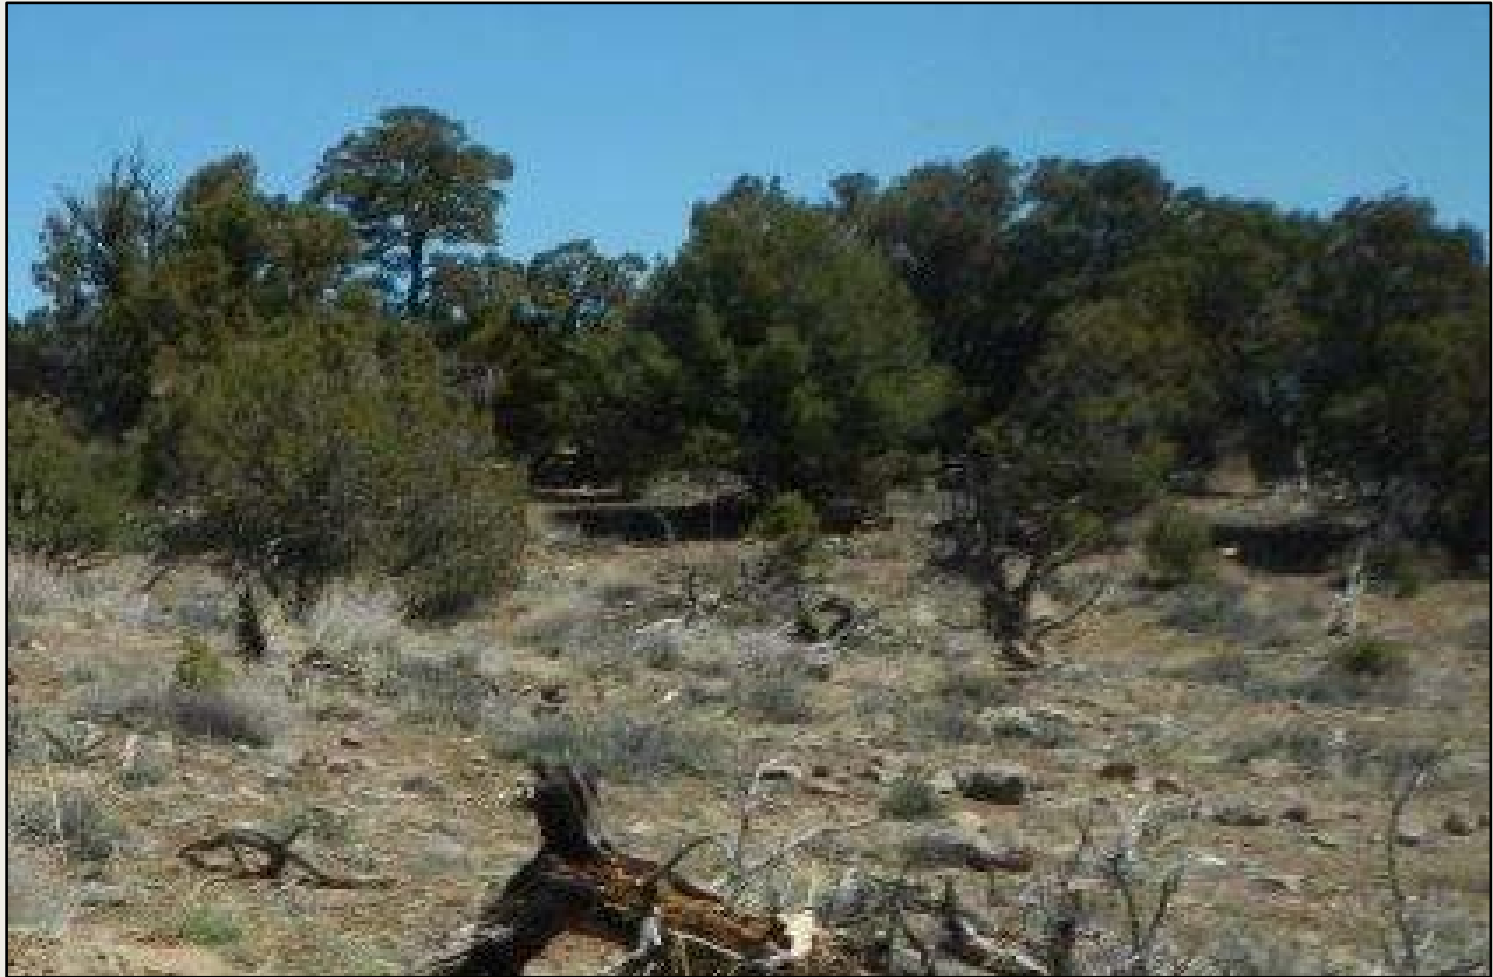
Photo 5. View of reference area, comprised of pinyon-juniper woodland with understory of sagebrush, antelope bitterbrush, and a mixture of grasses and forbs.
