**Inspection Photos**  
**Location Name: Emerald C-1 HZ**  
**Location ID: 316328**  
**Inspection Date: April 9, 2020**

Location Name: Emerald C-1 HZ

Location ID: 316328

Inspection Date: April 9, 2020

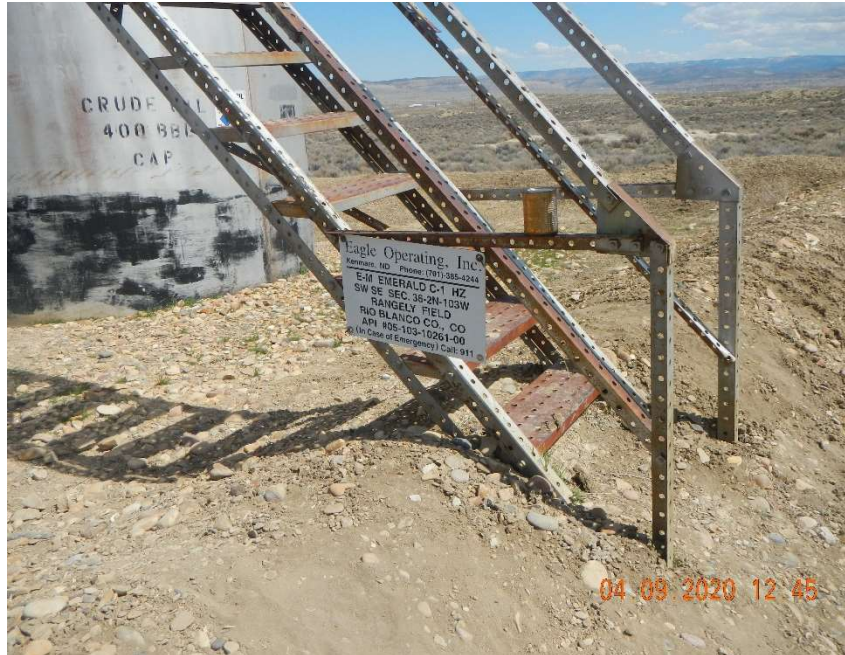
**Location sign.**

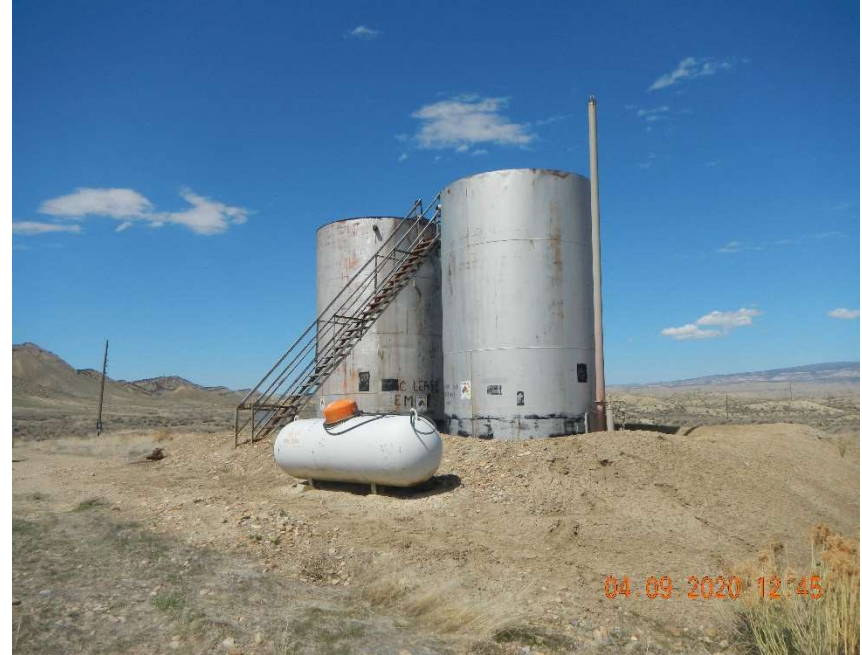
**Tank battery.**

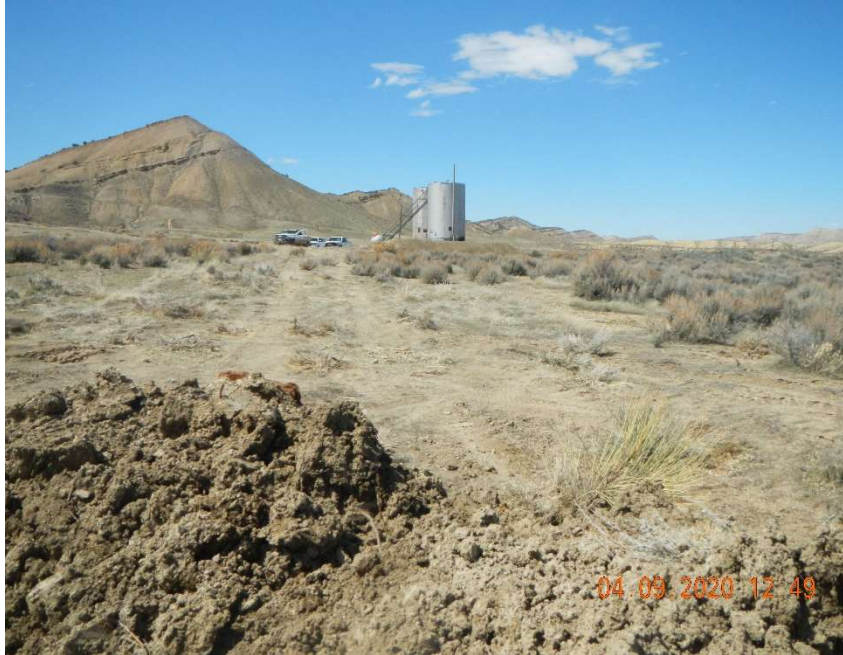
**View of the tank battery from the excavation.**

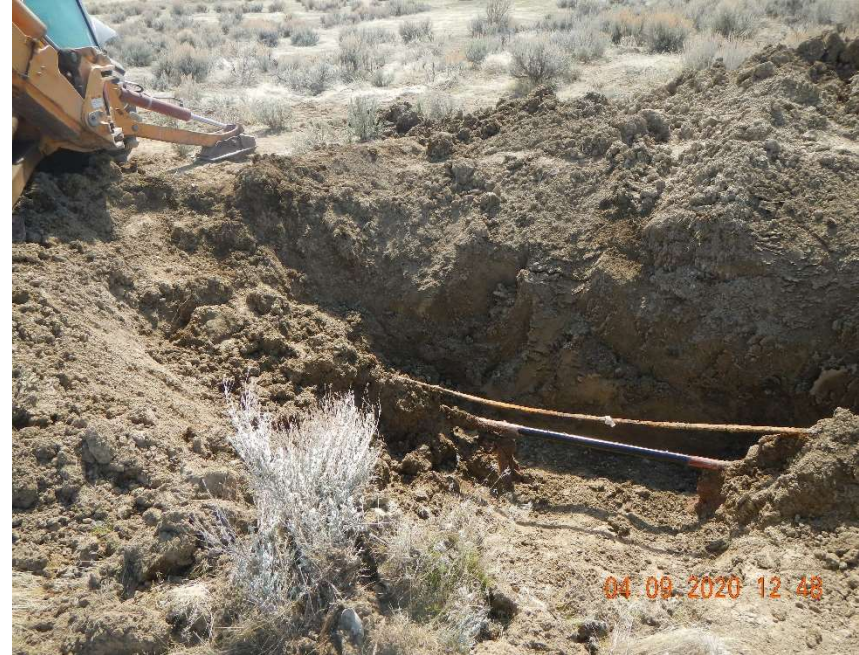
**Excavation, repaired flowline and electrical conduit.**

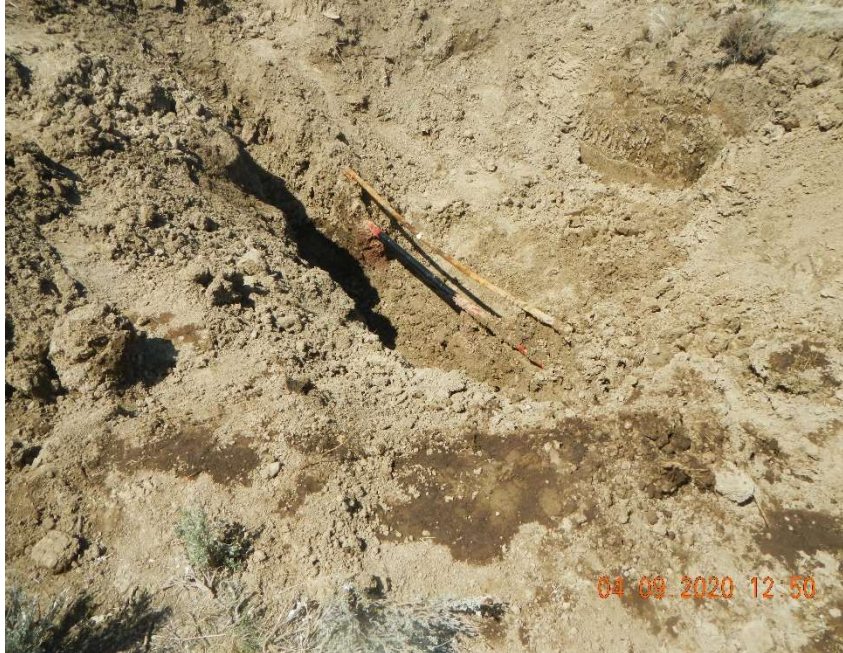
Excavation, impacted material from the excavation, repaired flowline and electrical conduit.

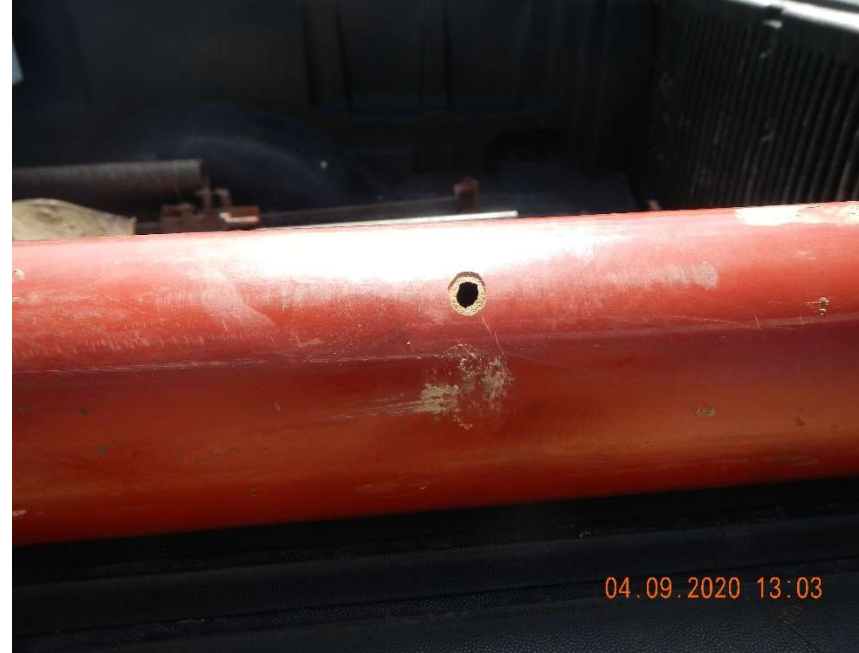
Cut out section of the flowline that failed the pressure test.

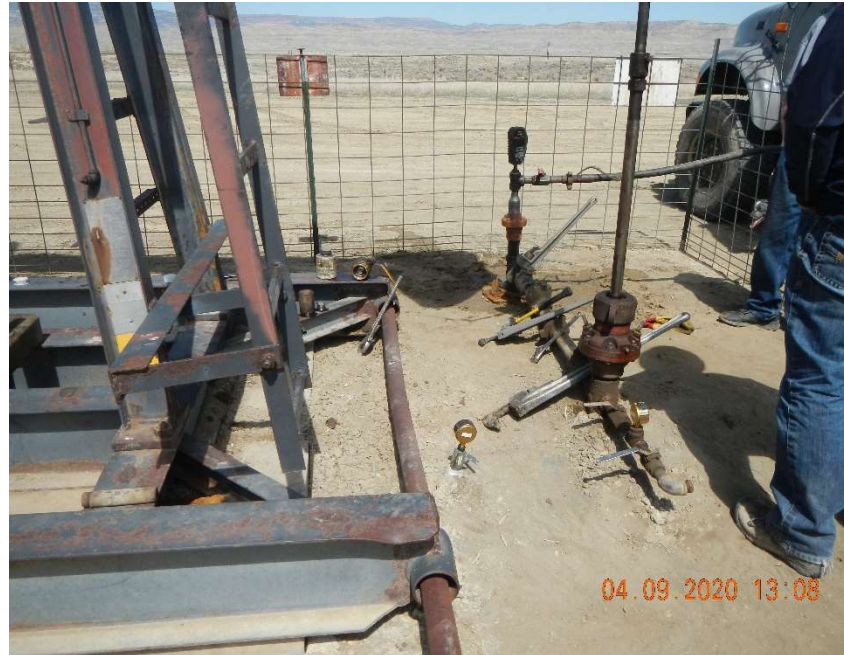
**Pressure testing the repaired flowline with water.**
