Inspection Photos
Operator: Kinder Morgan
API#: 033-06184
Date: 4/14/2020

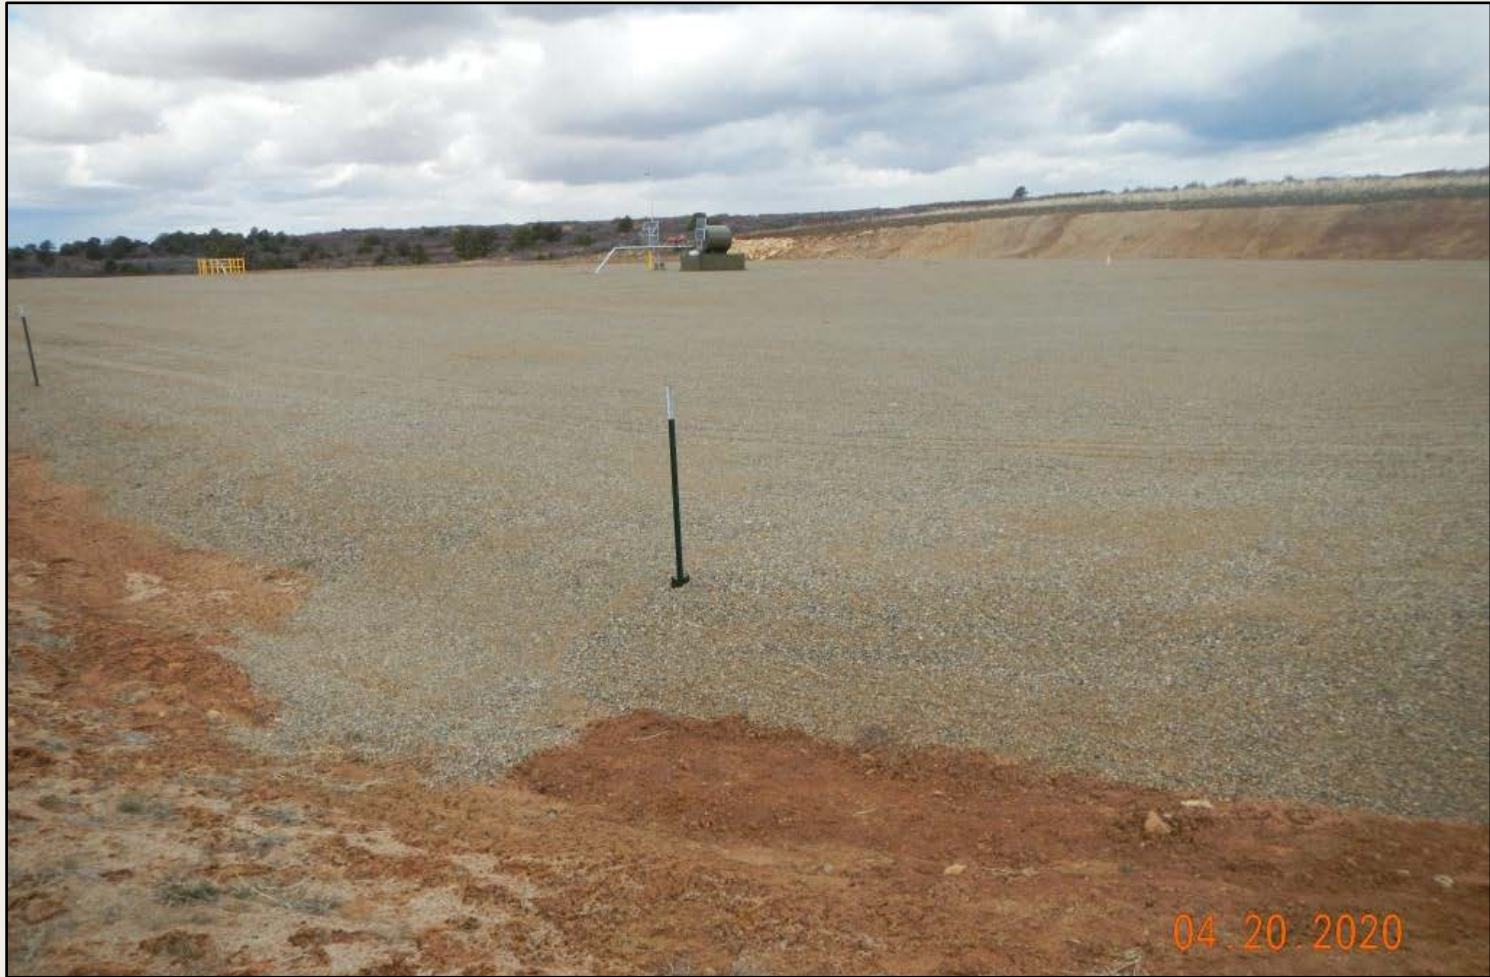
Photo 1. View of the project area from the southeastern corner facing center. Interim reclamation is not conducted.

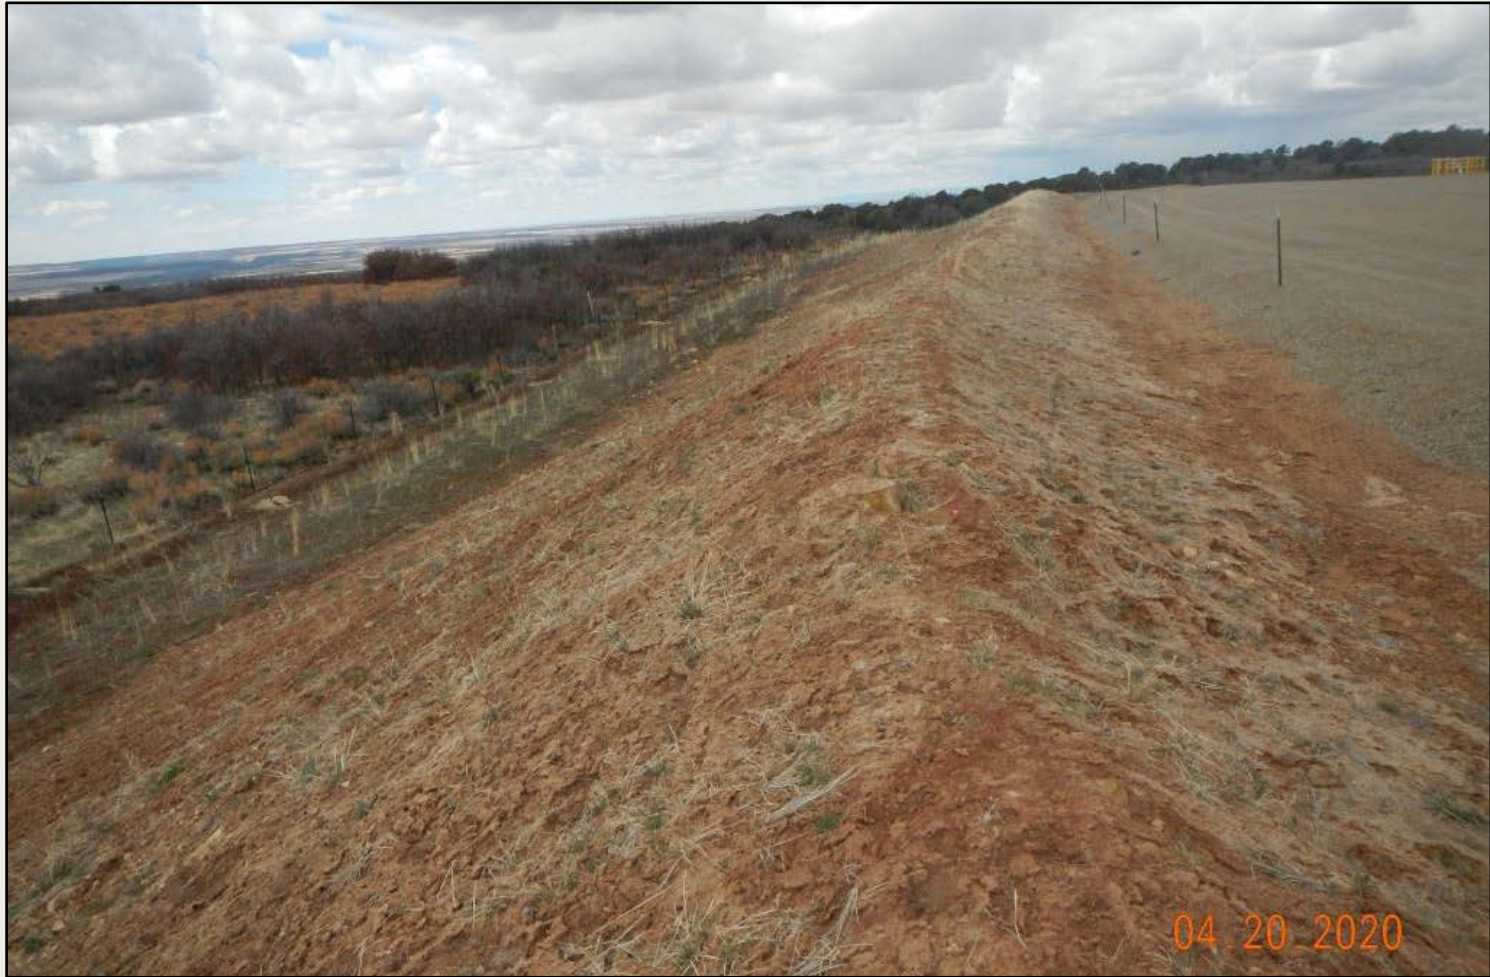
Photo 2. View of the southern fill slope from the southeastern corner facing westward. Revegetation is progressing with young grasses such as squirreltail and Indian ricegrass.

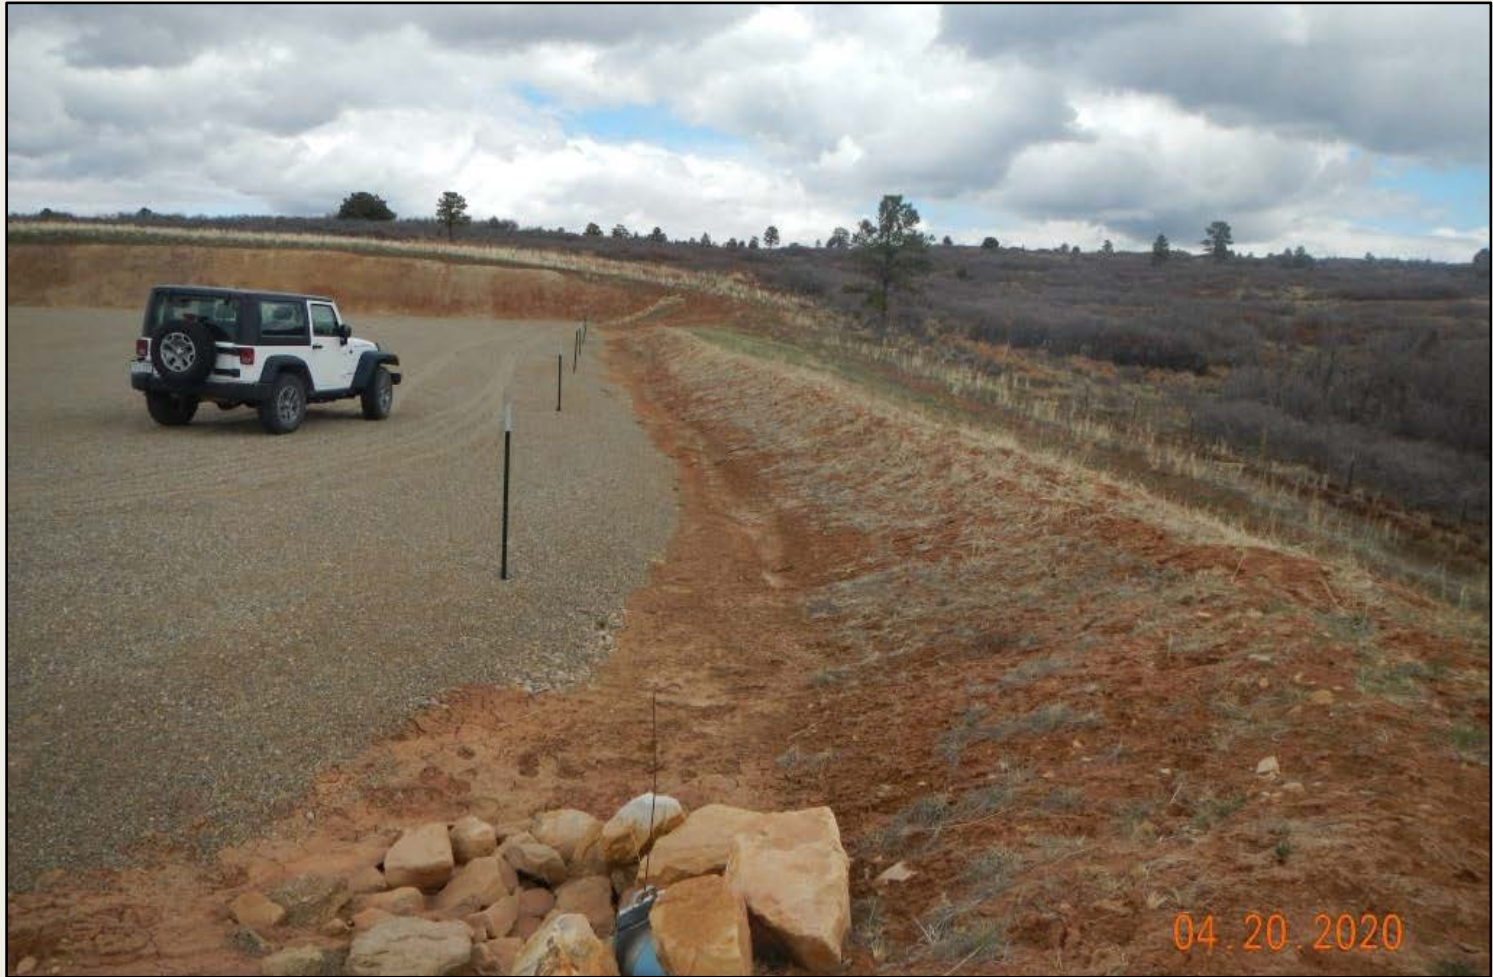
Photo 3. View of the eastern project area from the southeastern corner facing northward.

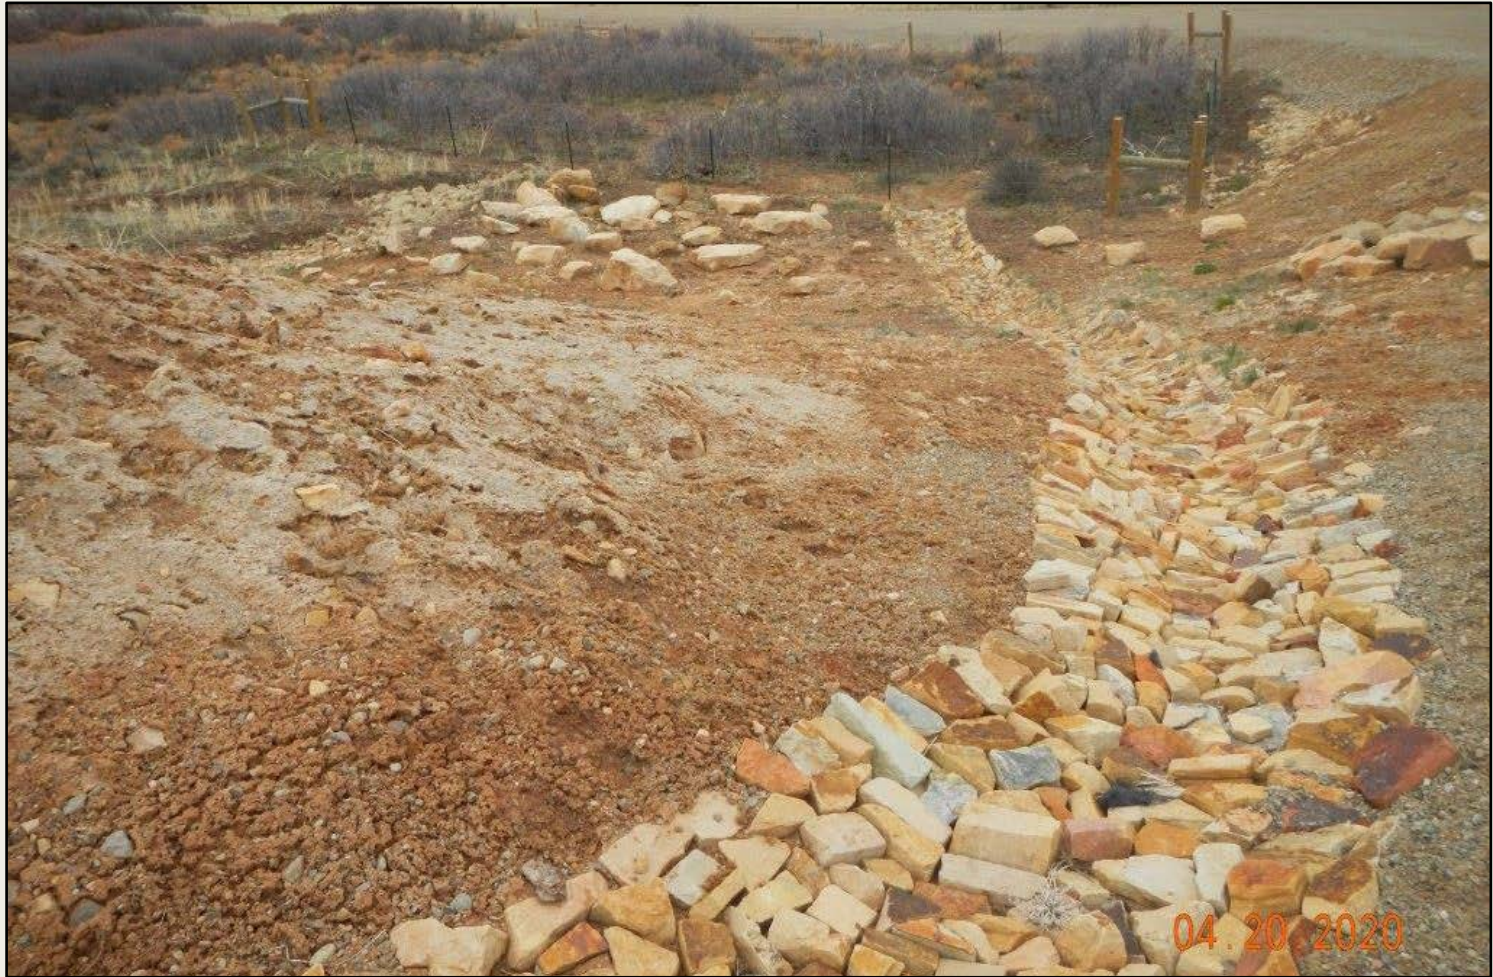
Photo 4. View of course rock run-down at well pad entrance appears to be functioning at this time.

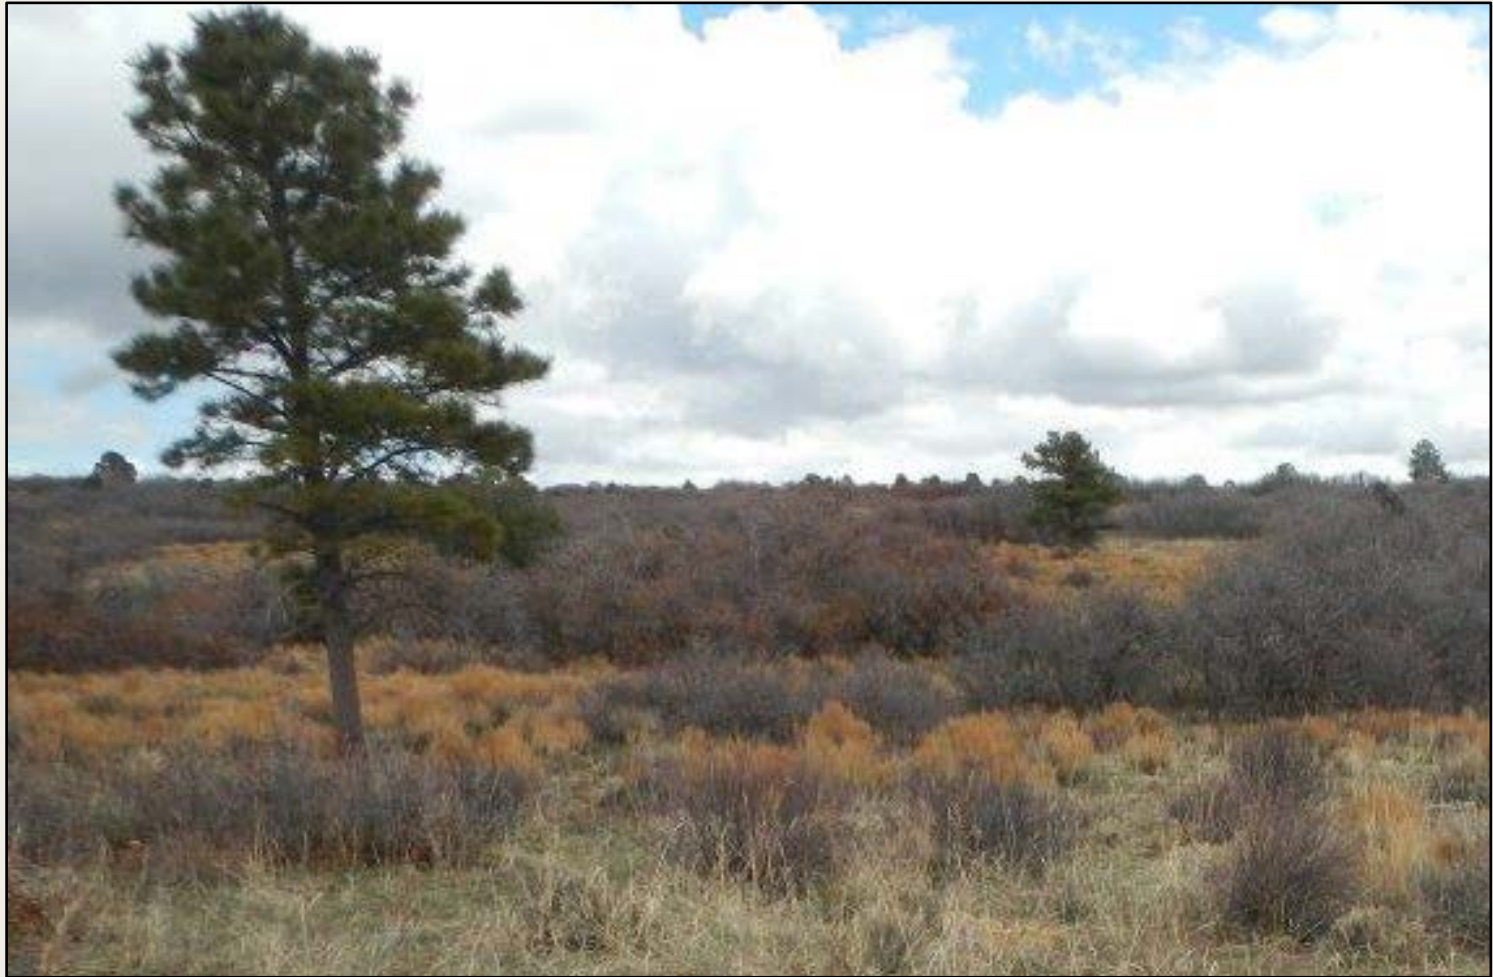
Photo 5. View of reference area, comprised of gambel oak and black sage shrubland with scattered ponderosa pine trees and grasses such as western wheatgrass and squirreltail in the understory.
