Inspection Photos  
Operator: Kinder Morgan  
API#: 033-06135  
Date: 4/14/2020

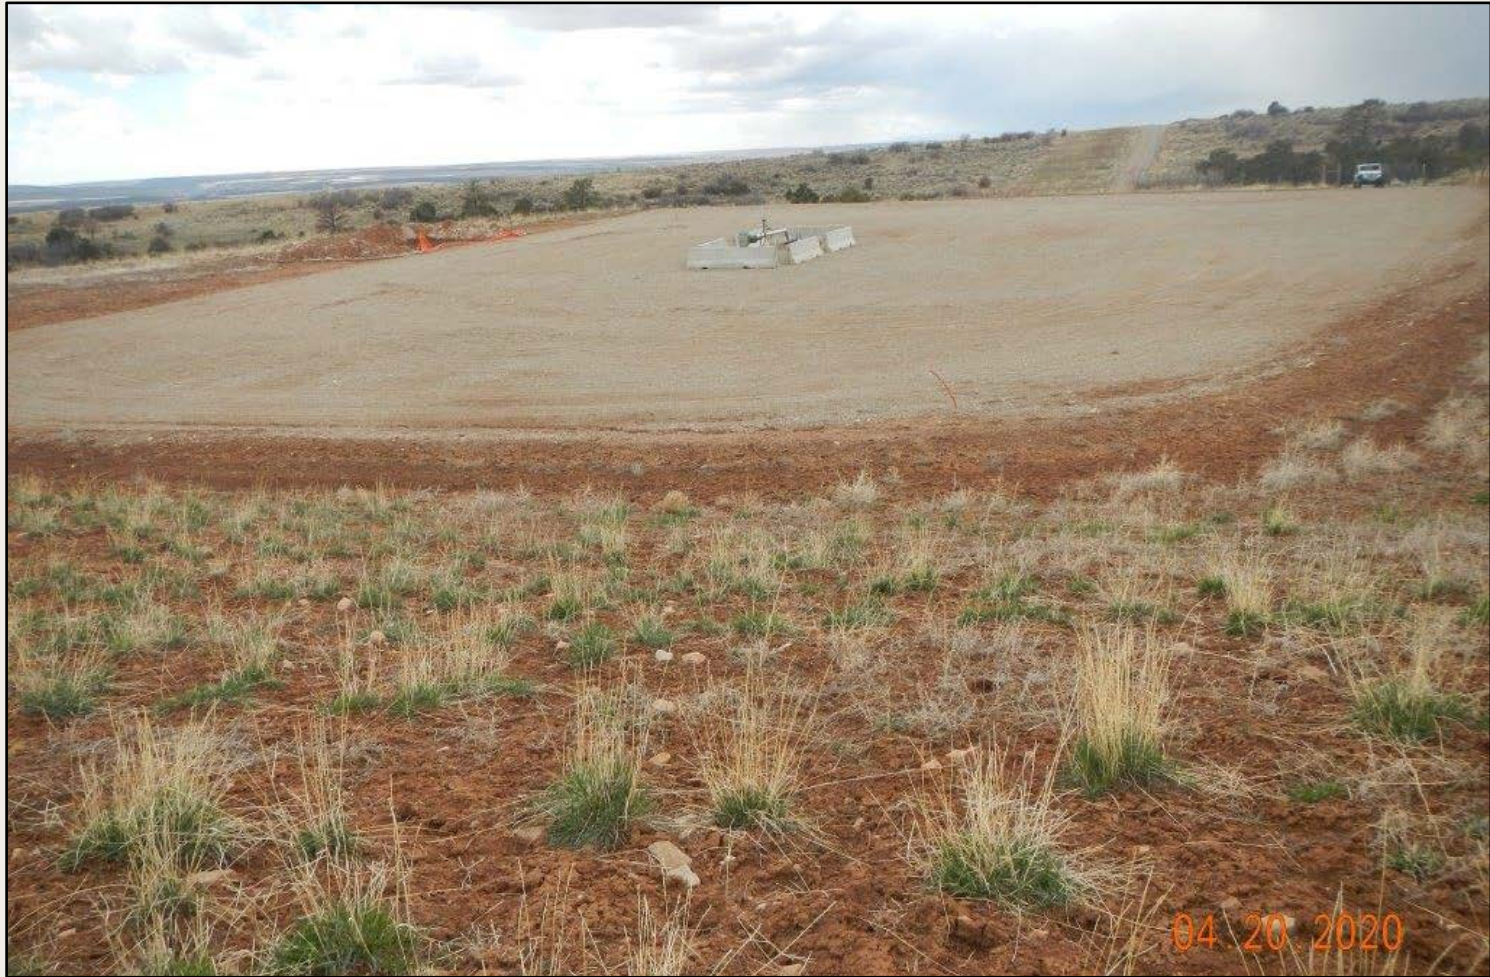
Photo 1. View of the project area from the northeastern corner facing center.

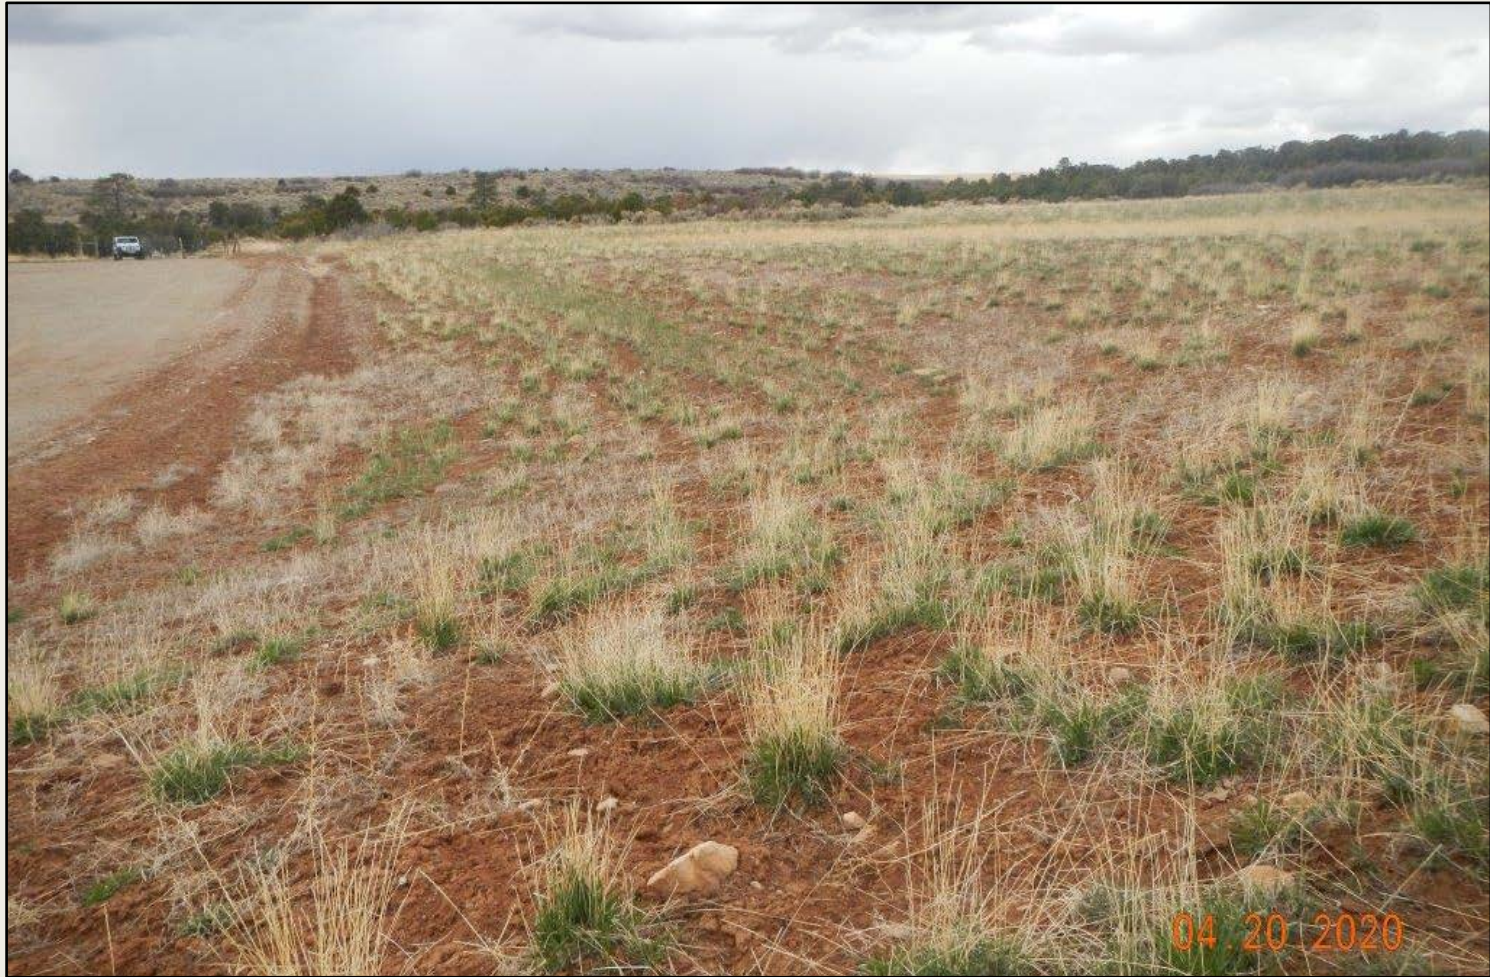
Photo 2. View of the northern fill slope from the southwestern corner facing eastward. Revegetation is progressing with young grasses such as crested wheatgrass, intermediate wheatgrass, and western wheatgrass.

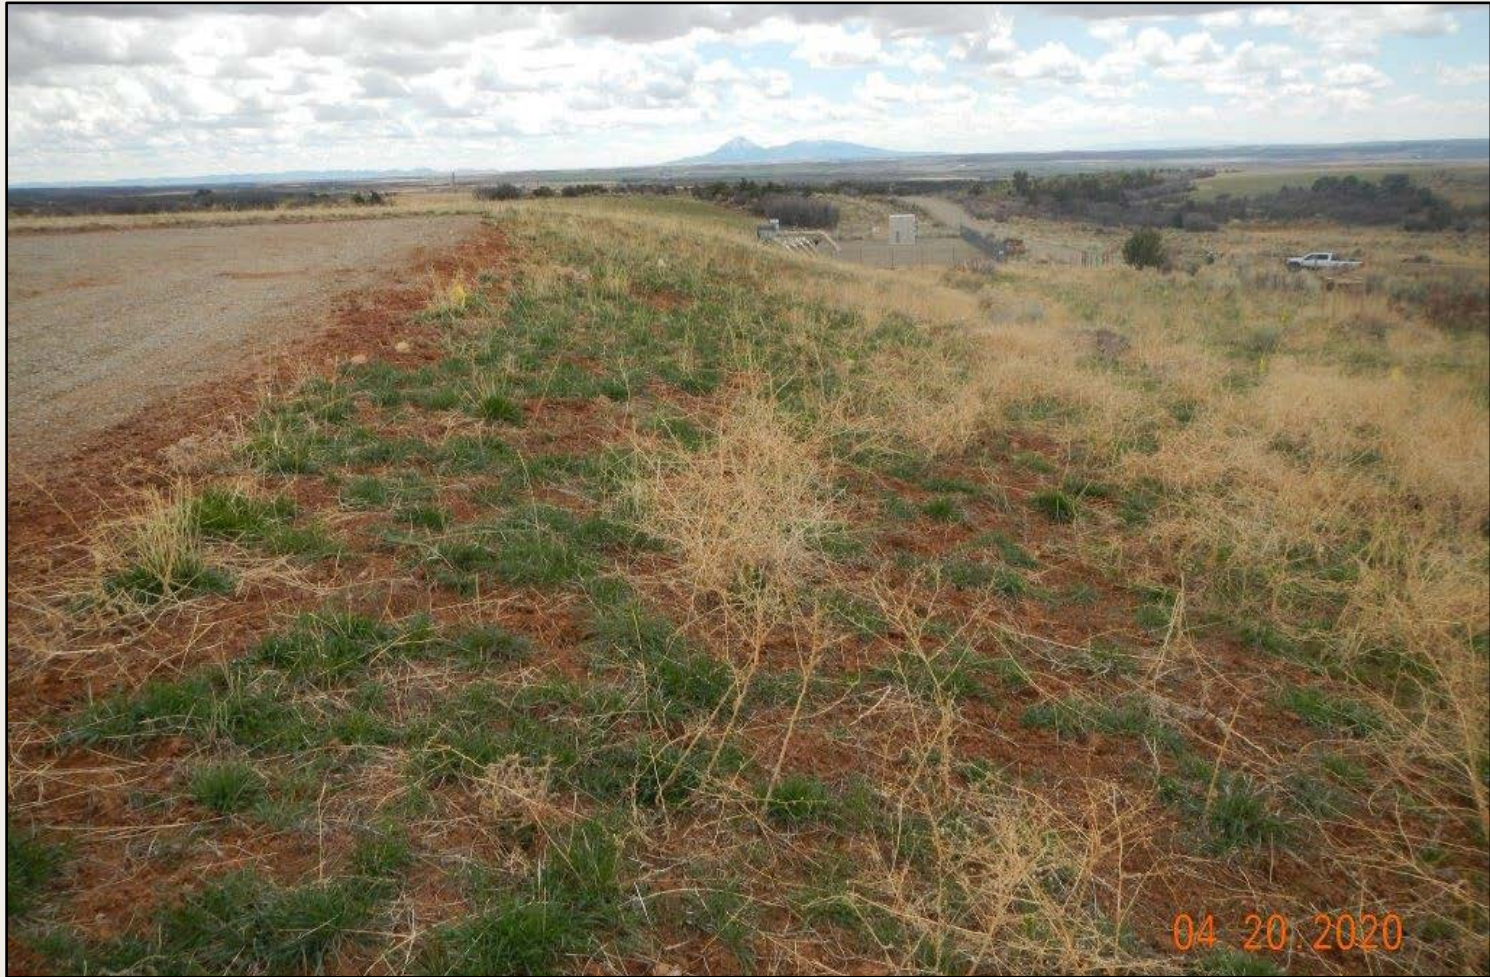
Photo 3. View of the western fill slope from the northwestern edge facing southward.

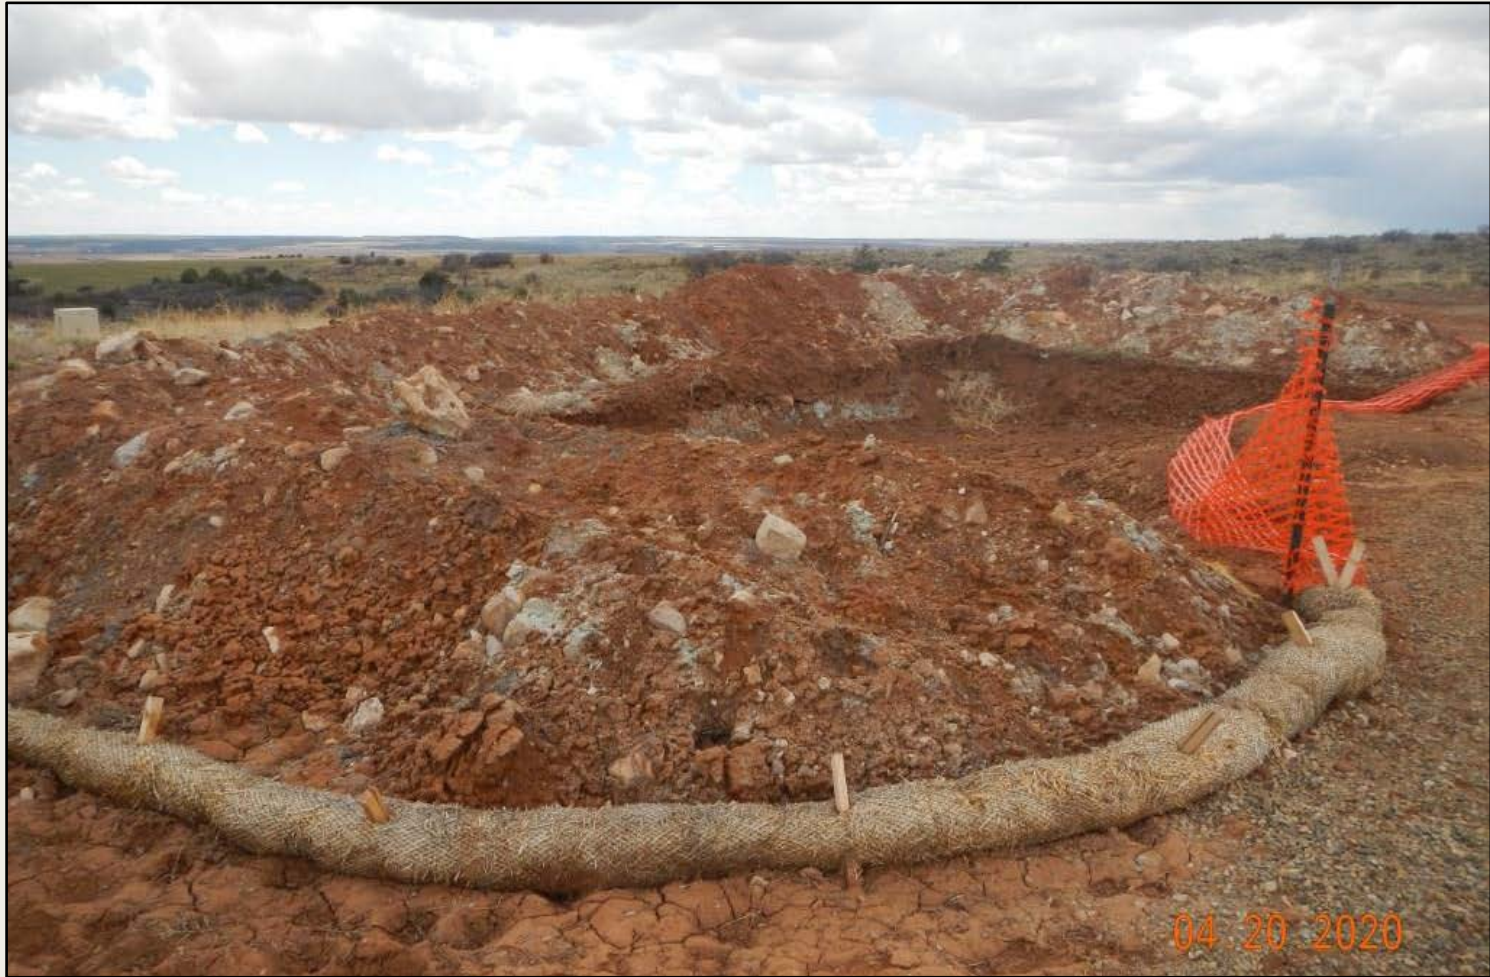
Photo 4. View of project disturbance within the southern project area. Revegetation is required when work is completed here.

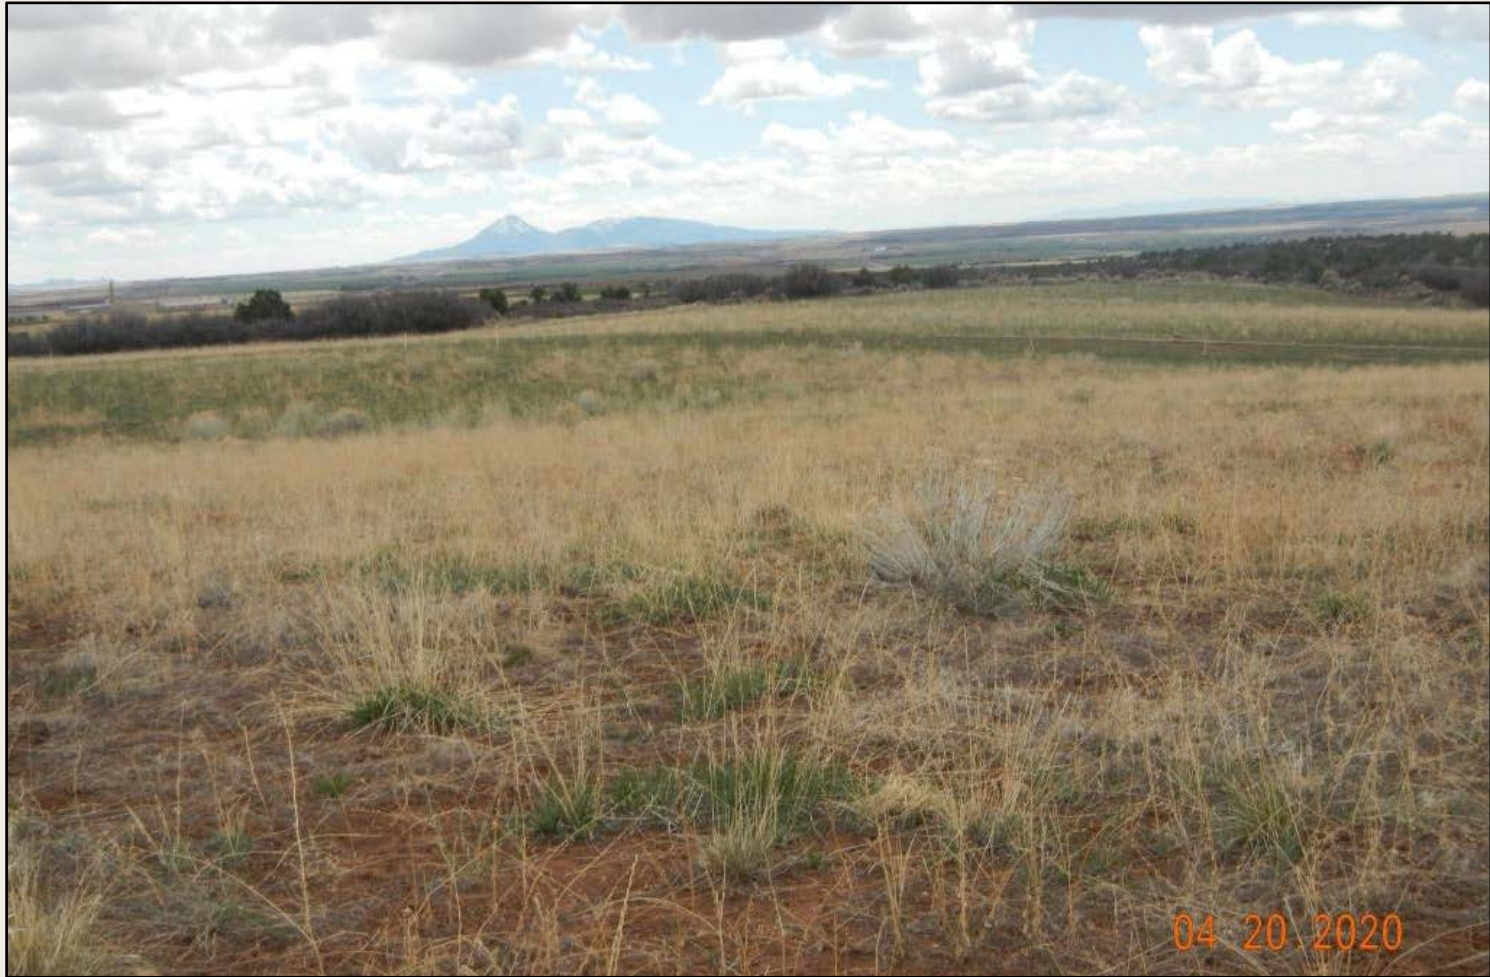
Photo 5. View of reference area, comprised of open grass field similar to interim reclamation area.
