KP Kauffman - COGCC Inspection Photos
Location: Nessu Consolidated Flowline Release
Spill ID # 470915 Date 4/20/2020

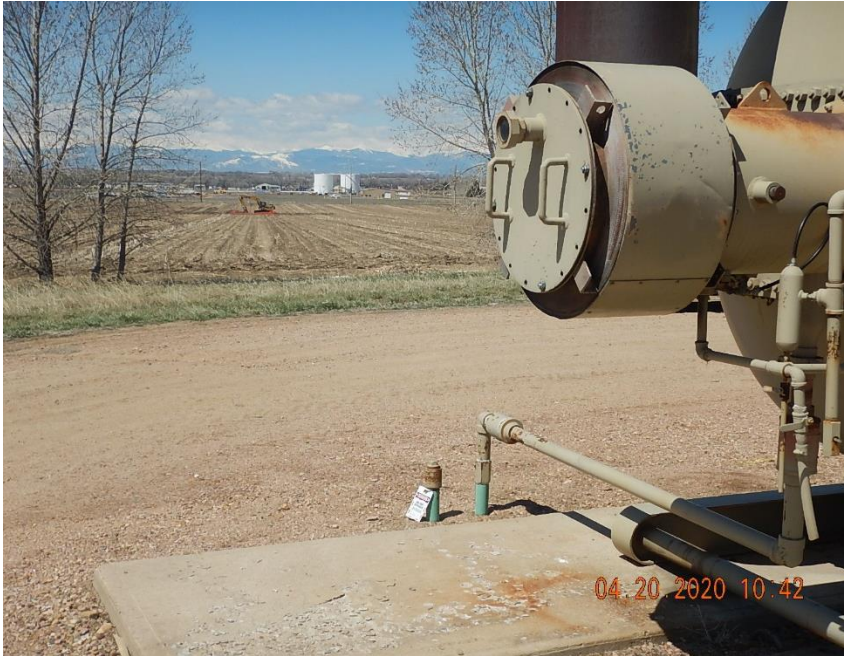
View from Nessu facility (ID #453316) towards excavation at Spill ID #470915 (looking West)

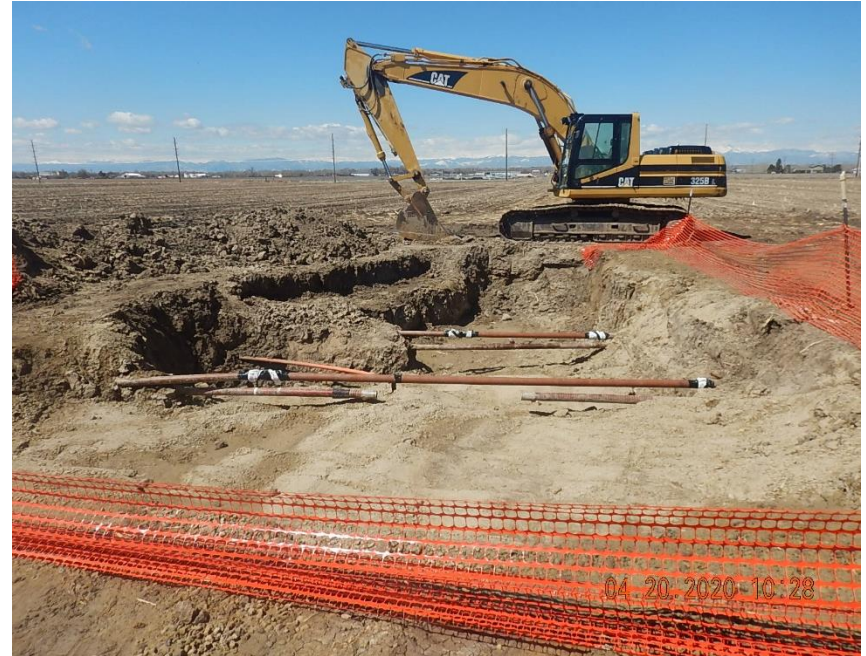
Closer view of excavation at Spill ID # 470915 with flowlines exposed (looking West)

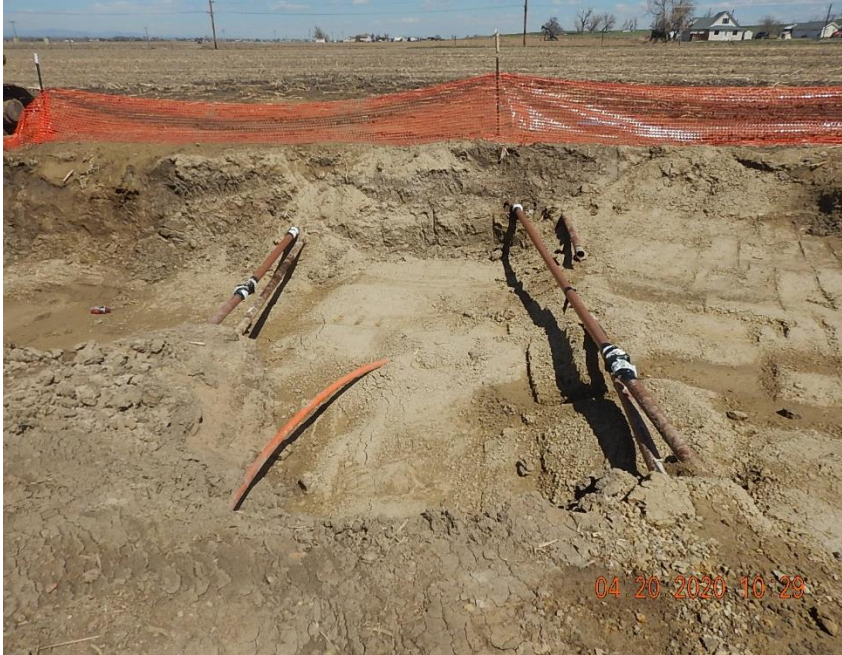
View of flowlines exposed; repair work appears to be in progress (looking North)

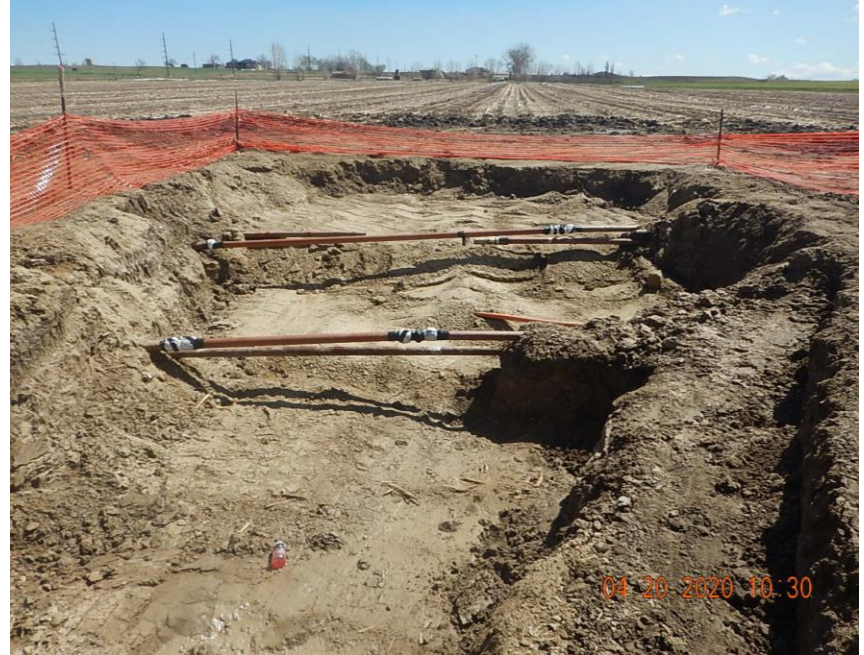
View of excavation and flowlines exposed (to east)

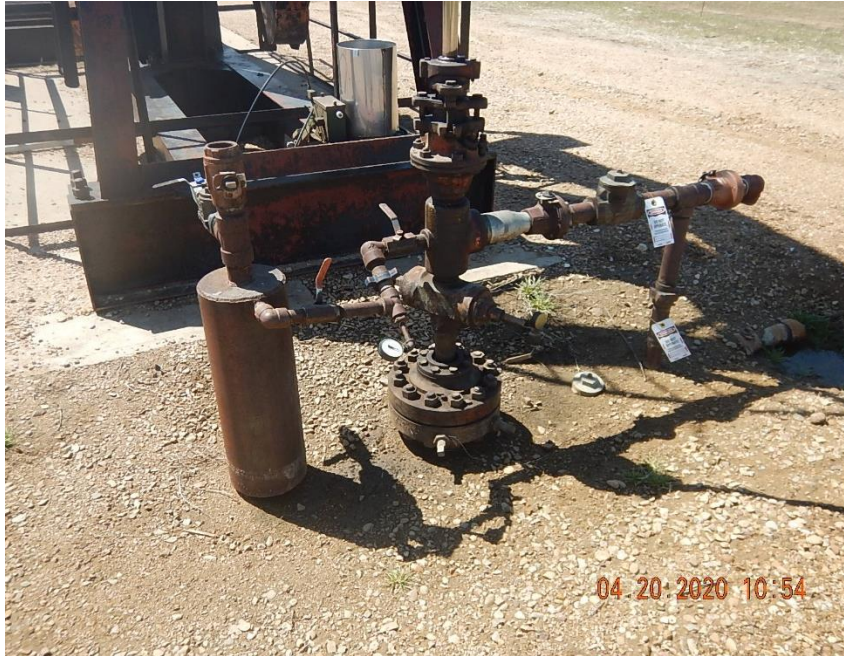
**View of Nessu #1 wellhead (API 123-07762);
OOSLAT (flowline shut in/ tagged out)**

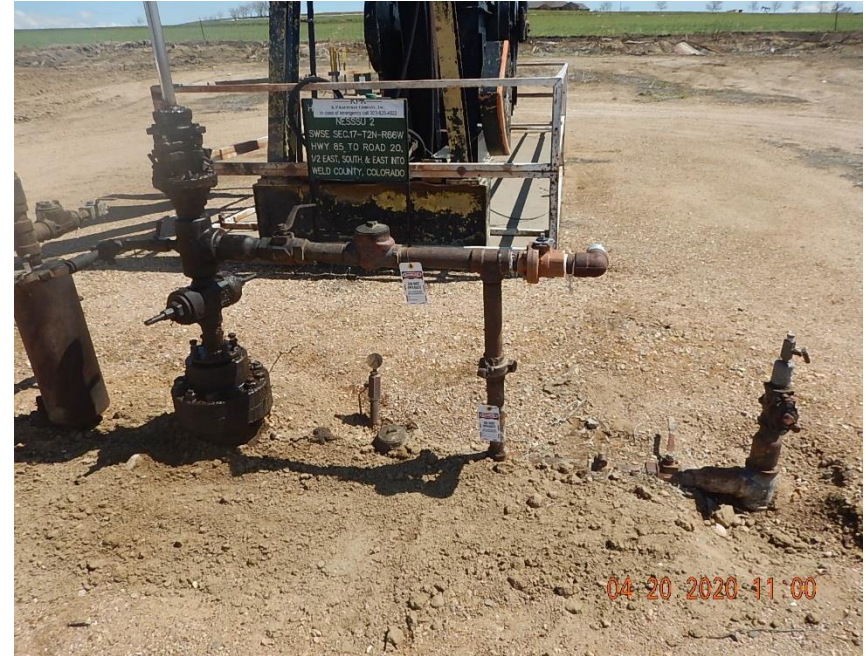
**View of Nessu #2 wellhead (API 123-08811);
OOSLAT (flowline shut in/ tagged out)**
