Inspection Photos

API: 055-06287

Operator: TABULA RASA ENERGY

Inspection Date: 4/22/2020

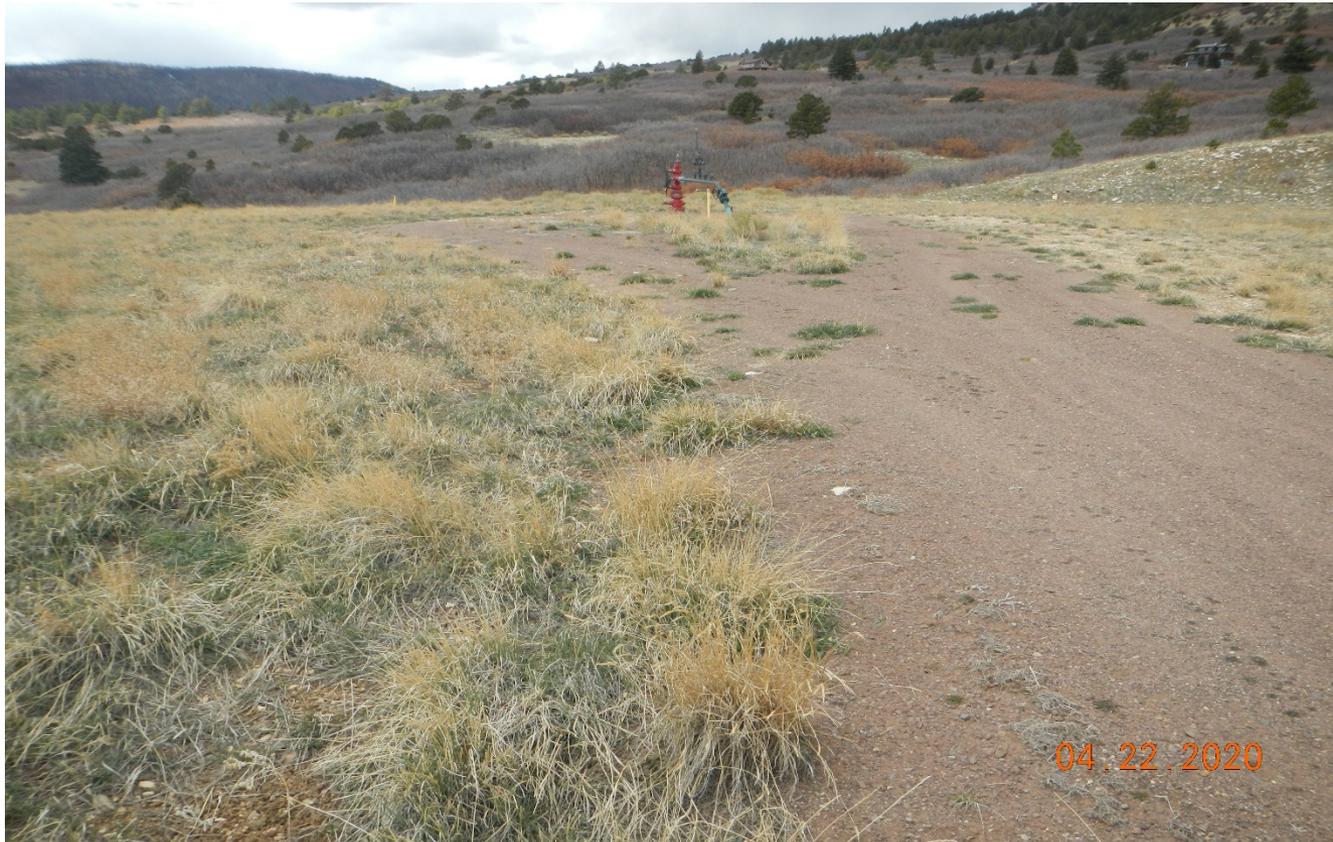
Photo 1. Facing west toward the location.

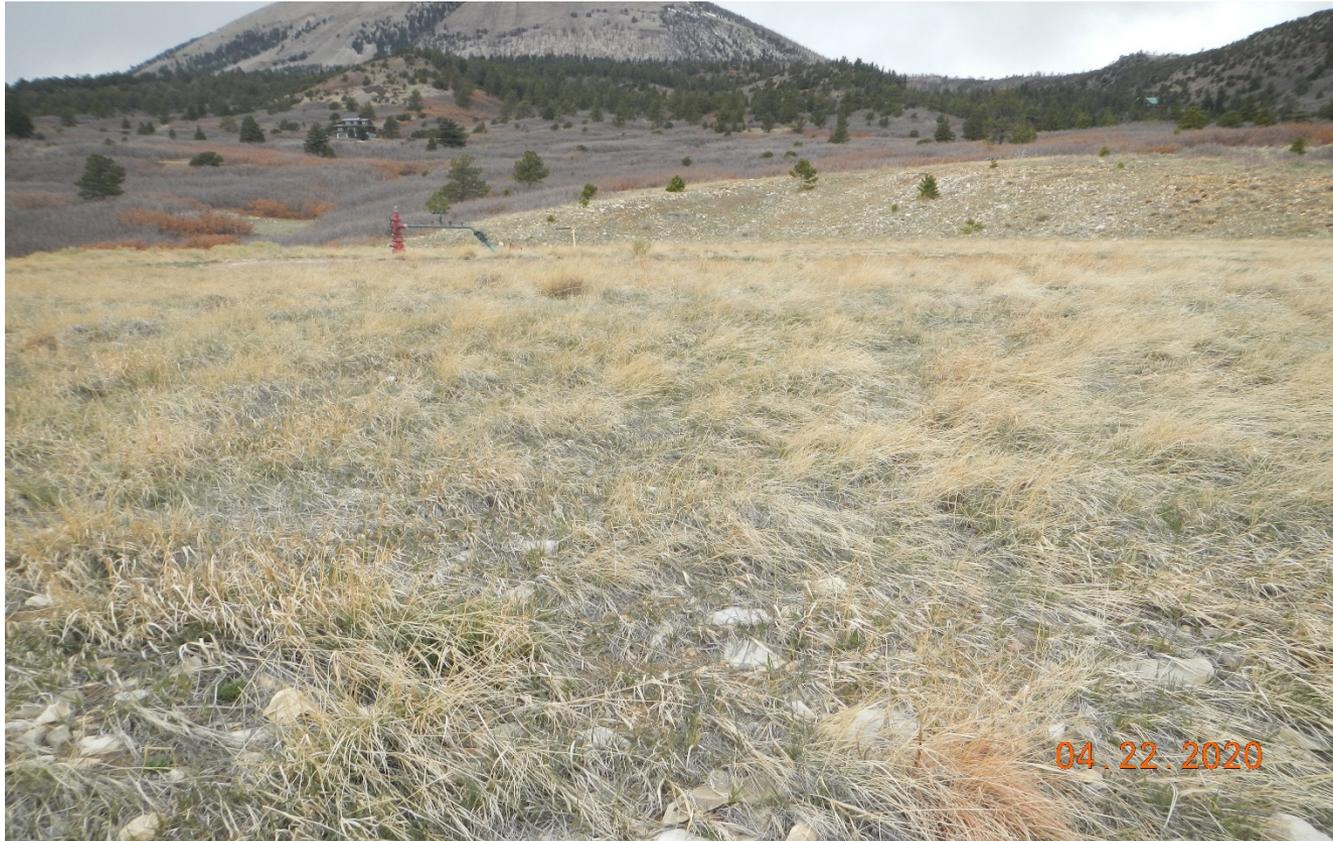
Photo 2. Facing northwest toward the location. Vegetation is well established in the interim reclamation area.

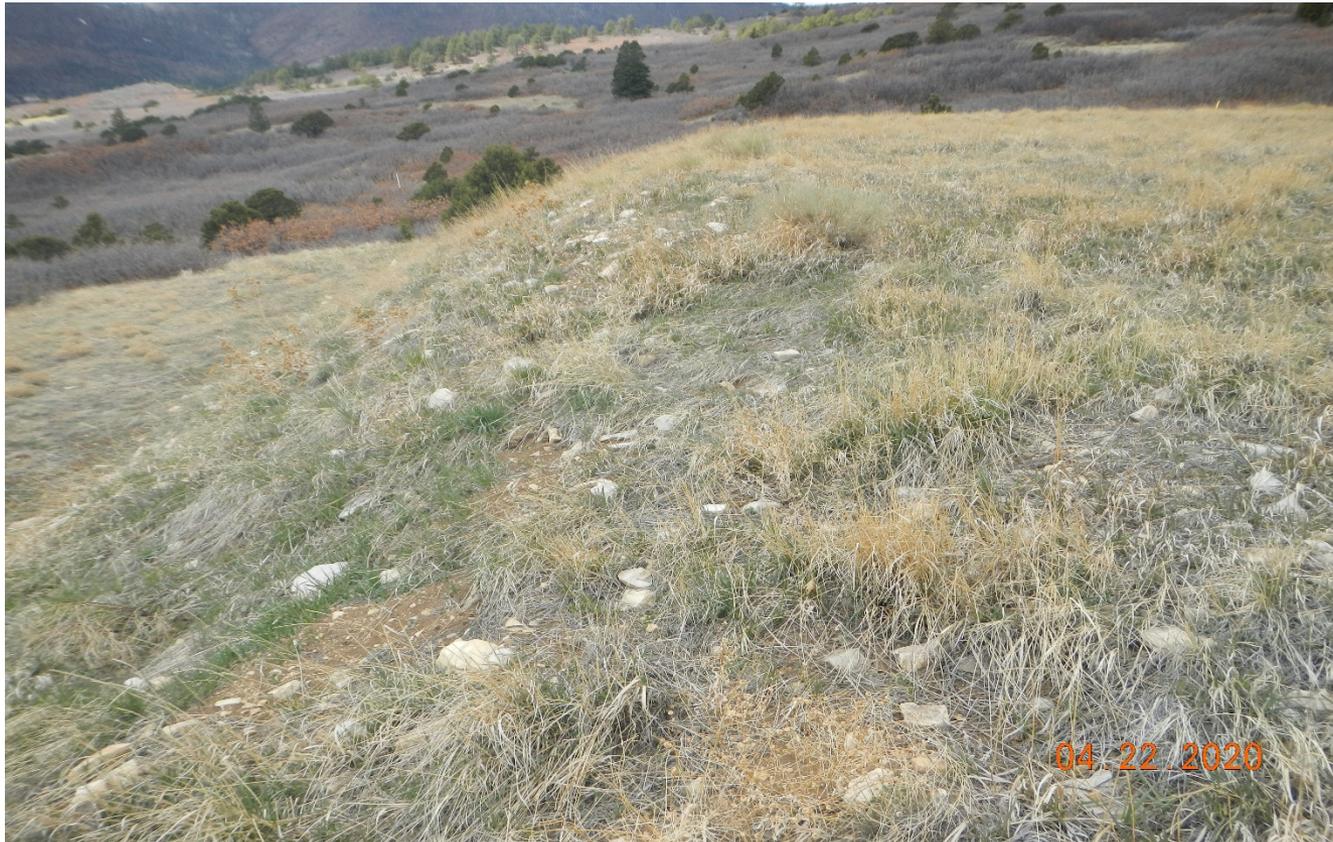
Photo 3. Facing toward the fill slope which is stabilized with vegetation.

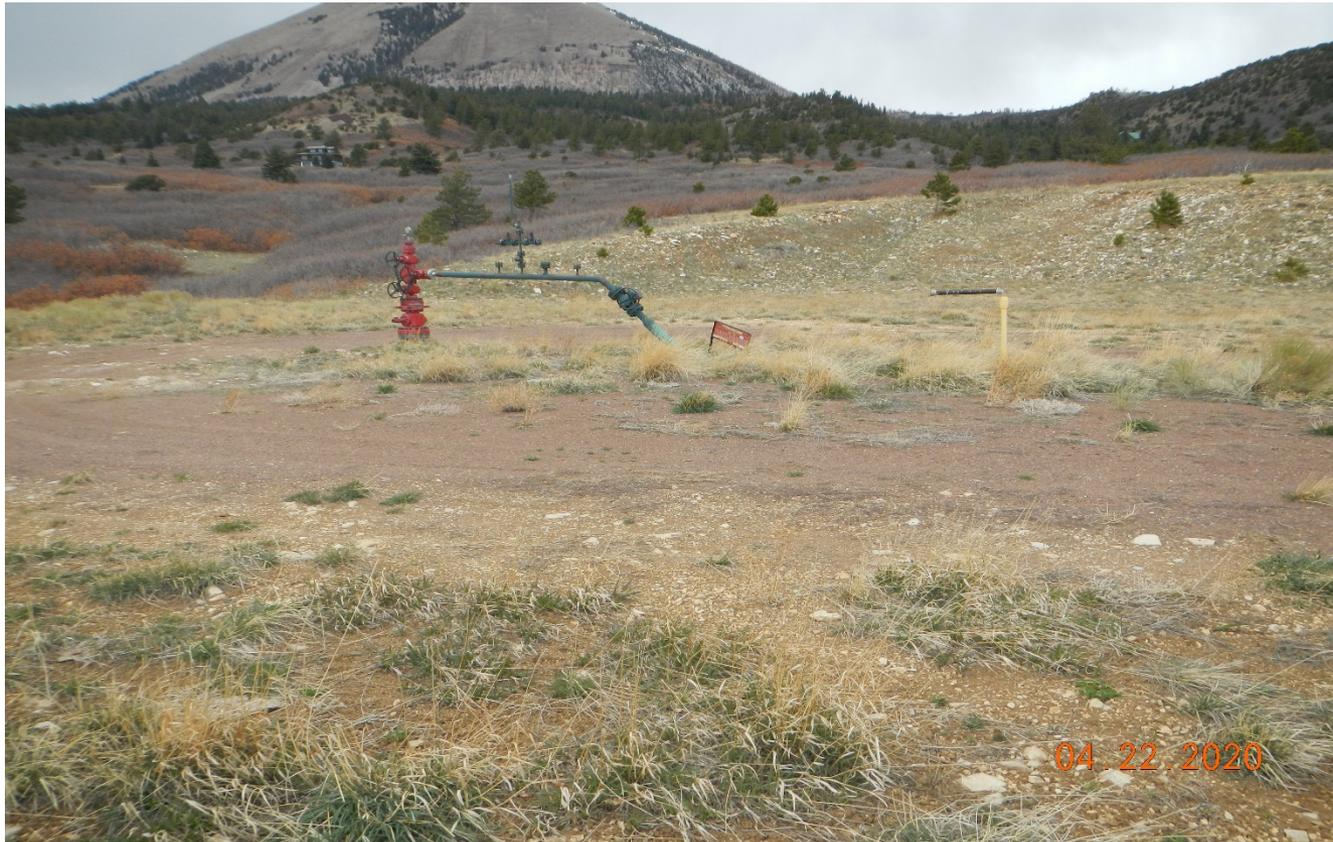
Photo 4. Facing toward the well.

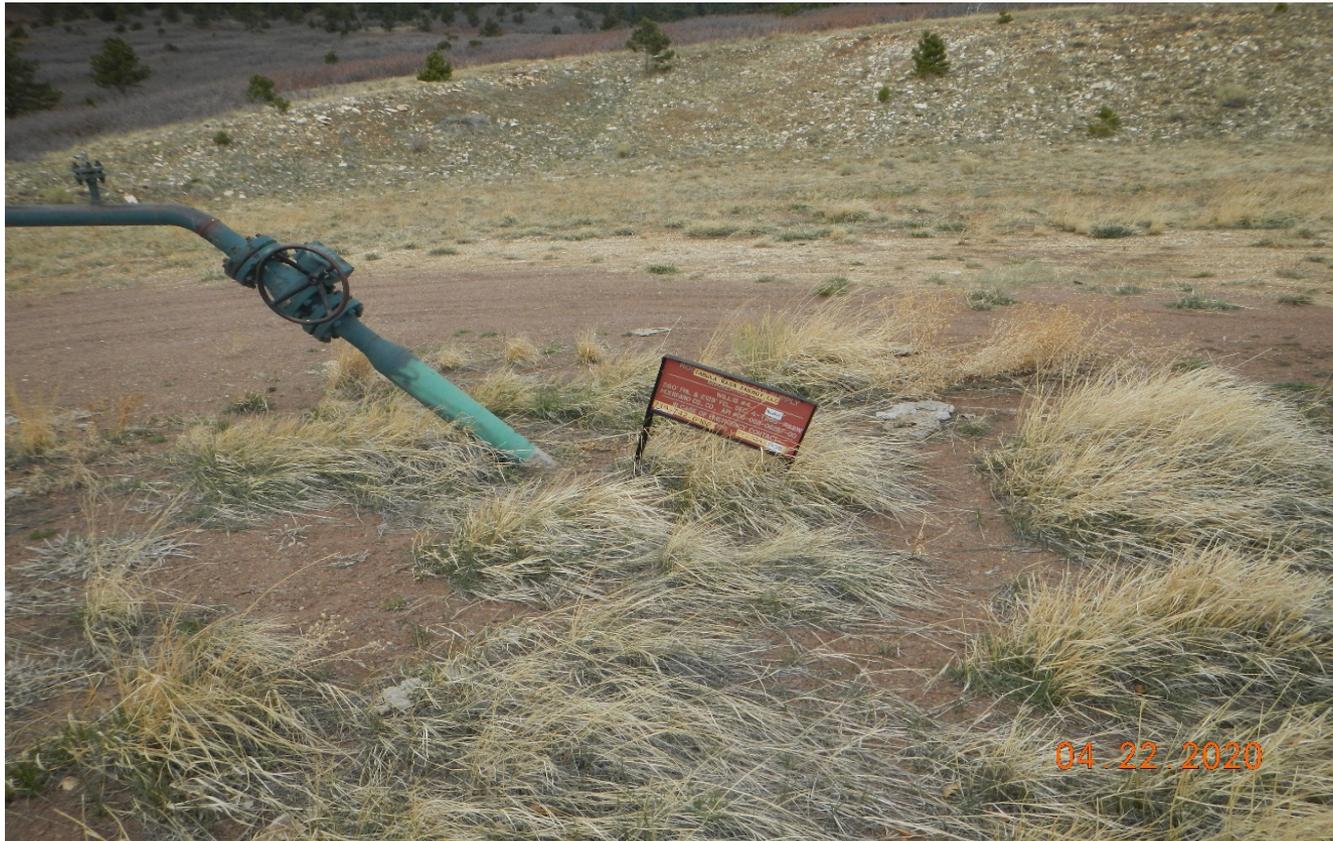
Photo 5. Well sign is posted at the well site. Emergency contact number on the sign needs to be updated.

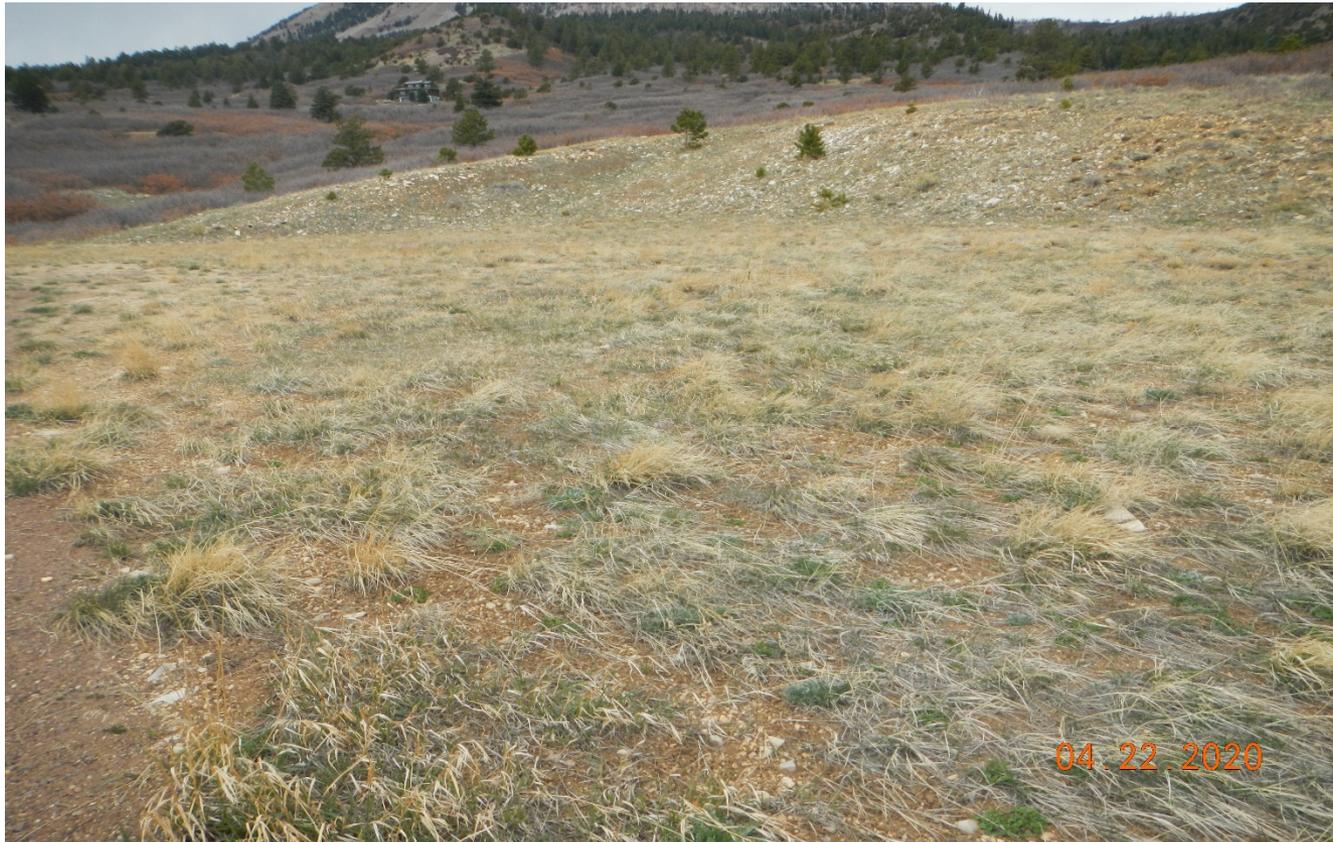
Photo 6. Facing northwest toward the cut slope. Vegetation is well established in the interim reclamation area.
