# Inspection Photos

API: 055-06209

Operator: TABULA RASA ENERGY

Inspection Date: 4/22/2020

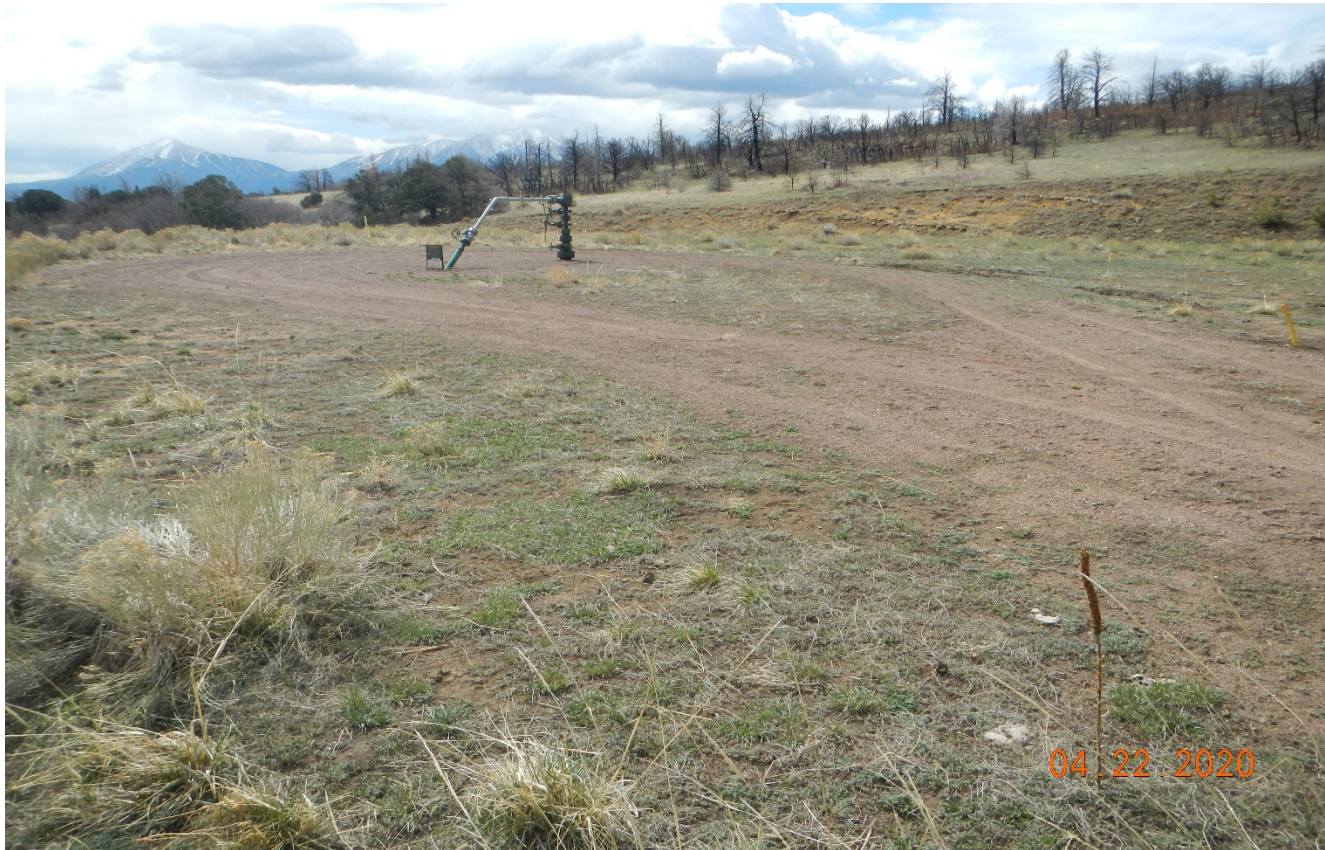
**Photo 1.** Facing south toward the location.

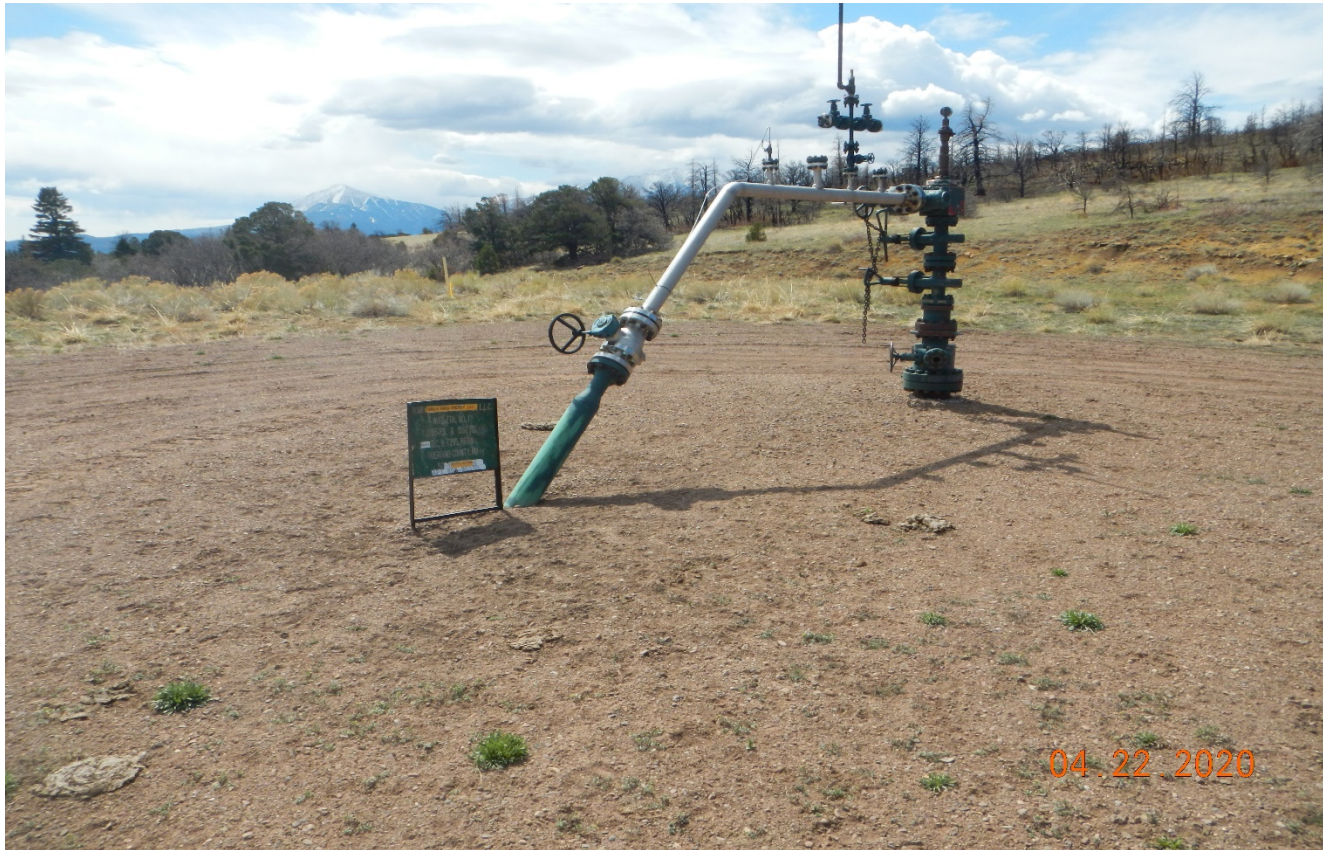
**Photo 2.** Well sign is posted at the well head. Emergency contact number on the sign needs to be updated.

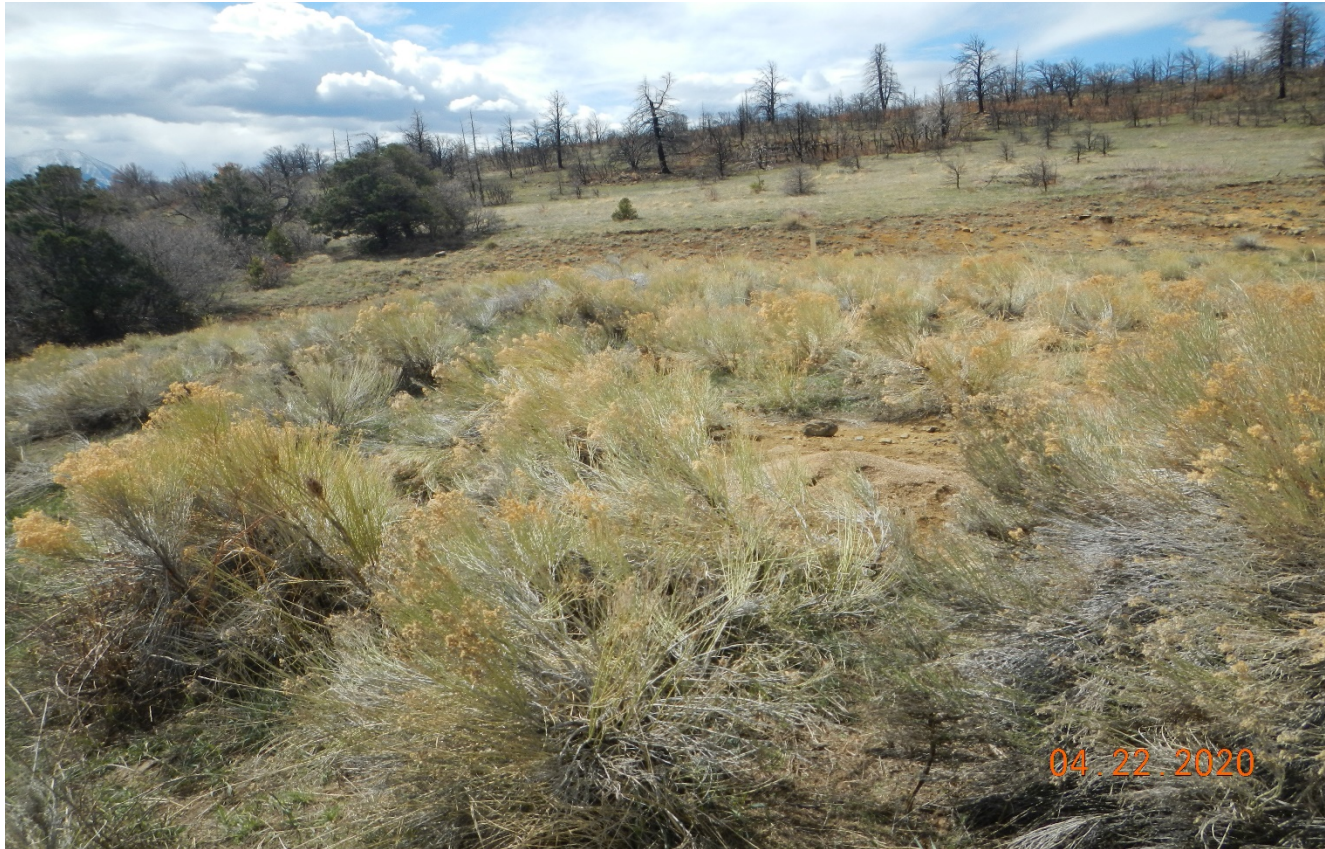
**Photo 3.** Vegetation is well established along the fill slope. There is a lot of Native Rubber rabbit brush in this area.

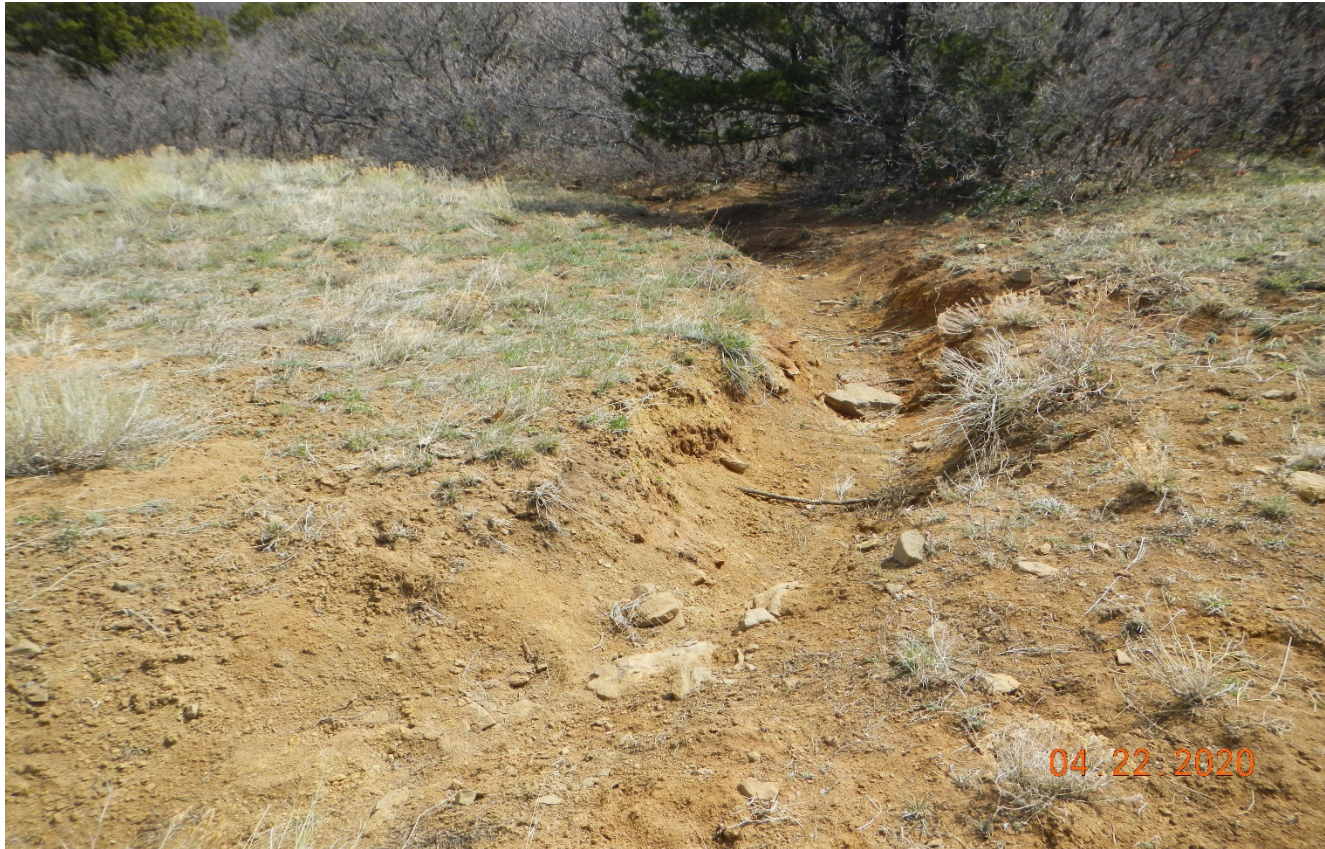
**Photo 4.** There is an erosion channel at the southeast side that will need to be repaired and stabilized.

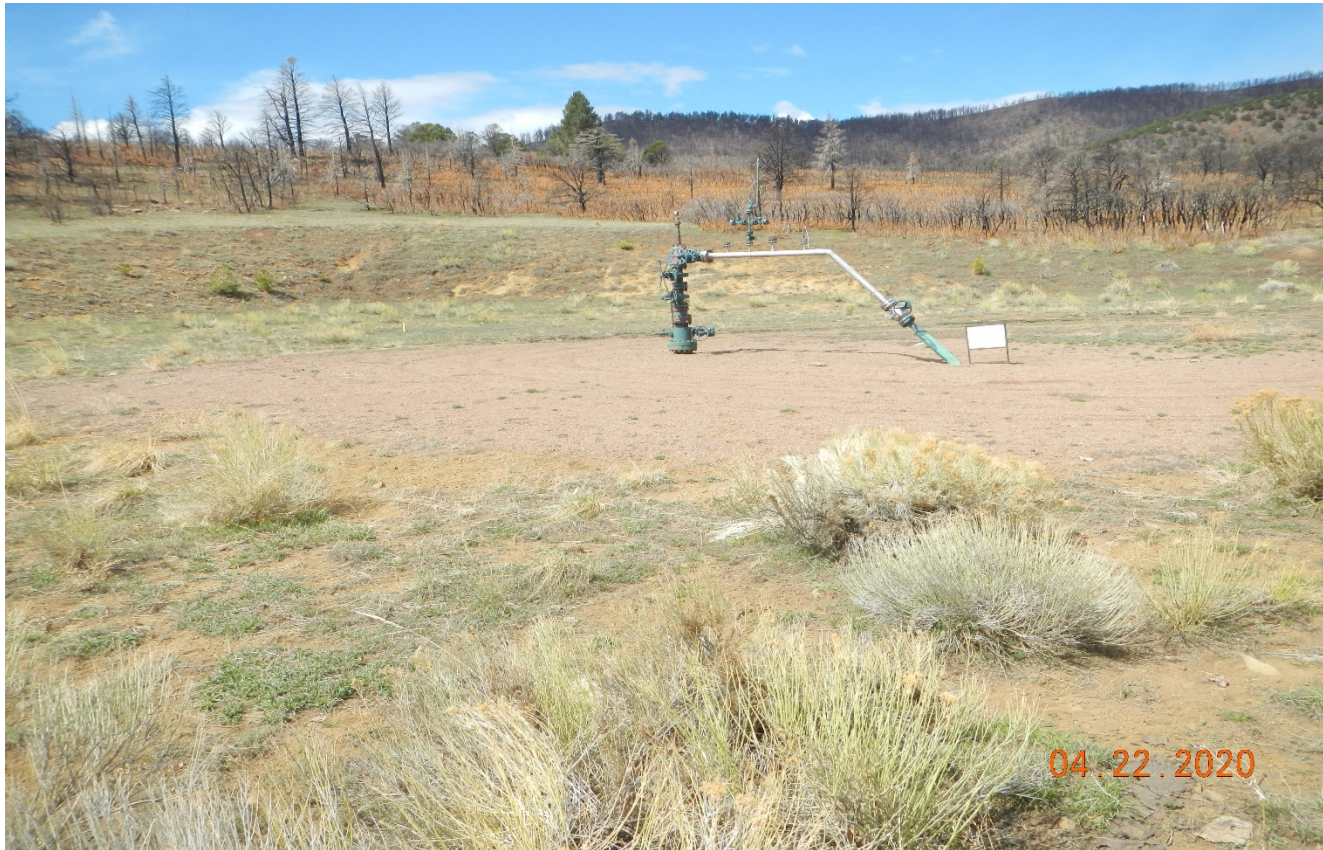
**Photo 5.** Facing northwest toward the location.
