# Inspection Photos

API: 055-06301

Operator: TABULA RASA ENERGY

Inspection Date: 4/22/2020

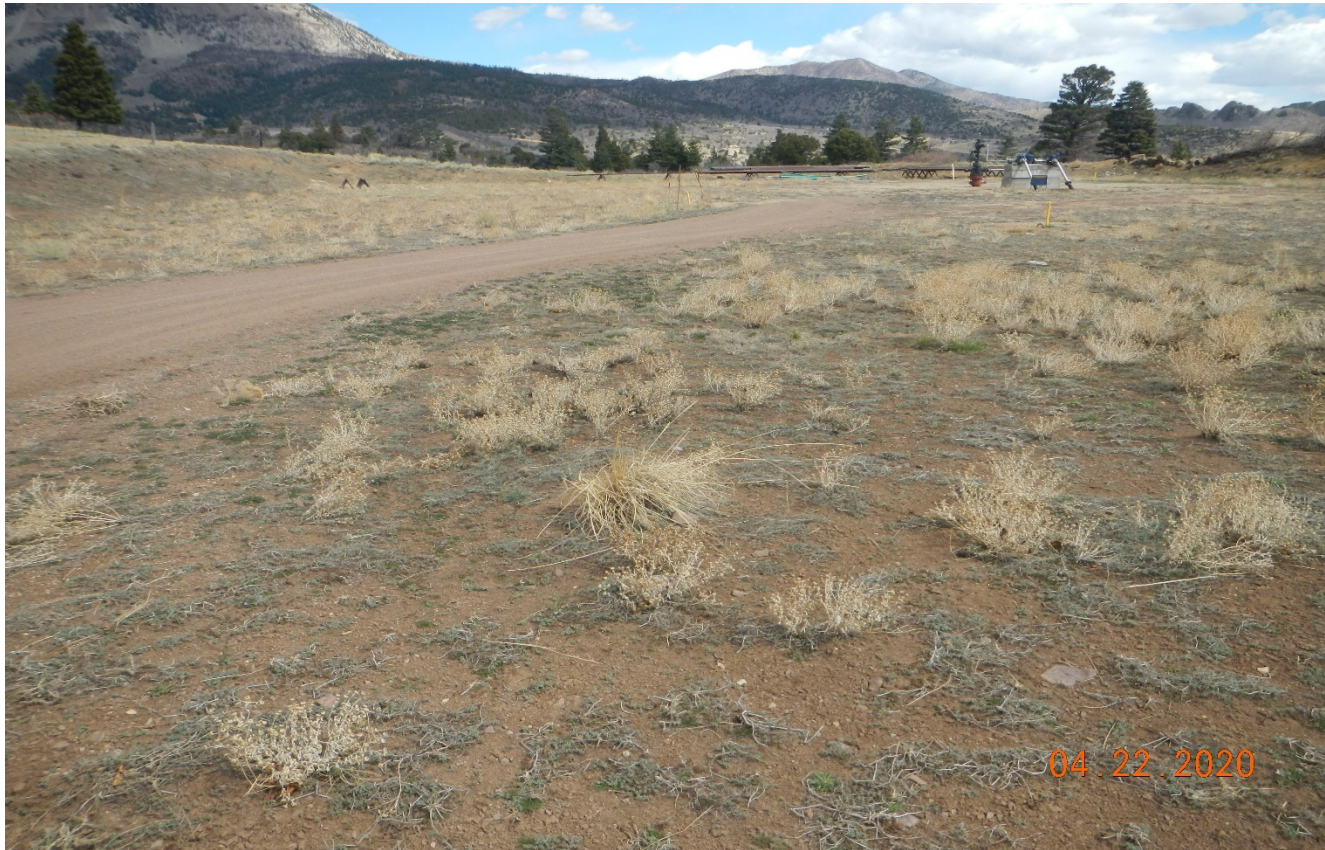
**Photo 1.** Facing north toward the location.

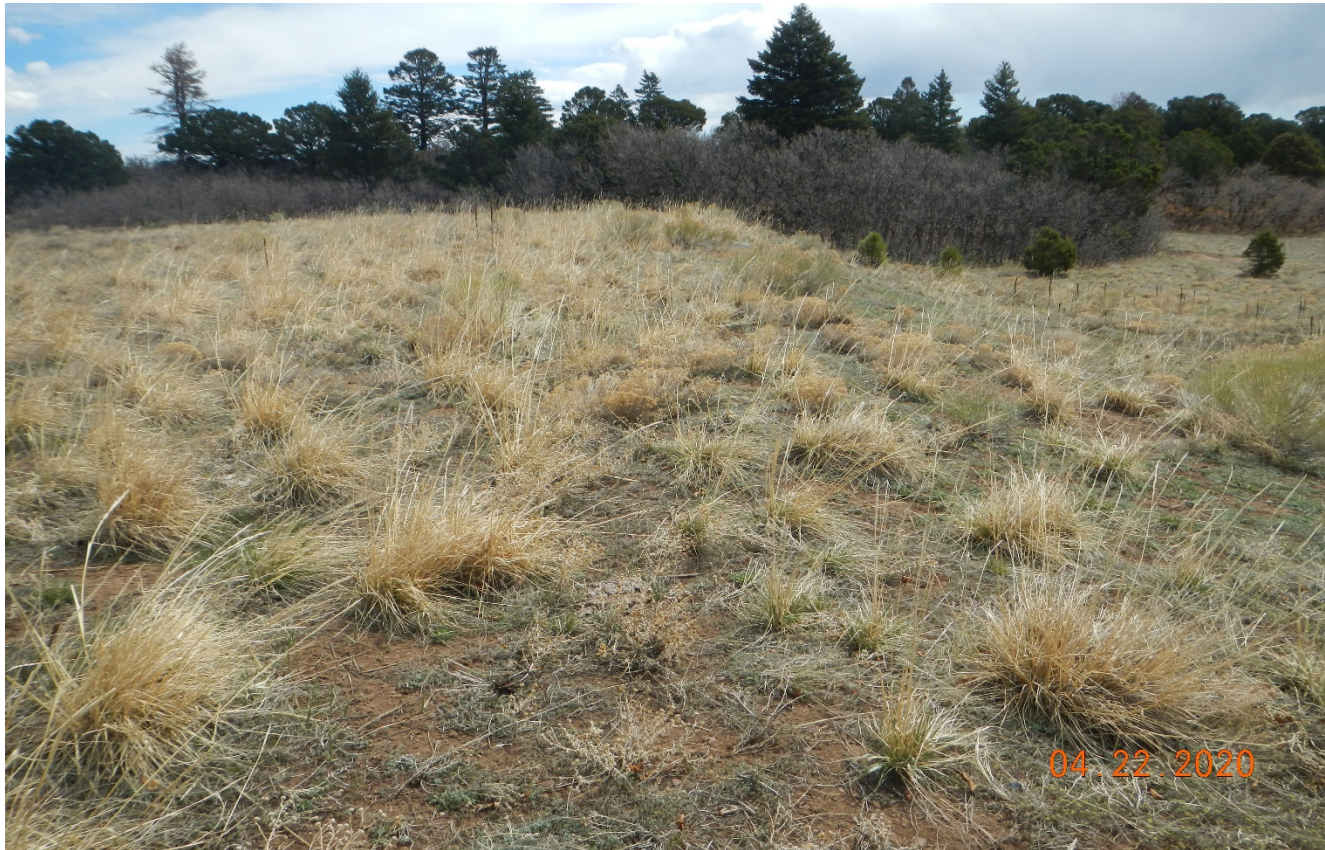
**Photo 2.** Vegetation is well established along the fill slope.

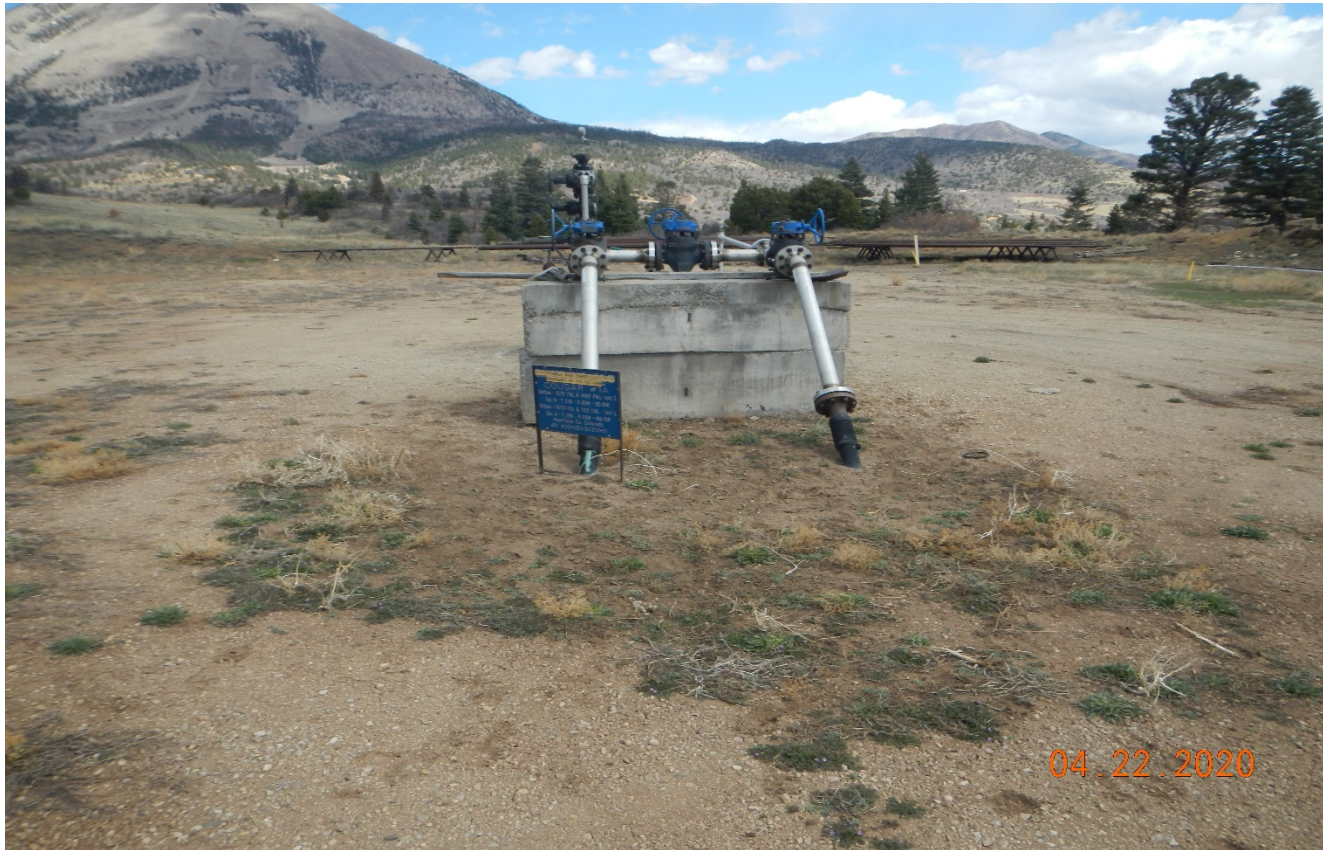
**Photo 3.** Well sign is posted at the well head. Emergency contact number on the sign needs to be updated.

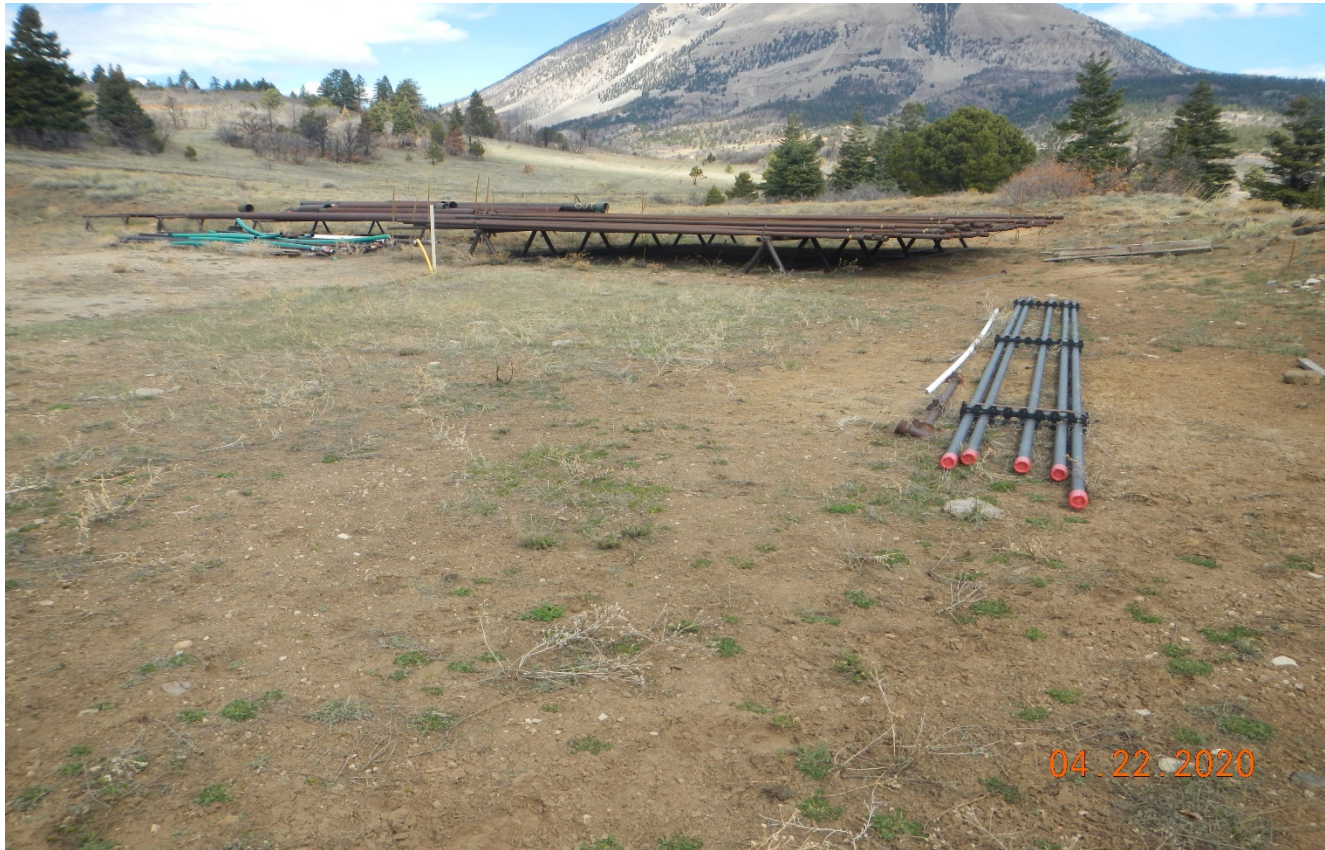
**Photo 4.** There is unused pipe being stored at the north side of the location.

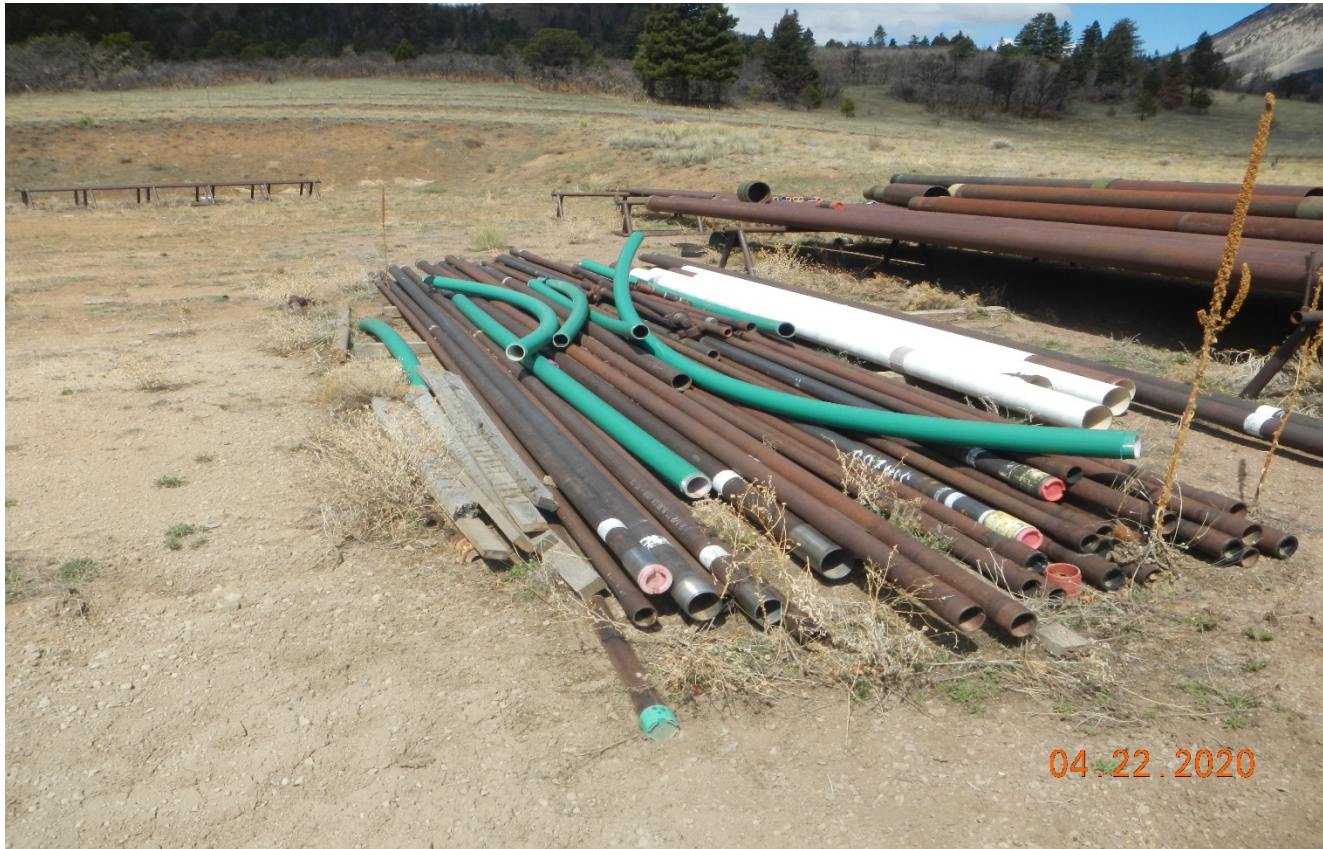
**Photo 5.** The unused pipe at the location needs to be removed.
