Inspection Photos  
Operator: Red Mesa  
API#: 067-06124  
Date: 4/23/2020

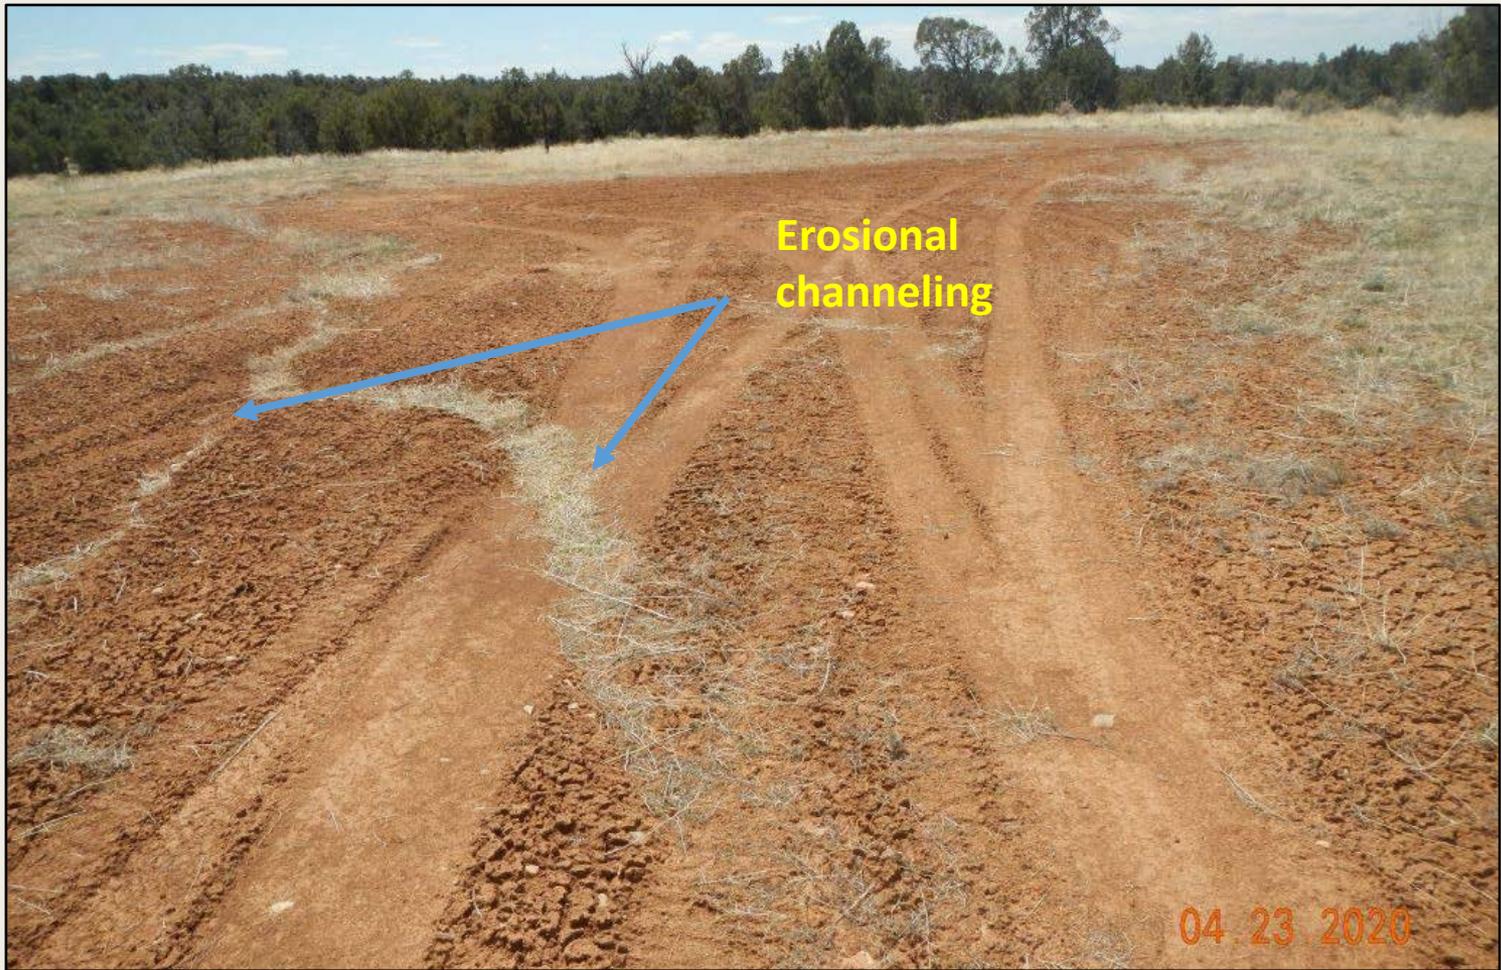
Photo 1. View of the project area from the well pad entrance facing center. Erosional channeling occurring from the access entrance and flowing southeastward.

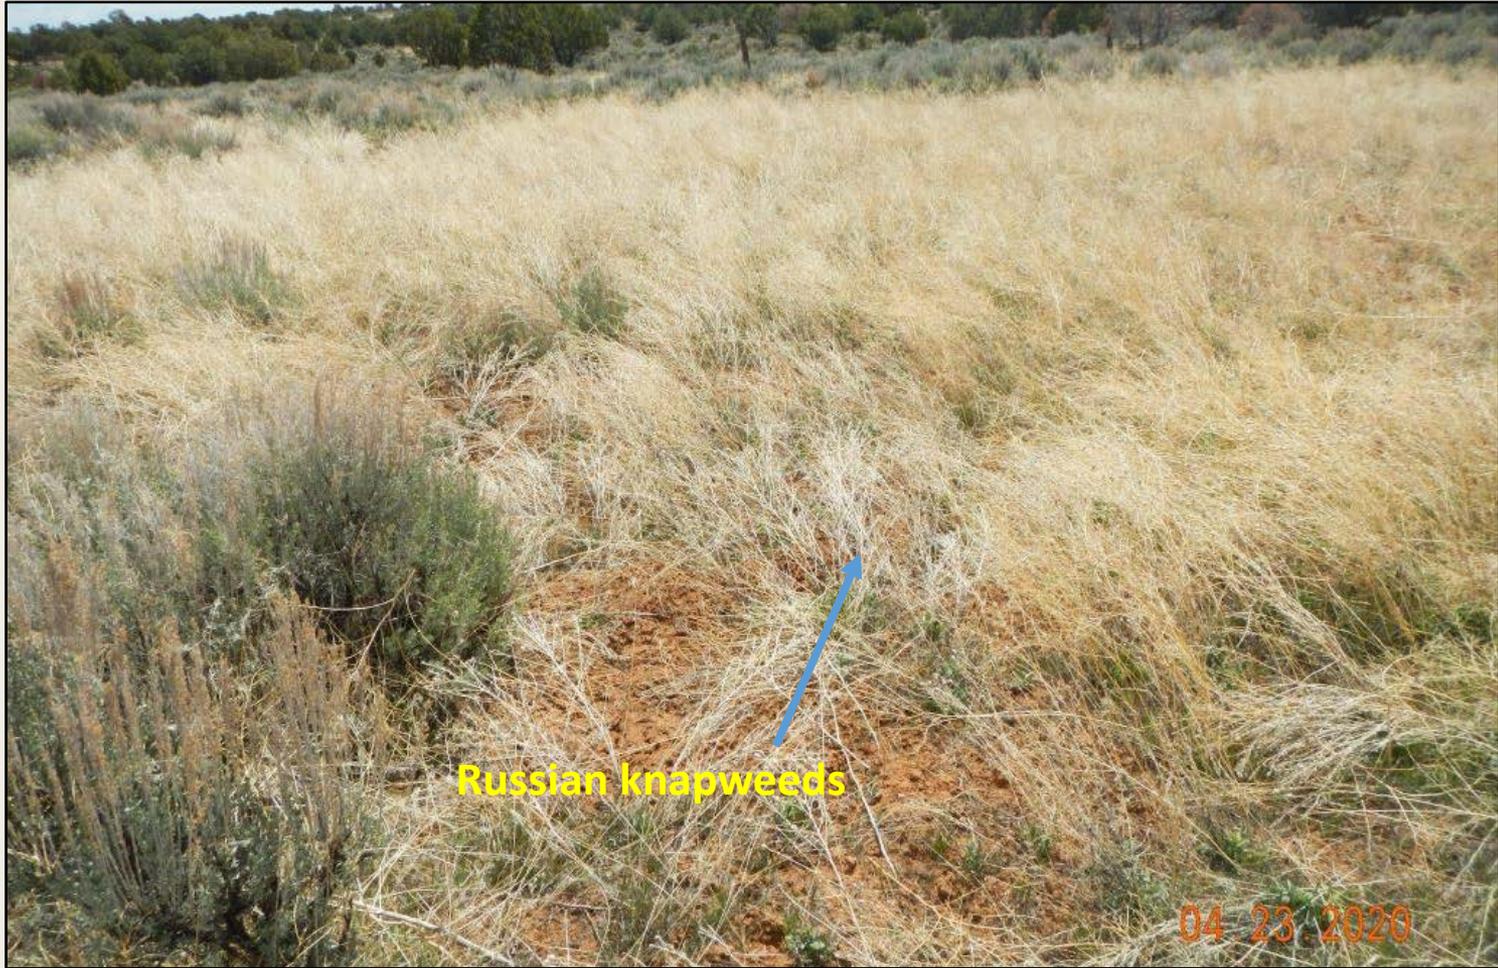
Photo 2. View of dense Russian knapweeds within the eastern project area.

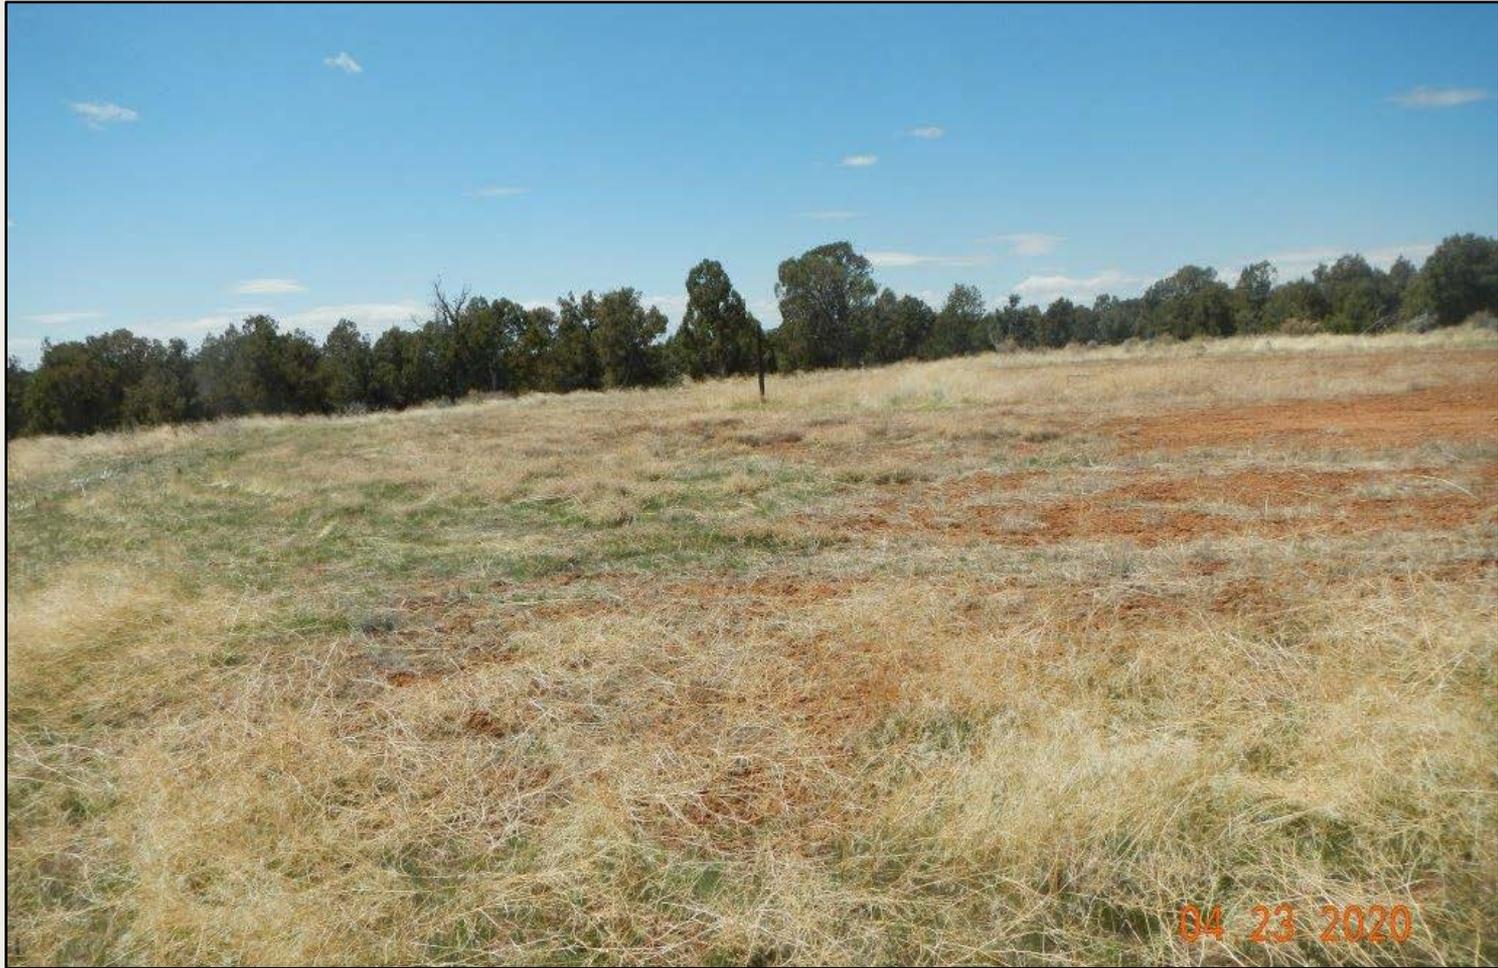
Photo 3. View of the southern project area from the southeastern corner facing westward. Plugged well marker in place.

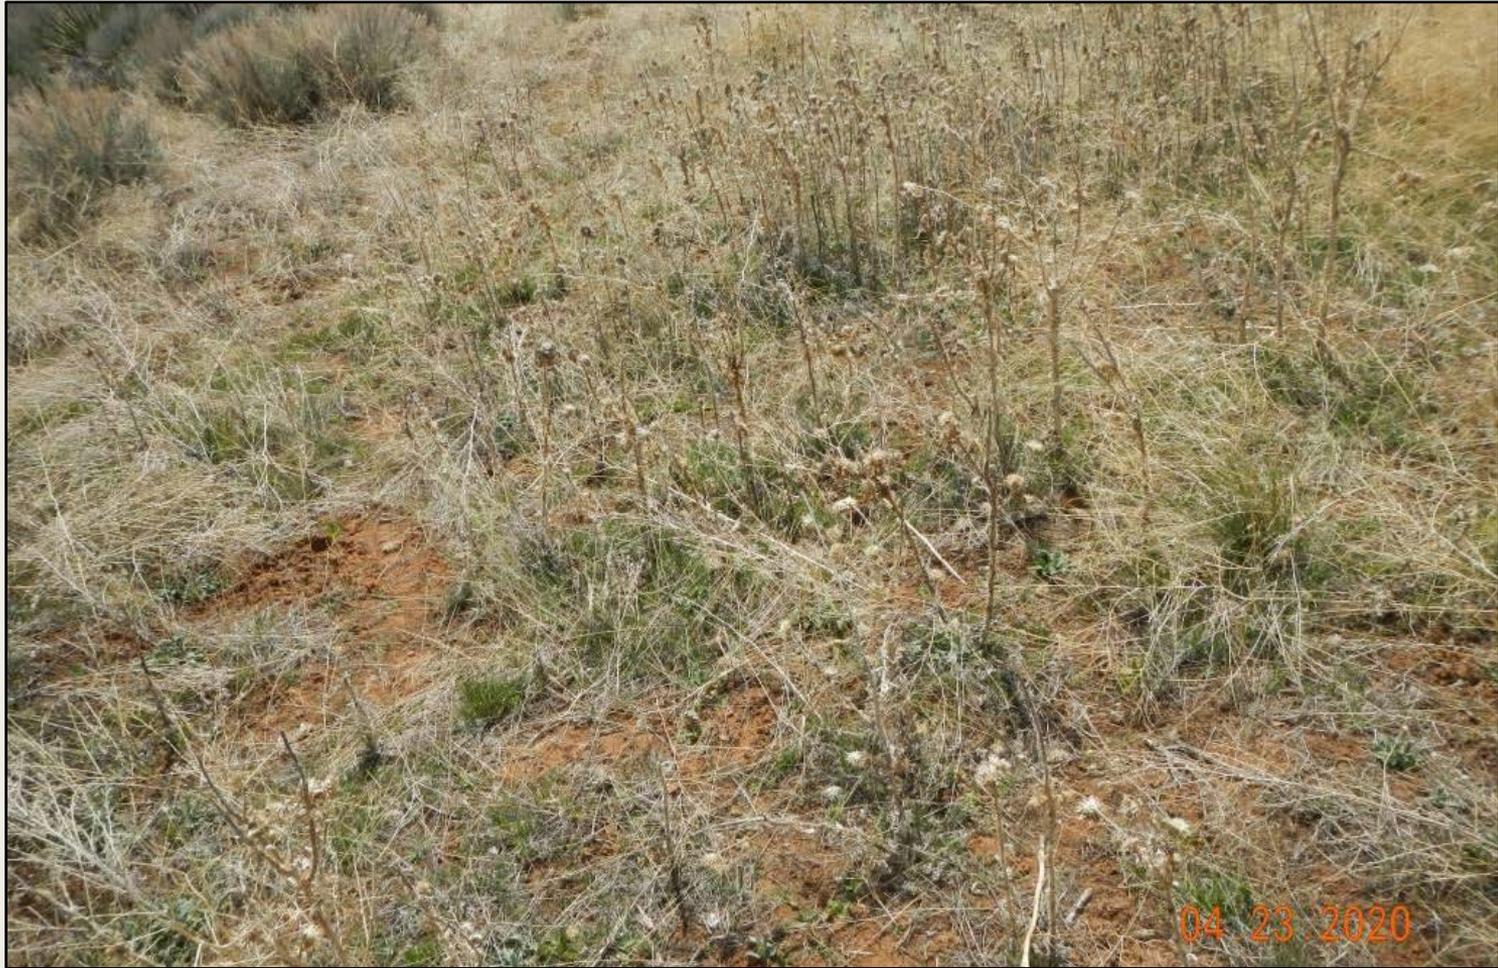
Photo 4. View of musk thistles within the southern project area.

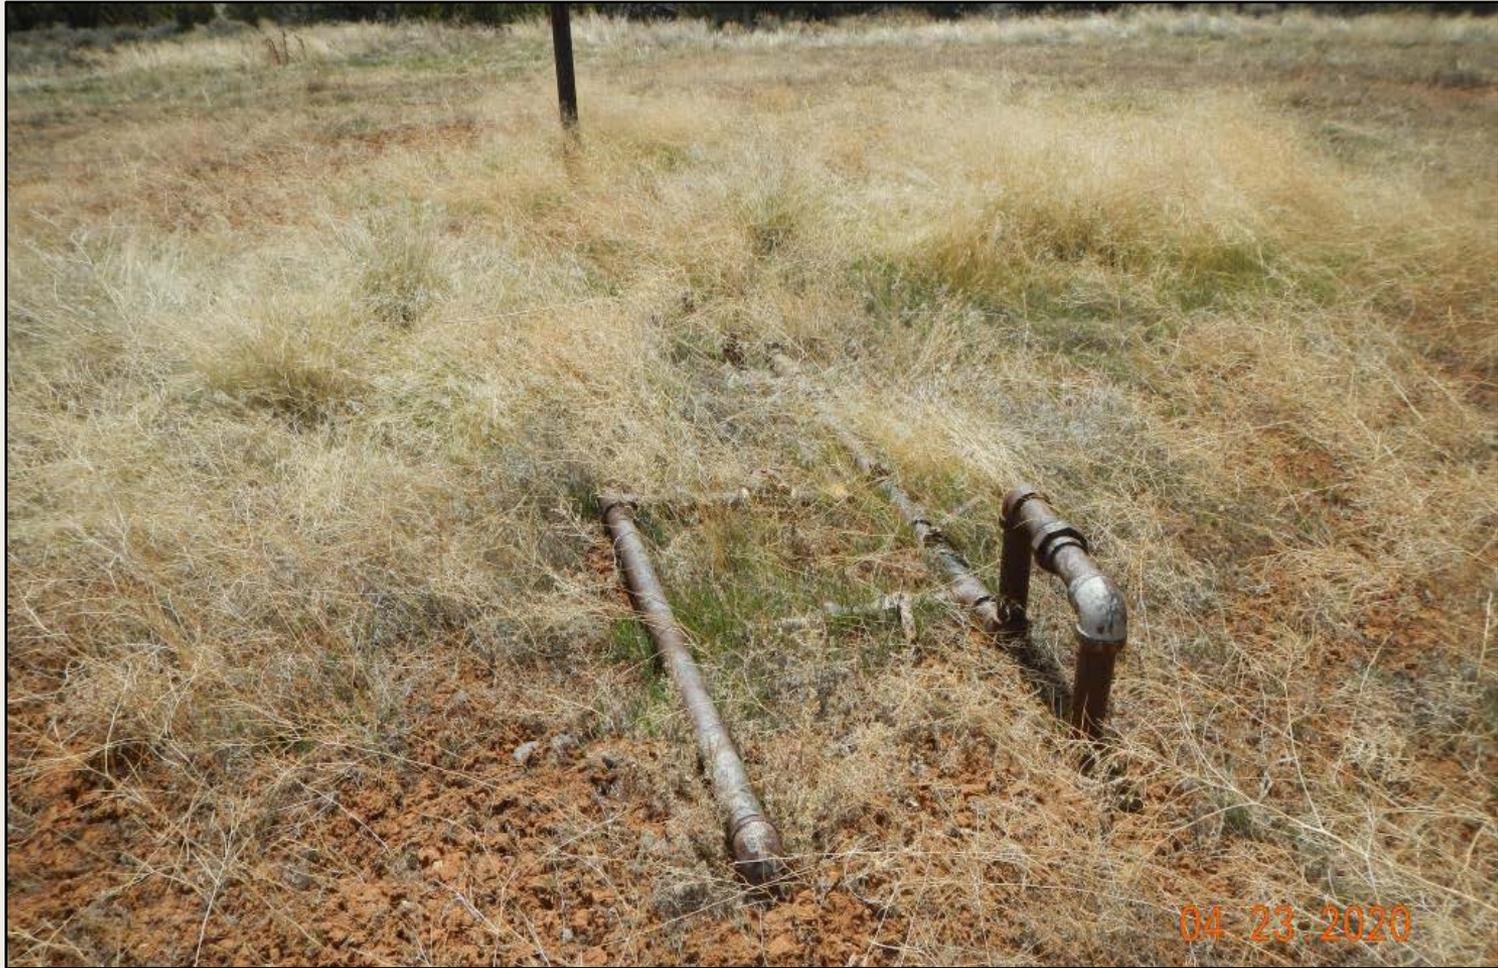
Photo 5. View of plugged well marker and remaining lines around plugged well location.

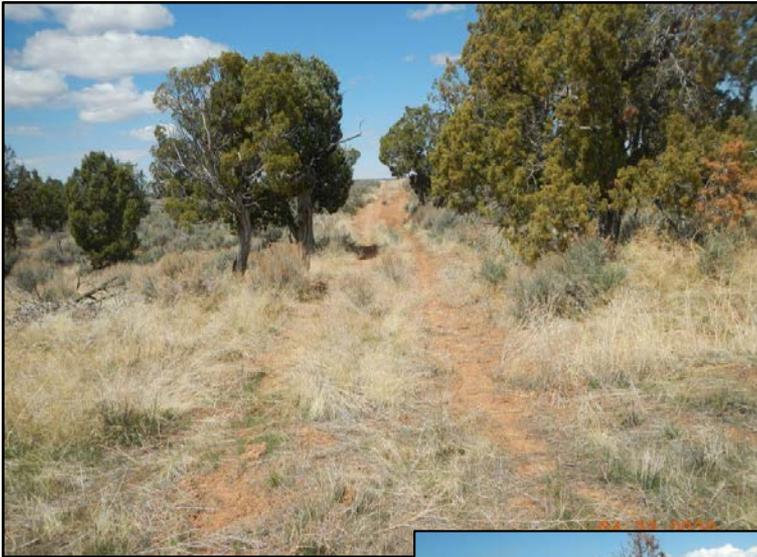
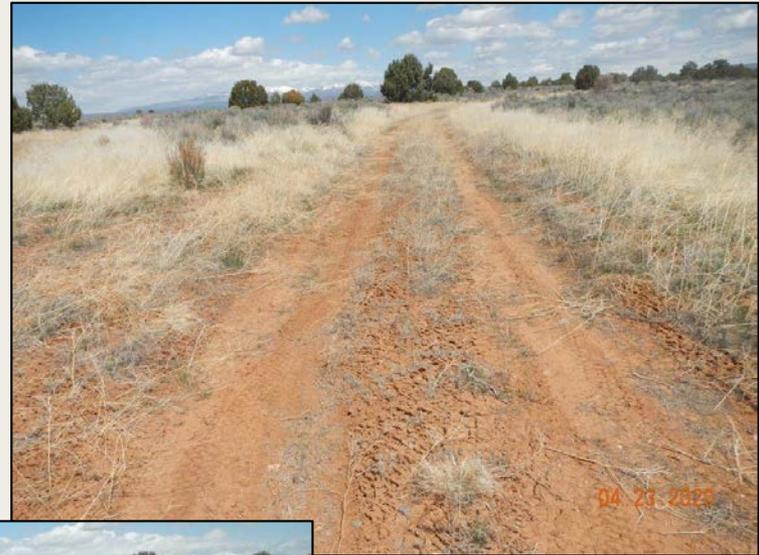
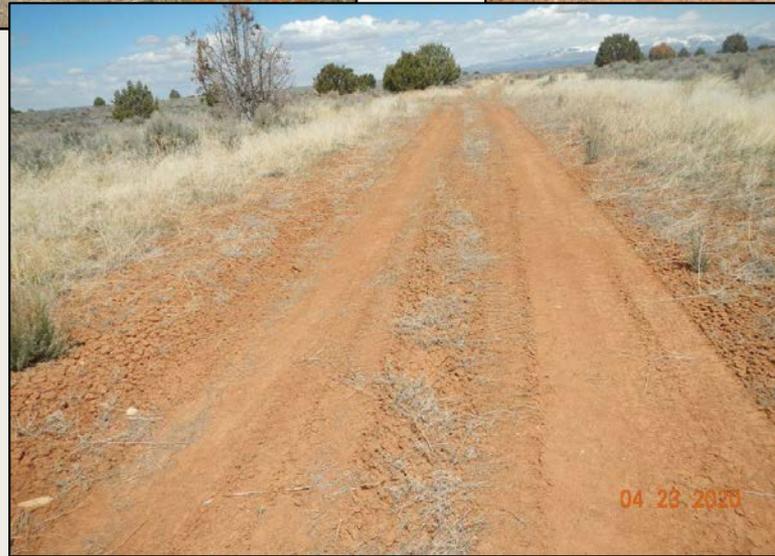
Photos 6-8. View of three separate access roads leading to well location.

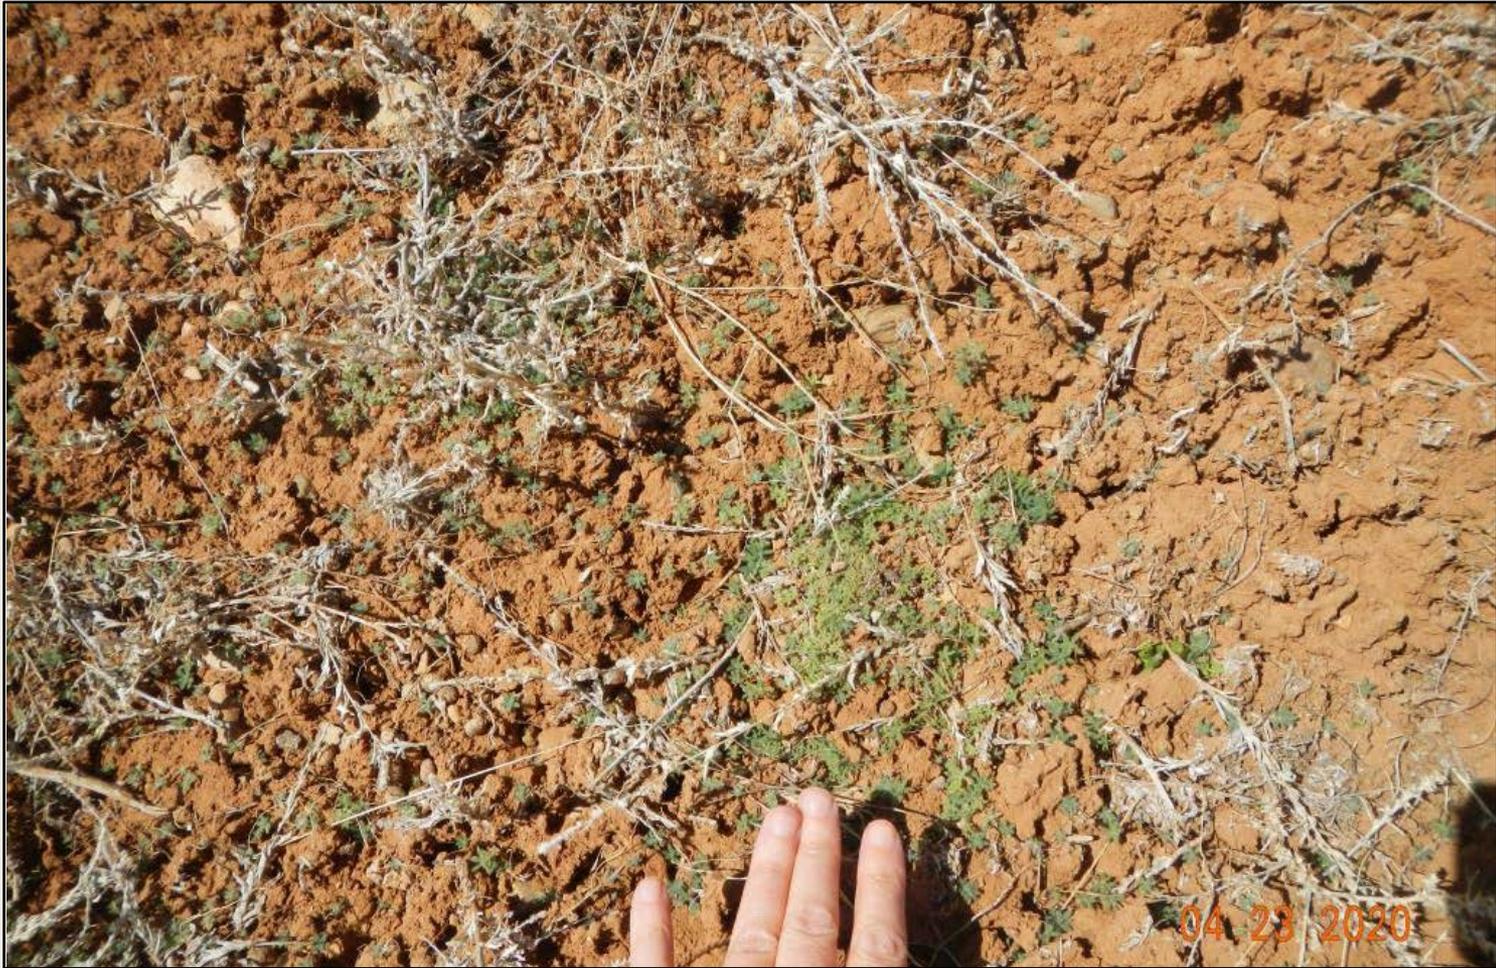
Photo 9. View of dense kochia seedlings in an early growing condition at this time.

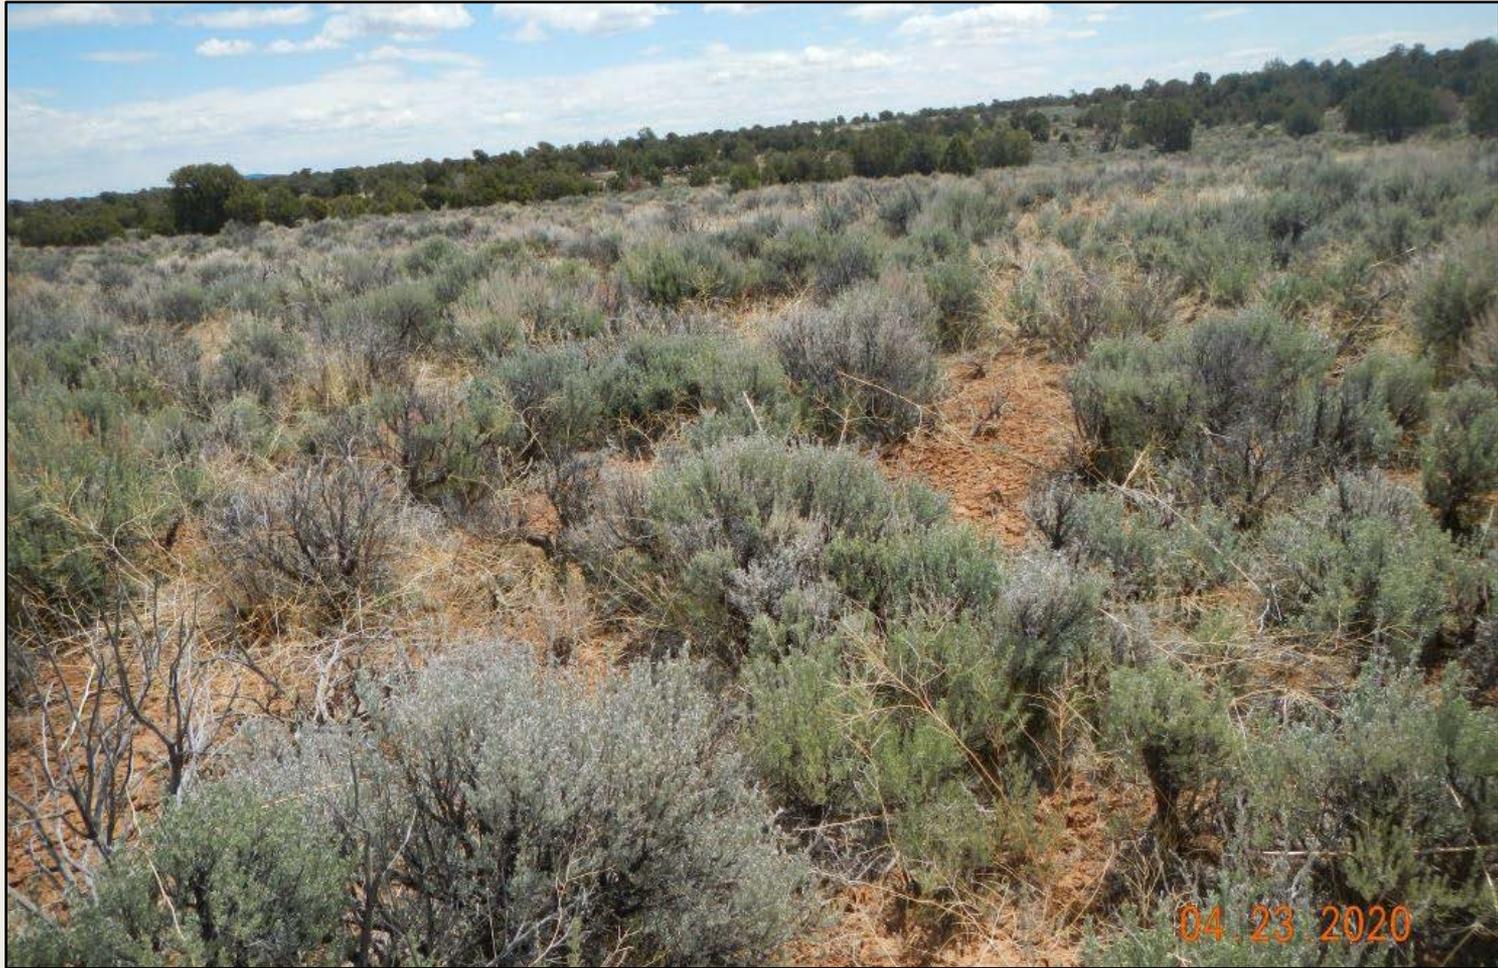
Photo 10. View of reference area vegetation comprised of open sagebrush shrubland with scattered juniper trees Grasses/herbs in the understory such as blue grama, sand dropseed and Indian ricegrass, penstemon spp. are observable in a dormant vegetative condition.
