Inspection Photos

4/22/2020

Operator: CAERUS PICEANCE LLC - 10456

Facility ID: 419752

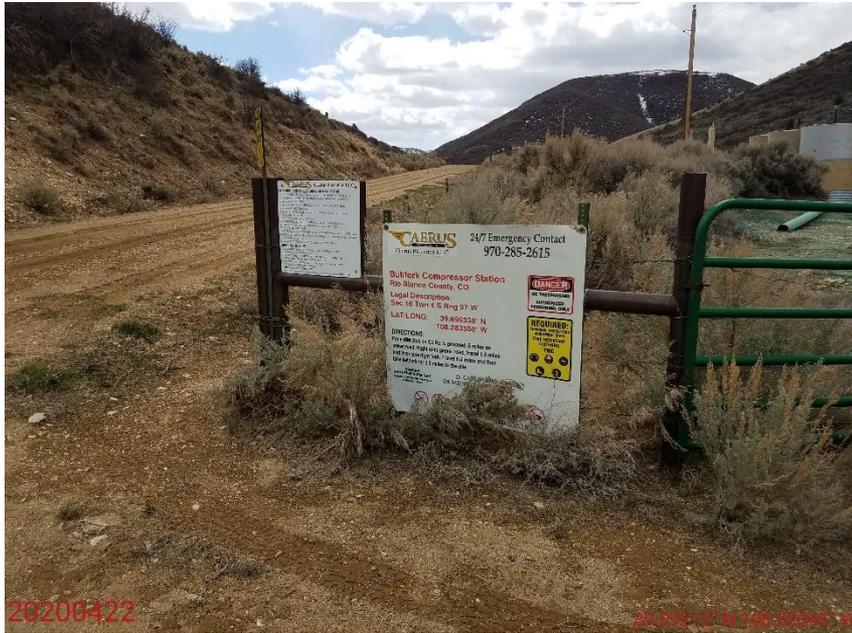
Photo 1: Photo of sign at Location entrance on the northeast corner of the Location.

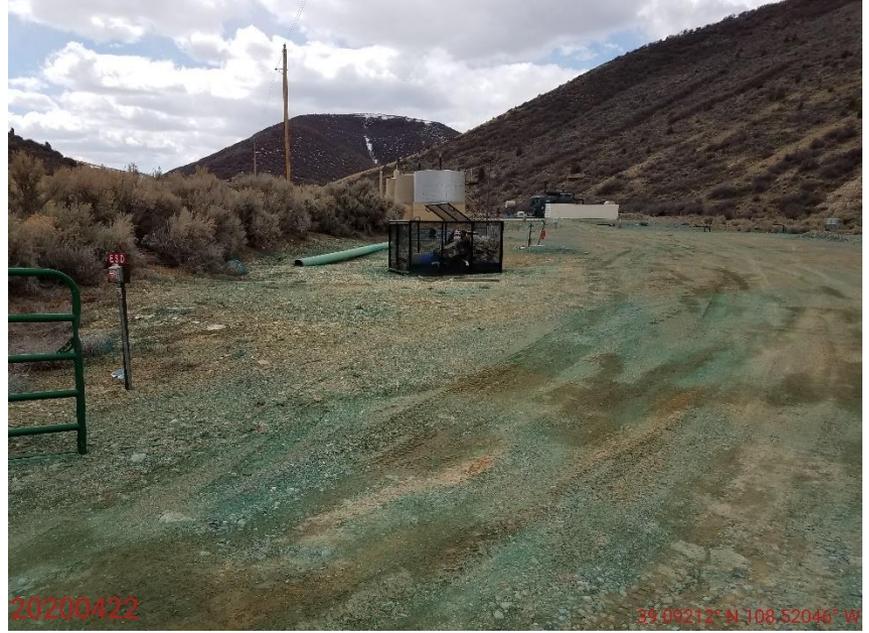
Photo 2: Photo taken from the northeast end of the Location, facing south. Photo provides an overview of the location.

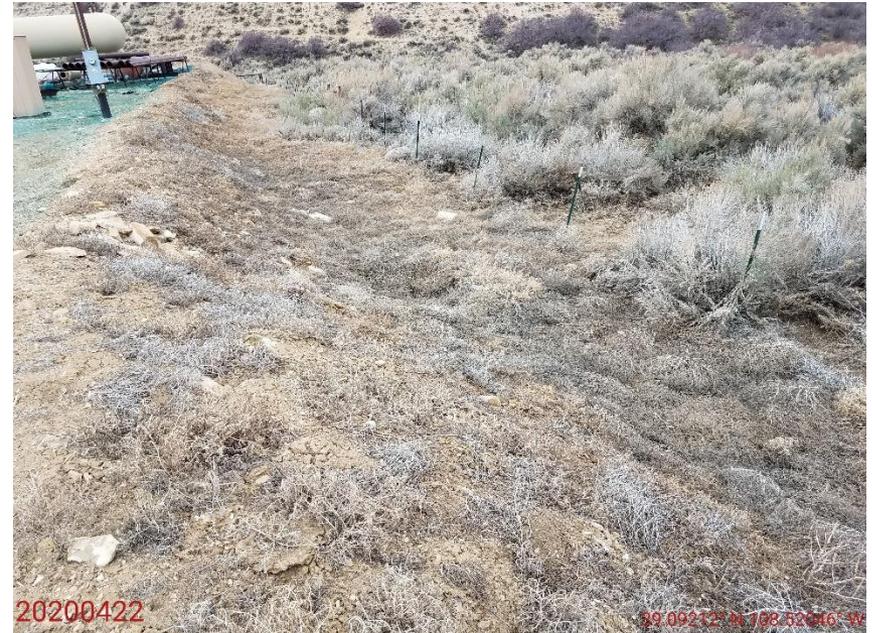
Photo 4: Photo taken from the northeast end of the Location, facing west. Photo shows weed debris has established/accumulated on the perimeter slopes/berms of the Location. Weed debris requires removal and proper disposal.

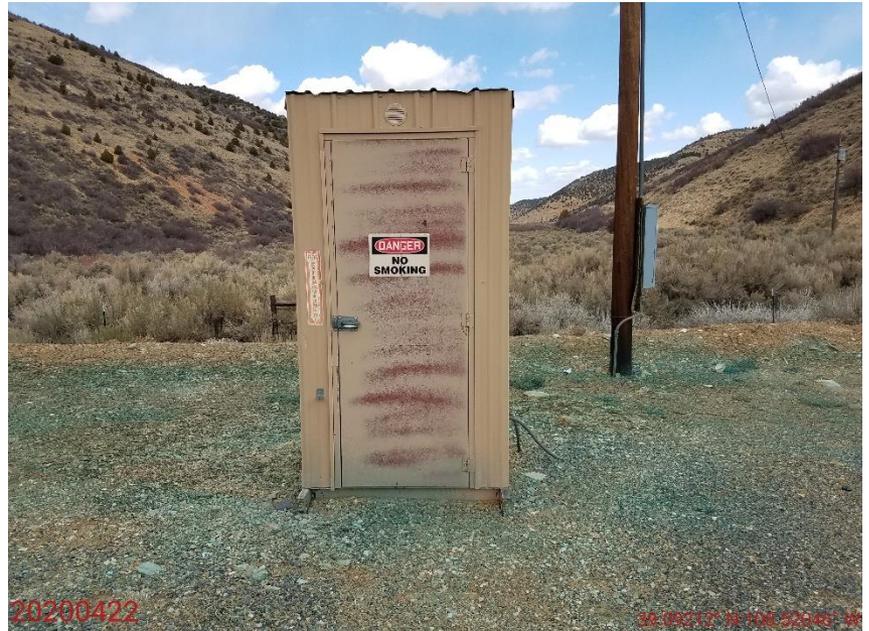
Photo 6: Photo taken from the north end of the Location, facing north. Photo shows unused equipment (shed) stored on Location. All stored/unused equipment and trash debris requires removal in accordance with Rule 603.f

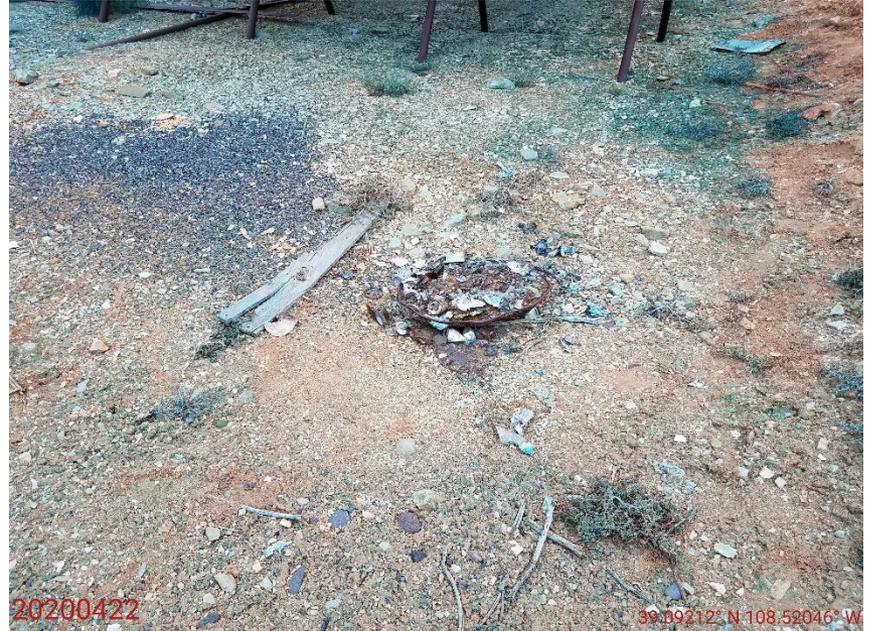
Photo 8: Photo taken from the north end of the Location. Photo shows trash debris stored on Location. All stored/unused equipment and trash debris requires removal in accordance with Rule 603.f

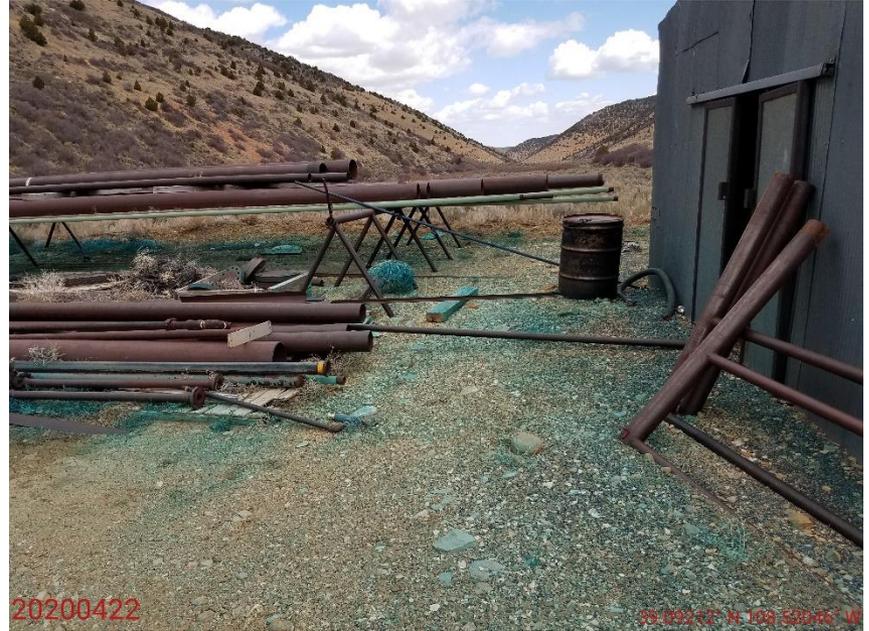
Photo 10: Photo taken from the north end of the Location. Photo shows unused equipment (shed, pipe, etc...) and trash debris stored on Location. All stored/unused equipment and trash debris requires removal in accordance with Rule 603.f

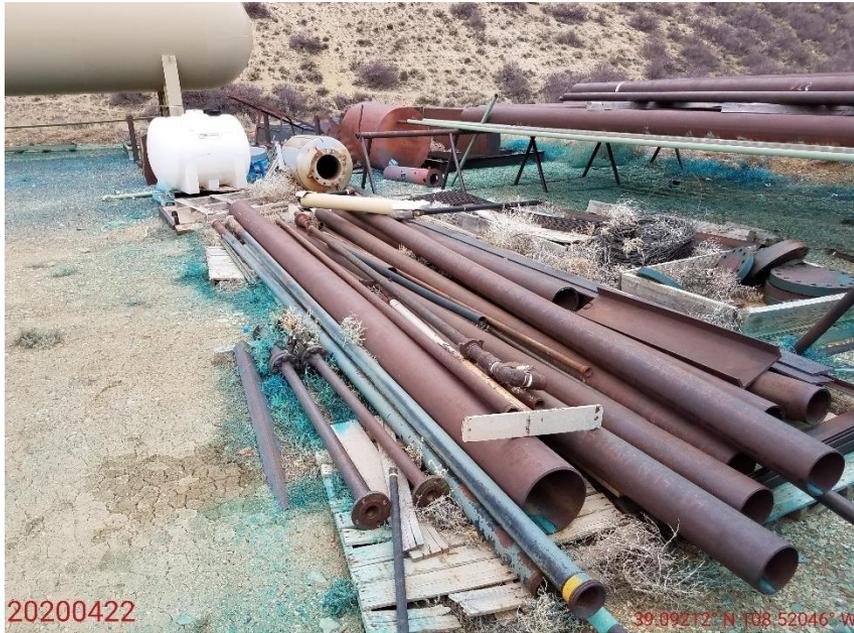
Photo 11: Photo taken from the north end of the Location. Photo shows unused equipment (pipe, tanks, etc...) and trash debris stored on Location. All stored/unused equipment and trash debris requires removal in accordance with Rule 603.f

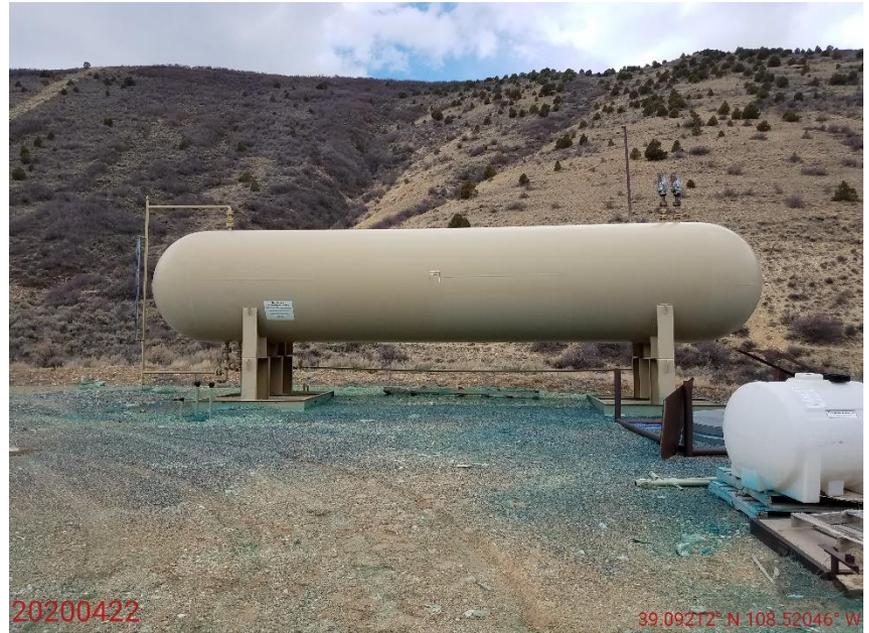
Photo 12: Photo taken from the north end of the Location. Photo shows unused equipment (tanks, etc...) and trash debris stored on Location. All stored/unused equipment and trash debris requires removal in accordance with Rule 603.f

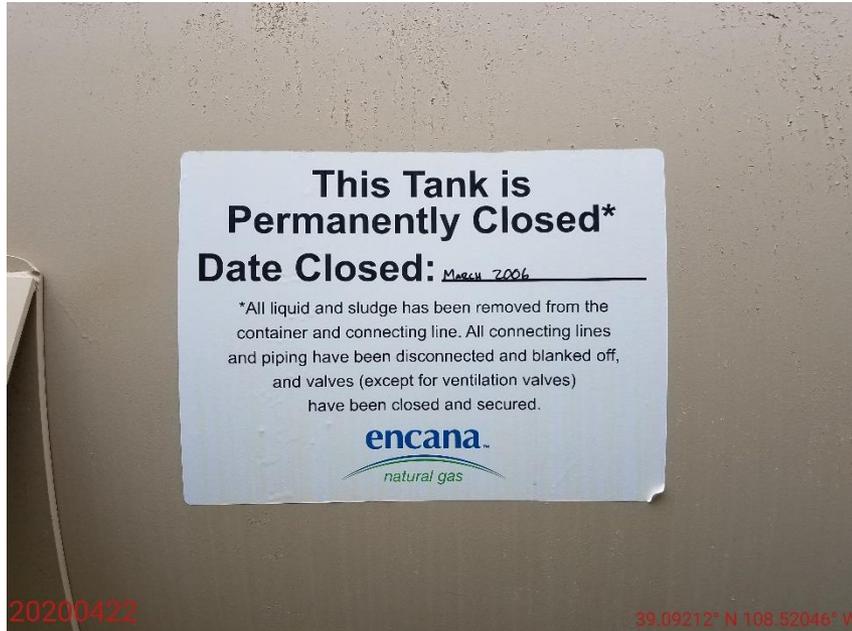
Photo 13: Photo of sign on tank observed in photo 12. Photo shows tank has been “permanently closed” since March 2006. Tank is considered unused equipment and requires removal.

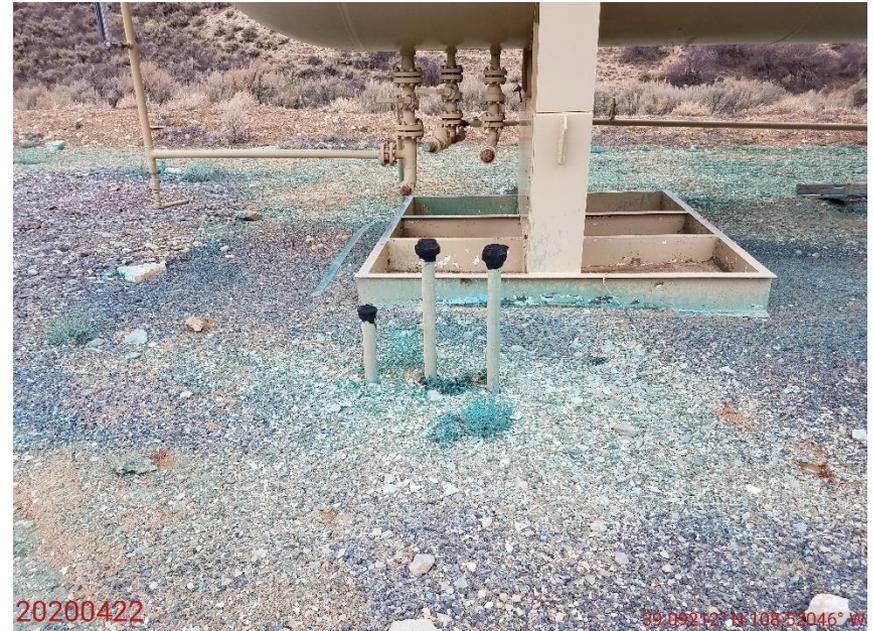
Photo 14: Photo taken from the north end of the Location. Photo shows unused/abandoned equipment (risers) on Location. All unused/abandoned equipment requires removal in accordance with Rule 603.f

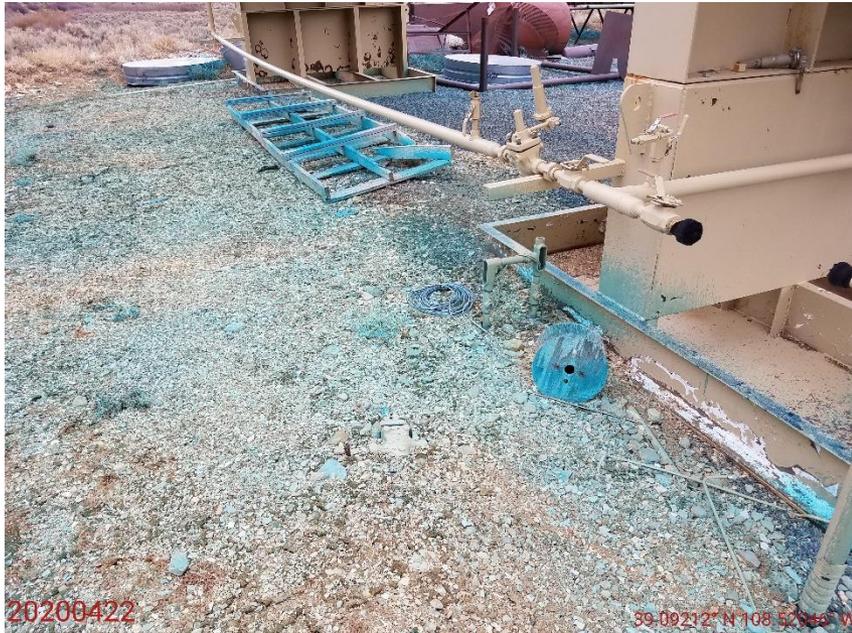
Photo 15: Photo taken from the northwest end of the Location. Photo shows trash debris stored on Location. All stored/unused equipment and trash debris requires removal in accordance with Rule 603.f

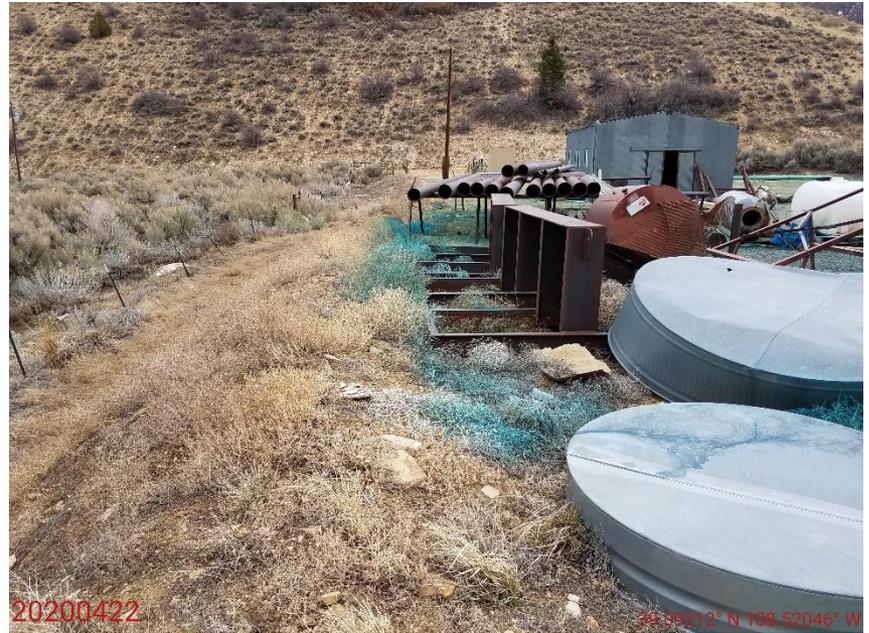
Photo 16: Photo taken from the northwest end of the Location, facing east. Photo shows unused equipment and trash debris stored on Location. Photo also shows weed debris has established/accumulated on the perimeter slopes/berms of the Location.

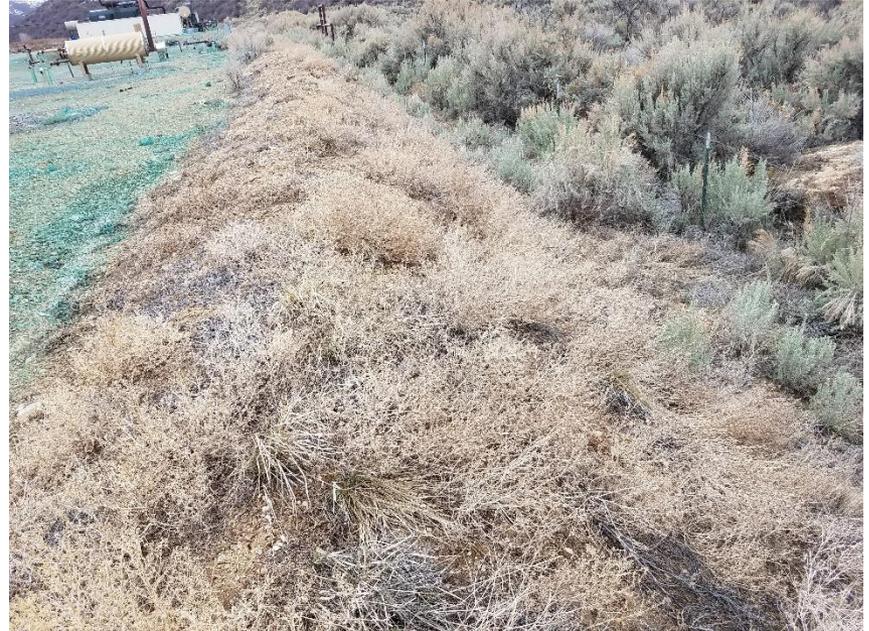
Photo 17: Photo taken from the northwest end of the Location, facing south. Photo shows weed debris has established/accumulated on the perimeter slopes/berms of the Location.

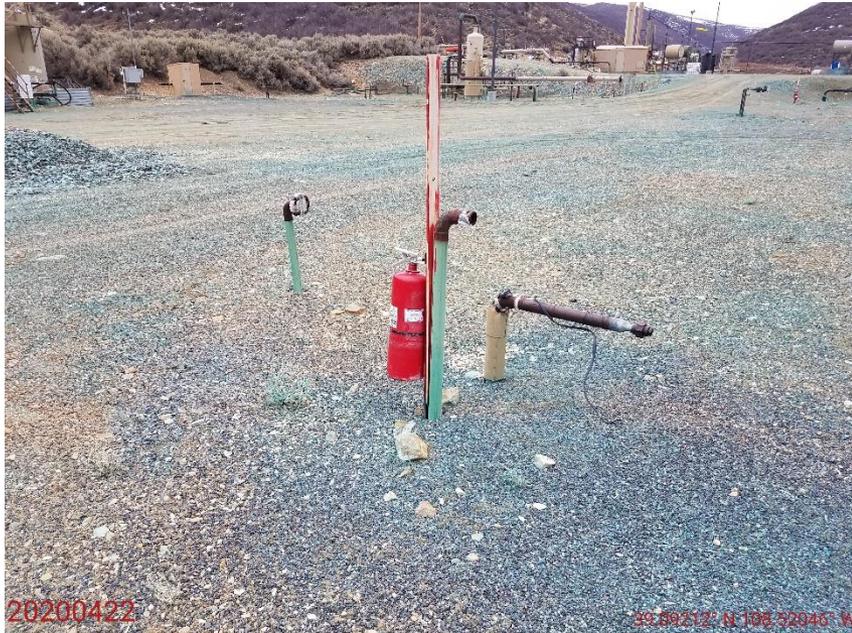
Photo 19: Photo taken from the northwest end of the Location, facing southeast. Photo shows unused/abandoned equipment (risers) on Location. All unused/abandoned equipment requires removal in accordance with Rule 603.f

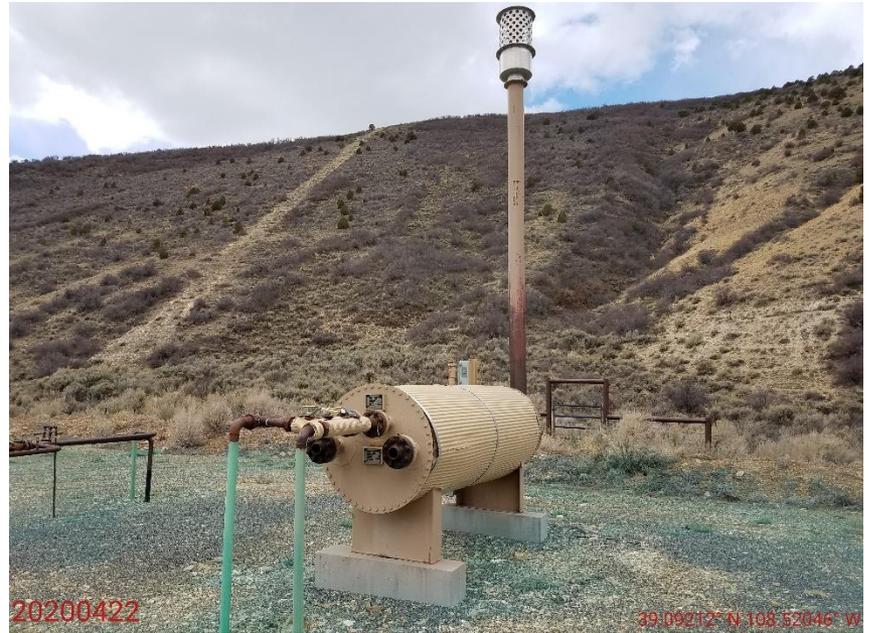
Photo 20: Photo taken from the northwest end of the Location, facing west. Photo shows unused/abandoned equipment (heater treater) on Location. All unused/abandoned equipment requires removal in accordance with Rule 603.f

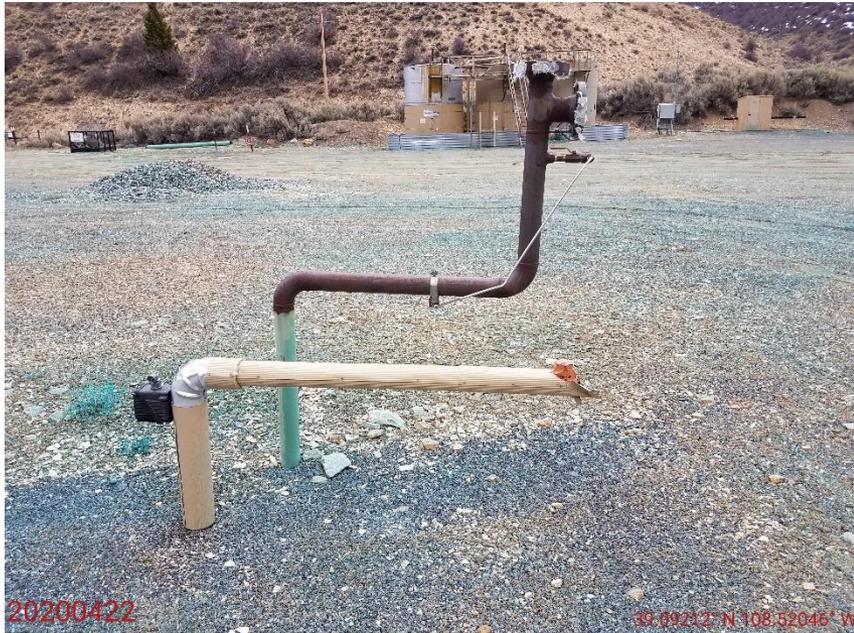
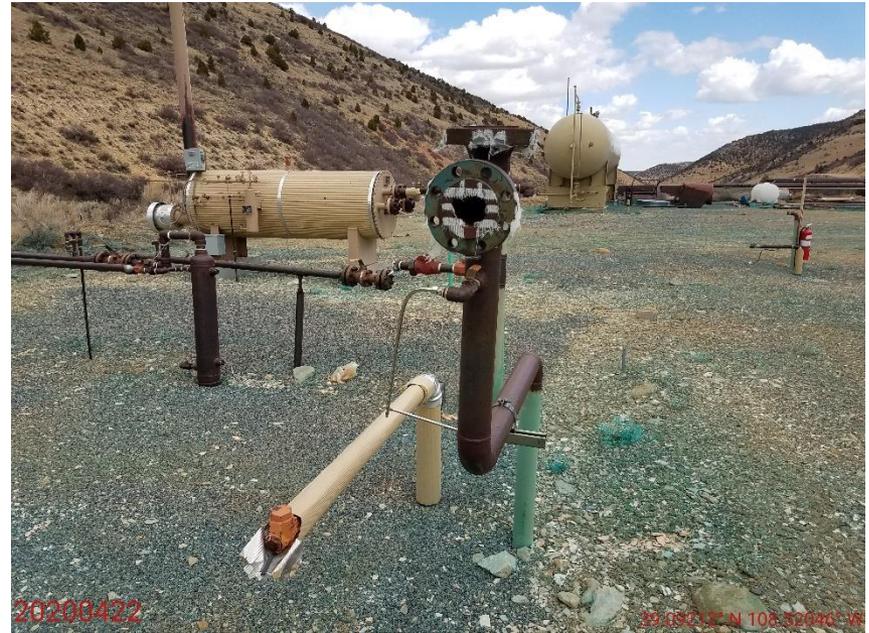
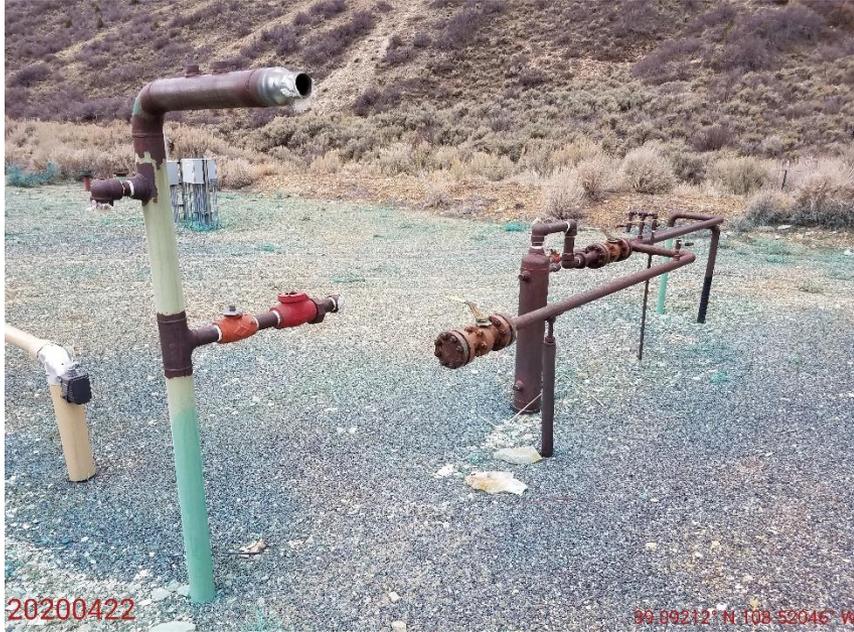
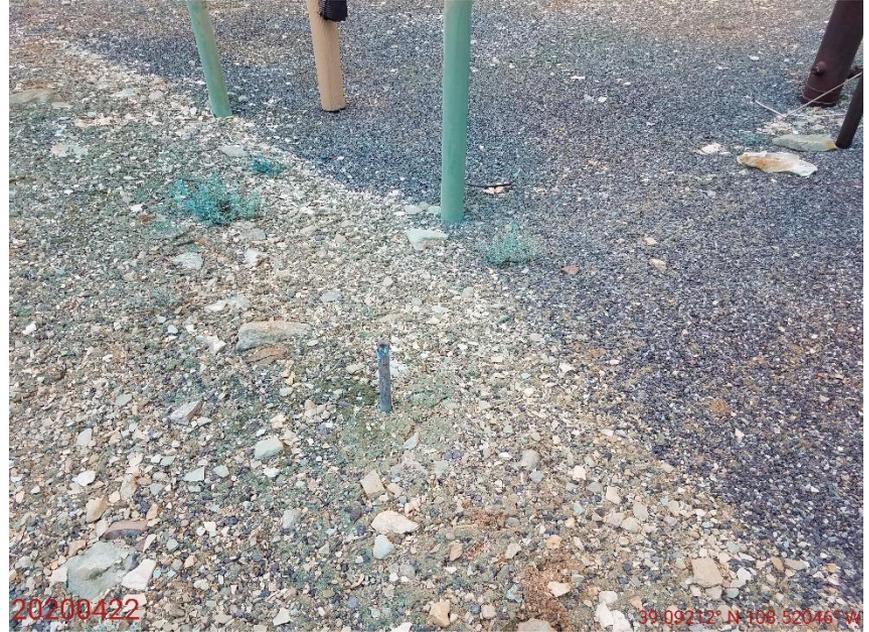
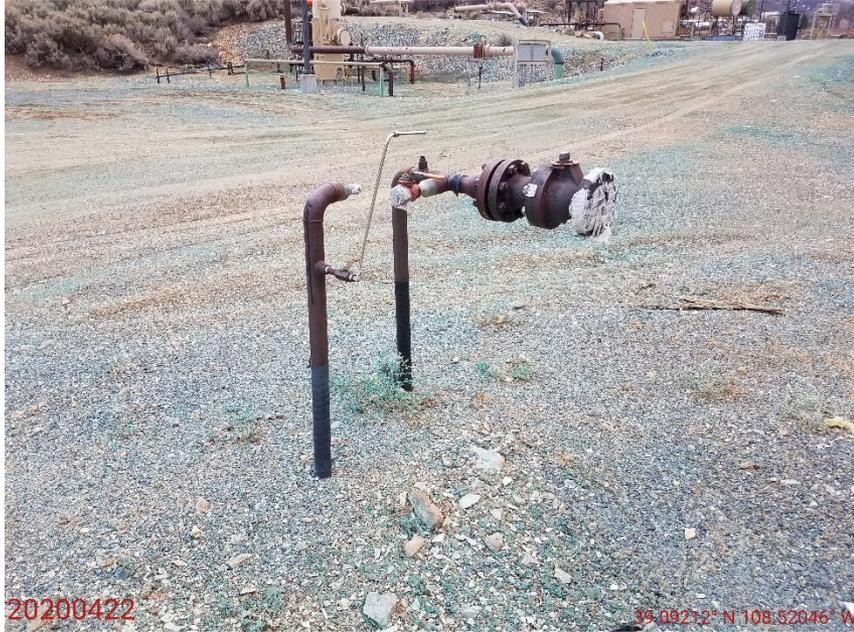
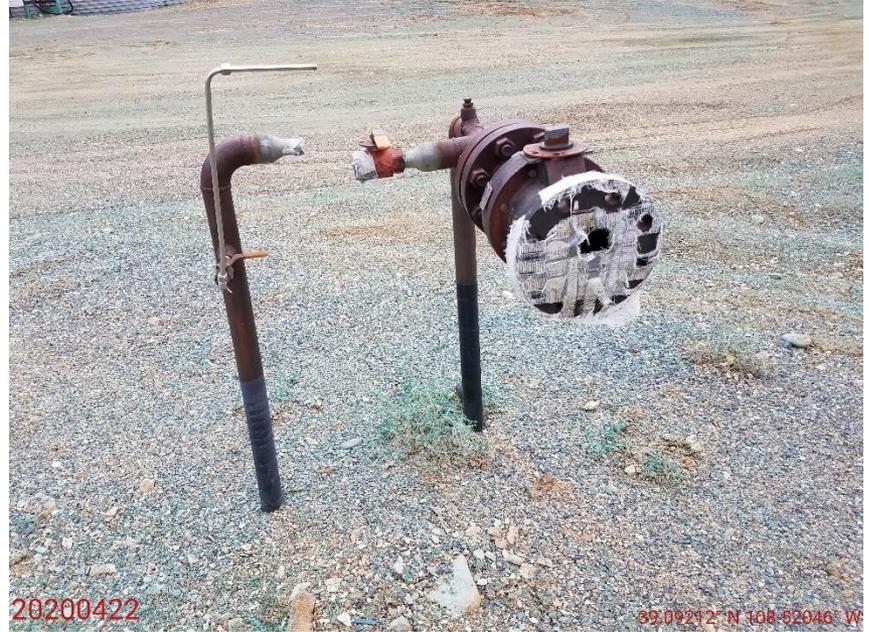
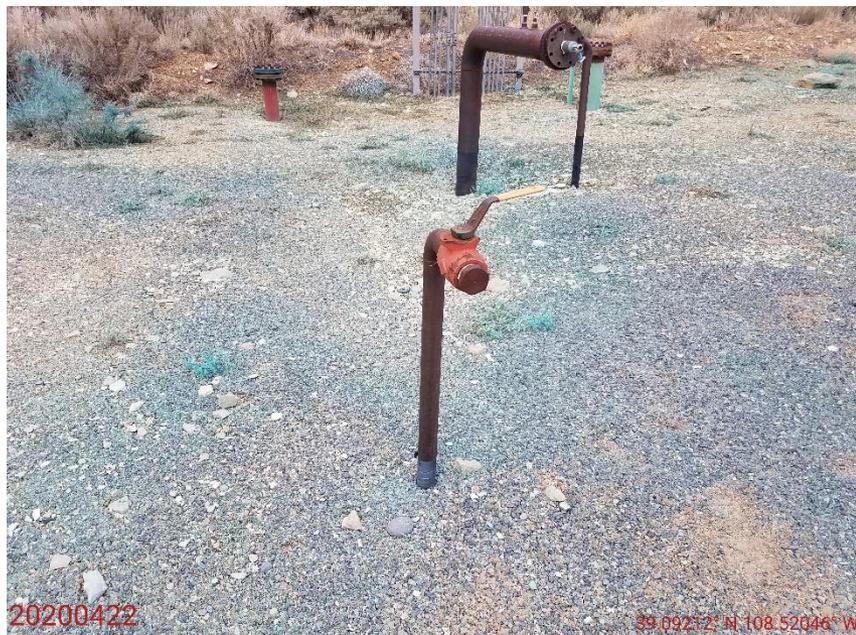
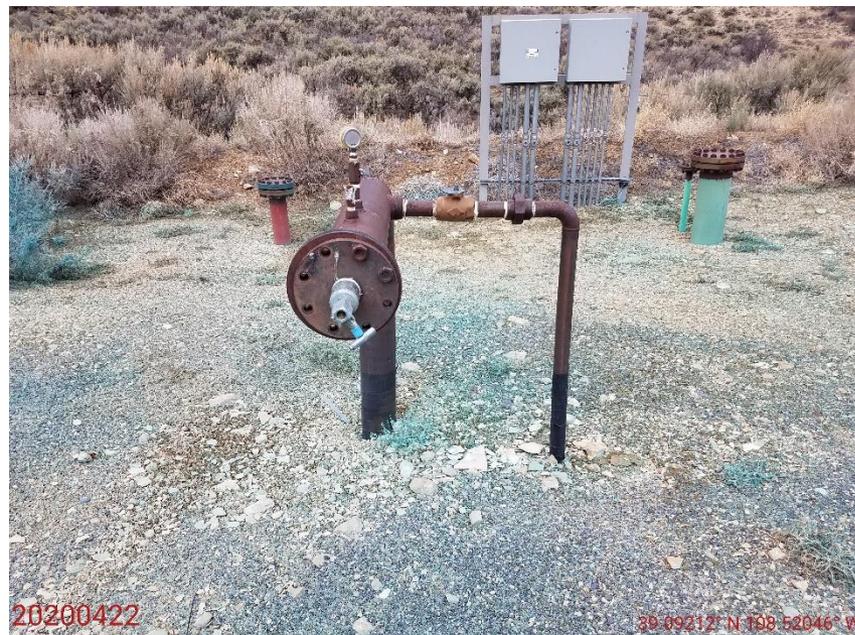
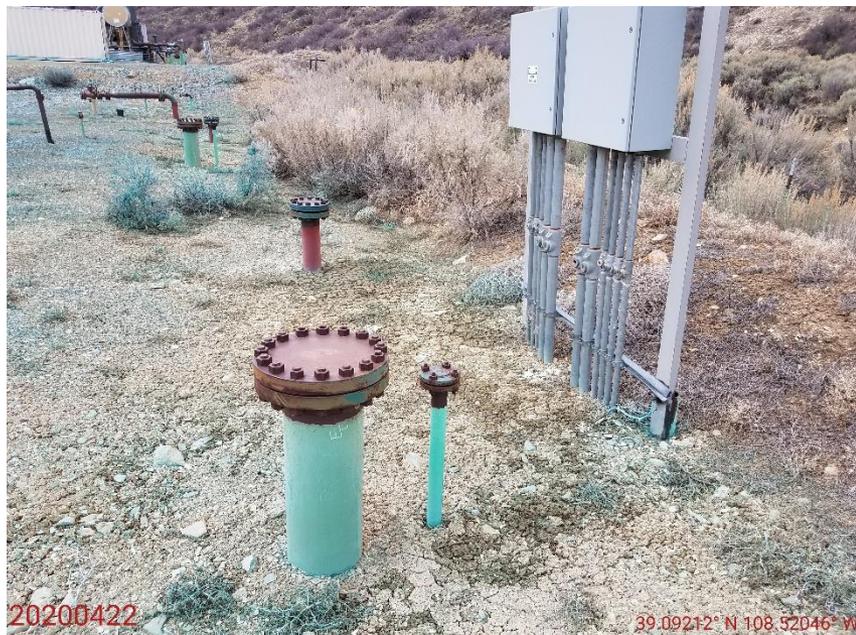
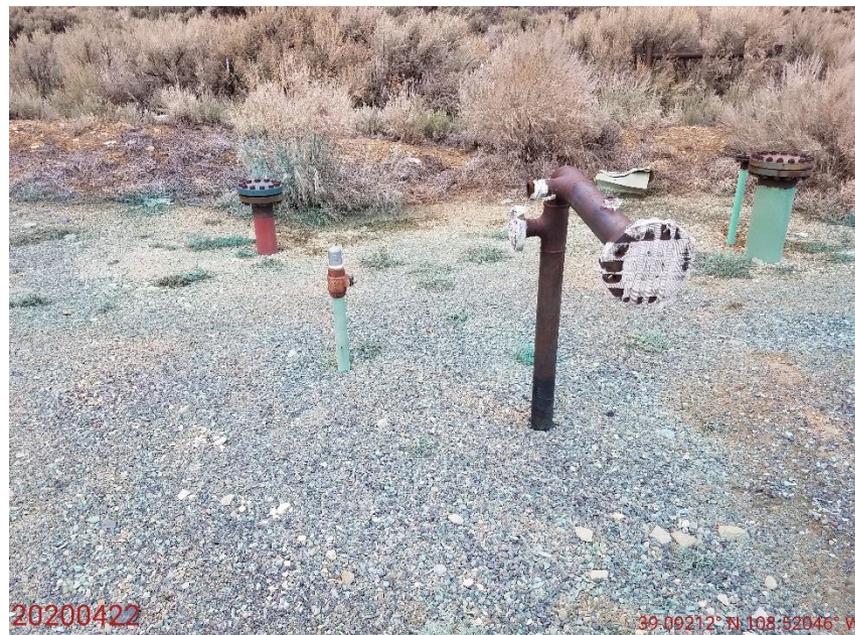
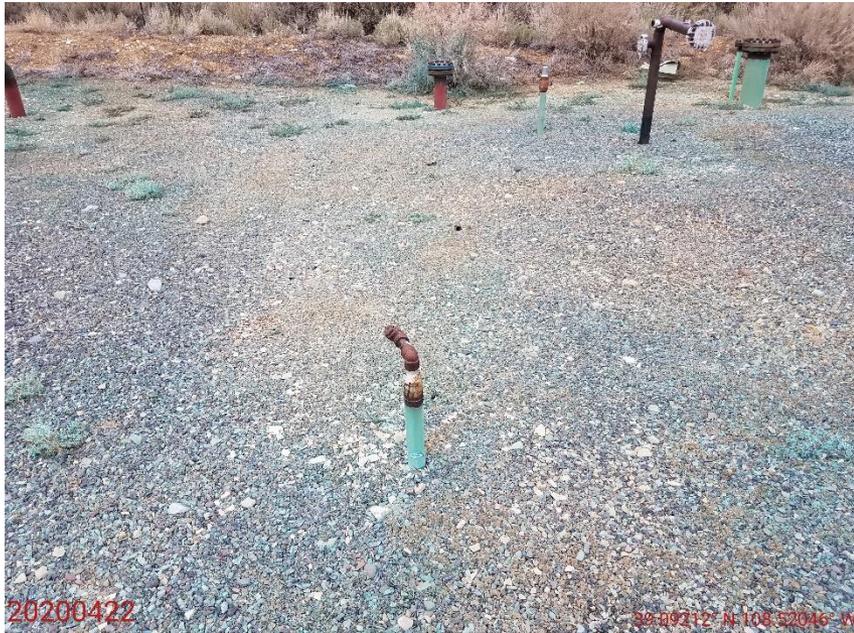
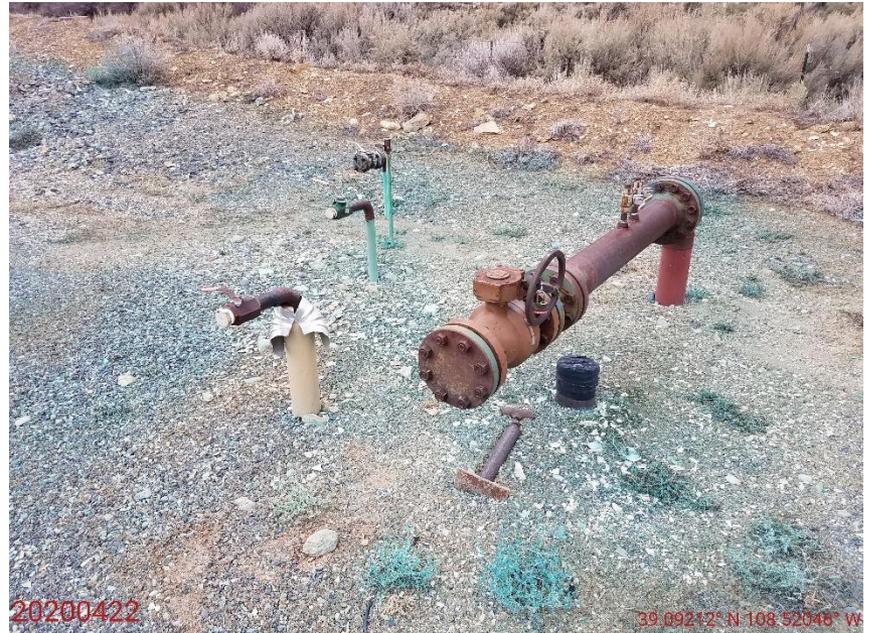
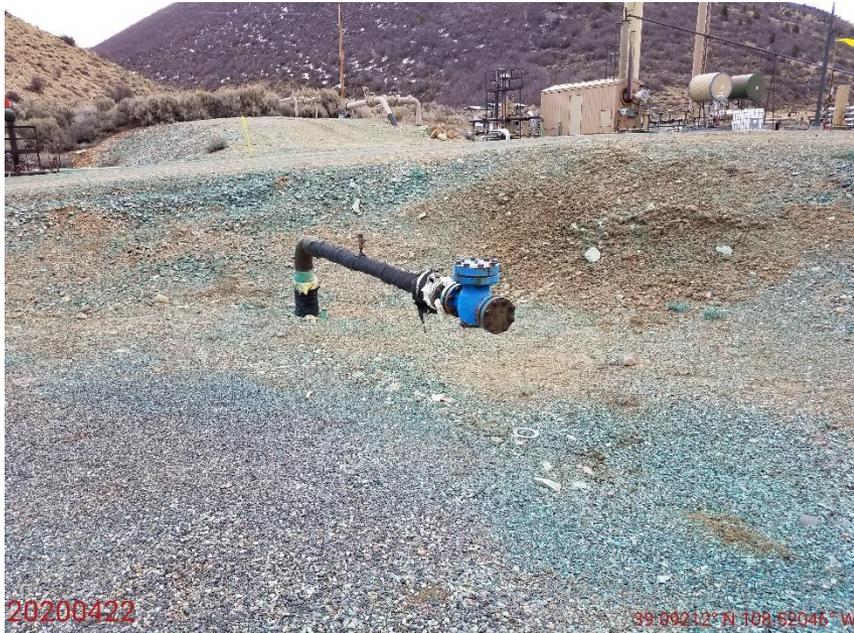
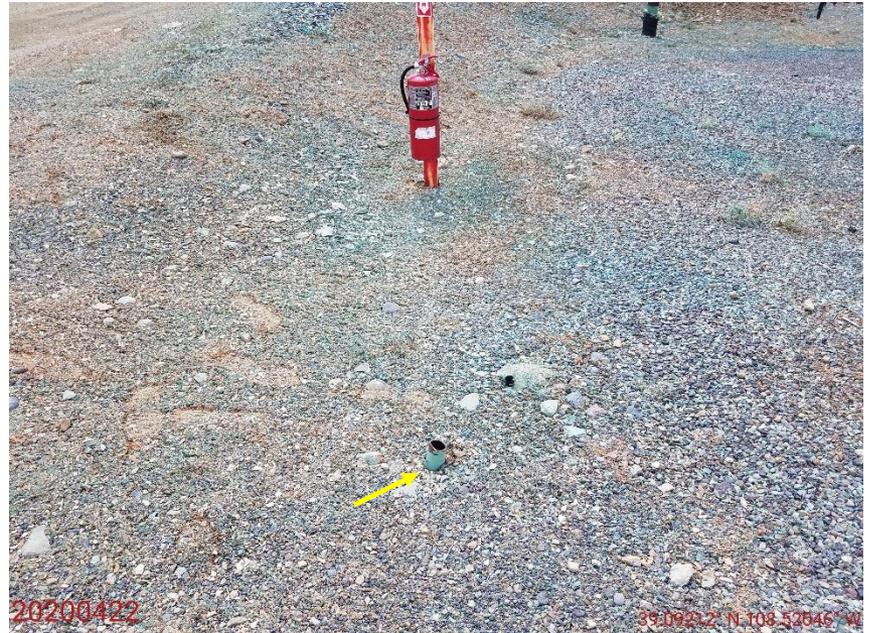
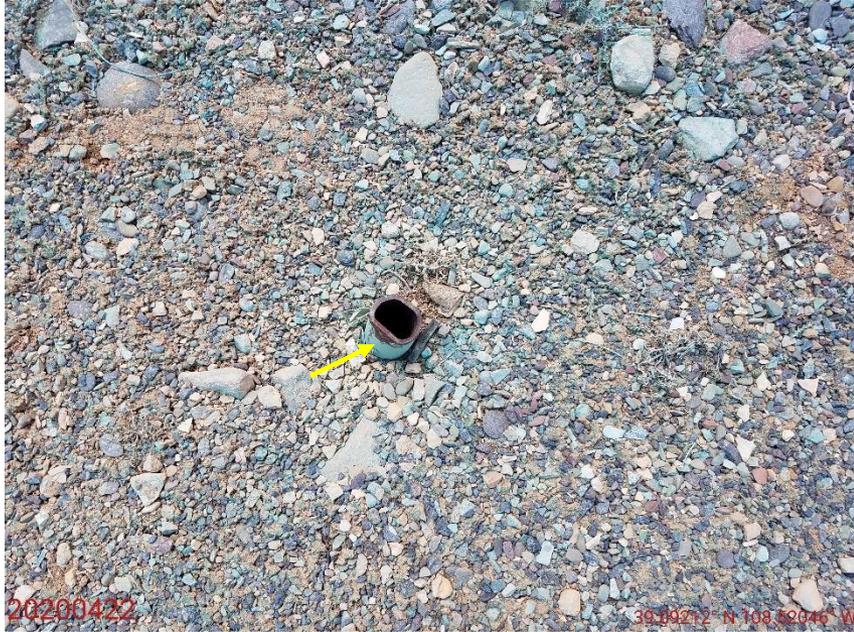
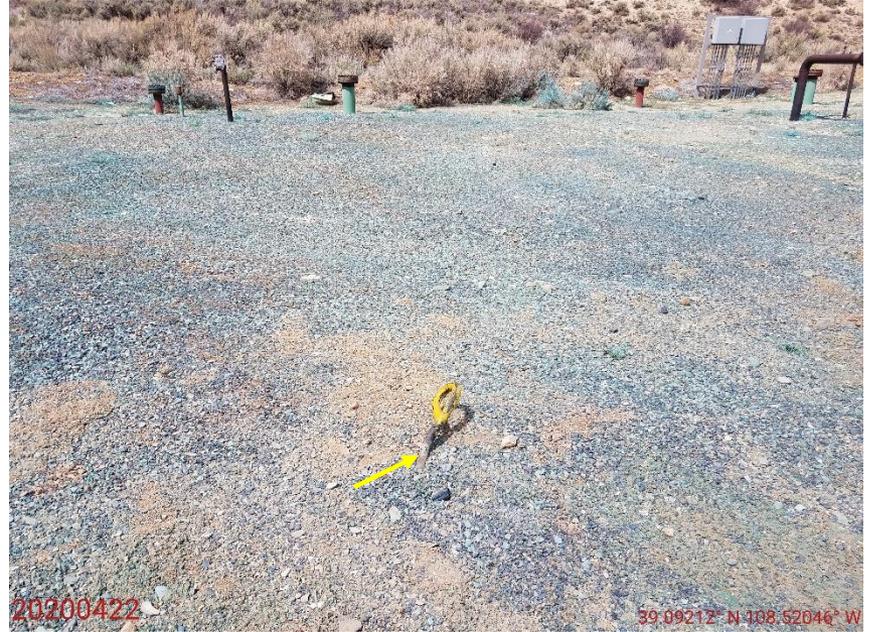
Photo 21: Photo taken from the northwest end of the Location, facing east. Photo shows unused/abandoned equipment (risers) on Location. Equipment appears to have been associated with a compressor, that has since been removed. All unused/abandoned equipment requires removal in accordance with Rule 603.f

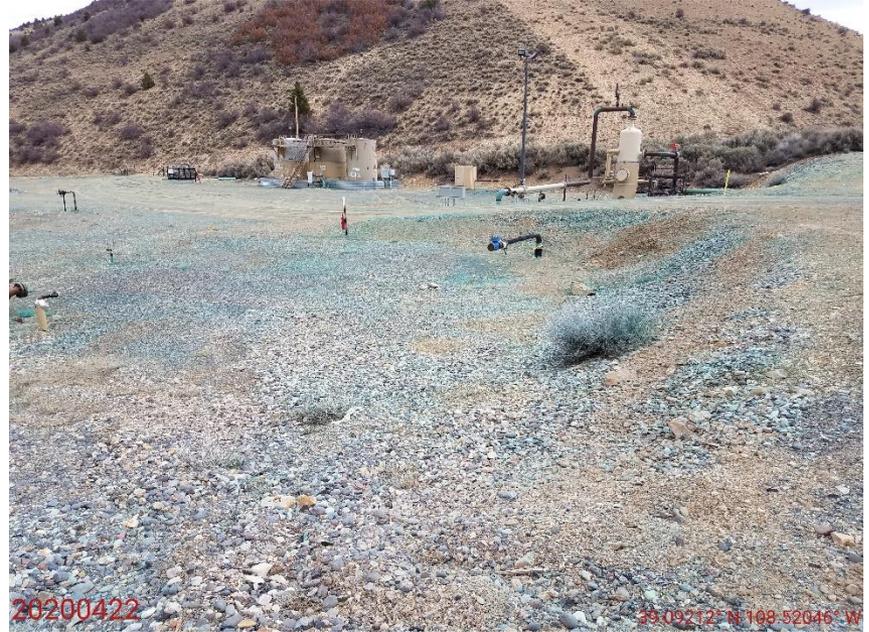
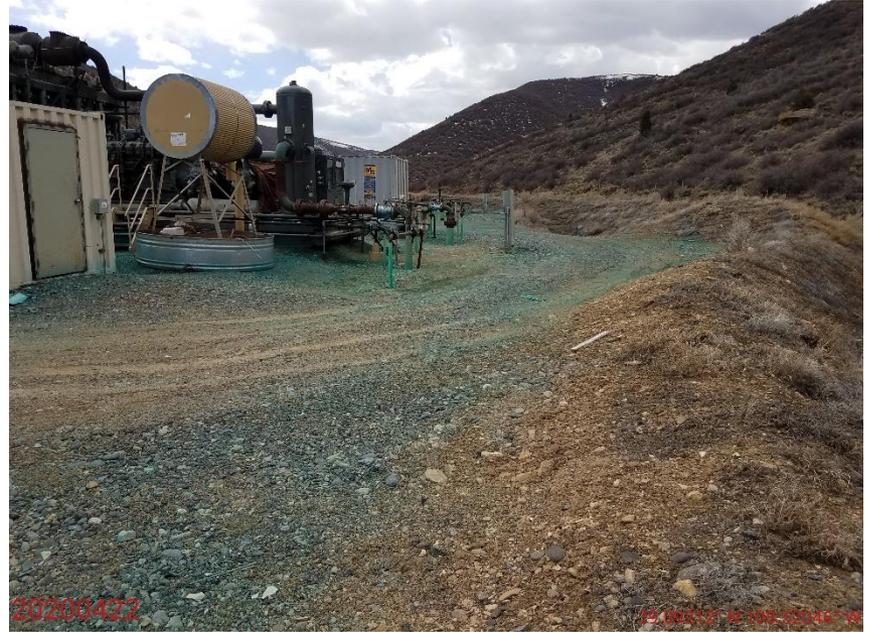
Photo 37: Photo taken from the west end of the Location, facing north. Photos 37-40 provide an overview of the Location from north, northeast, southeast to south. Photos also show unused/abandoned equipment on Location.

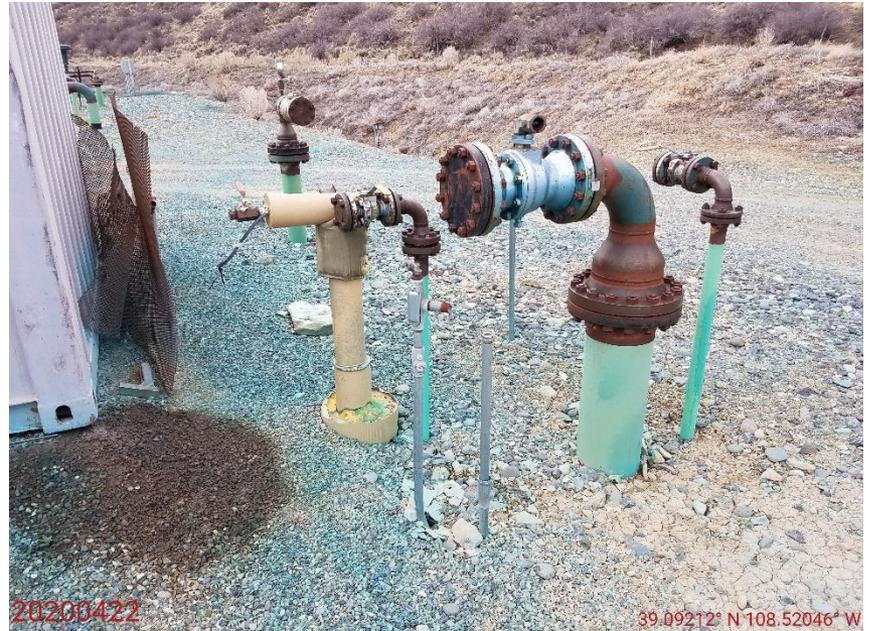
Photo 42: Photo taken from the north end of the Location, facing southwest. Photo shows unused/abandoned equipment (risers) on Location. Equipment appears to have been associated with a compressor, that has since been removed. All unused/abandoned equipment requires removal in accordance with Rule 603.f. Photo also shows stained soils.

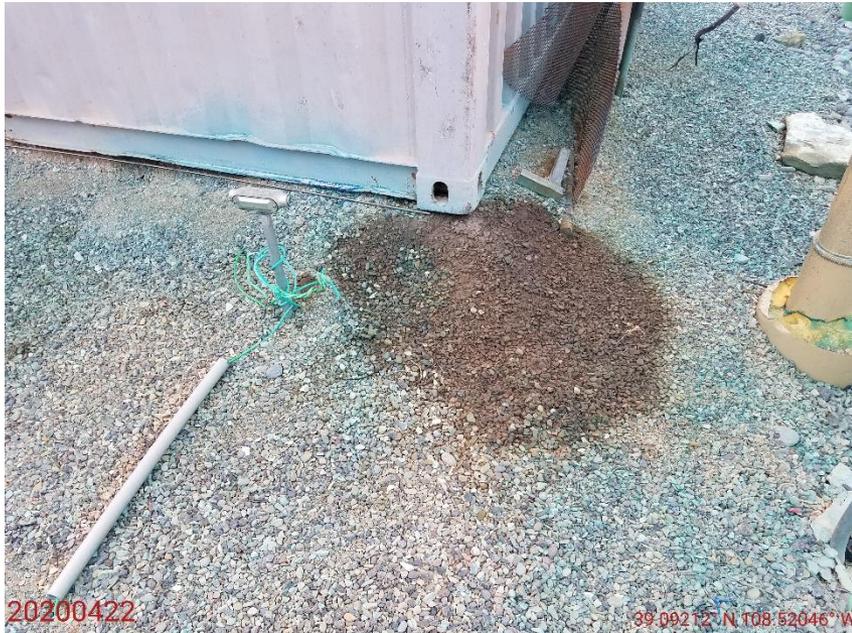
Photo 43: Continued from photo 42. Photo shows stained soils.

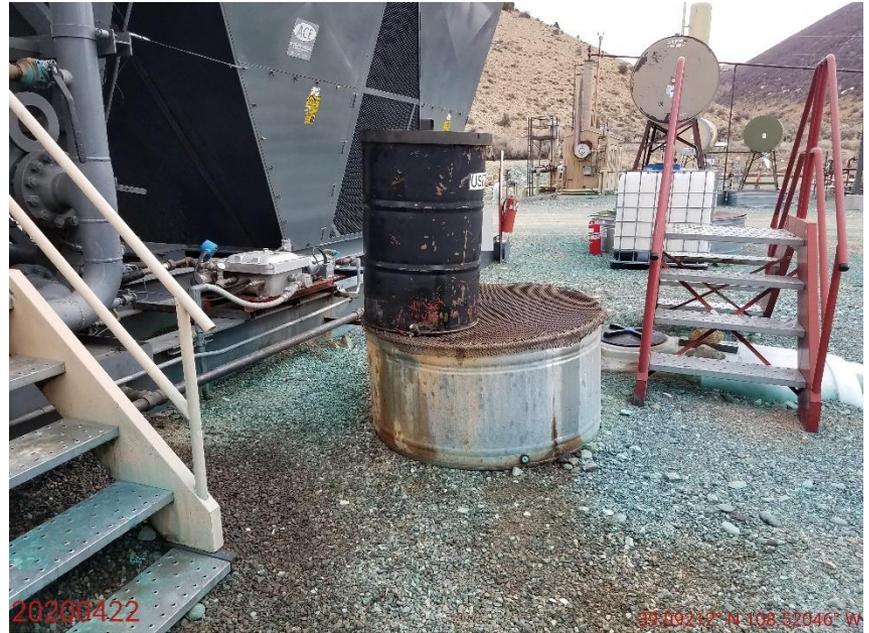
Photo 44: Photo taken from the compressor on the west end of the Location. Photo shows barrel of oil placed upon secondary containment. Photo also shows stained soils on Location.

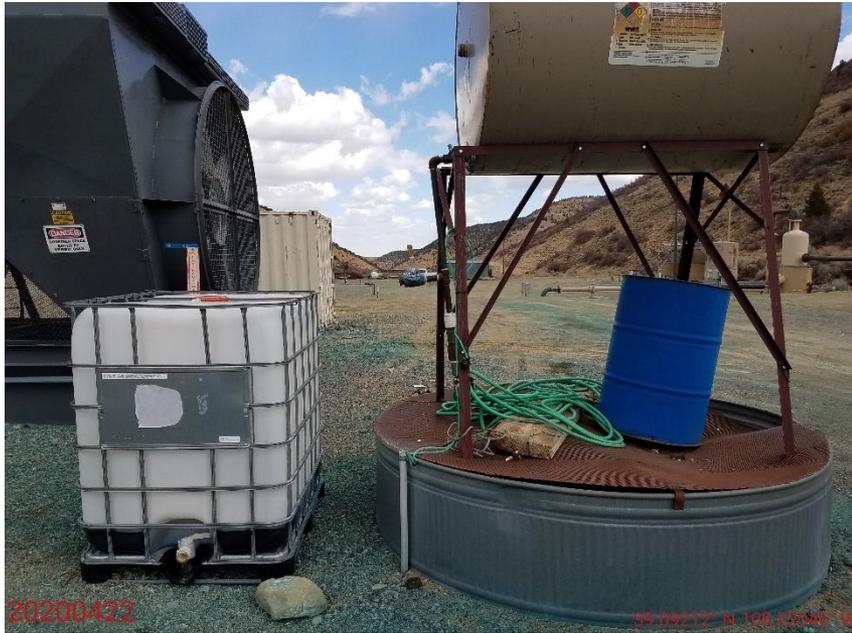
Photo 45: Photo taken from the west end of the Location, facing north. Photo of containment BMP.

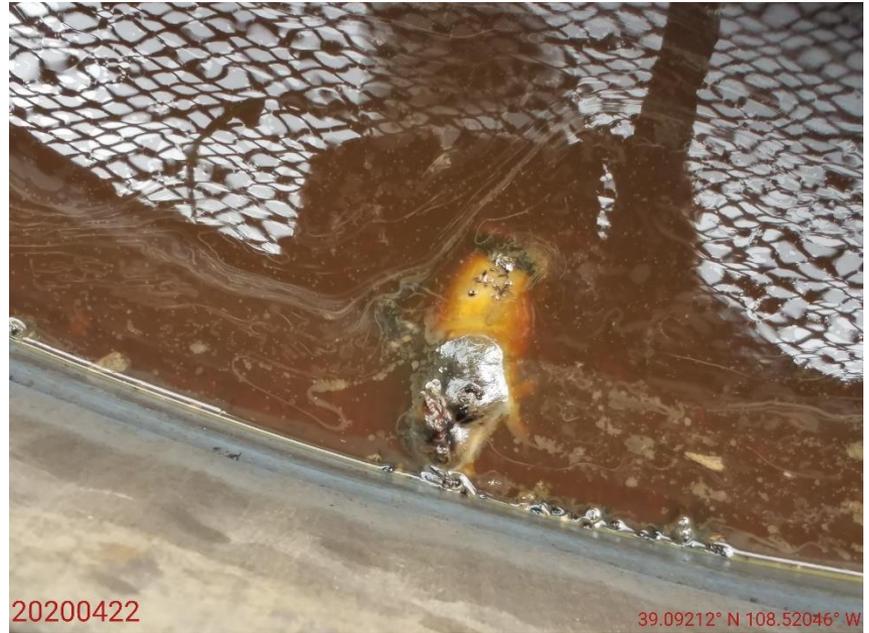
Photo 46: Continued from photo 45. Photo shows containment BMP has filled with chemicals/fluids. Photo also shows wildlife appears to have entered and died within the BMP.
