Inspection Photos

4/22/2020

Operator: CAERUS PICEANCE LLC - 10456

Facility ID: 419752

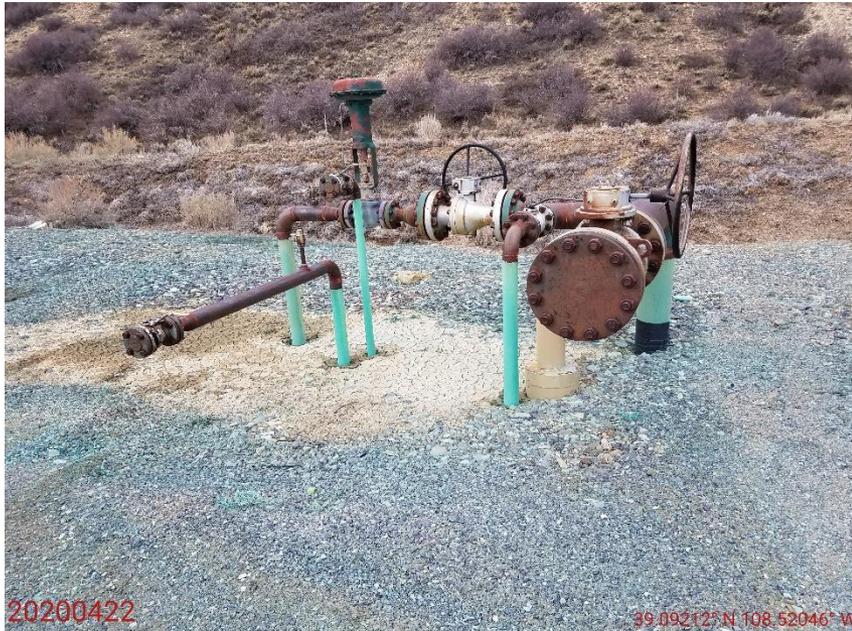
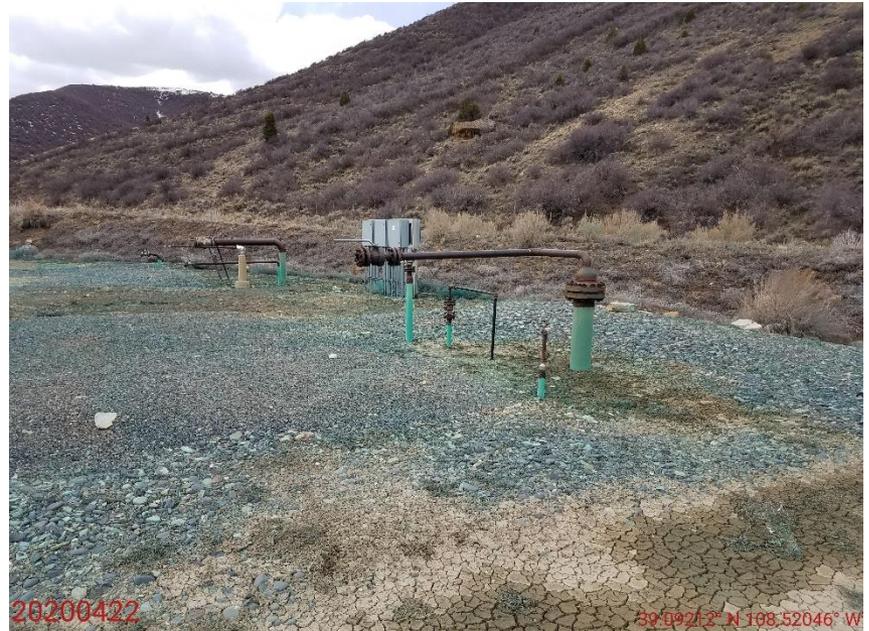
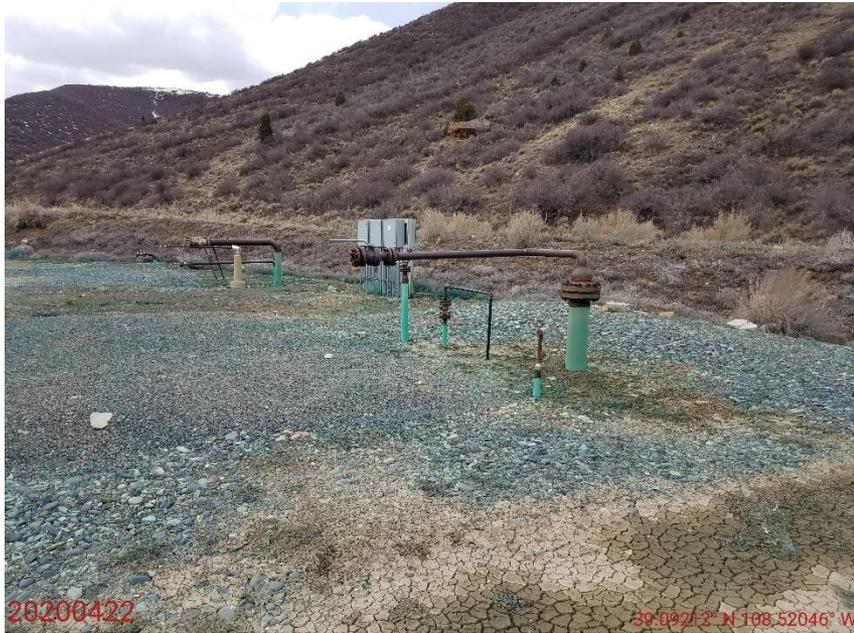
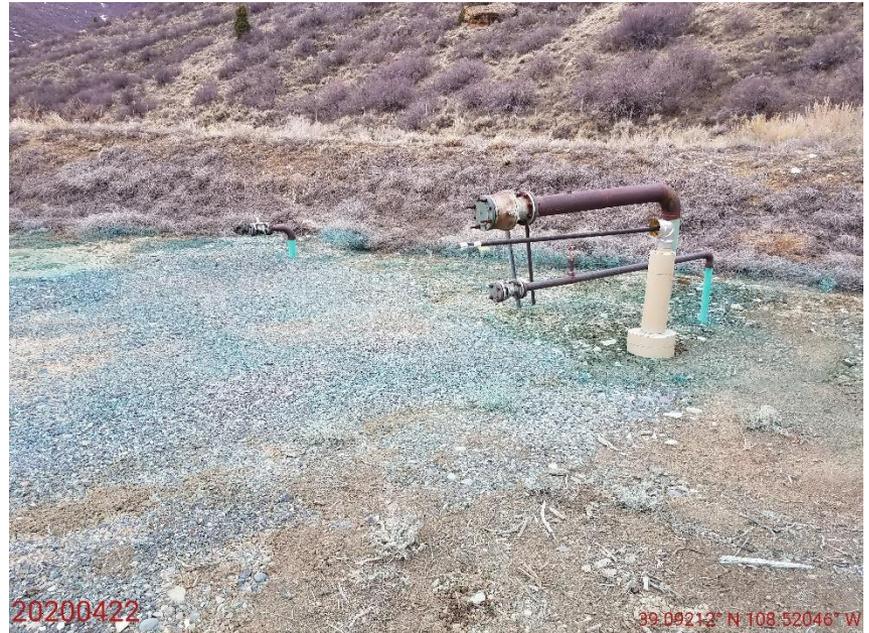
Photo 47: Photo taken from the southwest area of the Location. Photo shows unused/abandoned equipment (risers) on Location. Equipment appears to have been associated with a compressor, that has since been removed. All unused/abandoned equipment requires removal in accordance with Rule 603.f. Photo also shows stained soils.

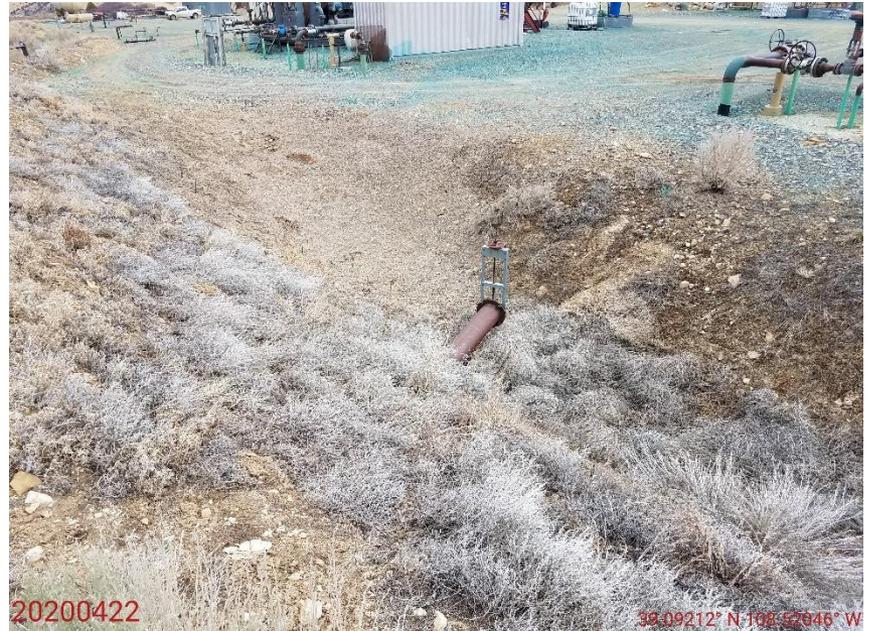
Photo 52: Photo taken from the southwest end of the Location, facing north. Photo shows stormwater containment pond. Pipe with gate installed to allow flow/discharge. Outlet of BMP appears to discharge directly into a creek adjacent to the Location.

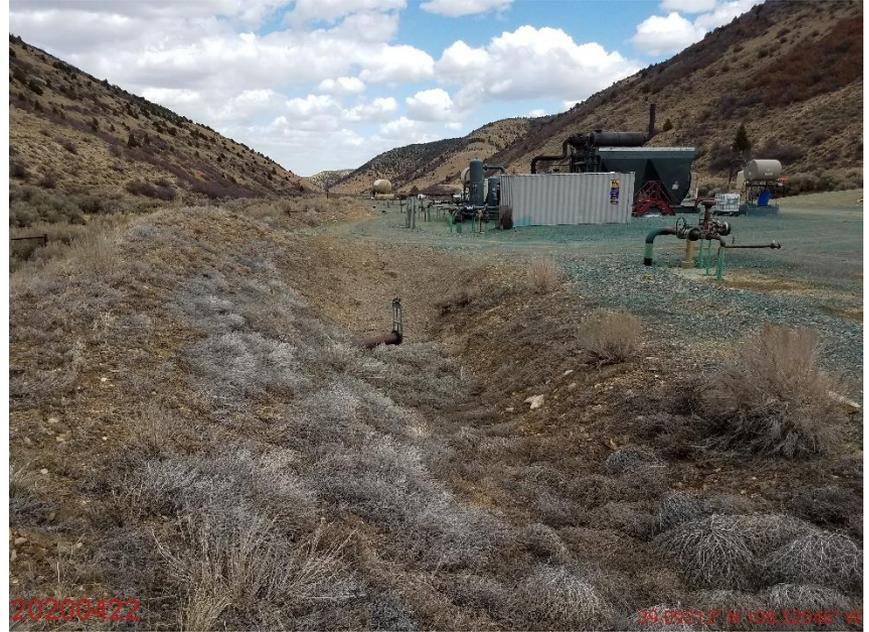
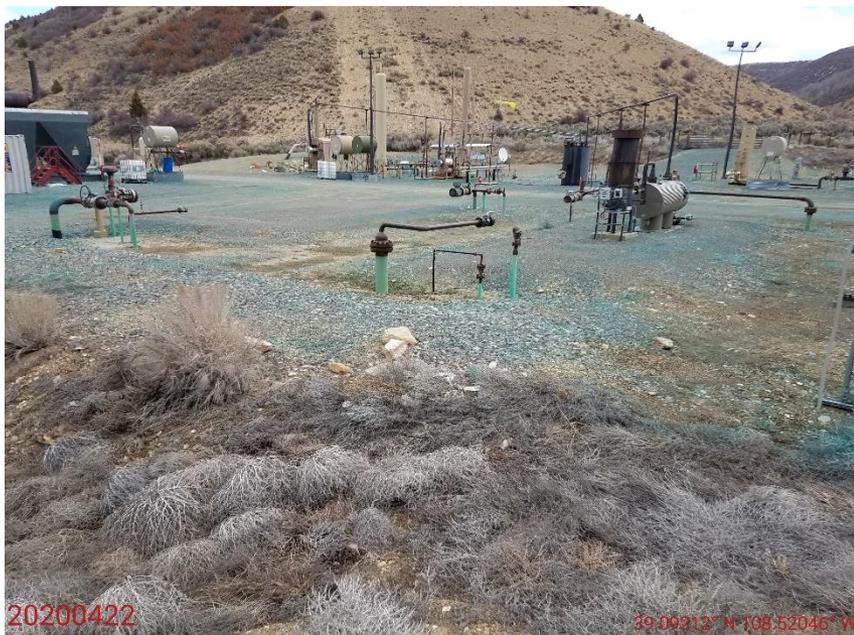
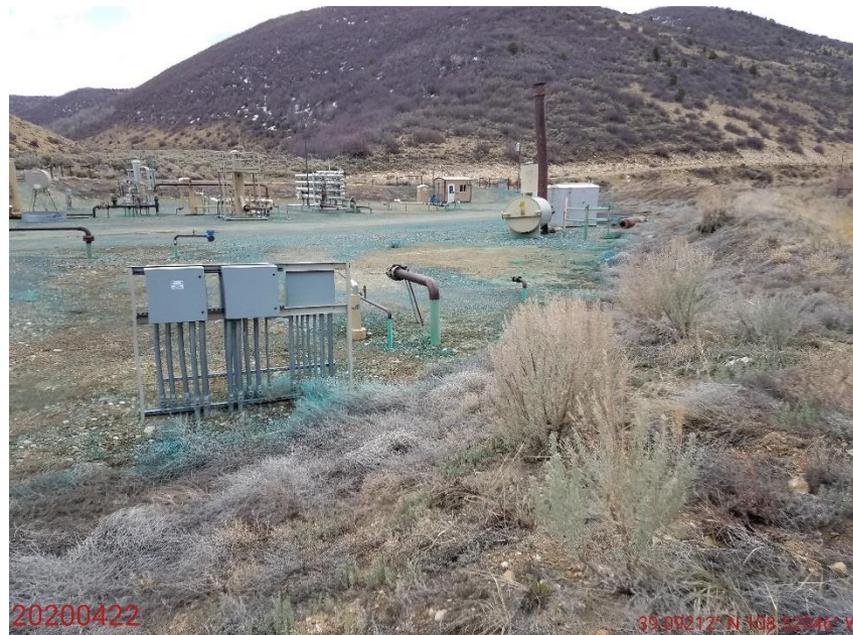
Photo 54: Photo taken from the southwest end of the Location, facing north. Photos 54-56 provide an overview of the Location from north, east to southeast. Photos also show unused/abandoned equipment on Location.

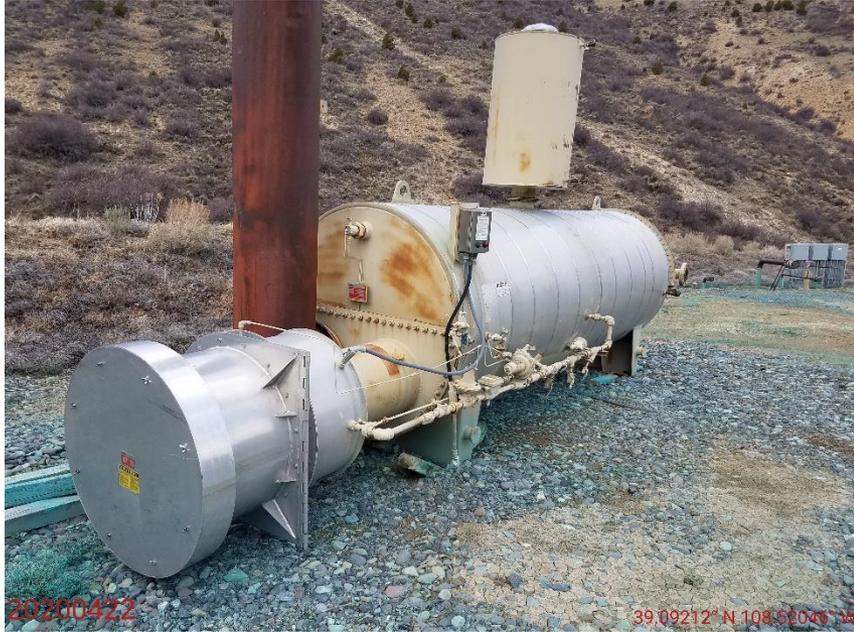
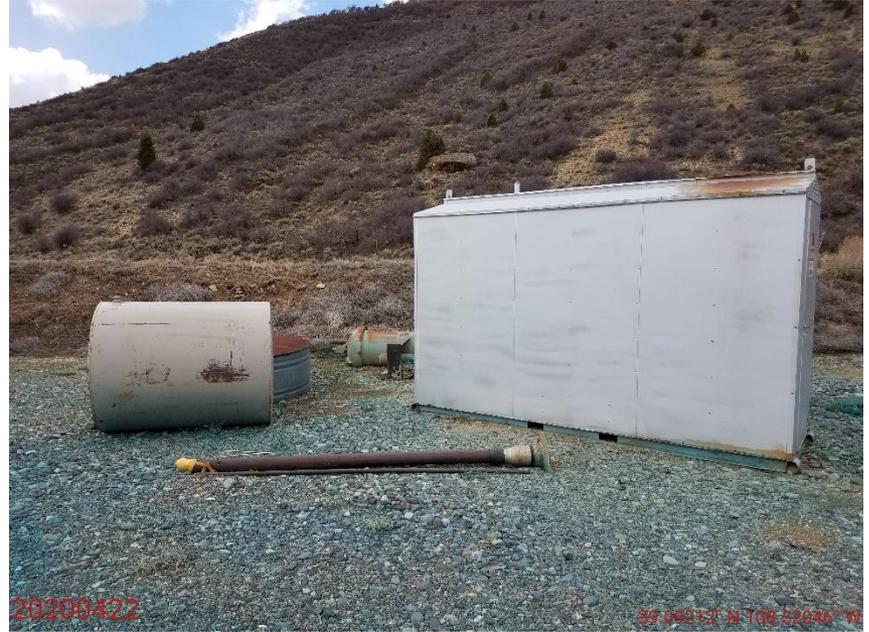
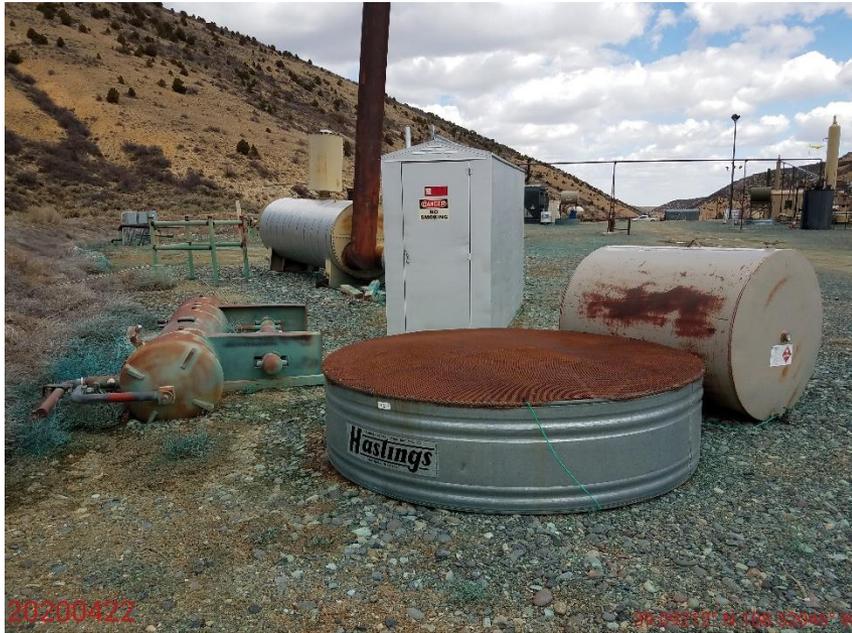
Photo 57: Photo taken from the southwest end of the Location. Photo shows unused equipment being stored on Location.

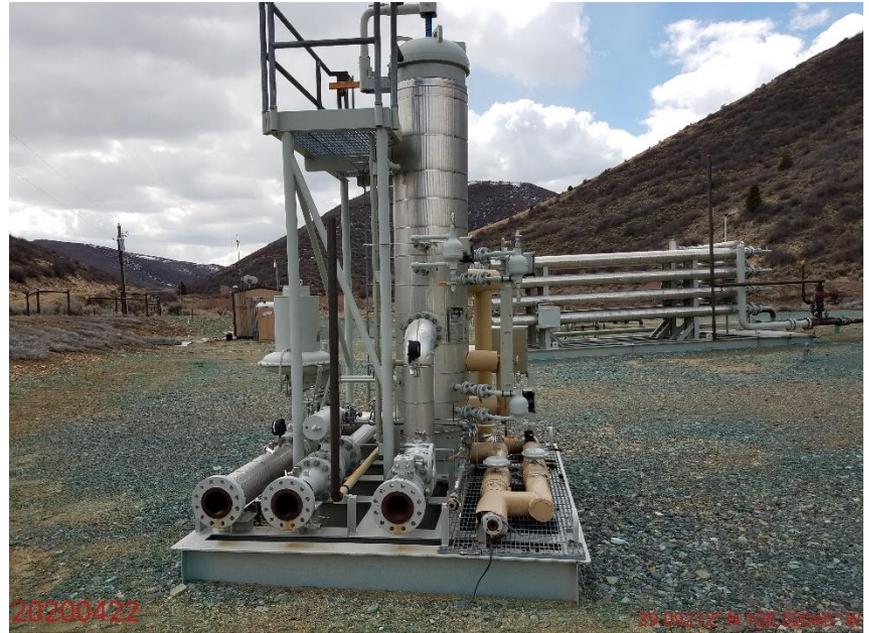
Photo 60: Photo taken from the southeast end of the Location, facing south. Photo show an unused Coalescing Filter stored on the Location. Filter missing blind flange ends; flanges are required to be placed on filter immediately.

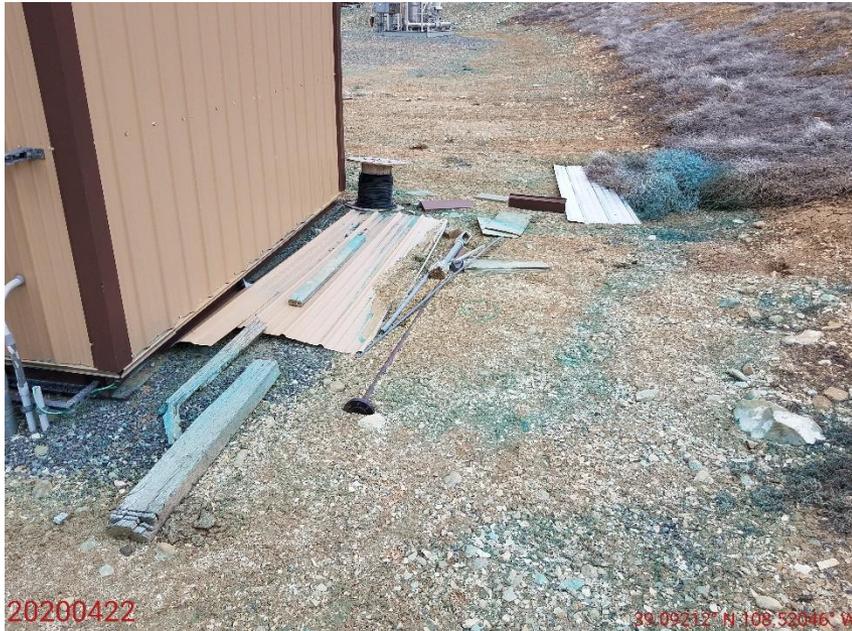
Photo 61: Photo taken from the shed on the southeast end of the Location. Photo shows trash debris on Location. All trash debris requires removal in accordance with Rule 603.f.

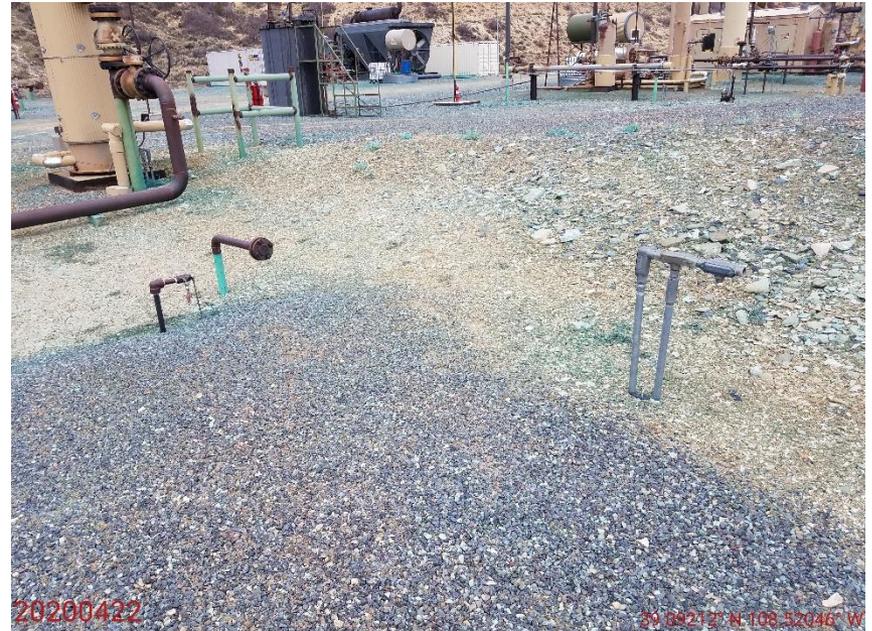
Photo 62: Photo taken from the east end of the Location, facing northwest. Photo shows unused/abandoned equipment (risers) on Location. All unused/abandoned equipment requires removal in accordance with Rule 603.f.

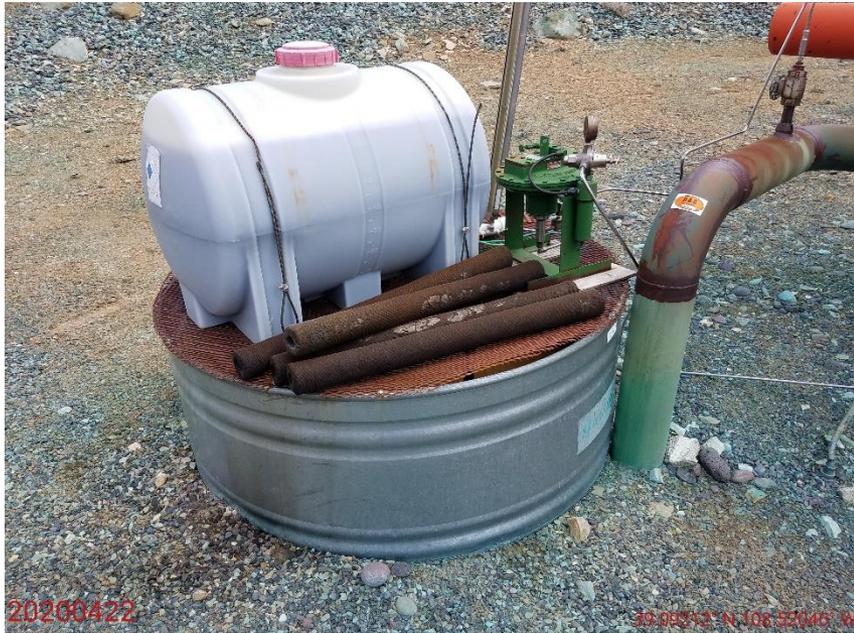
Photo 63: Photo taken from the east end of the Location. Photo shows unused equipment/trash debris placed on top secondary containment. Unused equipment/trash debris requires removal in accordance with Rule 603.f.

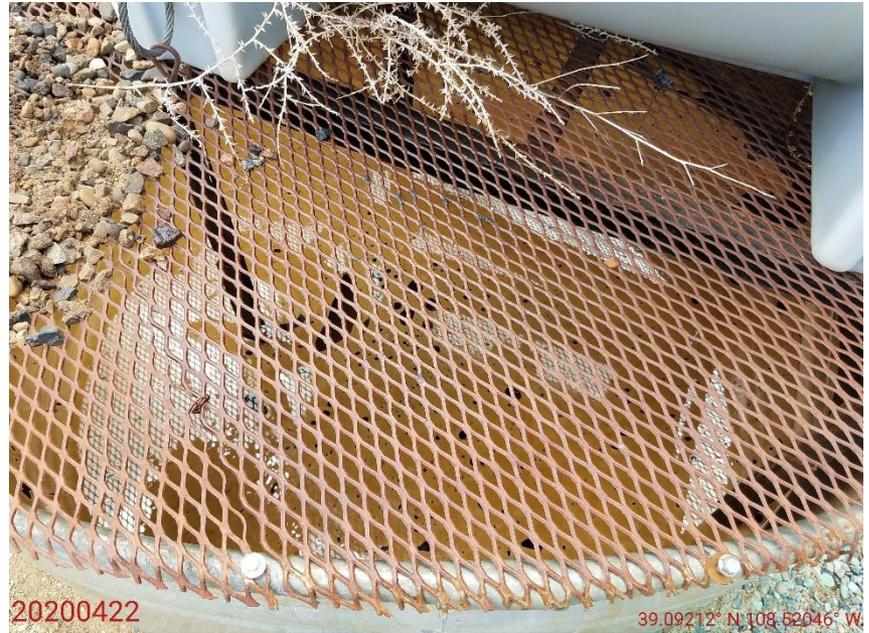
Photo 64: Continued from photo 63. Photo shows chemicals/fluids within secondary containment that needs to be removed.

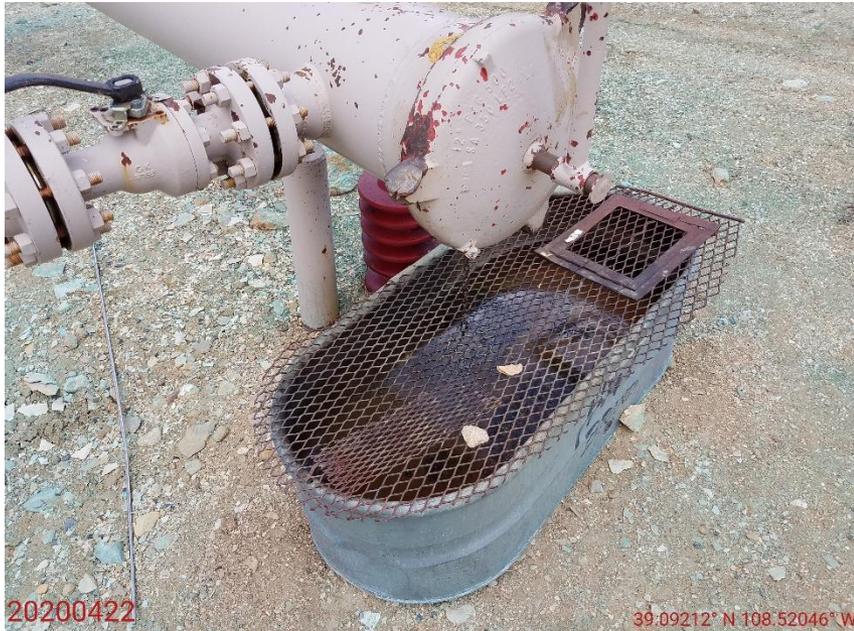
Photo 65: Photo taken from east end of the Location. Photo shows chemicals/fluids within secondary containment that needs to be removed.

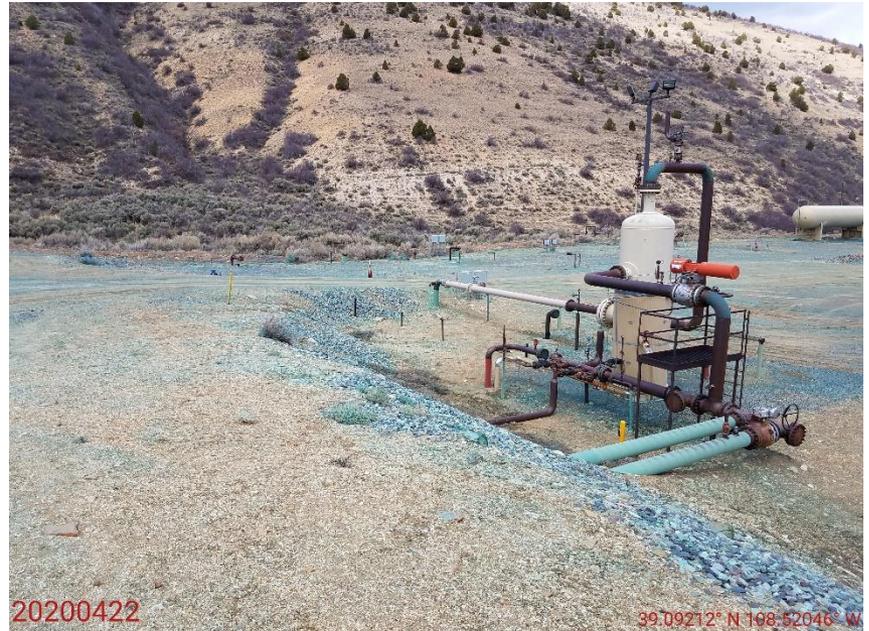
Photo 66: Photo taken from the east end of the Location, facing northwest. Photo shows vertical separator that appears to remain in use on Location.

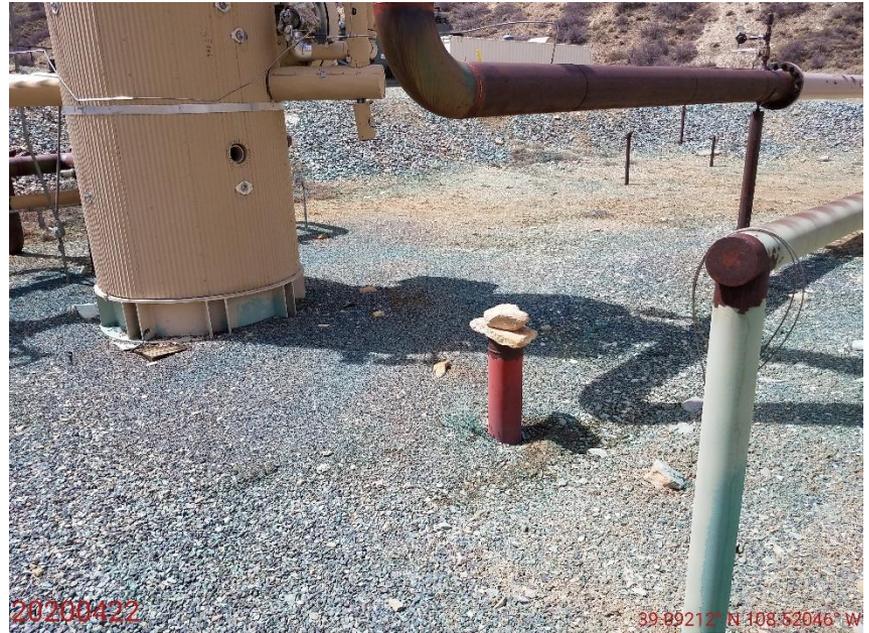
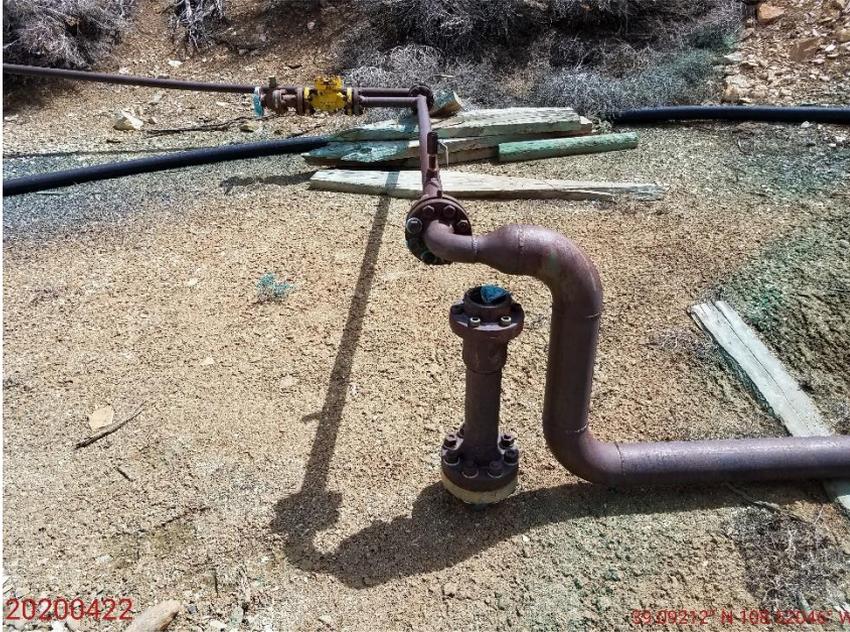
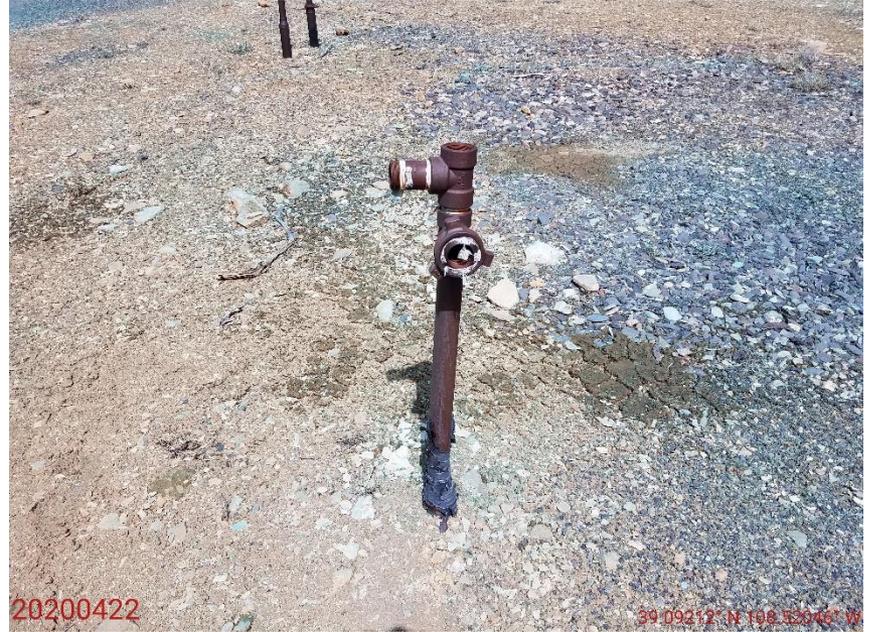
Photo 68: Photo taken from the northeast end of the vertical separator. Photo shows unused/abandoned equipment (risers) on Location, with stones placed upon the open pipe; this is improper capping procedure. All unused/abandoned equipment requires removal in accordance with Rule 603.f.

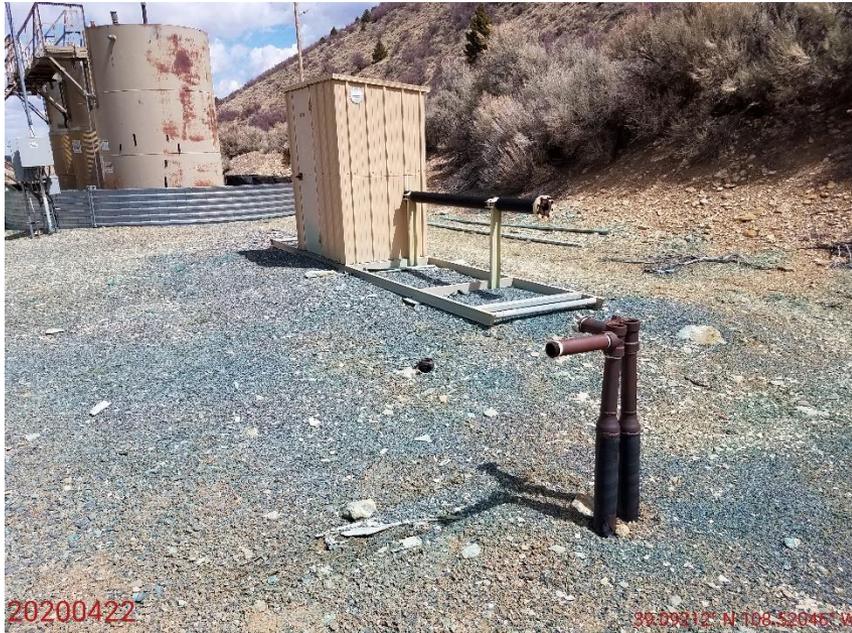
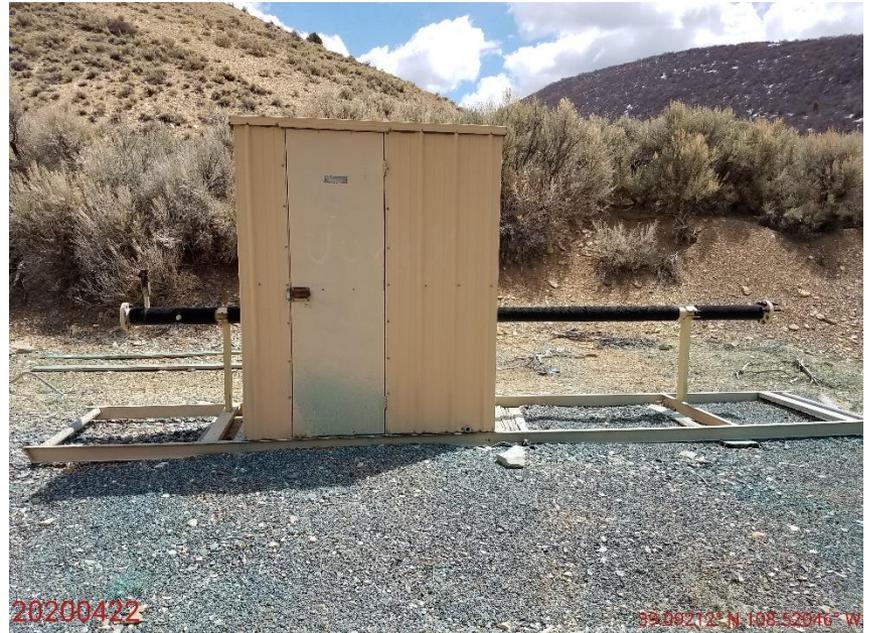
Photo 71: Photo taken from the east end of the Location, facing northeast. Photo shows unused/abandoned equipment (meter shed, risers) on Location, with stones placed upon the open pipe; this is improper capping procedure. All unused/abandoned equipment requires removal in accordance with Rule 603.f.

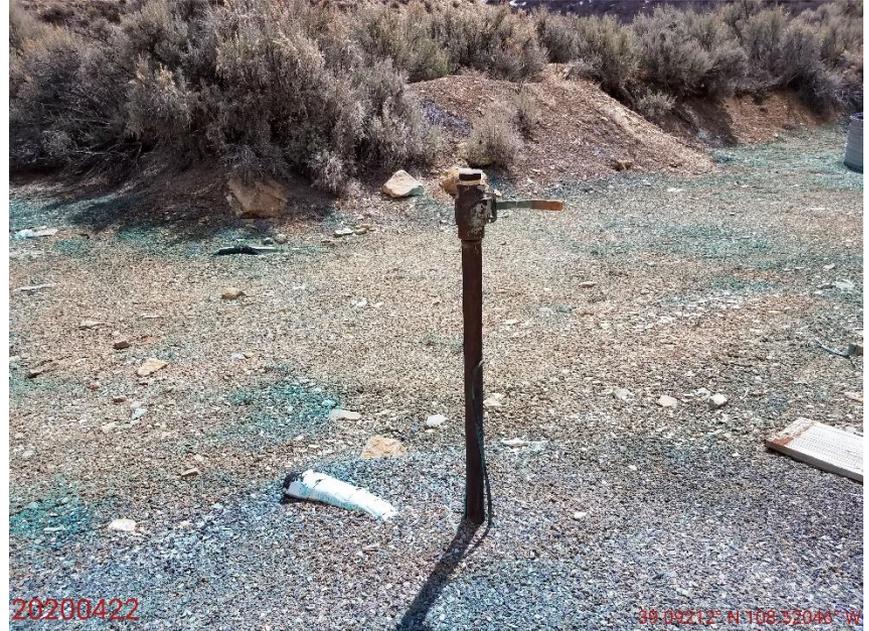
Photo 73: Photo taken from northeast end of the Location. Photo shows unused equipment and trash debris on Location. All stored/unused equipment and trash debris requires removal in accordance with Rule 603.f

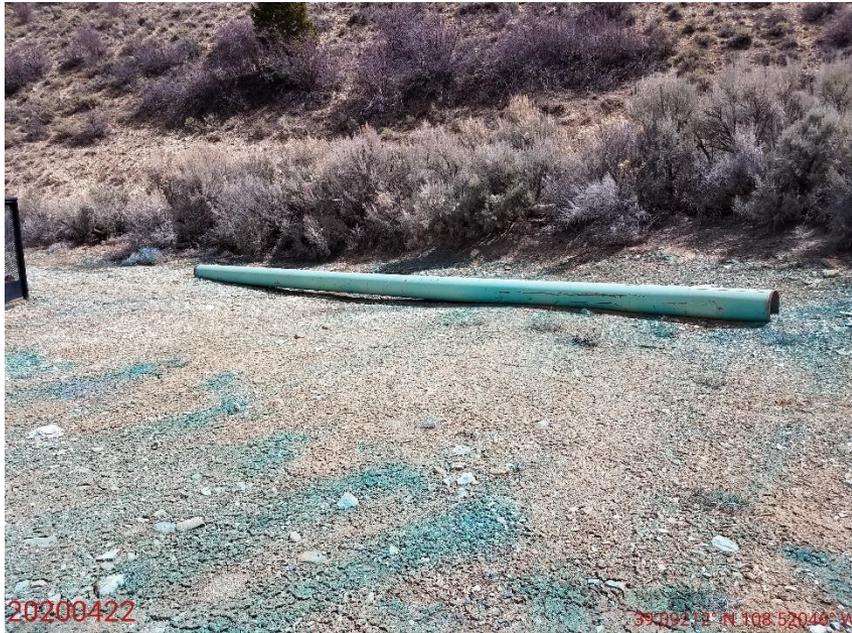
Photo 75: Photo taken from the northeast end of the Location, facing east. Photo shows unused equipment (pipe) stored on Location. All stored/unused equipment and trash debris requires removal in accordance with Rule 603.f

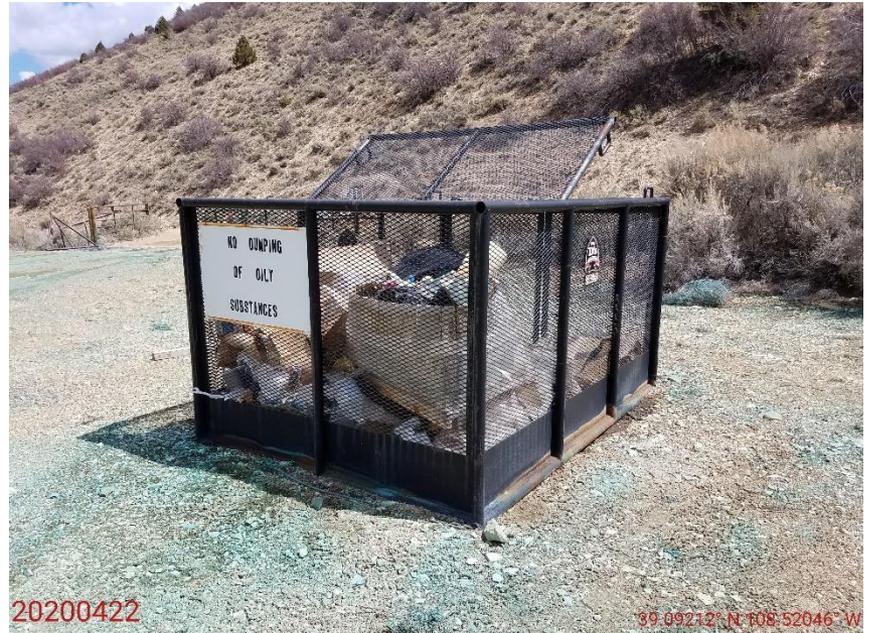
Photo 76: Photo taken from the northeast end of the Location, facing northeast. Photo shows trash container has been left open; Contained needs to be closed to prevent access by wildlife.

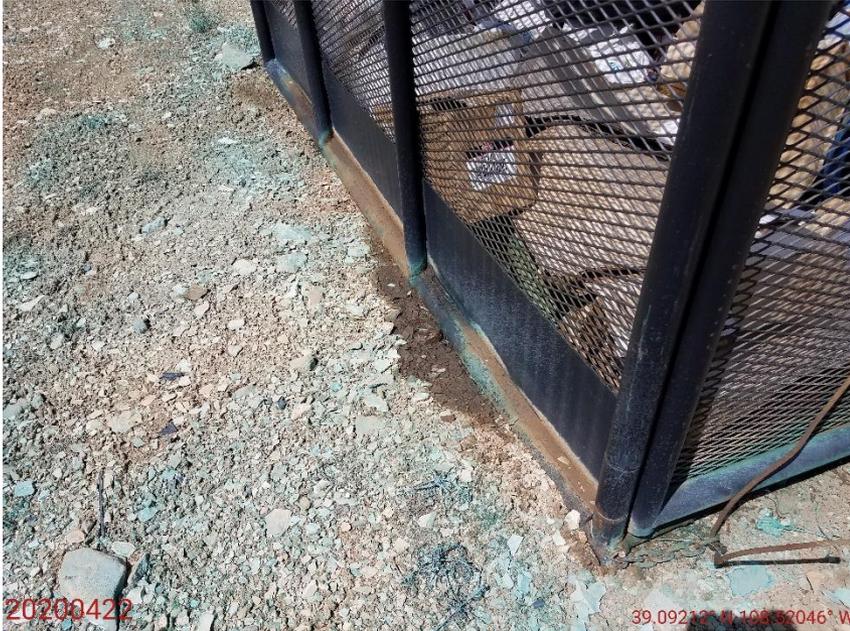
Photo 77: Photo taken from the trash container. Photo shows stained soils; oily chemicals appear to be discharging from the trash container.

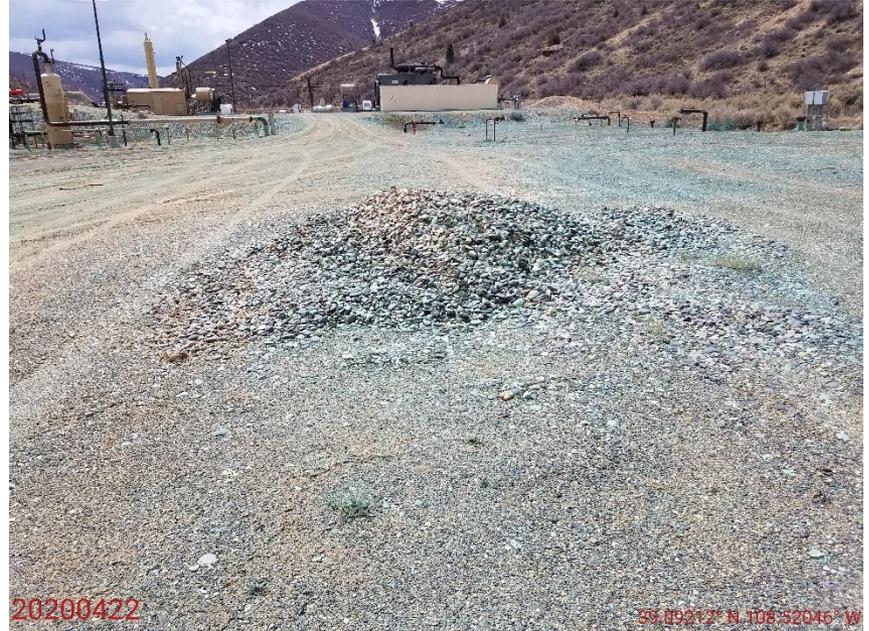
Photo 78: Photo taken from the north end of the Location. Photo shows unused rock material stored on the Location.

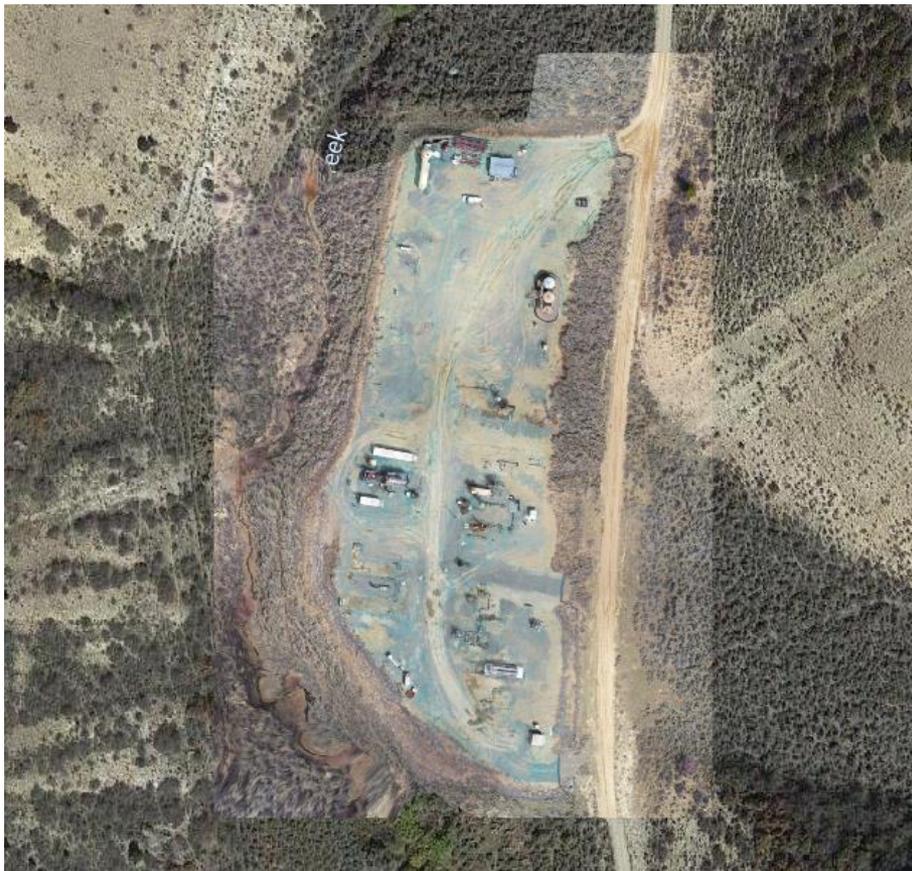
Photo 79: On 4/22/2020, Reclamation specialist Trujillo utilized a SUA to capture an aerial image of the Location; Photo shows large areas on the North and southeast ends of the Location where either unused/abandoned equipment, or trash debris is being stored. These areas also include areas where compressors were once located, but have since been removed. All stored/unused equipment and trash debris requires removal in accordance with Rule 603.f. These areas are also no longer needed for production activities and require reclamation in accordance with 1003 rules.

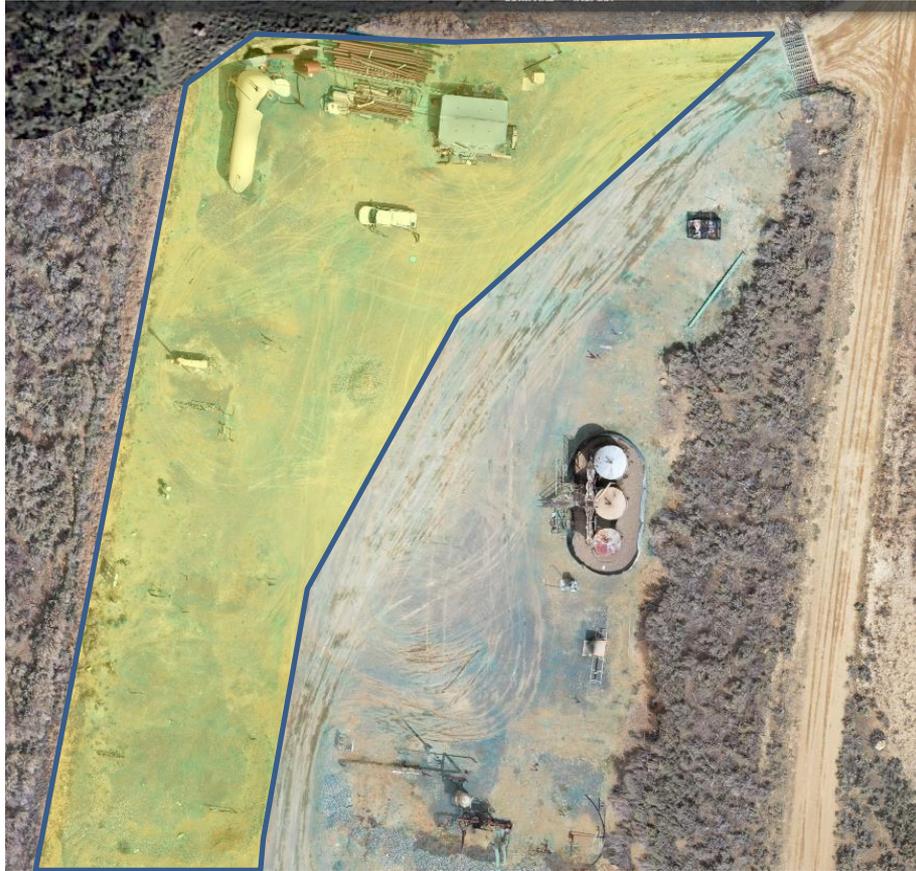
Photo 80: On 4/22/2020, Reclamation specialist Trujillo utilized a SUA to capture an aerial image of the Location; Photo shows large areas on the North ends of the Location where either unused/abandoned equipment, or trash debris is being stored. These areas also include areas where compressors were once located, but have since been removed. All stored/unused equipment and trash debris requires removal in accordance with Rule 603.f. These areas (yellow) are also no longer needed for production activities and require reclamation in accordance with 1003 rules.

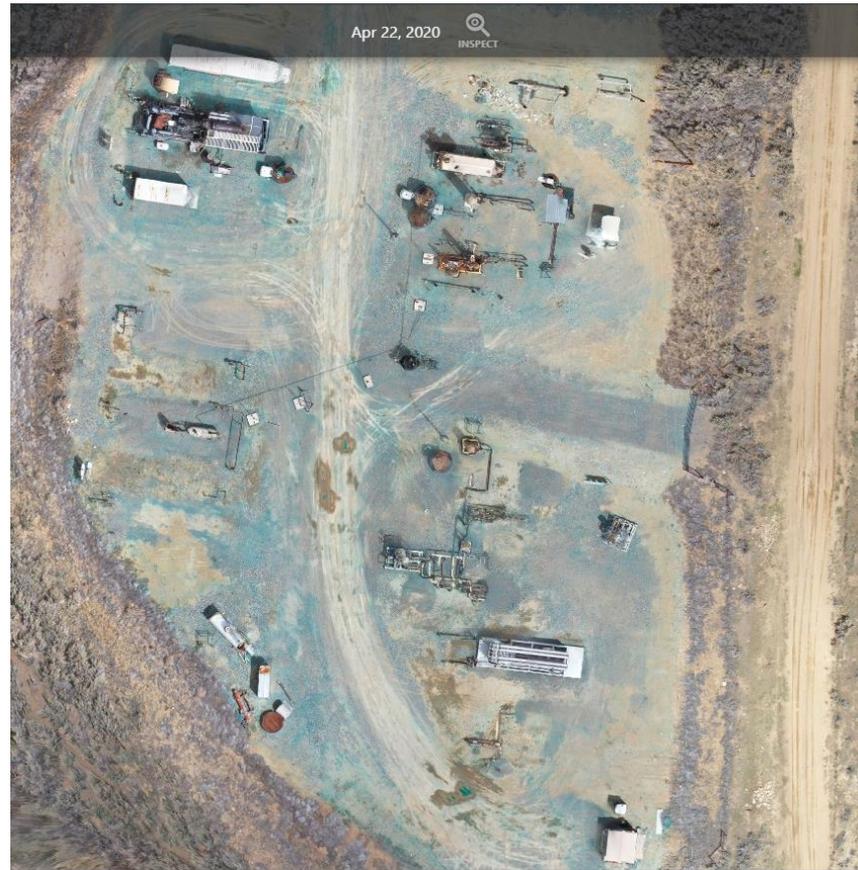
Photo 81: On 4/22/2020, Reclamation specialist Trujillo utilized a SUA to capture an aerial image of the Location; Photo shows large areas on the South ends of the Location where either unused/abandoned equipment, or trash debris is being stored. These areas also include areas where compressors were once located, but have since been removed. All stored/unused equipment and trash debris requires removal in accordance with Rule 603.f.

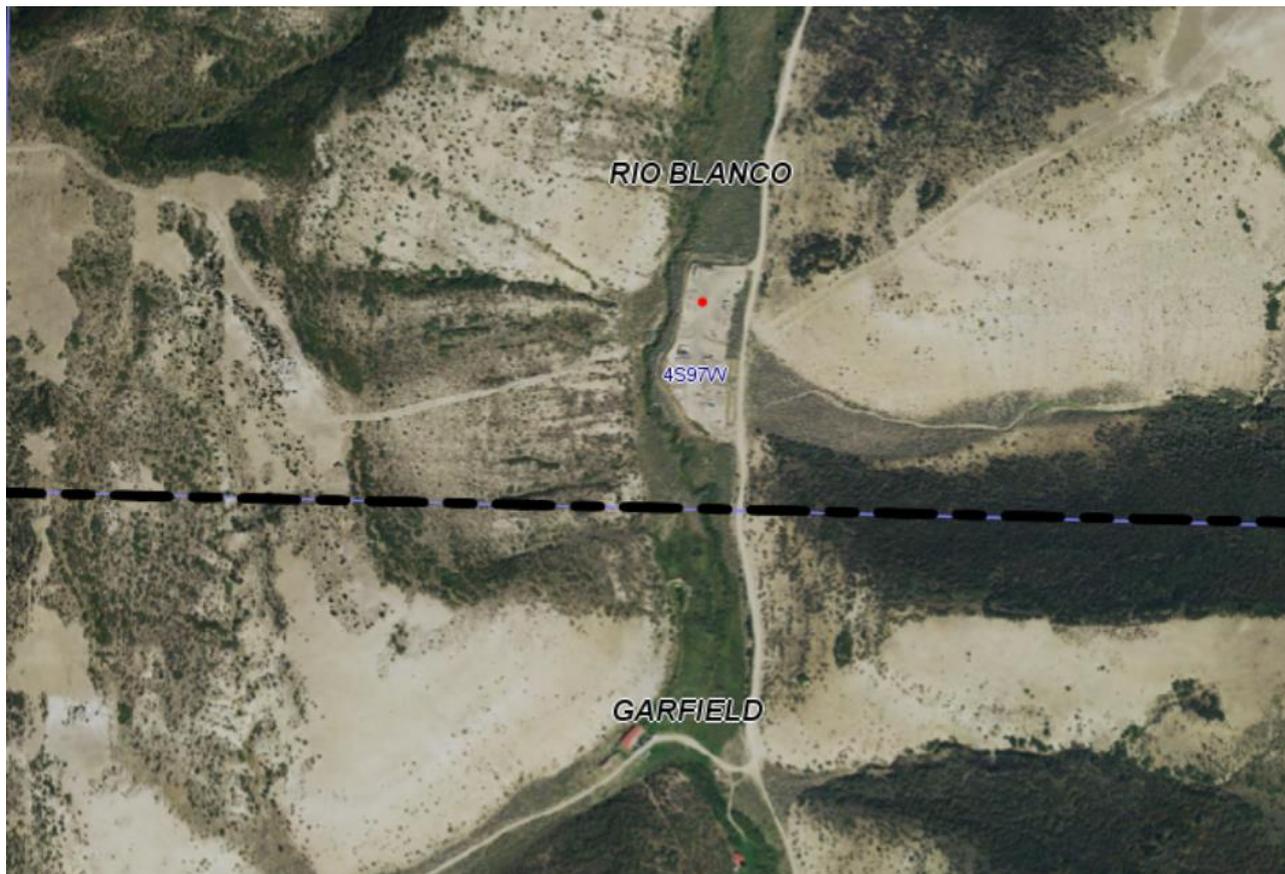
Photo 82: COGIS 2017 Aerial imagery. Scout card records show that the facility is located in Garfield County, Colorado; Photo shows the facility to be in Rio Blanco County, Colorado.
