Inspection Photos
Location Name: UPRR 43 PAN AM B#8
Location ID:318429

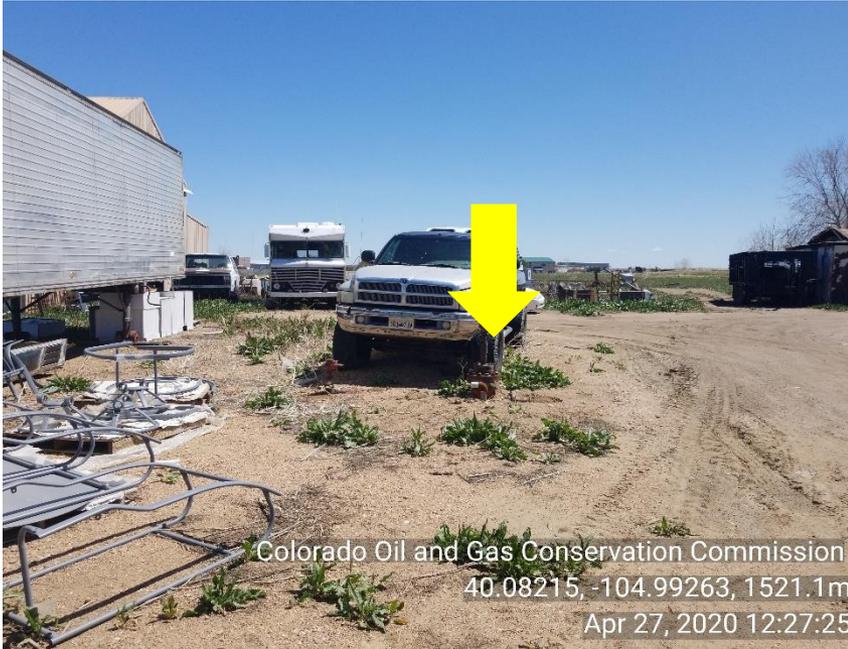
Photo 1 WH

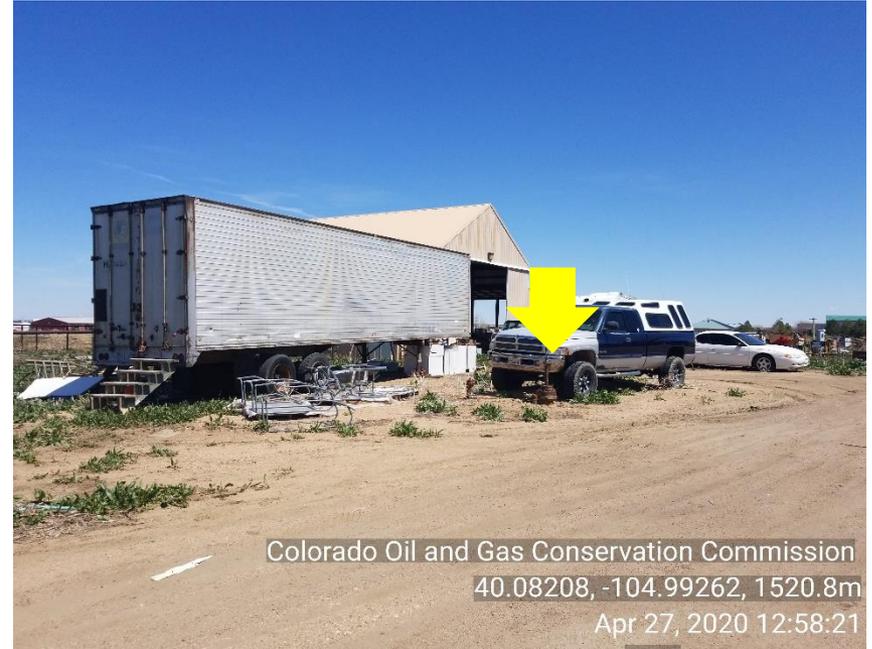
Photo 2 loc pic with WH

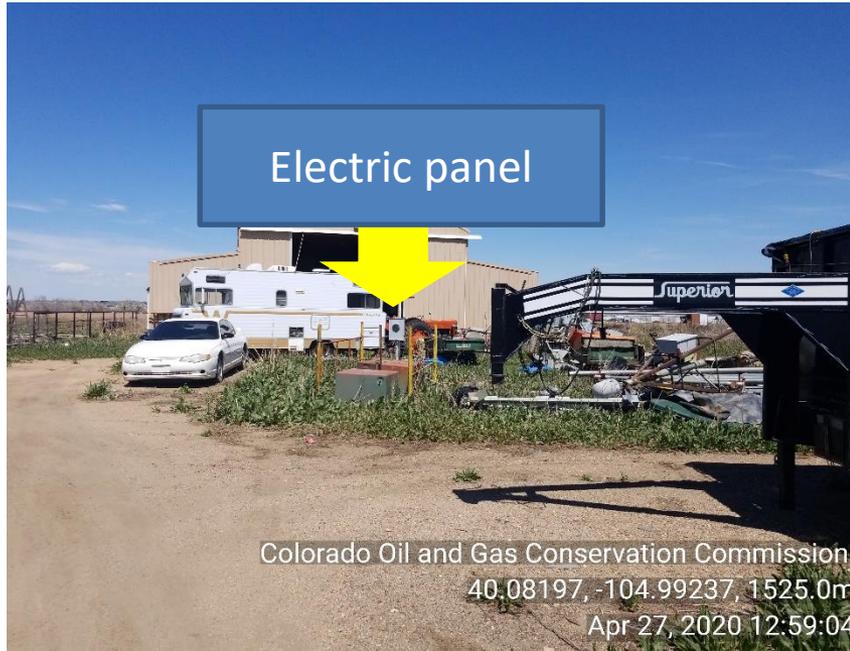
Photo 3 Electric panel for well

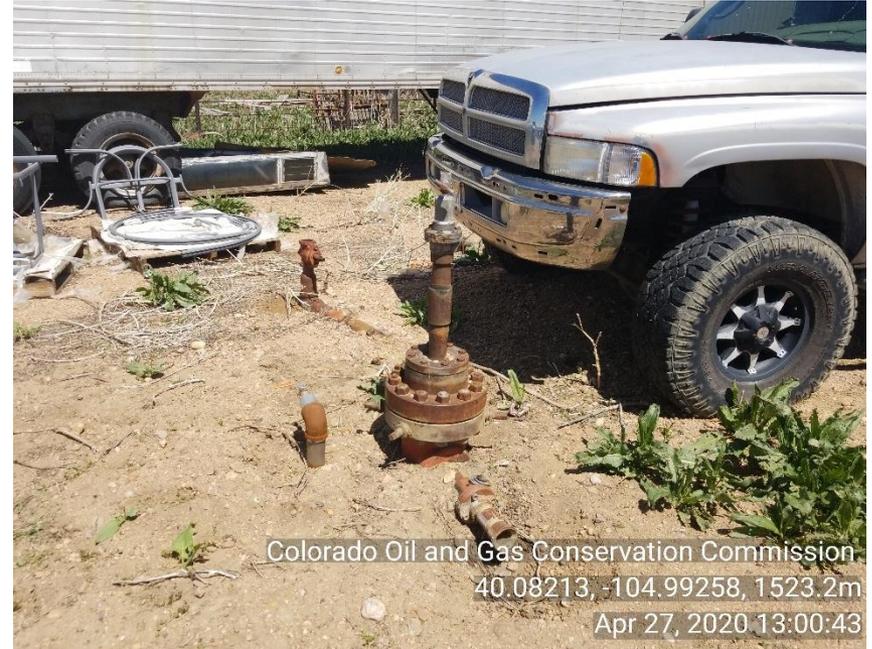
Photo 6 WH flow line not bull plugged or LOTO
