Inspection Photos

Location Name: MARALEX RESOURCES INC SULFUR GULCH 9-98-10-69S98W /10NWNW

Location ID: 312654

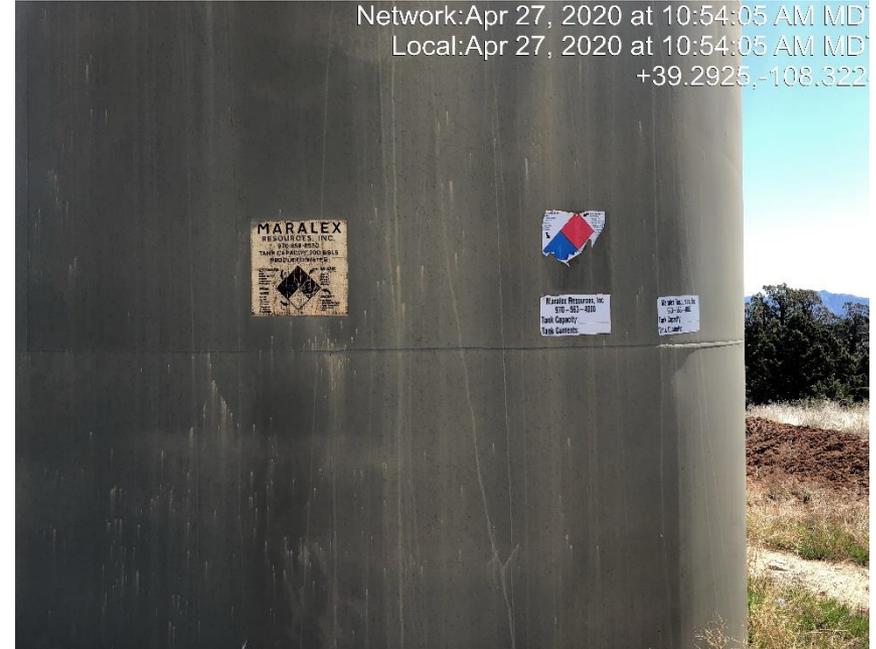
Photo #1046 Tank capacity, contents and NFPA labels weathered and not legible.

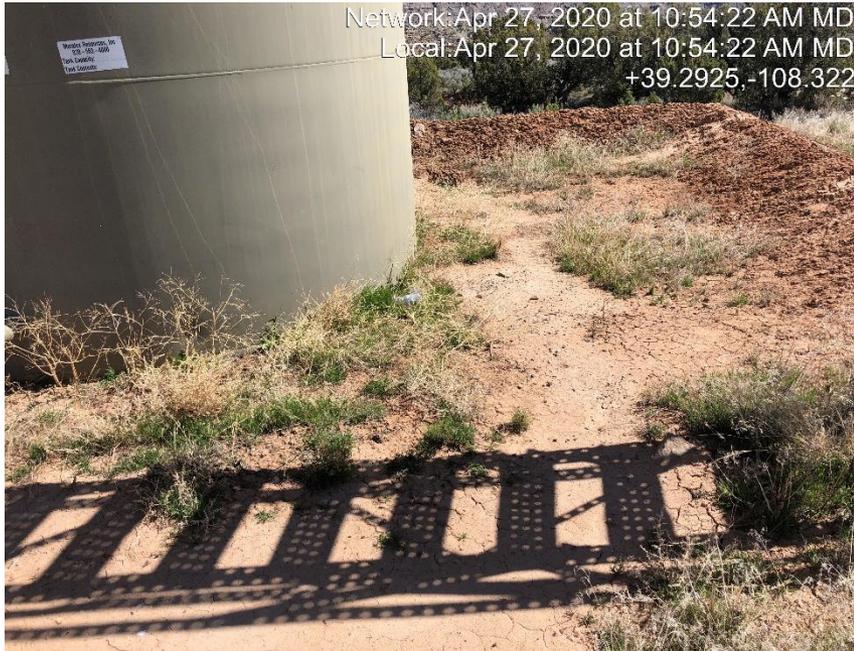
Photo #1047 Multiple places with debris on location.

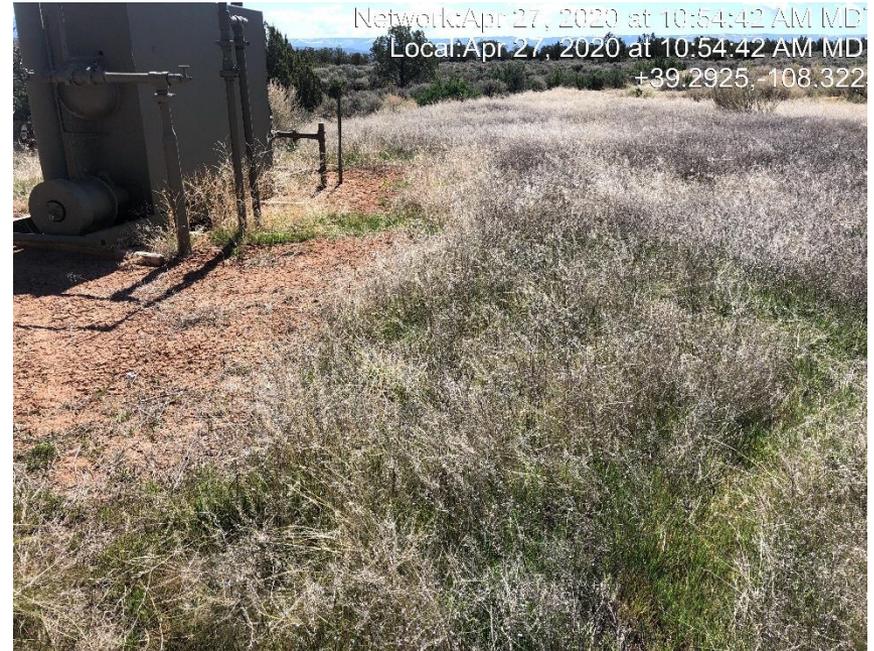
Photo #1048 Multiple places with debris on location.

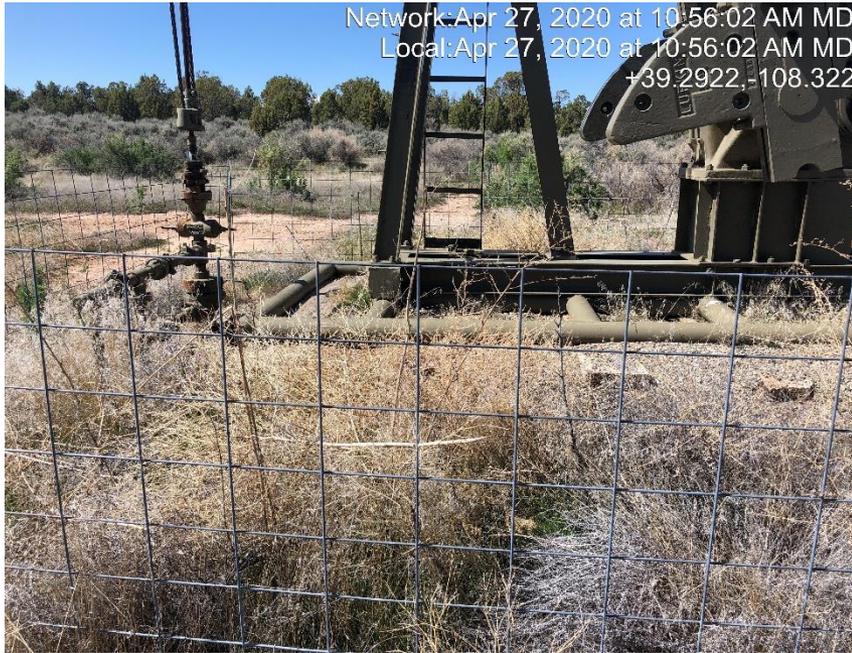
Photo #1050 Multiple places with debris on location.

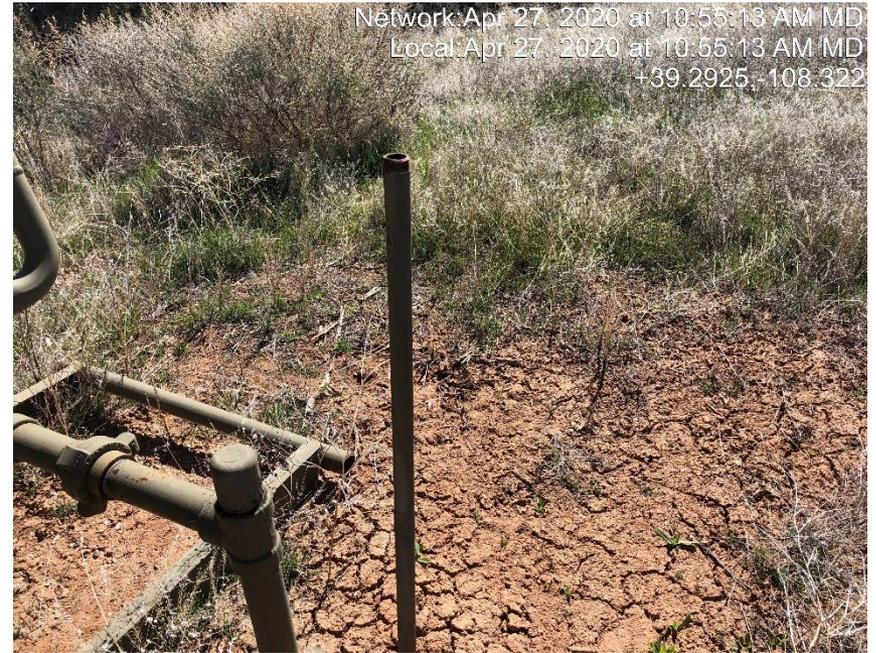
Photo #1049 Flow line riser not LO/TO.
