Inspection Photos

Location Name: MARALEX RESOURCES INC USA-69S98W /18NESW

Location ID: 312548

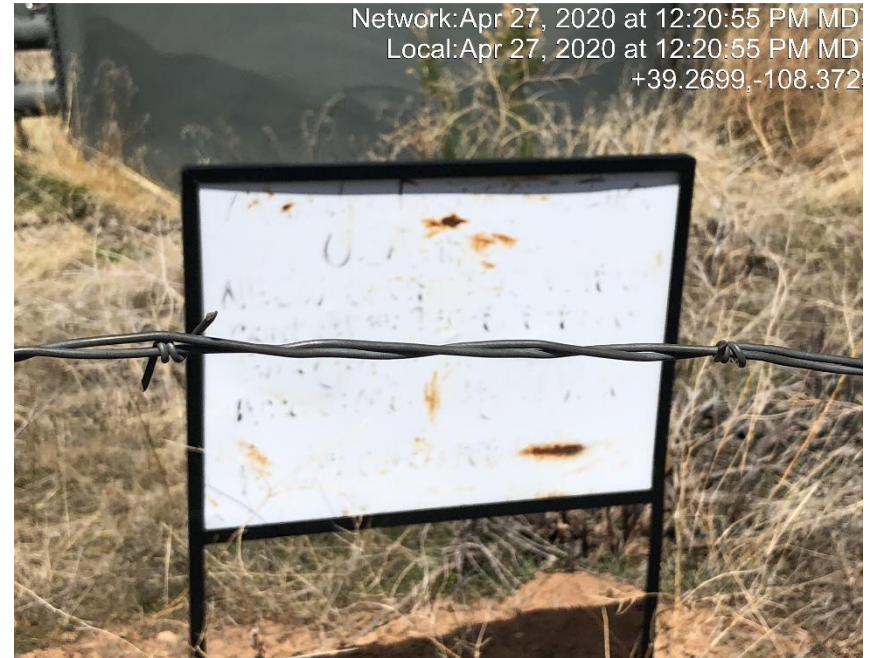
Photo #1052 Battery sign is weathered and not legible.

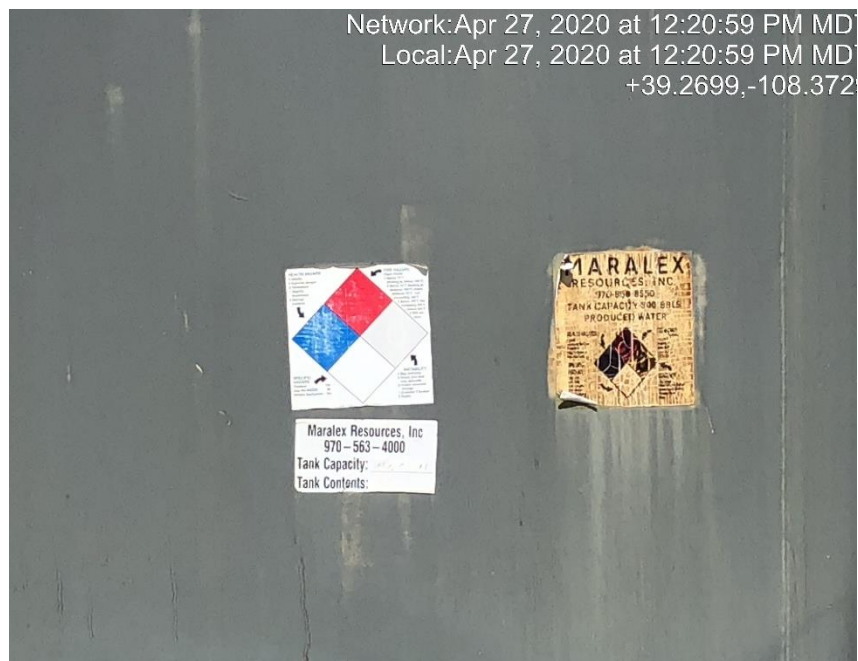
Photo #1053 Tank capacity, contents and NFPA label weathered and not legible.

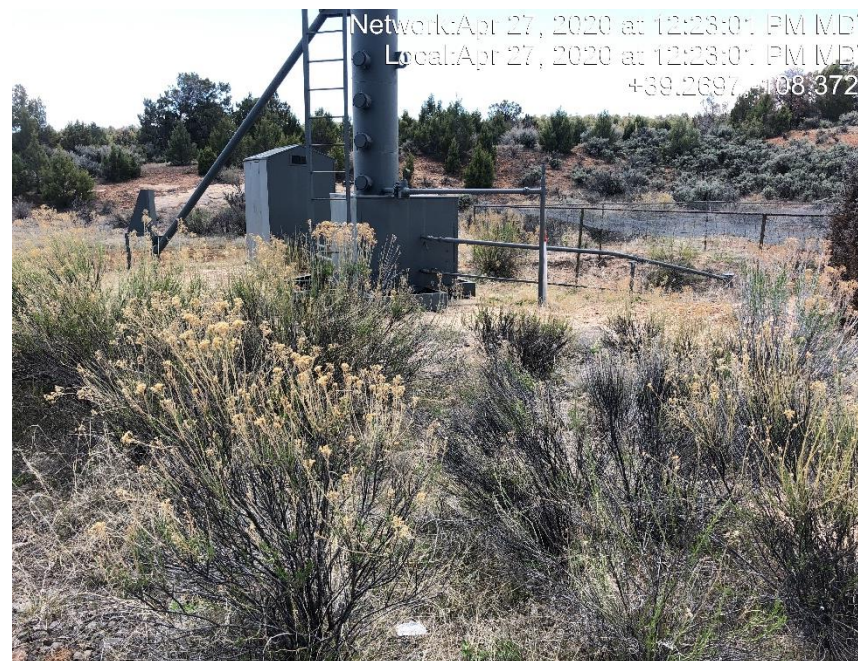
Photo #1054 Multiple places with debris on location.

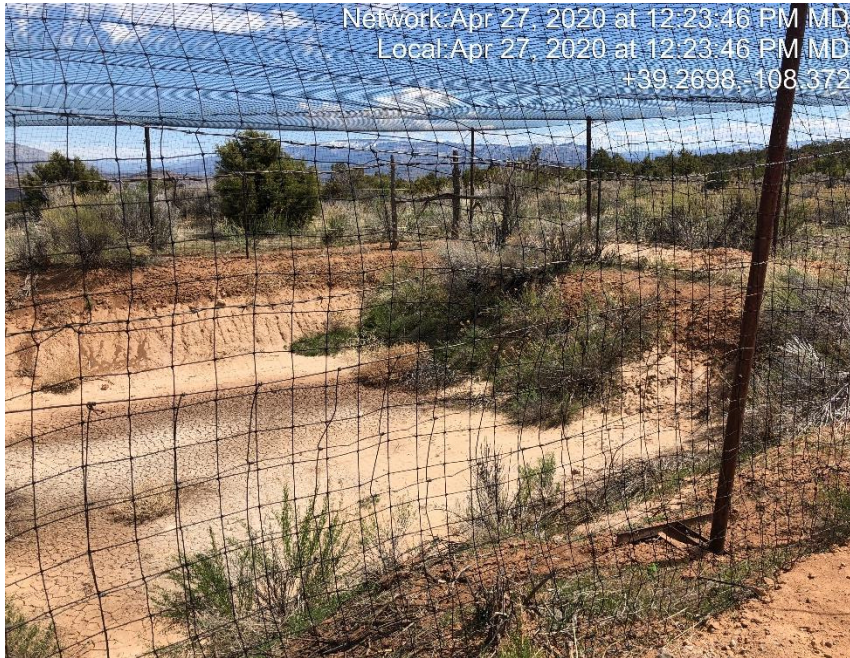
Photo #1055 Multiple places with debris on location.

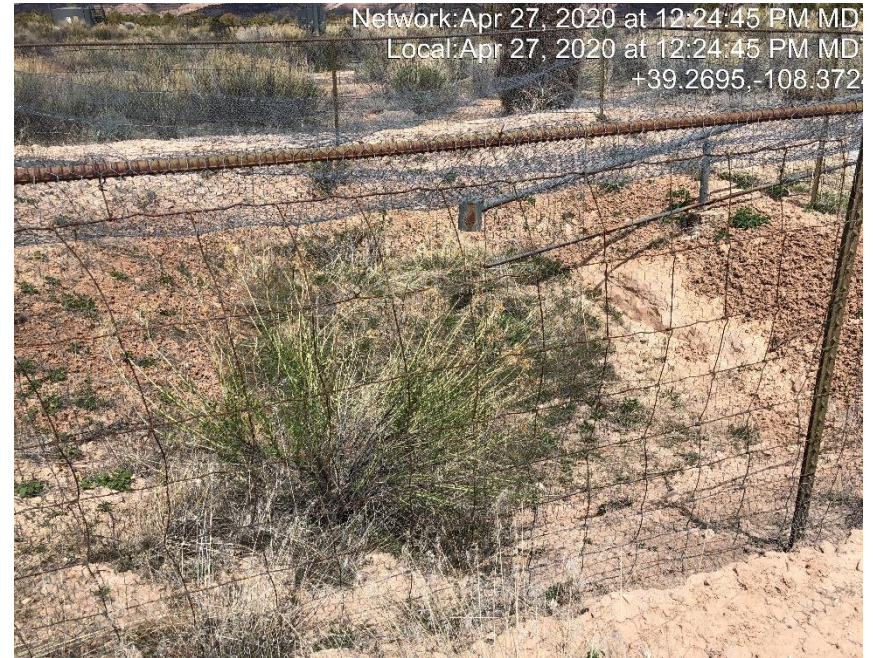
Photo #1056 Multiple places with debris on location.

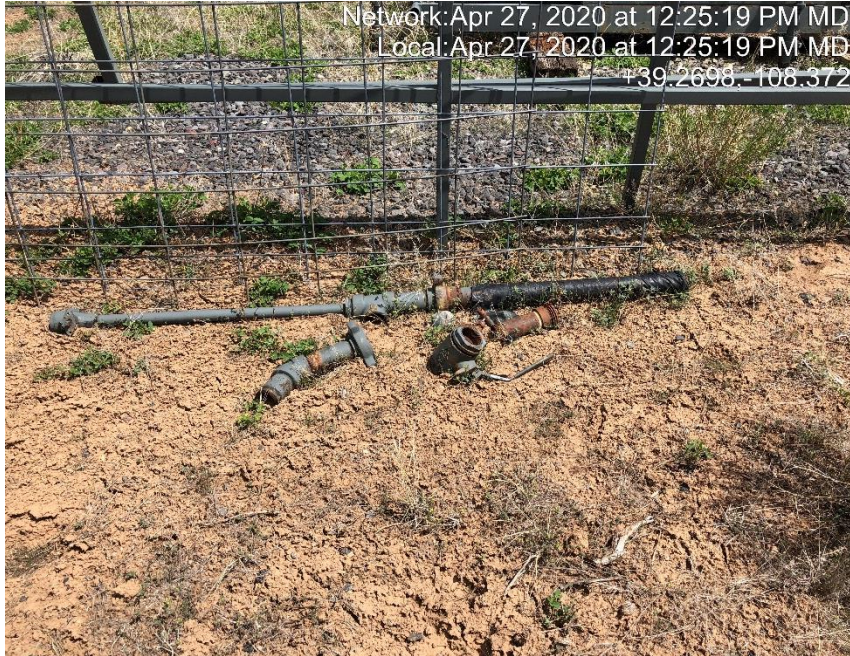
Photo #1057 Unused supplies and equipment.

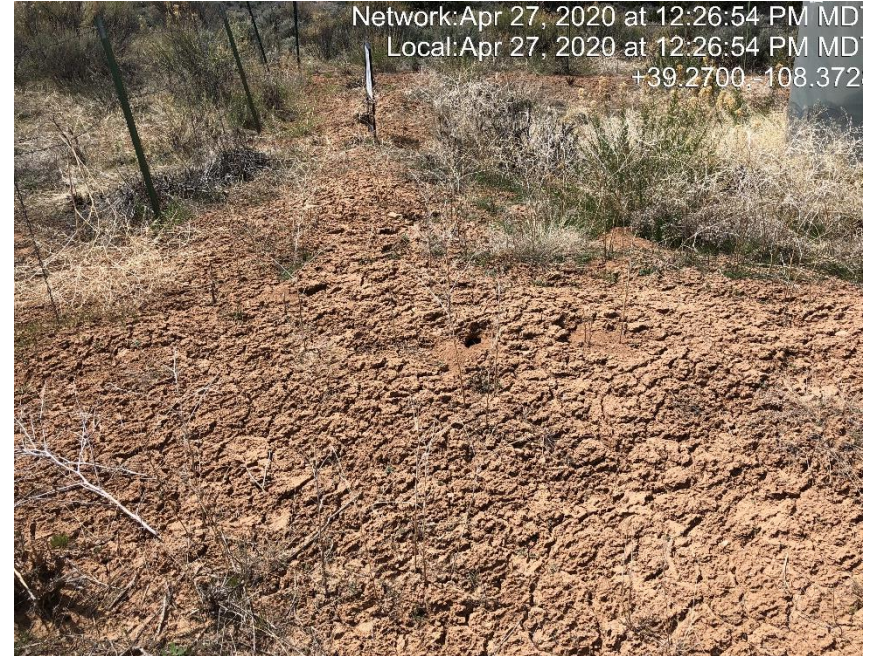
Photo #1060 Tank berm has eroded.
