Inspection Photos

Location Name: MARALEX RESOURCES INC SULFUR GULCH 9-98-21-69S98W /21NENE

Location ID: 312648

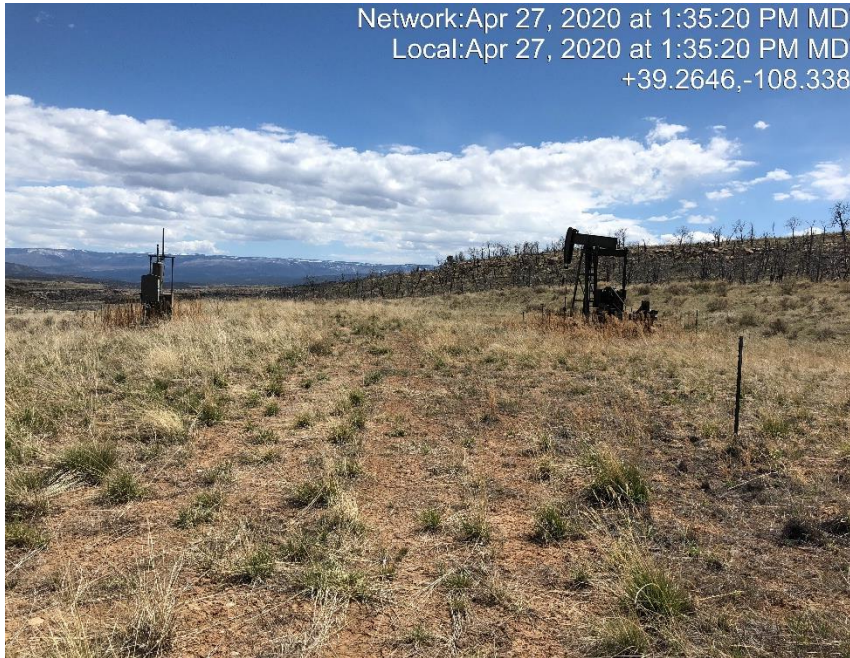
Photo #1062 from entrance to location

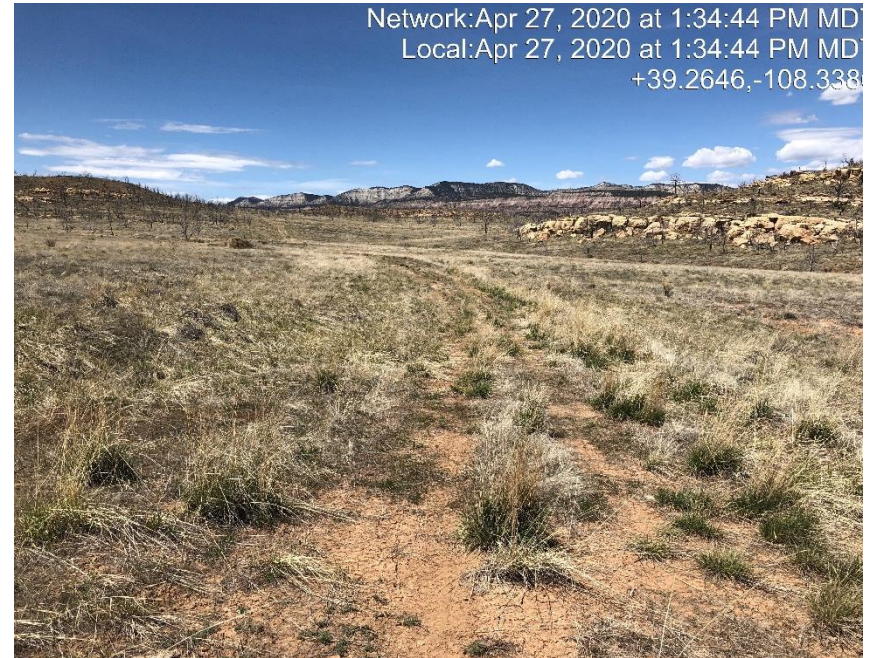
Photo #1061 Lease road has not been maintained.

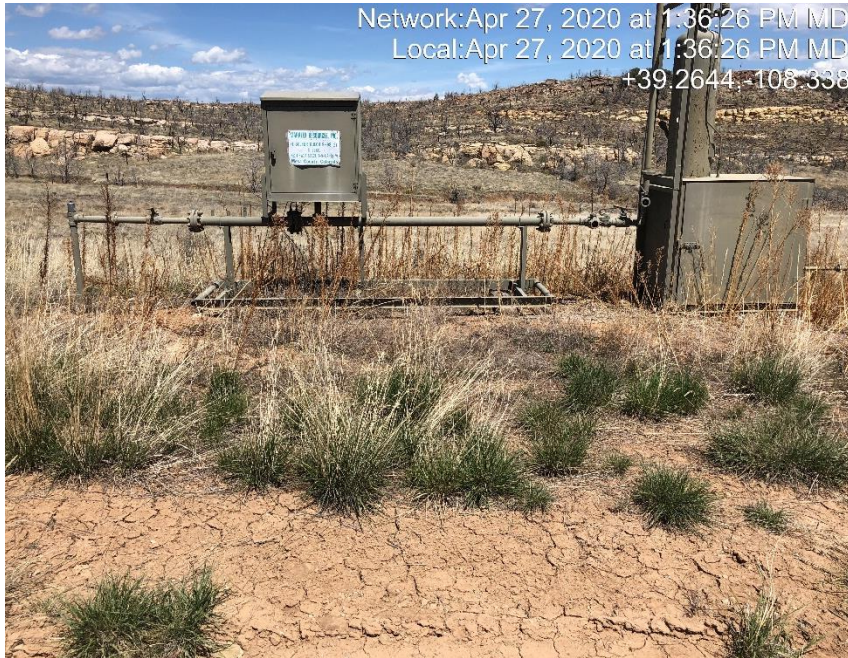
Photo #1064 Multiple places with debris on location.

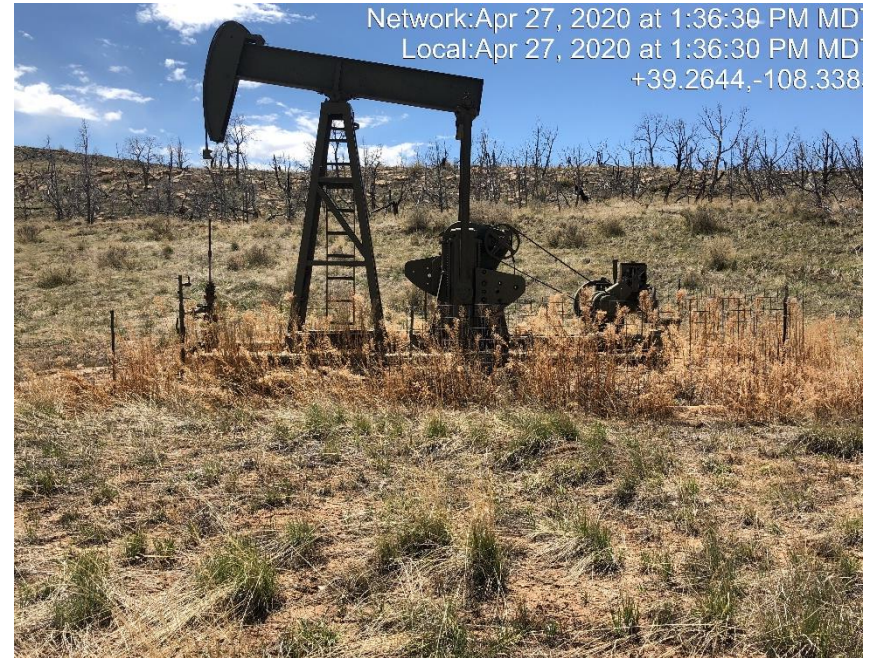
Photo #1065 Multiple places with debris on location.

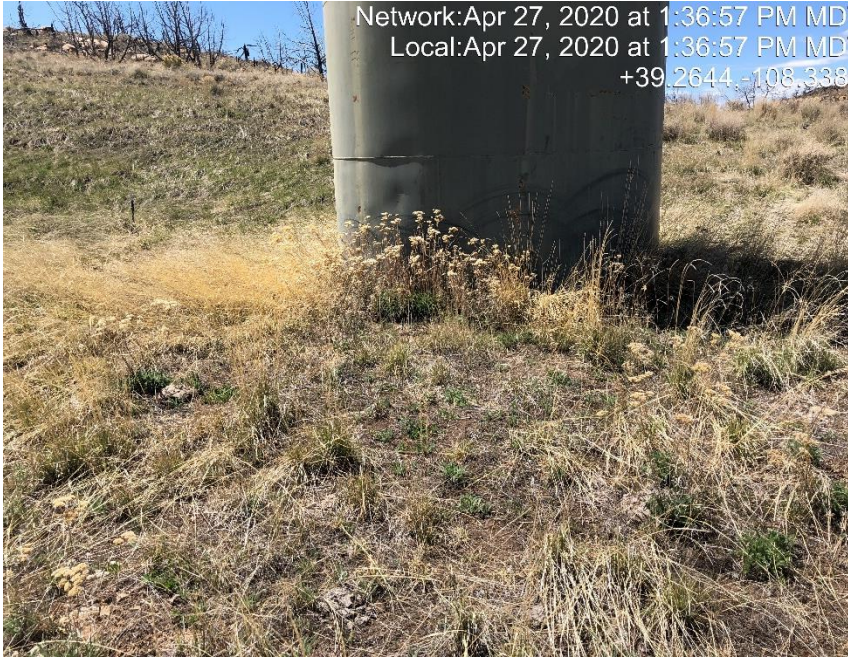
Photo #1066 Multiple places with debris on location.

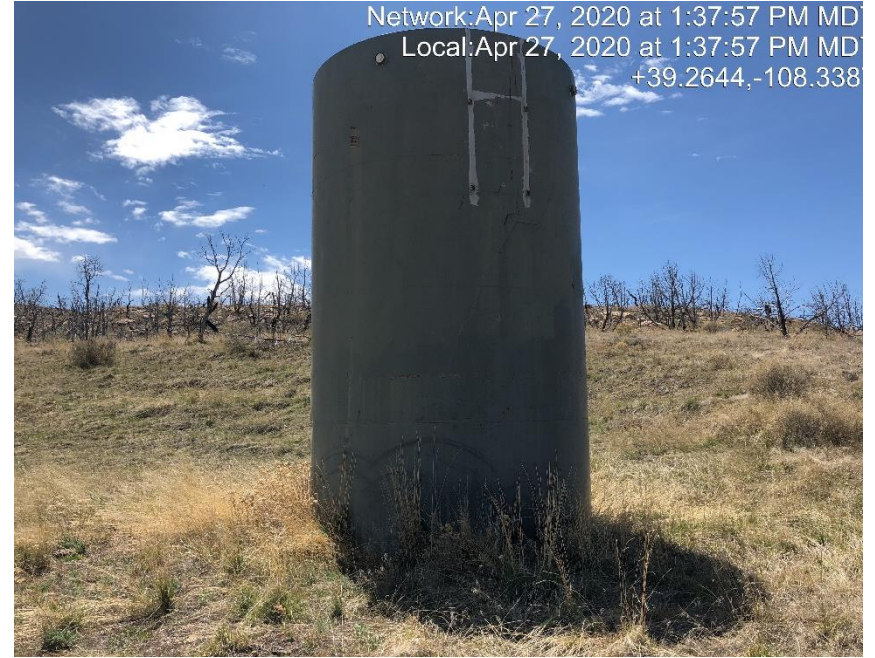
Photo #1068 Tank has been disconnected.
